**PHYSICAL CONDITION REPORT
FOR THE 2022 ROUTINE ELEMENT LEVEL AND FRACTURE CRITICAL INSPECTION**

SR 7 OVER SYMMES CREEK

BR#: LAW-7-02.40

**Inspected: September 27 through September 29, 2022
Report: December 19, 2022**

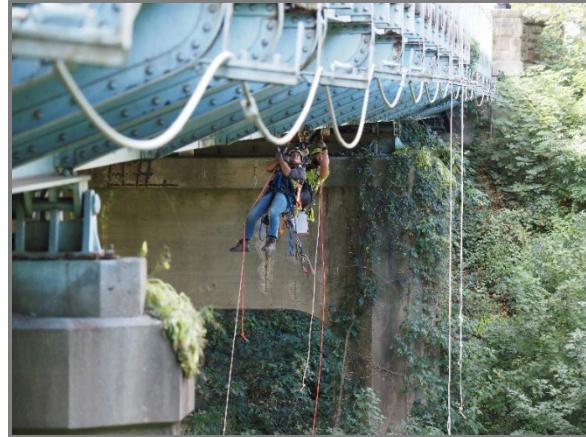
Photo 1 – Rope access inspection of Span 2 truss framing.

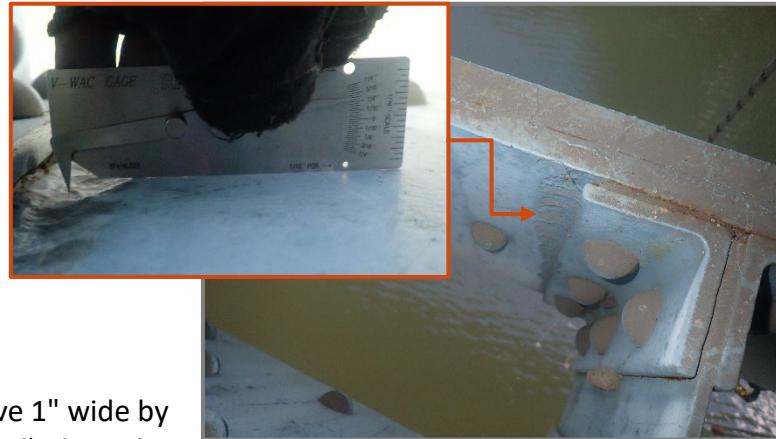
The truss lower chord members have 1" wide by up to 1/8" deep pitting (1/16" typical) along the full height of the exterior faces at the interfaces with the gusset plates and on the interior faces at the interfaces with the internal diaphragm angles (See Photo 21). On L6-L7 of the Right Truss, there is up to 1 1/8" thick pack rust between the interior and exterior web plates near L7 that has caused the top and bottom 4" of the interior plate to be bowed (See Photo 22). There is pack rust up to 5/8" thick between lower chord interior faces and the internal diaphragm angles and up to 1/4" thick between lower chord members and isolated splice plates and gusset plates.

Photo 21 – Full height by 1" wide by 1/8" deep pitting to the interior of L4-L5 outboard web along mid-length internal diaphragm angles on Right Truss, looking southeast.

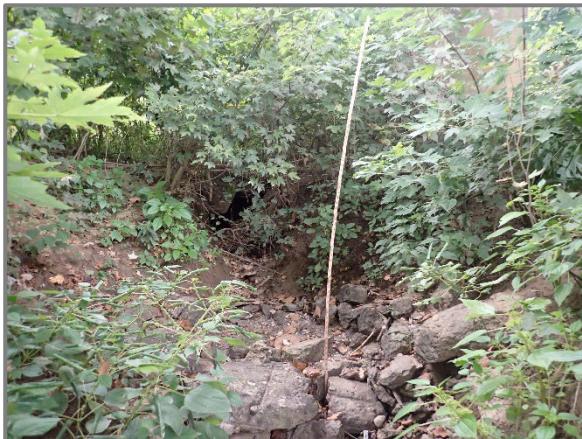
The channel, which flows between the piers in Span 2 at a skew, is in GOOD CONDITION [7-NBIS] overall with no scour noted around the substructure units (See Photo 44).

Photo 44 – General view of channel below Span 2, looking southeast.

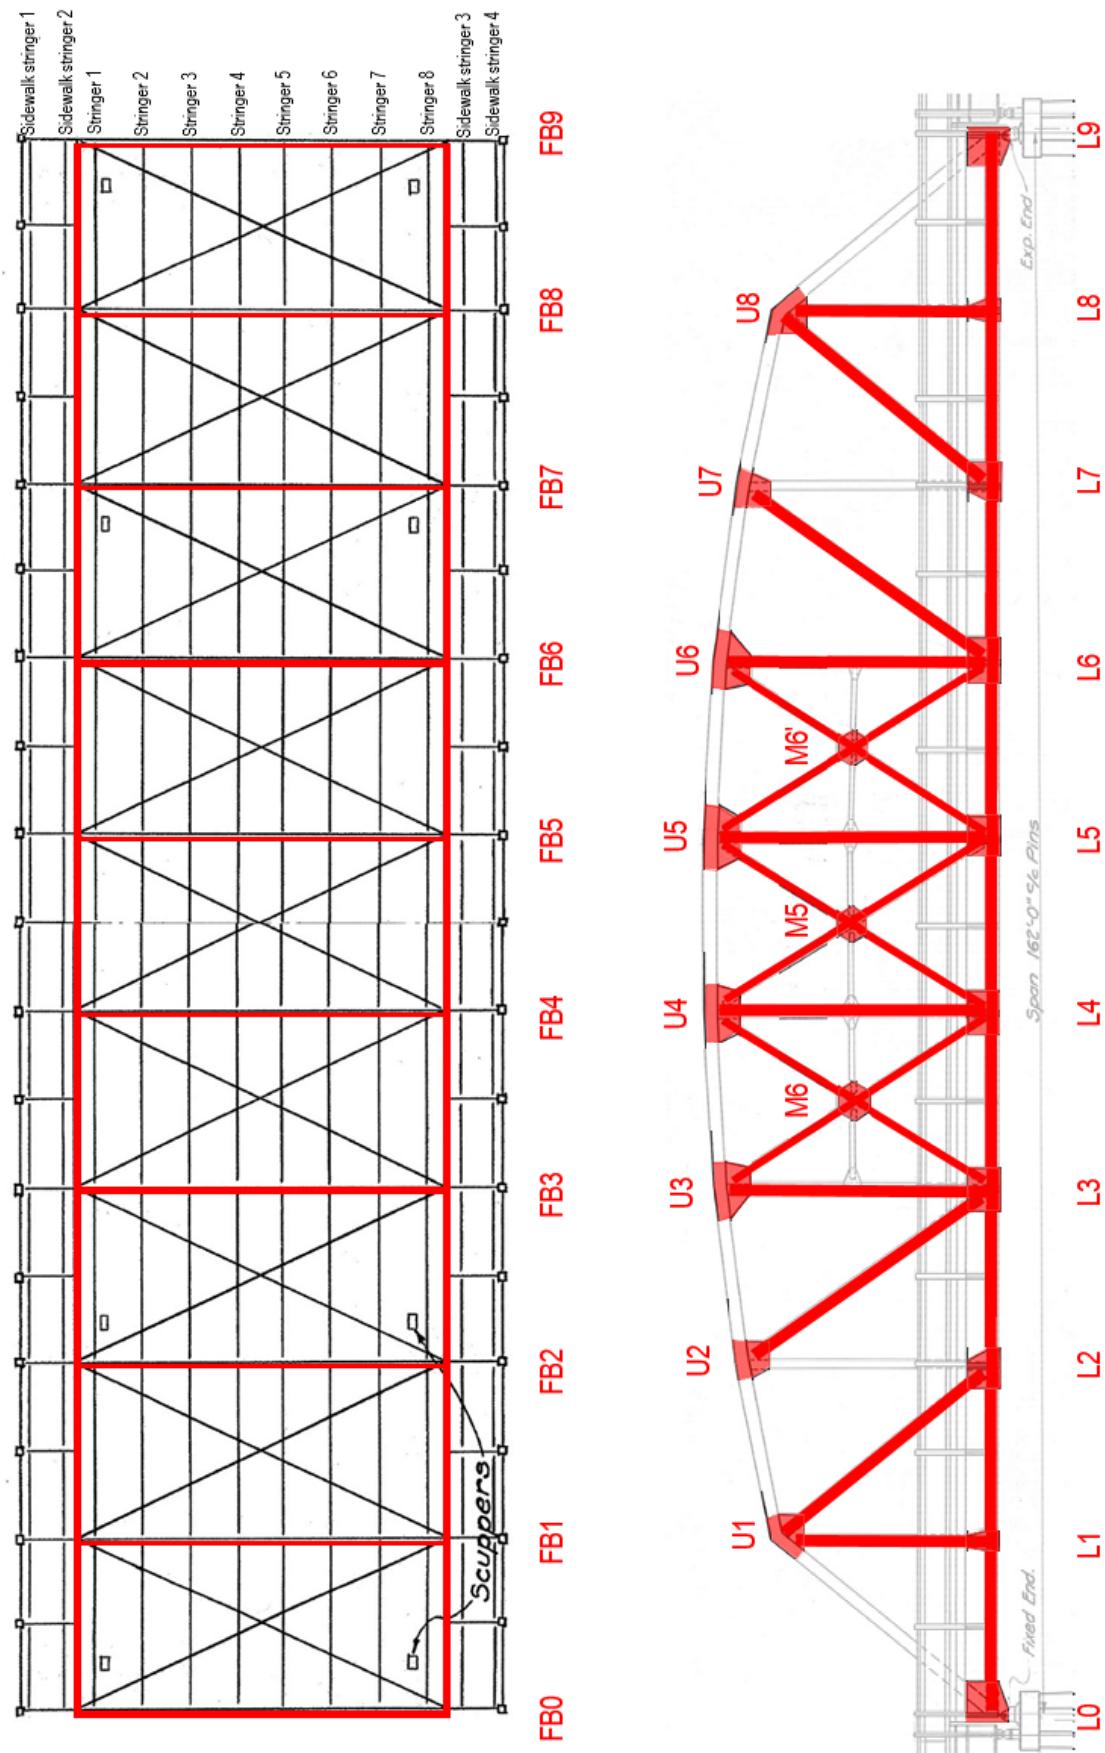
Figure 3 – Span 2 framing plan and truss south elevation (Images taken from the 1932 design drawings).
Lower chord members, diagonals, verticals (except U2-L2 & U7-L7), gusset plates, and floorbeams are fracture critical members.
