2000 PHYSICAL CONDITION REPORT

VETERANS' MEMORIAL BRIDGE OVER CUYAHOGA RIVER VALLEY

BRIDGE NO. CUY-6-1499
CUYAHOGA COUNTY, OHIO

**Ohio Department of Transportation
District 12**

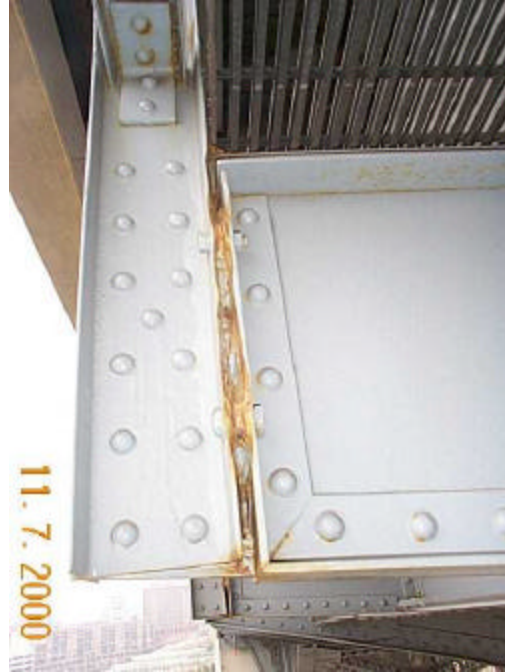
Holes and loss of section were also noted to numerous post channels throughout the span (Photo 14), as well as packrust (Photo 15) and missing bolts (Photo 16) between the end of the lower deck floorbeam and the vertical channel posts.

Photo 15 – Packrust between lower deck floorbeam and railing
dcp00195.jpg

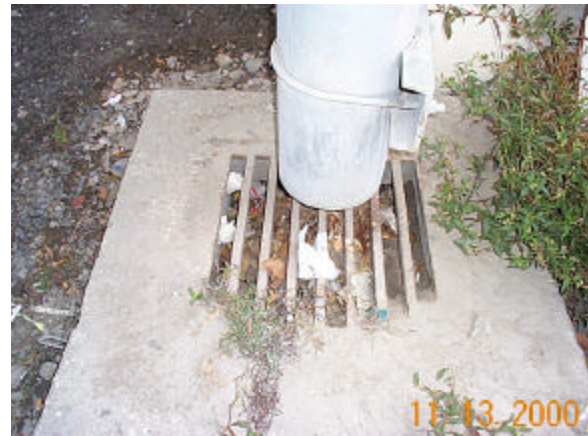
Storm sewer catch basins at the base of Pier 9, Pier 12, and the East Abutment were clogged with debris and vegetation (Photo 18).

Photo 18 – Pier 9 South Exterior clogged

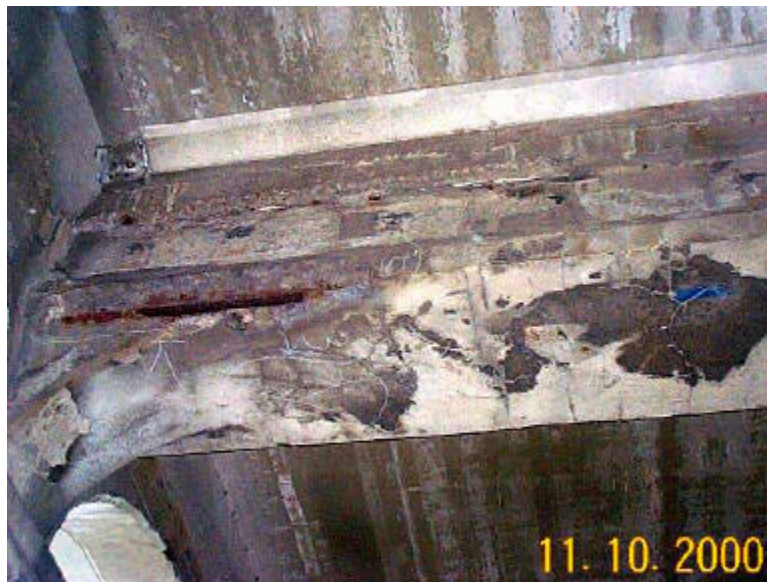
Photo 24 – Span 2, Floorbeam 8, South Bay (original)

There are three distinct and different upper deck floorbeams, which are based on the time of construction. These are floorbeams from original construction, floorbeams replaced during the 1967 rehabilitation and floorbeams replaced during the 1995 rehabilitation. All remaining floorbeams from original construction were strengthened during the 1967 rehabilitation. The majority of deficiencies to the floorbeams were found on those original floorbeams (Photo 24), with the other minor spalls and delaminations found on the 1967 rehabilitation replacement floorbeams. All the 1995 rehabilitation floorbeams were found to be in excellent condition.

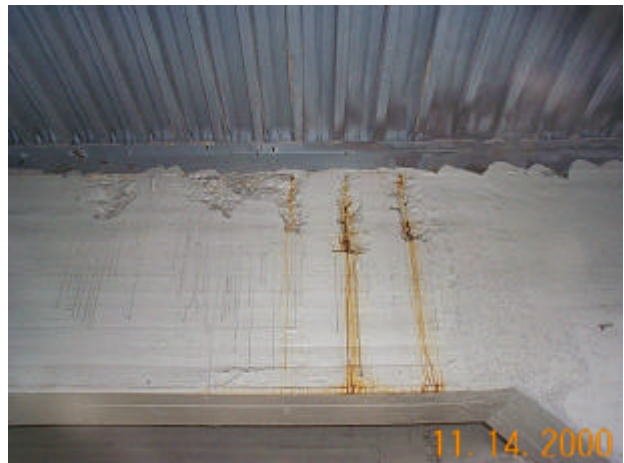
Photo 27 – Span 10, Floorbeam 5, South Bay
dcp00240.jpg

The lower deck floorbeams are in good condition. Generally, areas of delaminated concrete were noted to isolated, random floorbeams, while several other lower deck floorbeams have spalls with exposed reinforcing (Photo 26). While all the spalls have been sealed, bleeding and rust staining due to active corrosion is present at some locations (Photo 27). Minor hairline flexural and map cracks were noted but are not significant at this time.

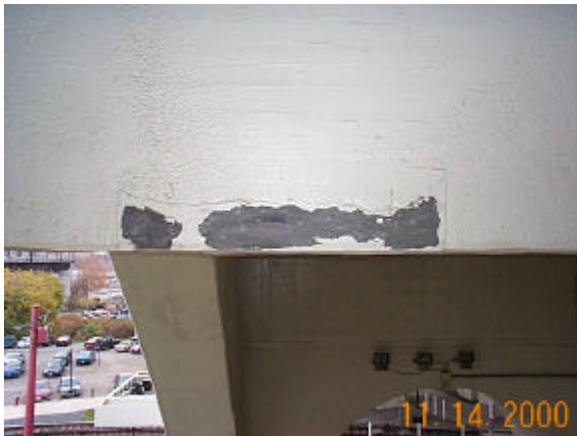
Photo 29 – Span 12, Floorbeam 4, South Bay
dcp00245jpg

In Span 12, spalls, cracks and crumbling concrete patches were noted. There are horizontal cracks at the south end of floorbeams 5 and 6 (Photo 28). A crumbling patch over Robert Lockwood Jr. Drive was noted on the east face of floorbeam 4 in the south bay (Photo 29). Similarly, a second poor patch with voids is located on the east face of floorbeam 6 in the center bay (Photo 30).

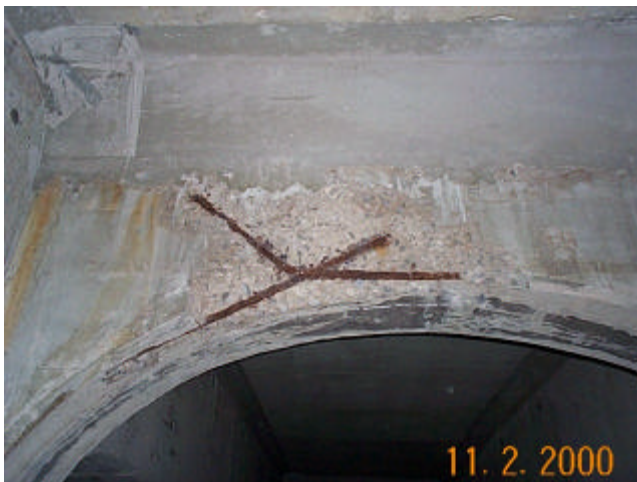
Photo 32 – Span 1A, North Interior
Jack Arch between FB 6 & 7

The upper deck jack arches are in good condition. Sporadic areas of voids, cracking and delamination (Photo 31) were noted, mainly in spans 1A and 1B and the north interior column line in span 2. There are two spalls with exposed reinforcing in span 1A at the north interior jack arch between floorbeam 5 and 6 and floorbeams 6 and 7 (Photo 32).

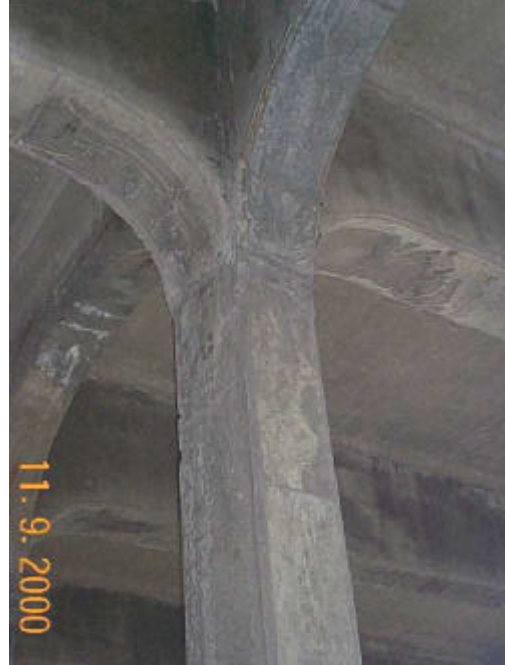
Photo 36 – Span 3, North Interior Col. 13
dcp00212.jpg

Cracks, delamination and spalls to the corbel detail were noted throughout the concrete spans (Photo 35). Additionally, three columns in span 3 were replaced without the corbel detail (Photo 36). Minor spalls with exposed reinforcing were observed in spans 1A and 1B, typically near the corbel detail (Photo 37).

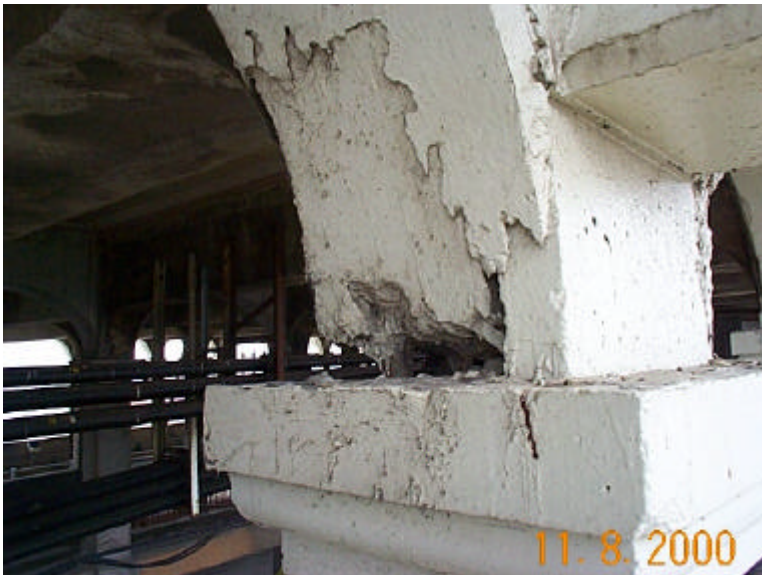
Photo 39 – Span 2, South
Exterior Column 7
dcp00211.jpg

Several columns also had spalls and/or voids to the column core above the corbel detail (Photos 38 and 39).

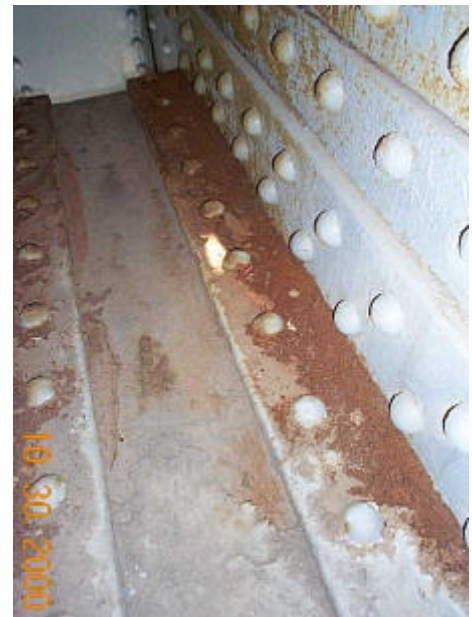
Debris and most noticeably sand blasting material from the recent rehabilitation are present at random locations throughout the steel span. Some of the material has been painted over (Photo 44). The amounts of accumulation of debris ranges from minor to moderate (Photo 45).

Photo 45 – Debris and Blast
Material

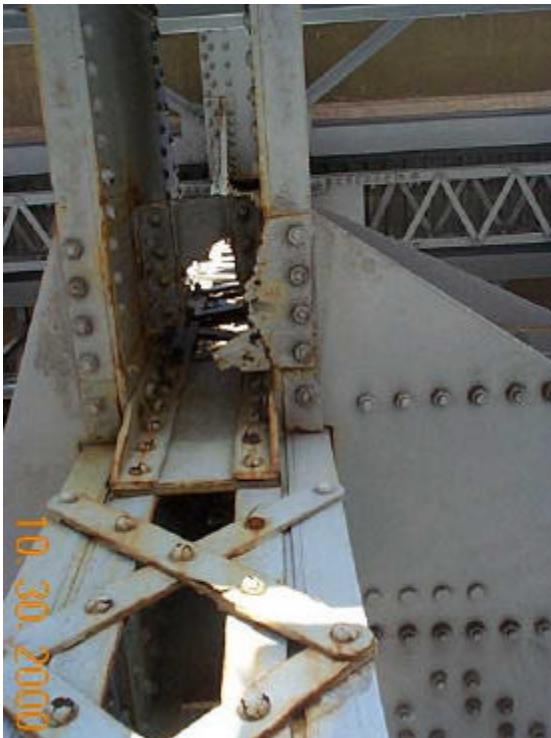
Photo 47 - South Arch U2-L2, flaking on lacing bars

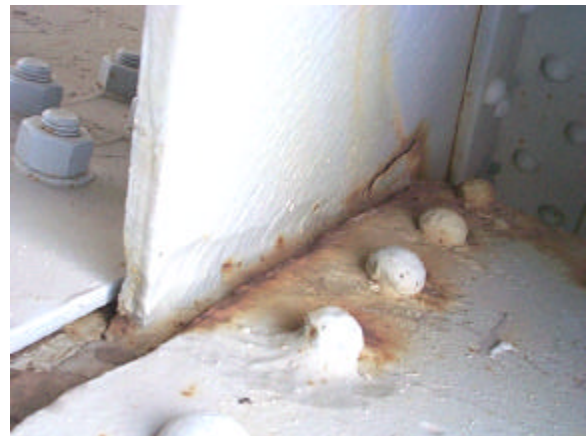
Photo 50b - North Arch South Gusset Plate
at L1'
dcp00330.jpg

The main truss gusset plates from Panel Points L1 to L4 and L1' to L4' have up to 30% section loss above the top flange of the lower chord (Photo 50a). Typically these plates have 1/8" to 1/4" loss in the area 2" above the lower chord and top lateral bracing gusset plates to both the exterior and interior faces. Throughout the life of the bridge, water has infiltrated through the upper deck truss openings and run along the top flange of the lower chord. This has caused early paint failure to the gusset plates, exposing the corrosion-resisting nickel steel. Currently, corrosion is beginning to reappear at these locations (Photo 50b).

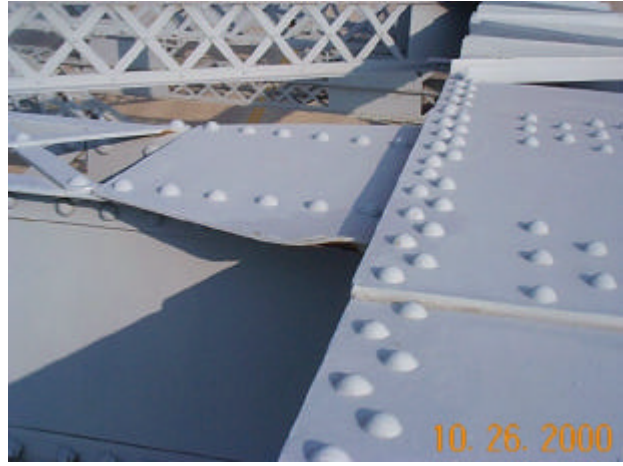
Packrust between the bottom bracing members and gusset plates was noted (Photo 58). Isolated areas of construction damage were also noted, including a bent horizontal gusset plate at U5' at the south arch (Photo 59). Water and debris accumulates in the uphill angle legs of horizontal bracing members.

Photo 59 - Bent Gusset at U5', South Arch

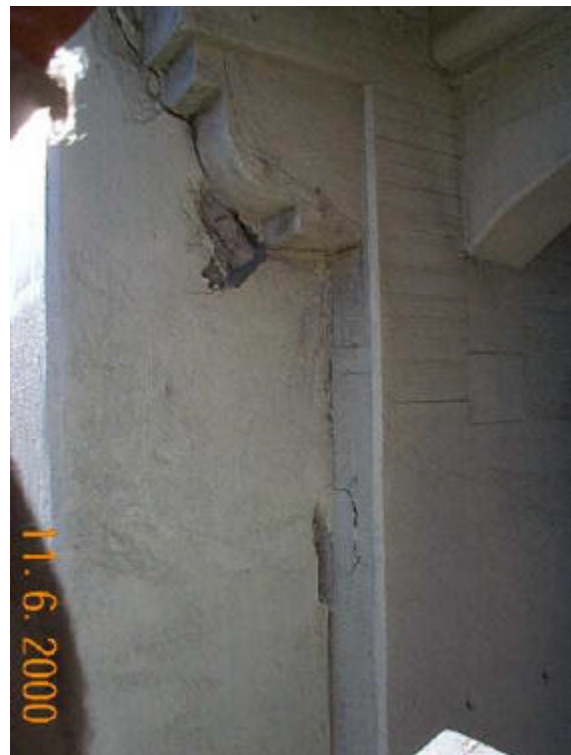
Photo 63 – Pier 9

The piers are in generally good condition. Cracks, delaminations, and/or spalls to the pier shafts are common, especially near corbel details and the interface between the lower pier shafts and adjacent end columns (Photos 62 & 63).

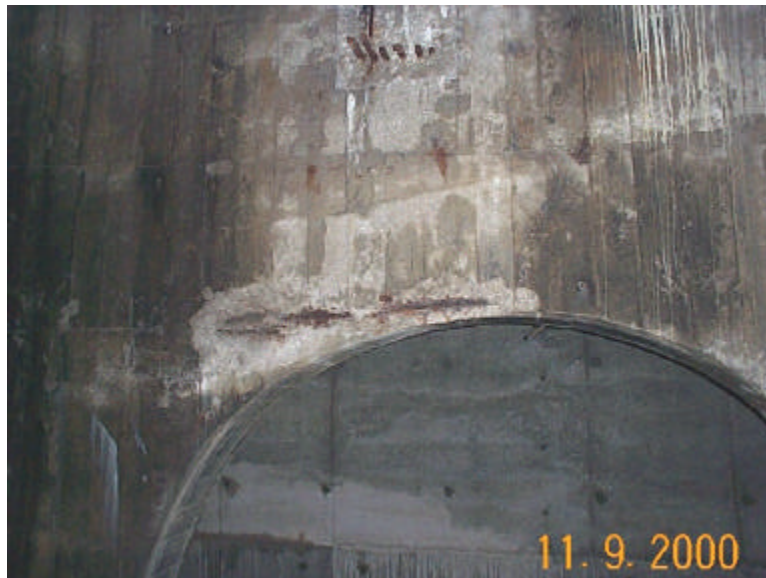
Photo 65 – Pier 3 North Interior Bay

Pier 3 and Pier 4 have extensive delaminations and spalls on the interior faces of the towers (Photo 64). The interior arches are also spalled with exposed reinforcing (Photo 65).

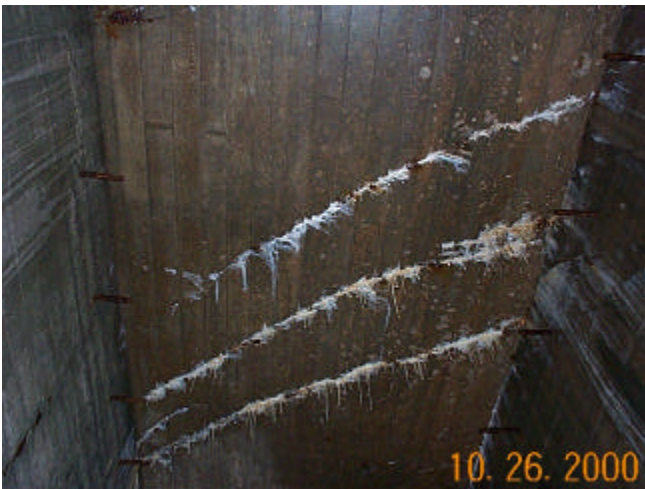
Photo 68 – South Cell, Roof Slab (1st cell from the West end)

The condition of the cellular construction is fair. There are areas of heavy cracking with efflorescence and spalls with exposed reinforcing to the walls and roof slabs in both the south and north bays (Photo 67, 68 & 69)

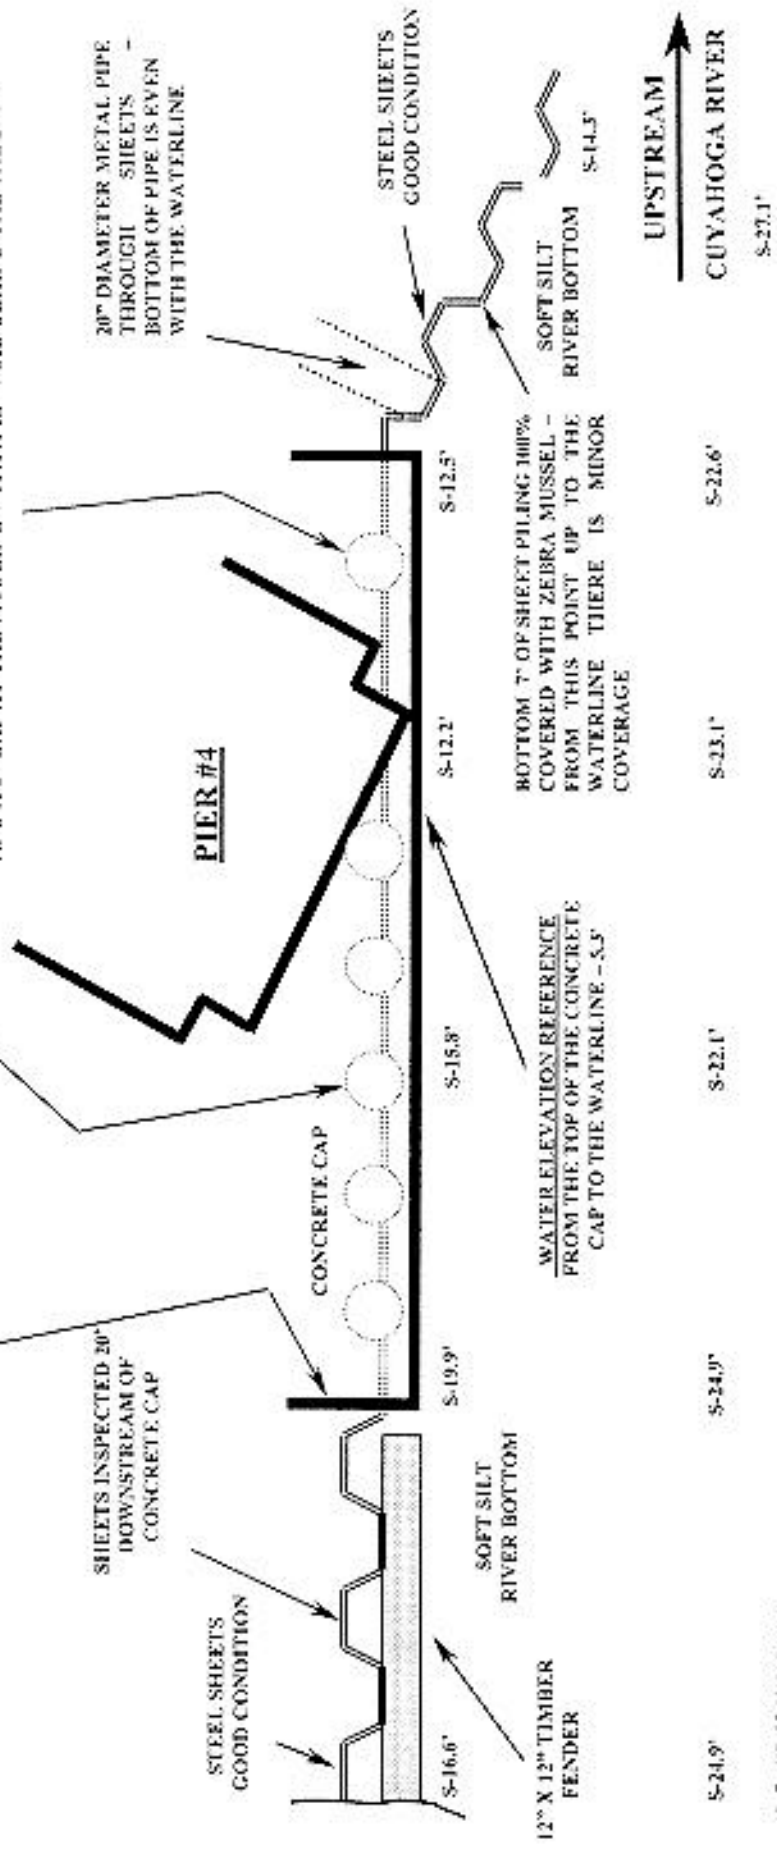
WHERE THE DOWNSTREAM SHEETS JOIN THE CONCRETE PIER COLUMN THERE IS APPROXIMATELY 5' OF THE CONCRETE FACE EXPOSED. WHERE THE STEEL SHEETS JOIN THE CONCRETE PIER COLUMN THERE IS 3" GAP AT THE TOP AND A 6" GAP AT THE MUDLINE WITH A 2.5' DEEP VOID BEHIND THE SHEETS.

WHERE THE UPSTREAM SHEETS JOIN THE CONCRETE PIER COLUMN THERE IS APPROXIMATELY 1' OF THE CONCRETE FACE EXPOSED. WHERE THE STEEL SHEETS JOIN THE CONCRETE PIER COLUMN THERE IS A 4" GAP AT THE TOP AND A 8" GAP AT THE MUDLINE WITH A 1.5' VOID BEHIND THE SHEETS.
