# 2010 PHYSICAL CONDITION REPORT

## CUY - 00006 - 1456 DETROIT-SUPERIOR BRIDGE OVER THE CUYAHOGA RIVER

**SFN 1800930**

**INSPECTED: AUGUST 30, 2010 THROUGH OCTOBER 3, 2010**

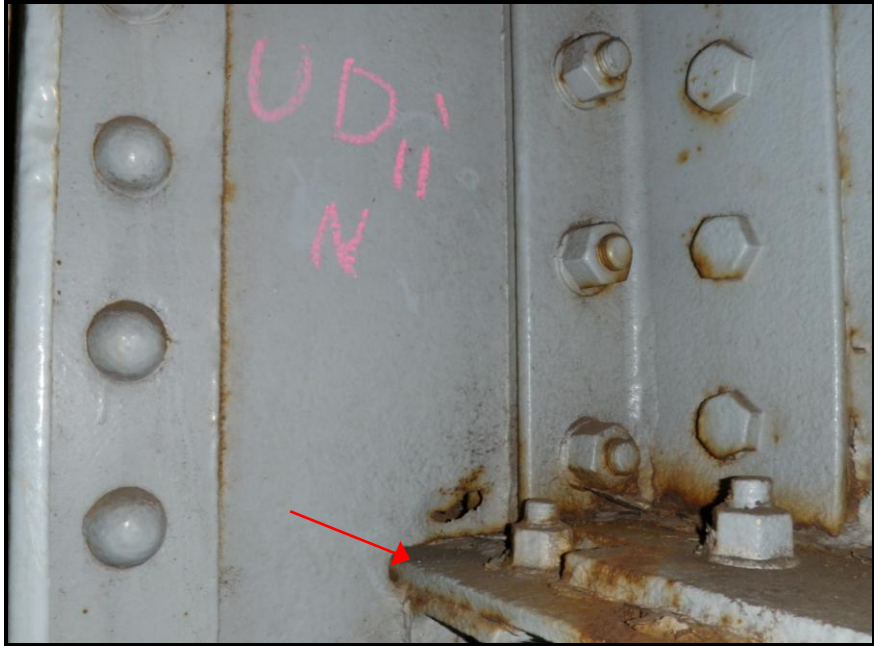
All of the steel floor beams in span 4 have active corrosion and pitting below the openings in the deck where the hangers connect to the trusses. In addition, some of the floor beams have small through holes. The through holes in the north sides of FB-U12, FB-U11', FB-U8' and FB-U6' have not changed since last inspection (See Photos 15 - 18). There are circular welds in the south sides of the webs of FB-U2' and FB-U1' near the connections with the south truss. These welds are cracked. The northern cracked weld in FB-U2' was previously noted, but the crack has grown. The southern cracked weld in FB-U2' and the cracked weld in FB-U1' are new (See Photos 19-22).

*Photo 16: Hole in FB-U11'-N Showing No Change from Previous Inspection*

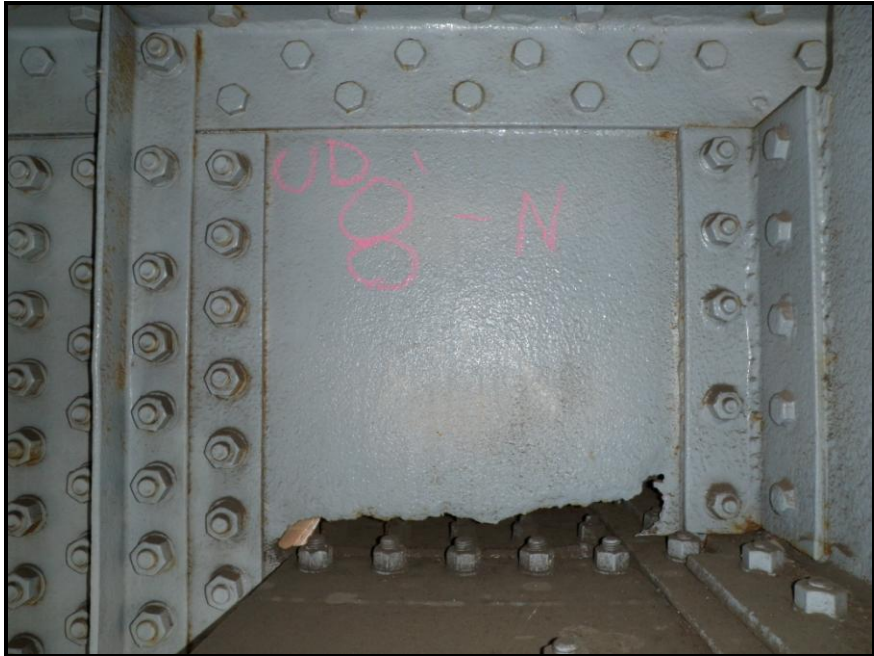
*Photo 17: Hole in FB-U8'-N Showing No Change from Previous Inspection*

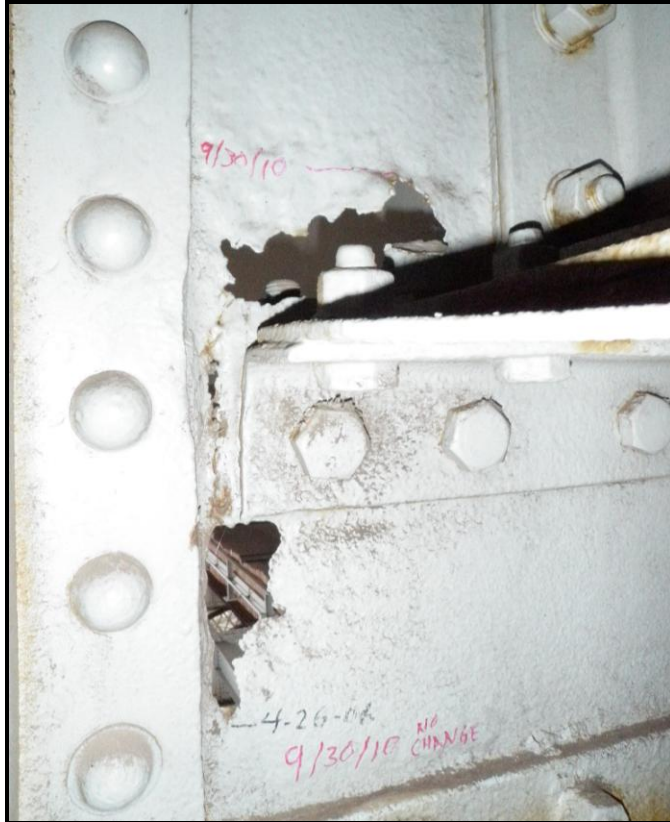
*Photo 18: Hole in FB-U6'-N Showing No Change from Previous Inspection*

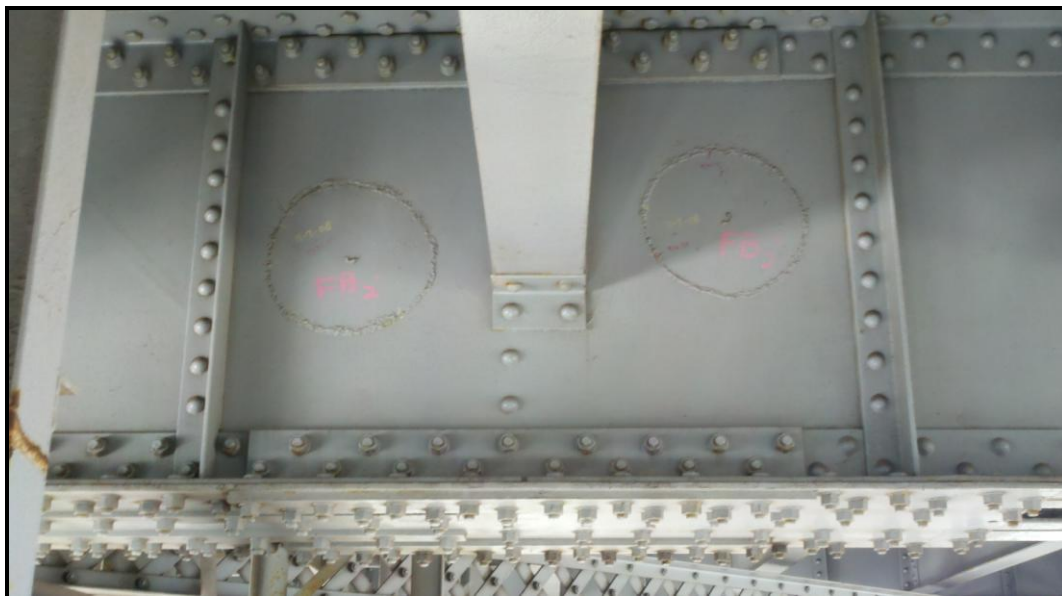
*Photo 19: Showing Location of Circular Welds in the South End of FB-U2'*

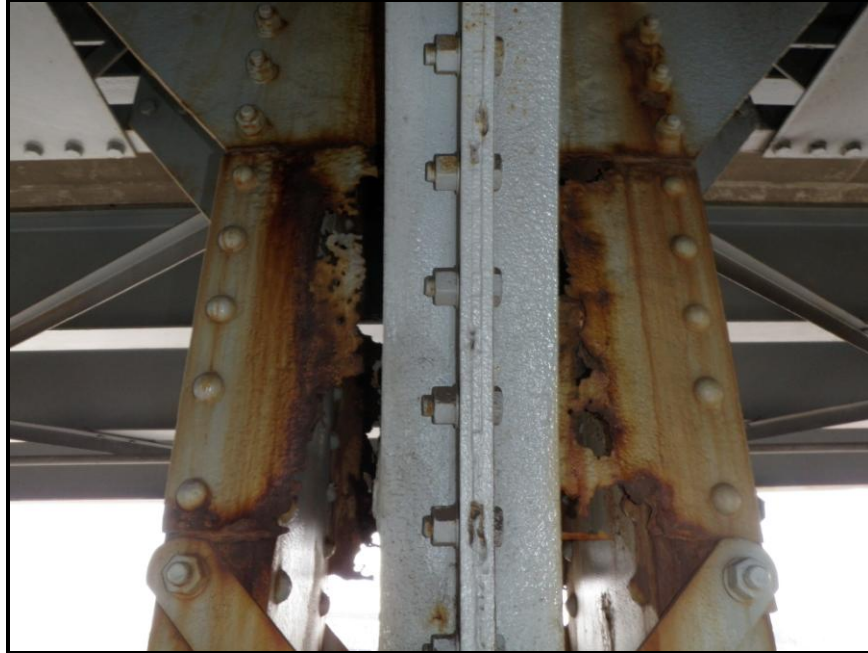
*Photo 29: Through Holes in Cover Plate of L<sub>0</sub>-S Vertical*

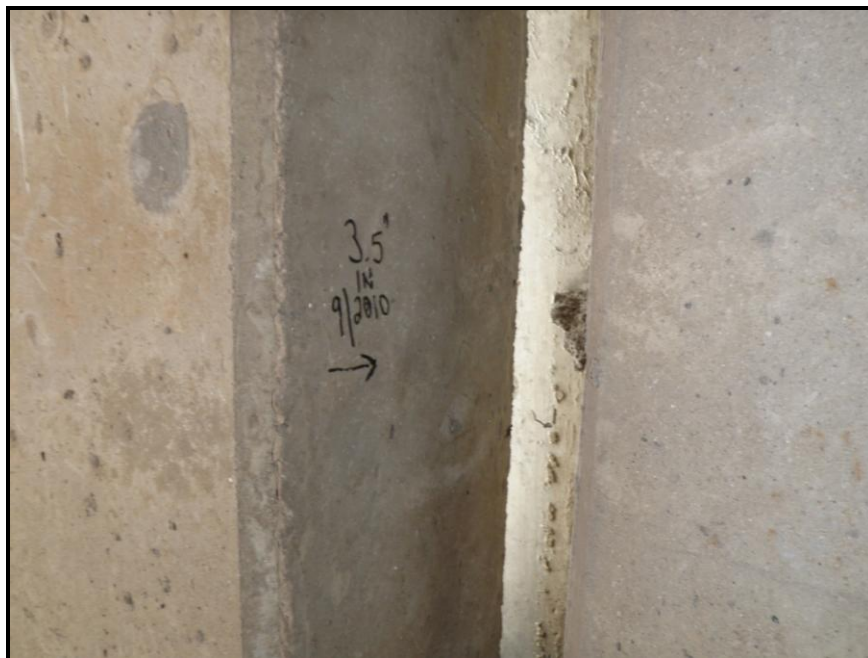
*Photo 56: Gap Measurement between the East Edge of Tower B Showing the Amount of Rotation Away from the Surrounding Structure*

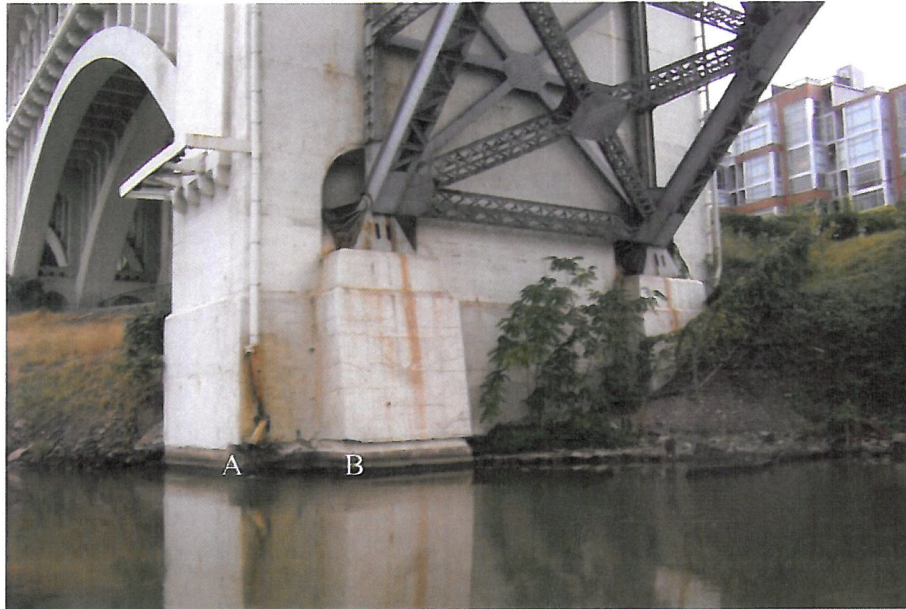
- The concrete surfaces had up to 1 ½-inch deep scaling typical with exposed aggregate. The conditions in the splash zone and at the corners were much worse. Photos 5, 6 and Figure 2 show heavy scaling and large corner spalls. The corner spall in the splash zone at corner A is 2 feet deep and 2.9 feet tall. It continues in both directions, eventually diminishing to the typical scaling discussed above. Likewise the corner spall in the splash zone at corner B is 1.3 feet deep and 3.7 feet tall. Both corners are rounded from the splash zone to the bottom. No exposed reinforcing steel was detected in these spalls.

*Photo 5 – Facing West. East face of Pier 3.  
Note Scupper Pipe disconnected allowing water to run down the east face of the Pier 3.*

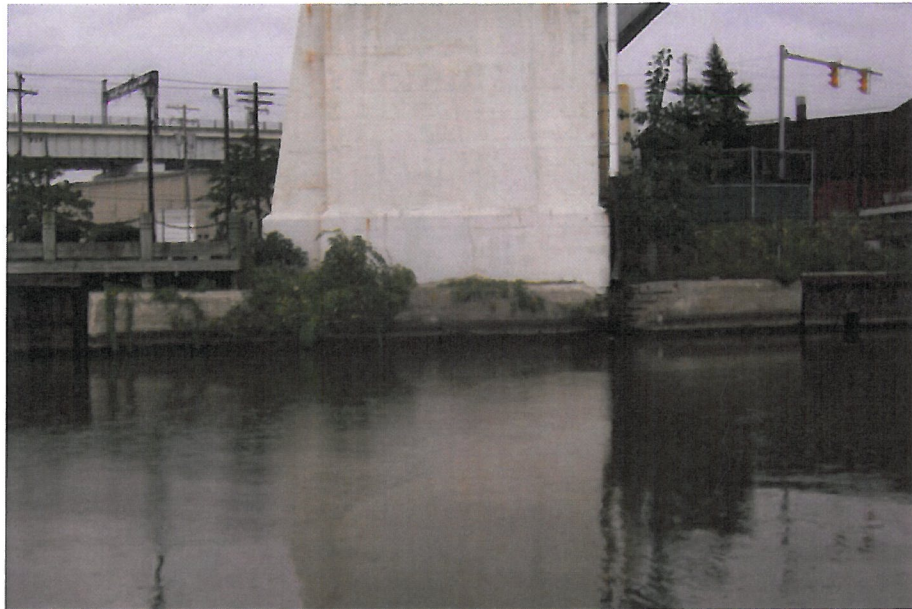
- The concrete surfaces had up to 1 ½-inch deep scaling typical with exposed aggregate. The conditions in the splash zone and at the corner were worse. The deterioration of the pier concrete at the corner below the horizontal construction joint (splash zone) is approximately 5 inches deep, 1-foot wide and 4 feet tall. This surface is shown in Photos 7 and 8. No exposed reinforcing steel was detected on the bridge pier.

- The bridge scupper drain pipe drips directly onto the river bank wall concrete cap adjacent to the pier corner. The concrete wall cap surrounding the corner of the pier has failed exposing its horizontal reinforcing steel. The 69-foot long wall cap is approximately 30 inches wide by 7 feet tall. This cap intersects the corner of the bridge pier 21 feet from its upstream end (Photos 7 and 8).

*Photo 7 – Facing Southeast. North face of Pier 4  
with concrete cap and adjacent steel sheet pile walls.*

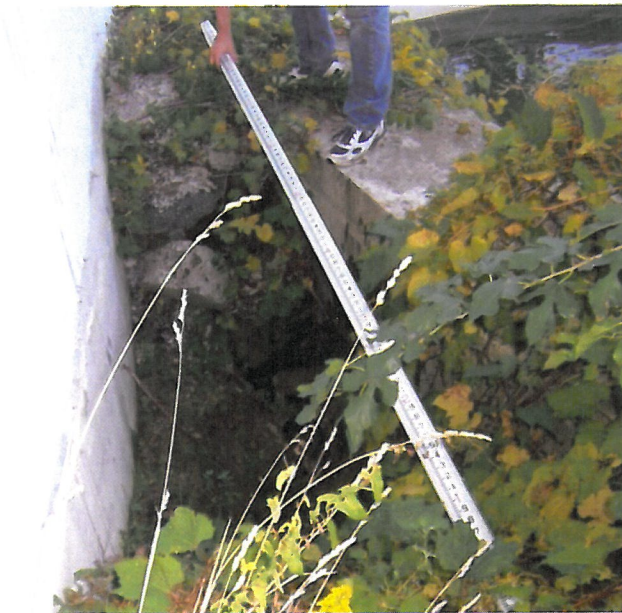
- There is a sinkhole on the surface along the north face of Pier 4 that is 4 feet wide, 8.5 feet long and 5 feet deep. Water was visible at the bottom of the sinkhole. This sinkhole has more than doubled in size since the 2003 inspection (see Photo 10). The backfill material, reinforcing steel and concrete made it impossible to probe perfectly vertical into the bottom of the sinkhole. However, the survey rod was lowered 17 feet into this hole at an angle suggesting a large void below the waterline. The diver probed into this cavity from the outside a distance of 8.1 feet. This is described below and shown in Figure 3.

Photo 10 – Facing Southwest. Sinkhole between Pier 4 and wall concrete cap. Sinkhole is 4 feet wide by 8.5 feet long by 5 feet deep with the water surface visible.

The bank material between the north face of Pier 4 and the retaining wall continues to wash out creating a larger sinkhole on the surface and void below it. There is a pedestrian sidewalk nearby without a sufficient fence separating the two. This sinkhole is a potential liability and should be excavated, the void inspected underwater and finally backfilled with large riprap stone.

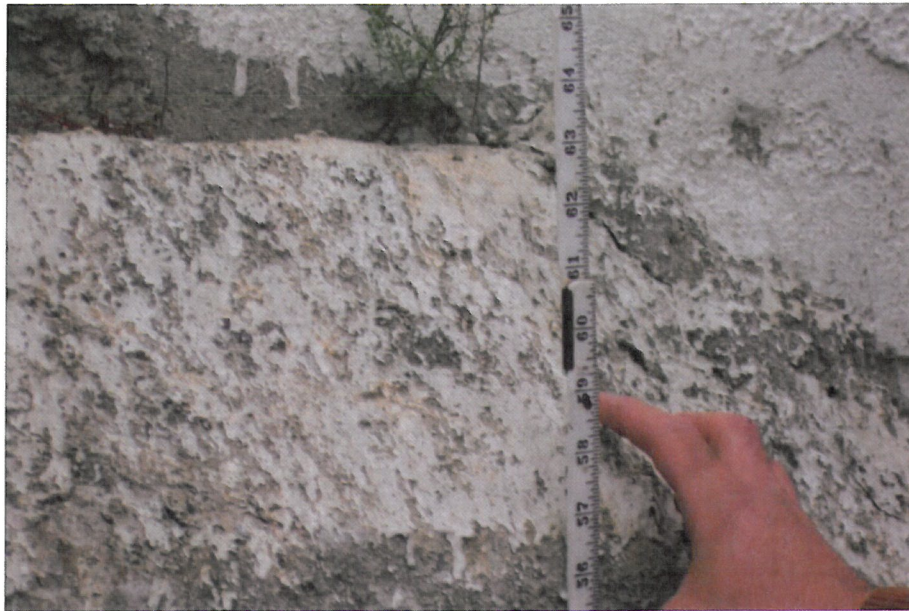
The top surface of the wall concrete cap on the west side of Pier 4 was chosen as the hydrographic reference point. The water surface was measured to be 5.25 feet below this point (see Photo 11).

*Photo 11 – Facing South. Hydrographic Reference Point  
Top of wall concrete cap next to Pier 4 is 5.25 feet above the water surface.*

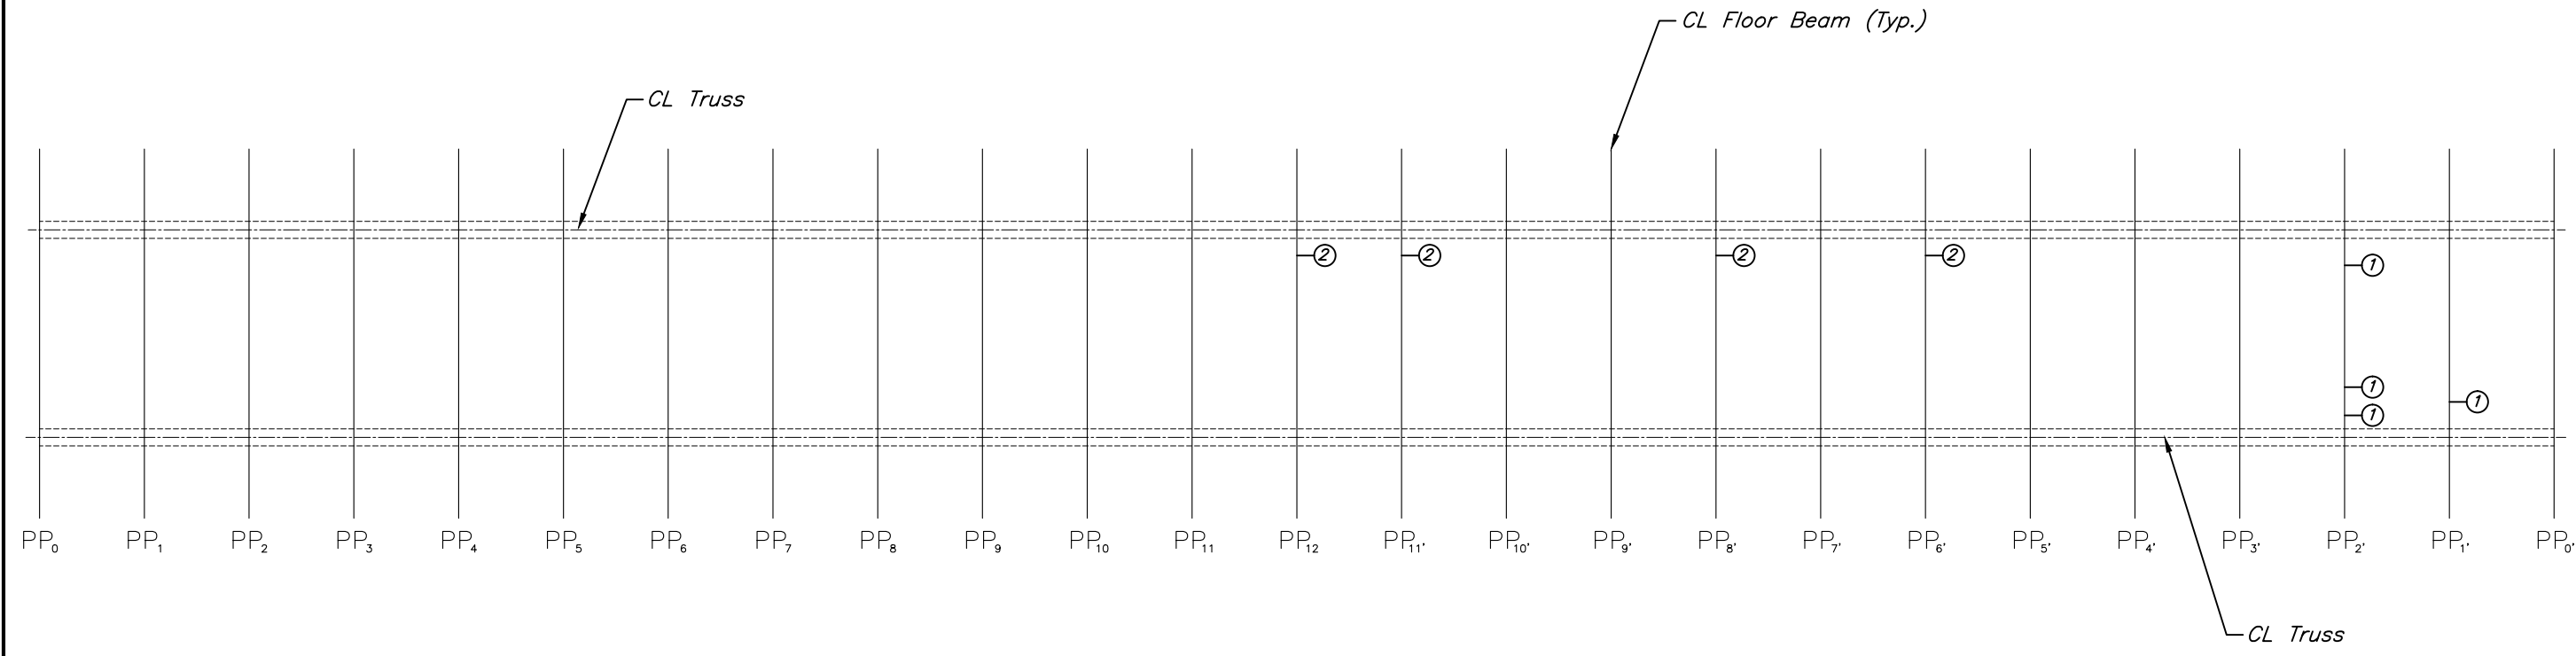
**PLAN - SPAN 4  
DEFICIENCY MAP**

*Span 4:*  
The stay-in-place forms are corroded

There are transverse cracks where utility pipes enter the deck. Cracks typically cross 2 stringers or 3 panels, between L<sub>8</sub>-L<sub>9</sub> and L<sub>8</sub>'-L<sub>9</sub>'

There are spalls with exposed reinforcing, between stringer lines C & D, located between pane points L<sub>7</sub>-L<sub>8</sub> (2 spalls), L<sub>11</sub>-L<sub>12</sub>, L<sub>12</sub>'-L<sub>11</sub>' & L<sub>1</sub>'-L<sub>0</sub>'
