CUV-06-1458  
Project Number

Veteran's Memorial Bridge (Detroit Superior Bridge)  
over the Cuyahoga River in Cleveland, Ohio  
Bridge Name

Oct 2, 2010  
Inspection Date

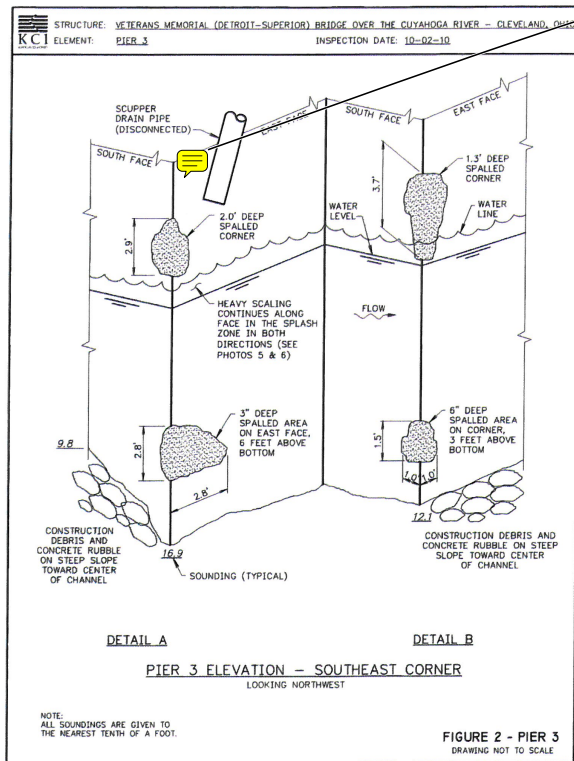
Photo 6 – Facing North. Southeast corner of Pier 3.  
Note the Scaling and Spalling of the concrete at the construction joint.
