***2015 BRIDGE INSPECTION  
FIELD REPORT***

## BRIDGE INSPECTION FIELD REPORT

Inventory Bridge Number: CUY 00006 14.560 N

USR 6 over (1499)CUY. RIVER & RTA

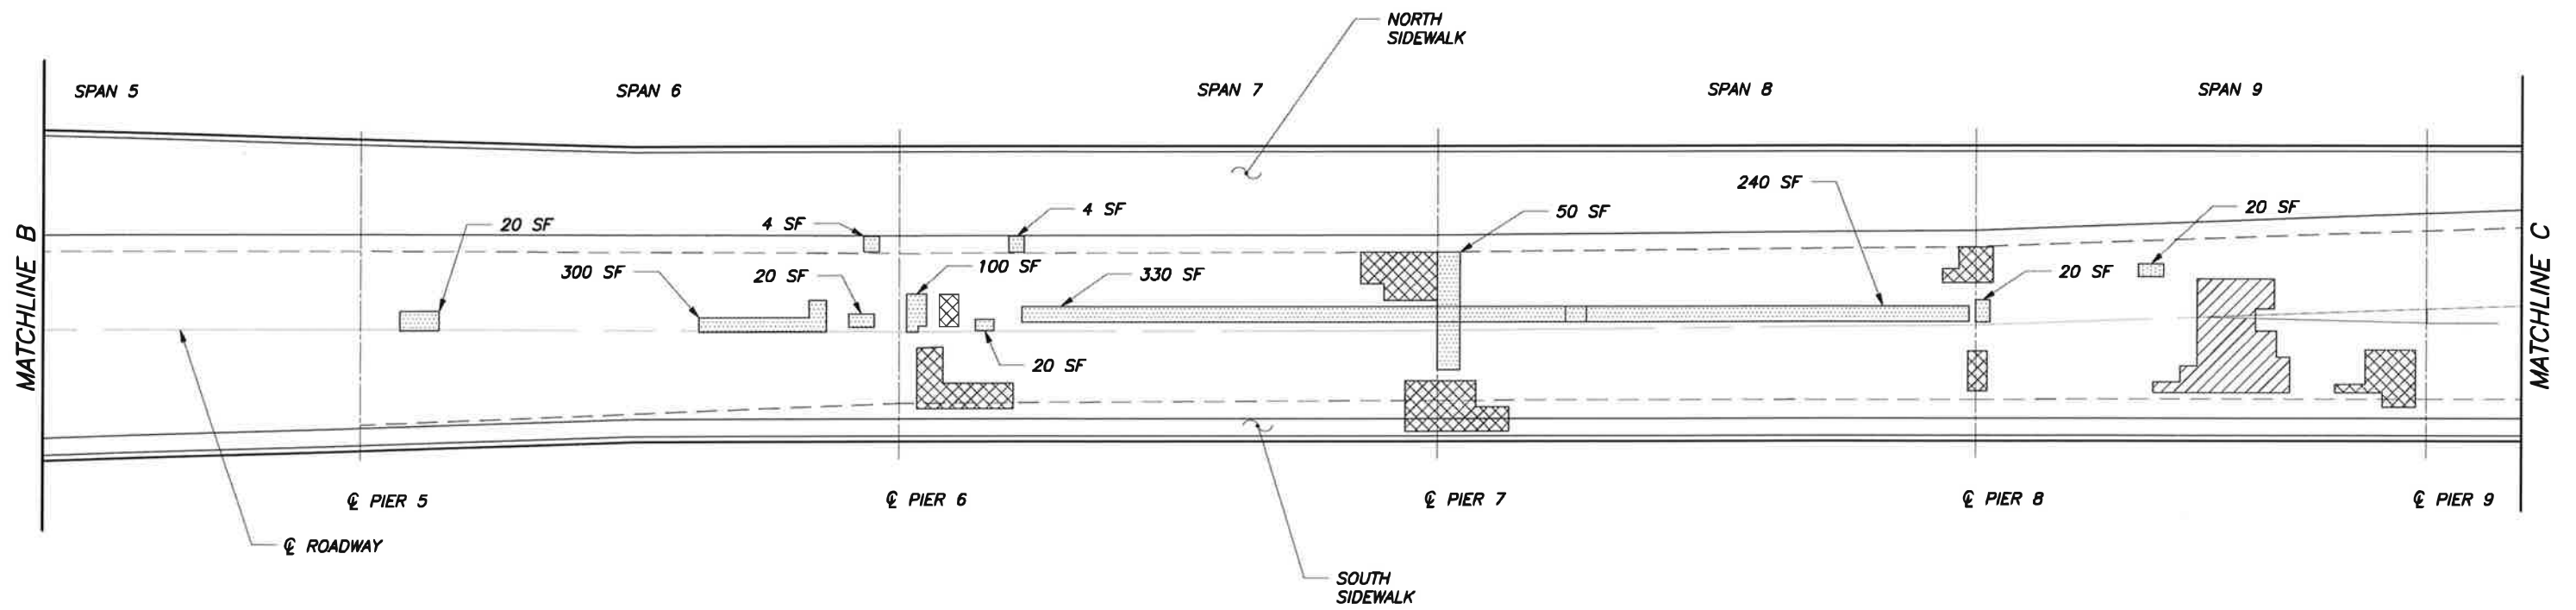
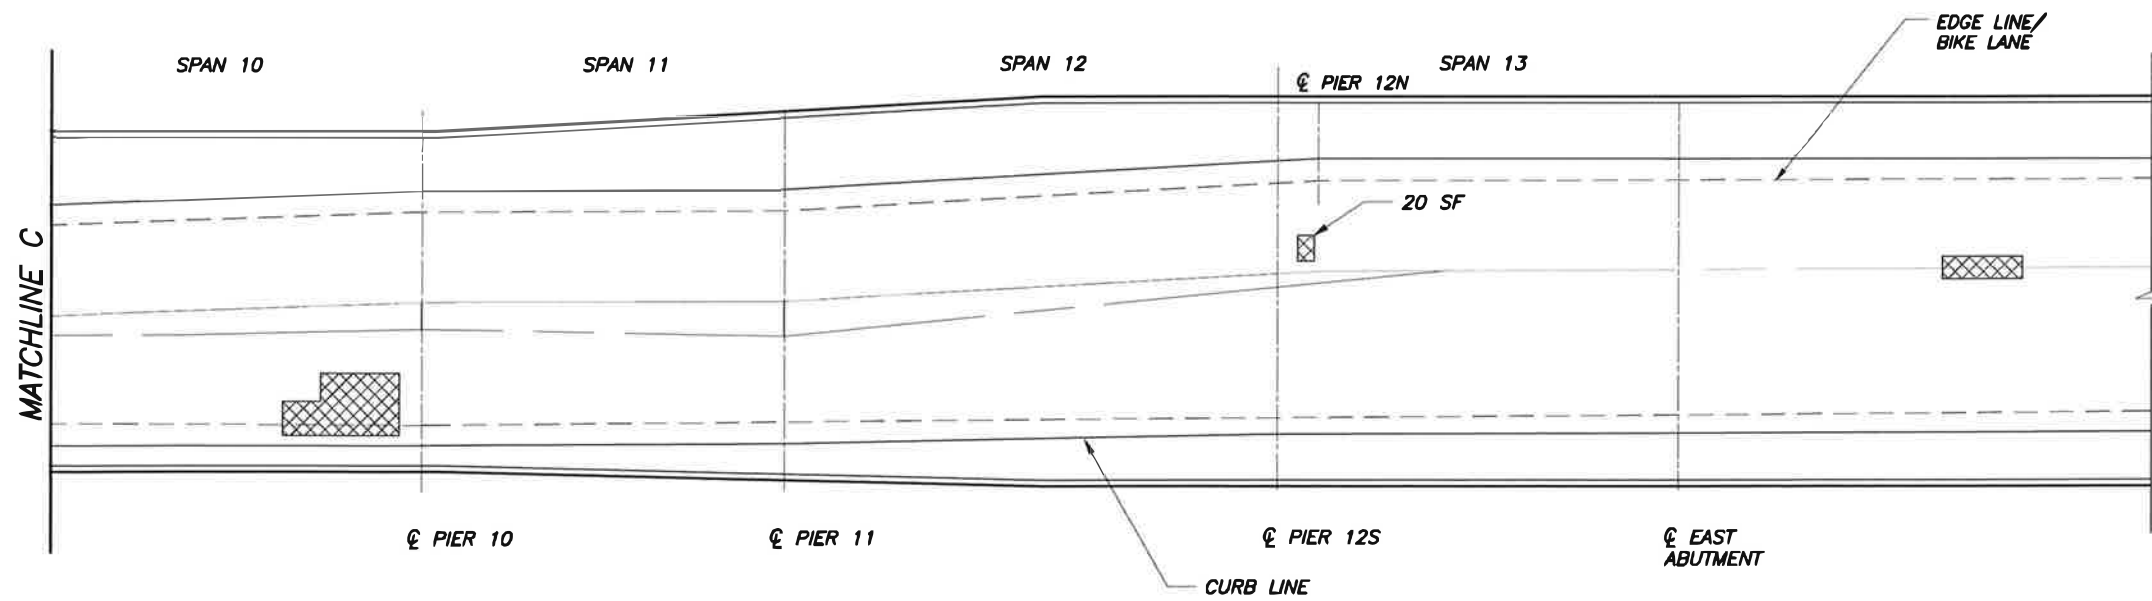
UPPER DECK FINDINGS SPANS 1A- EAST STATION
	B-2

-   DELAMINATED CONCRETE WEARING SURFACE WITH ESTIMATED AREA
-   PATCHED WEARING SURFACE NOVEMBER 2015
-   PREVIOUS WEARING SURFACE REPAIR

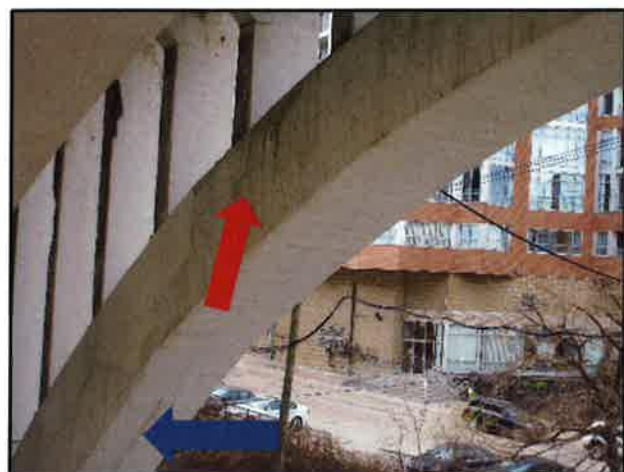
Photo B1 – Panels 1-4.

Photos represent the narrow, horizontal crack observed on the south face of the Span 3 NE Arch Rib. In several locations, a similar crack is present on the north face also. Arch segments shown in photos are identified in Figure B-1.

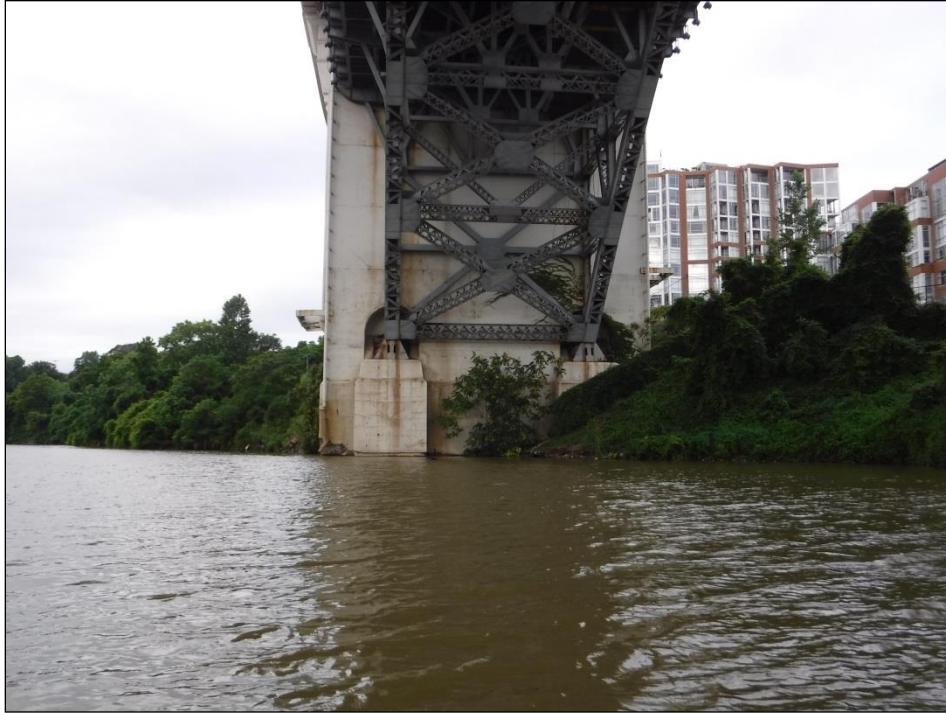
Photograph 5  
View of Pier 3,  
East Face.  
Looking West.

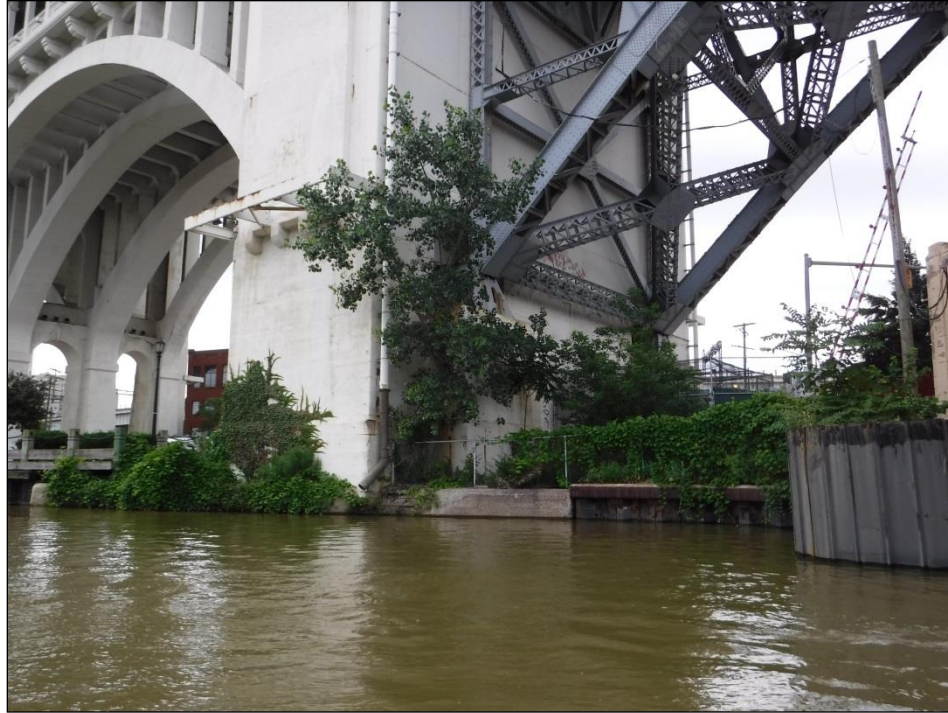
Photograph 9  
View of Pier 4  
West Elevation.  
Looking West.

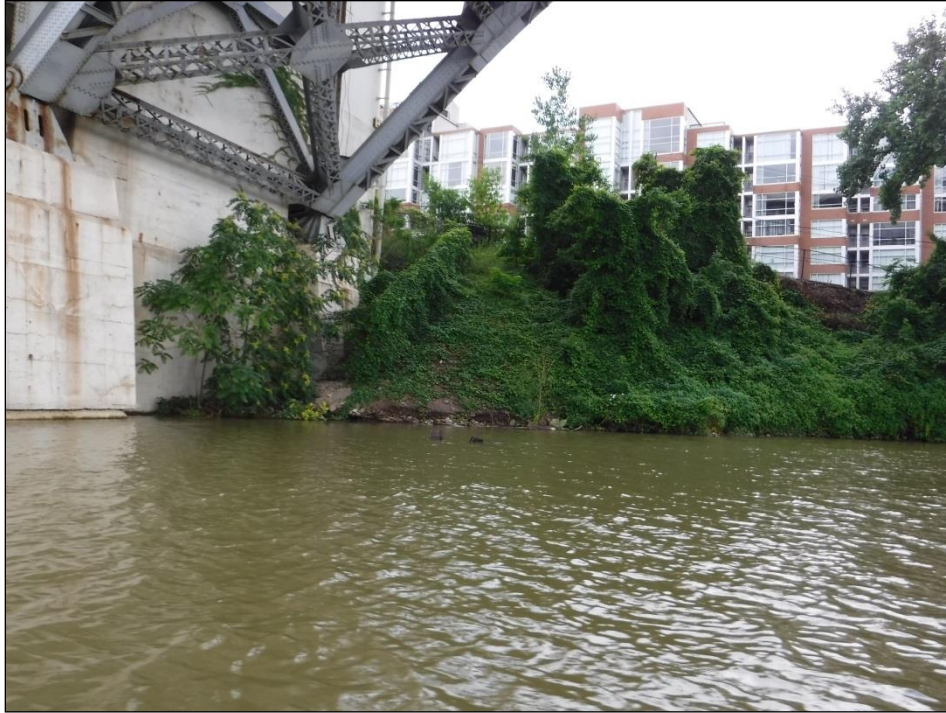
- Minor erosion and sloughing observed on northwest and southwest embankments adjacent to Pier 3.

Photograph  
13  
View of  
Northwest  
Embankment.

- We recommend a fendering system be installed to protect Pier 3 from boat and barge impacts. Place riprap or drive sheet pile along embankment adjacent to Pier 3 to prevent erosion and bank sloughing. Repair broken scupper drains and direct water flow from pier faces. Resurface all concrete pier faces. Grout voids at interfaces of sheet pile and concrete. Place riprap in sinkholes. Re-inspect the submerged substructure units at the normal maximum recommended interval of five (5) years and after a significant event such as flood, impact or other phenomenon that could affect the structural integrity of the bridge.
