STATE OF OHIO DEPARTMENT OF TRANSPORTATION  
BRIDGE INSPECTION REPORT

BRIDGE NUMBER **CUY 00010 1613**  
TWP ROUTE UNIT

# 2009 Annual Inspection of the Detroit-Superior Bridge CUY-10-1613 SFN 1801503

## Supplemental Report of 2009 Inspection Results

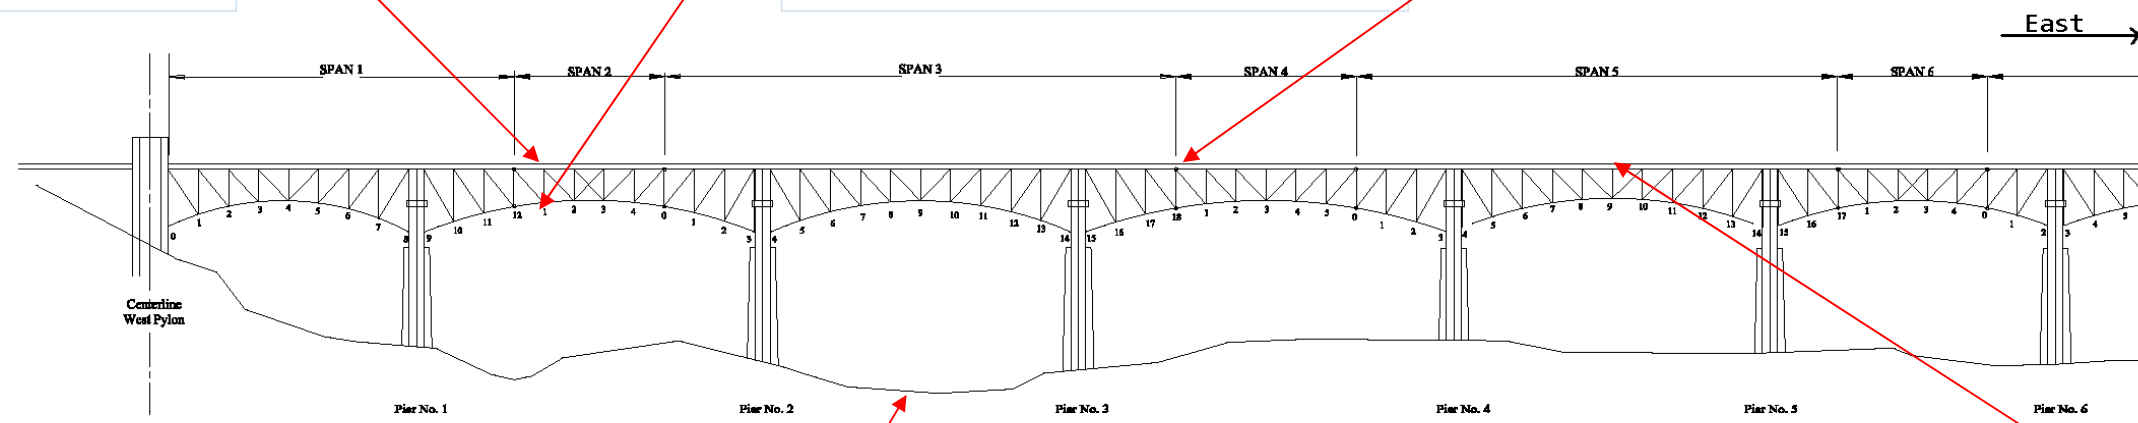
**CUY-10-1613 Elevation**  
Looking North,  
West Abutment to Pier 6

Collapsed (failed) timber fenders in river.

Spalling at top of decorative details over piers, exterior faces.

Leakage through joints at the ends, visible here in the form of icicles – typical all expansion joints.
