**SPAN 18
TRUSS A**

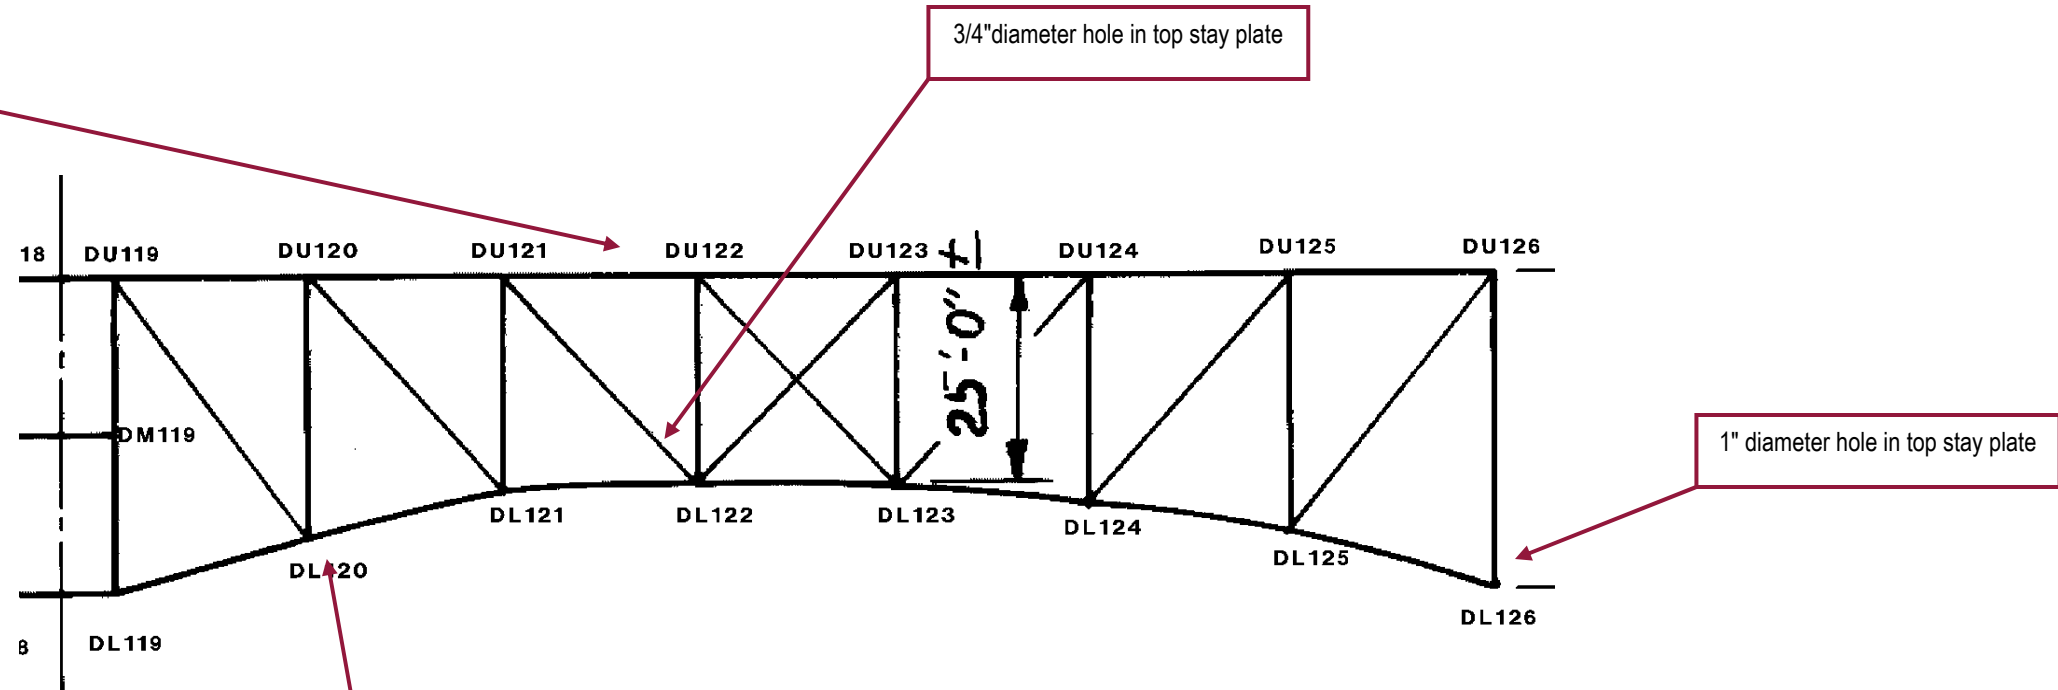
SPAN 18 TRUSS D

The Truss D upper chord in Span 18 is typically clean with paint intact and no significant deficiencies. DL122 is shown looking east.

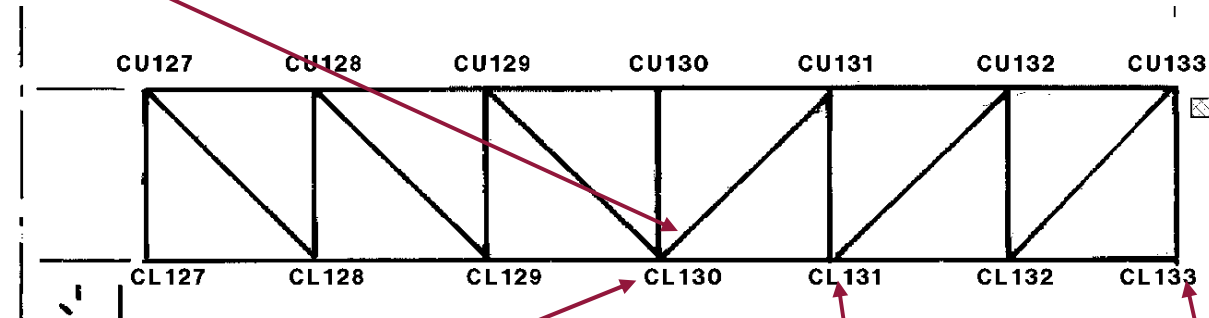
The south web fill plate exhibits 100% section loss below the bounds of the splice plate as well as 1/8" pitting on the bottom angles.
