***2014 BRIDGE INSPECTION
FIELD REPORT***

Inventory Bridge Number: CUY 00010 16.130 N

SR 10 over CUY RIVER VALLEY & FI RR

**2014 SUPERSTRUCTURE
INSPECTION FINDINGS**

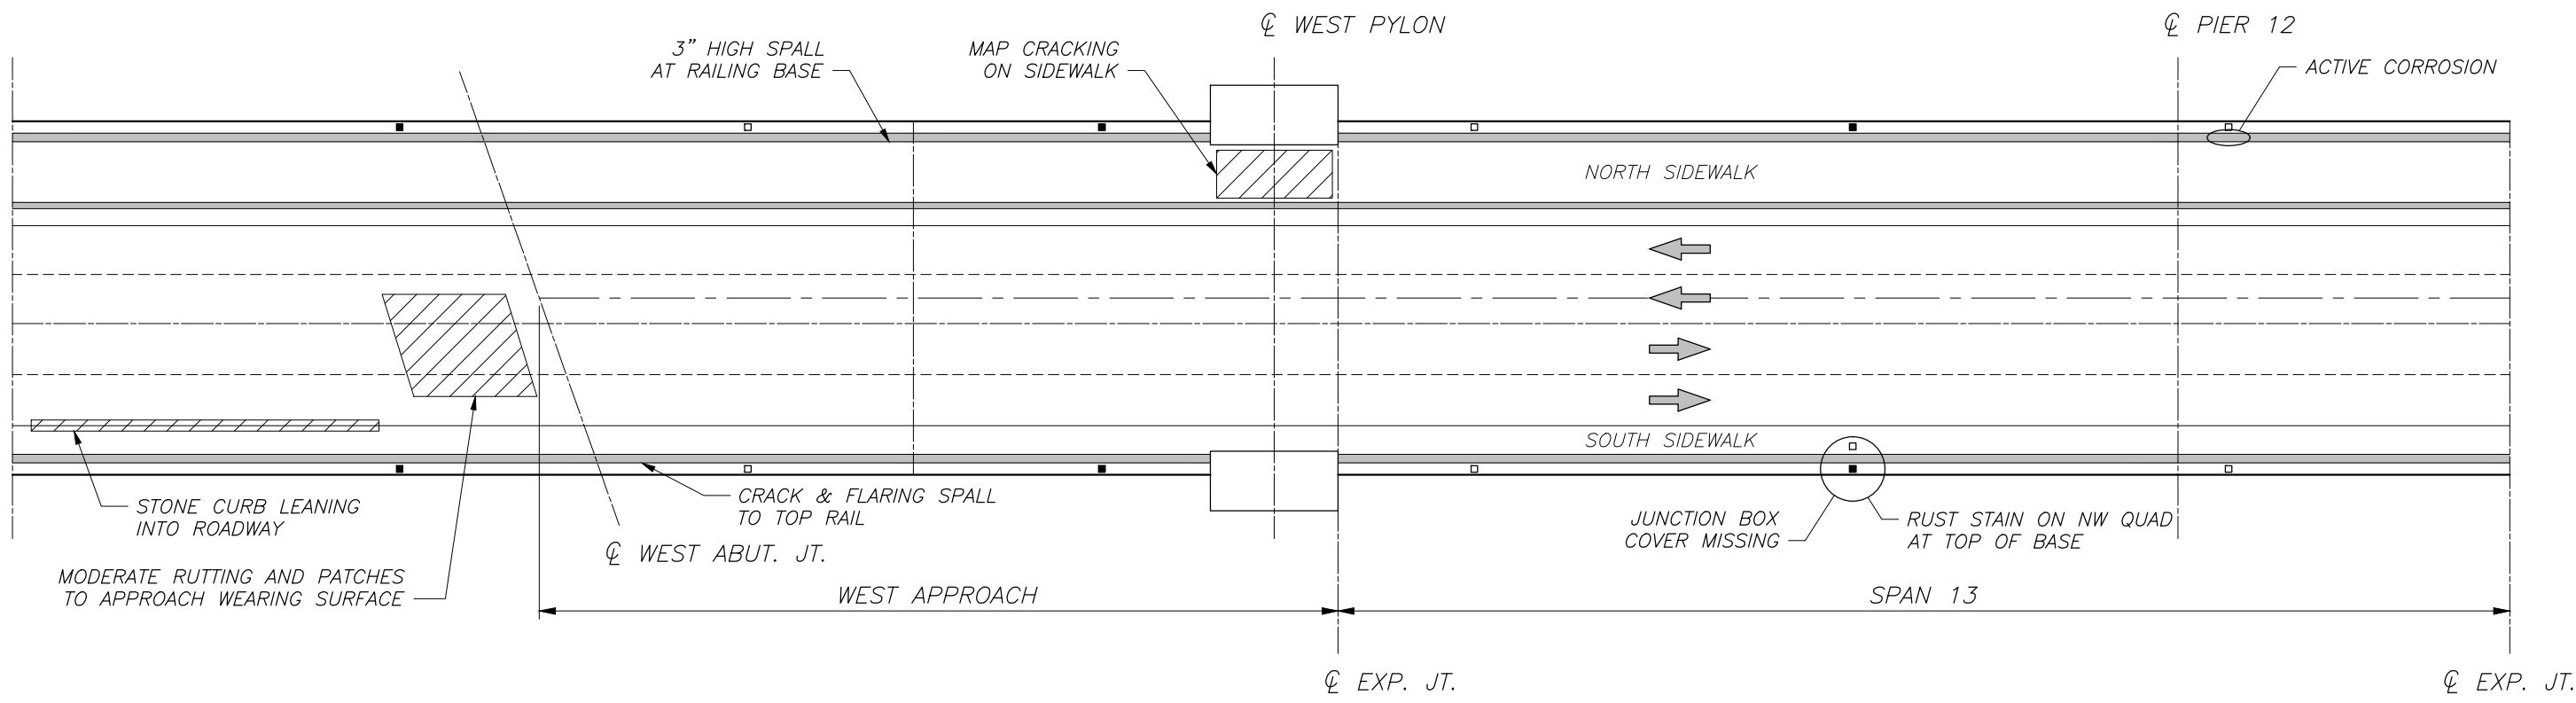
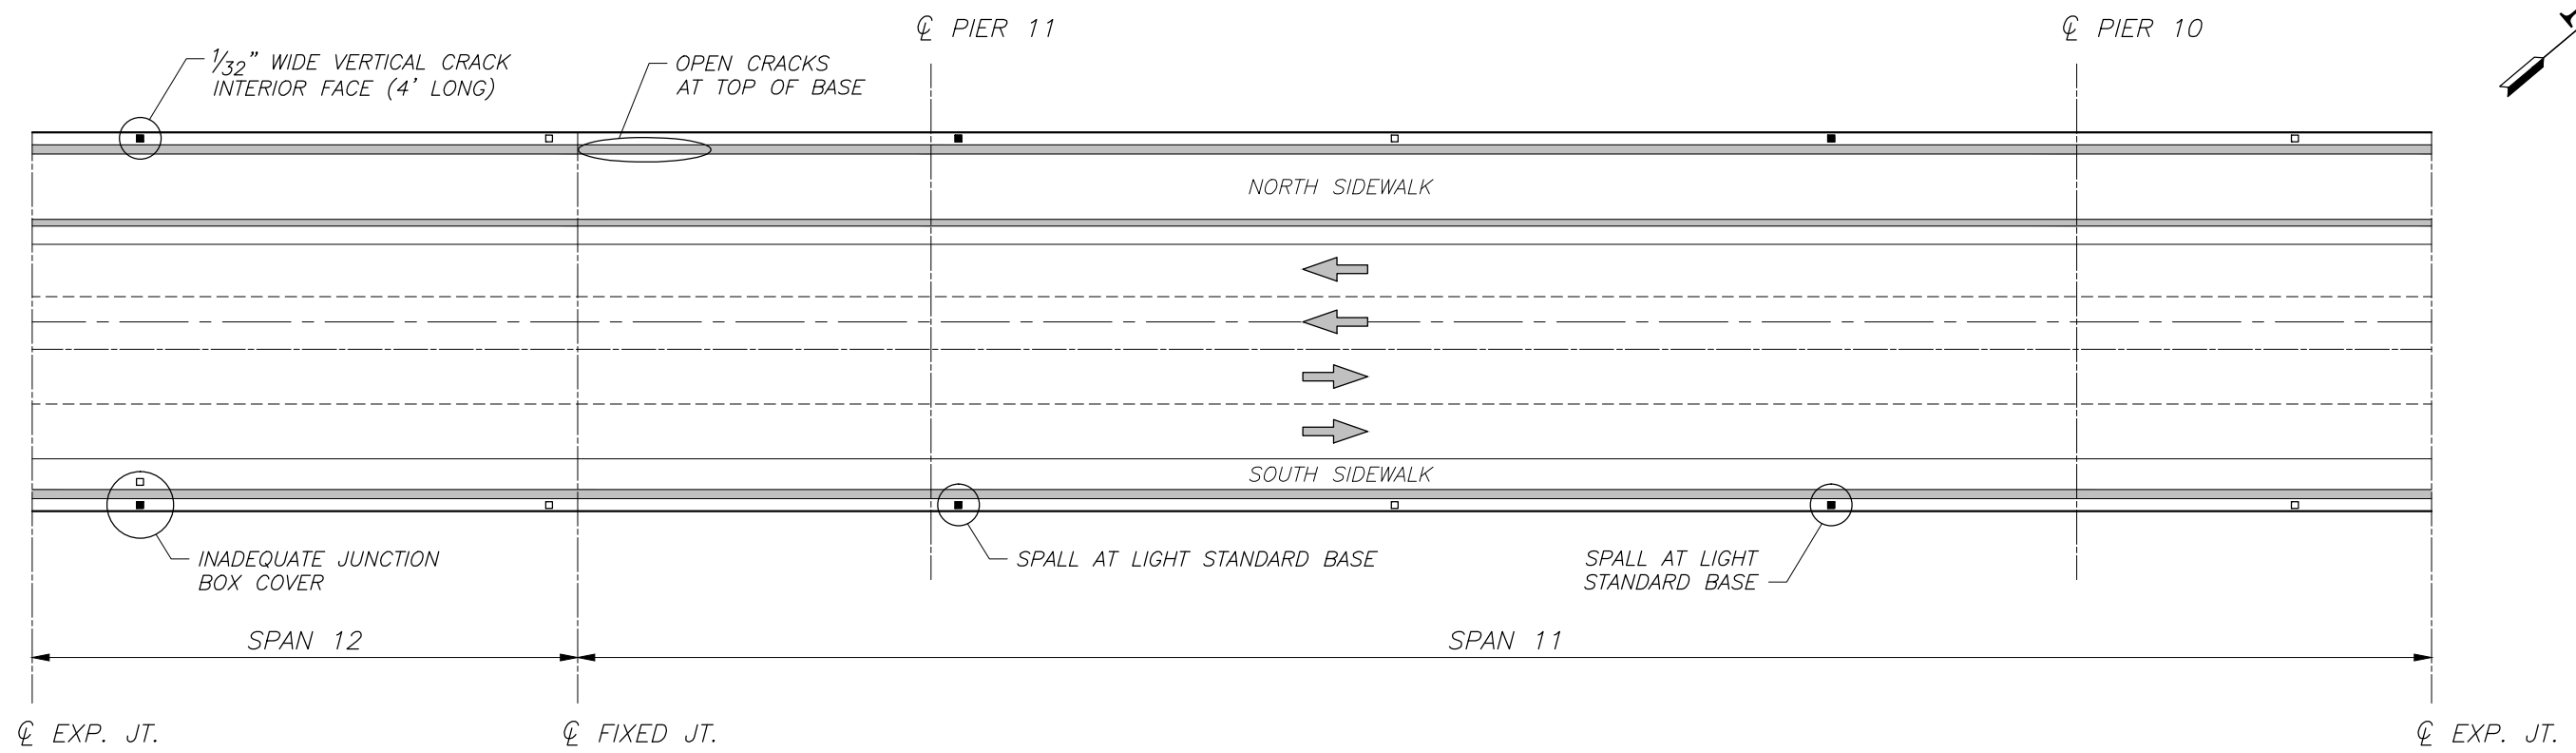
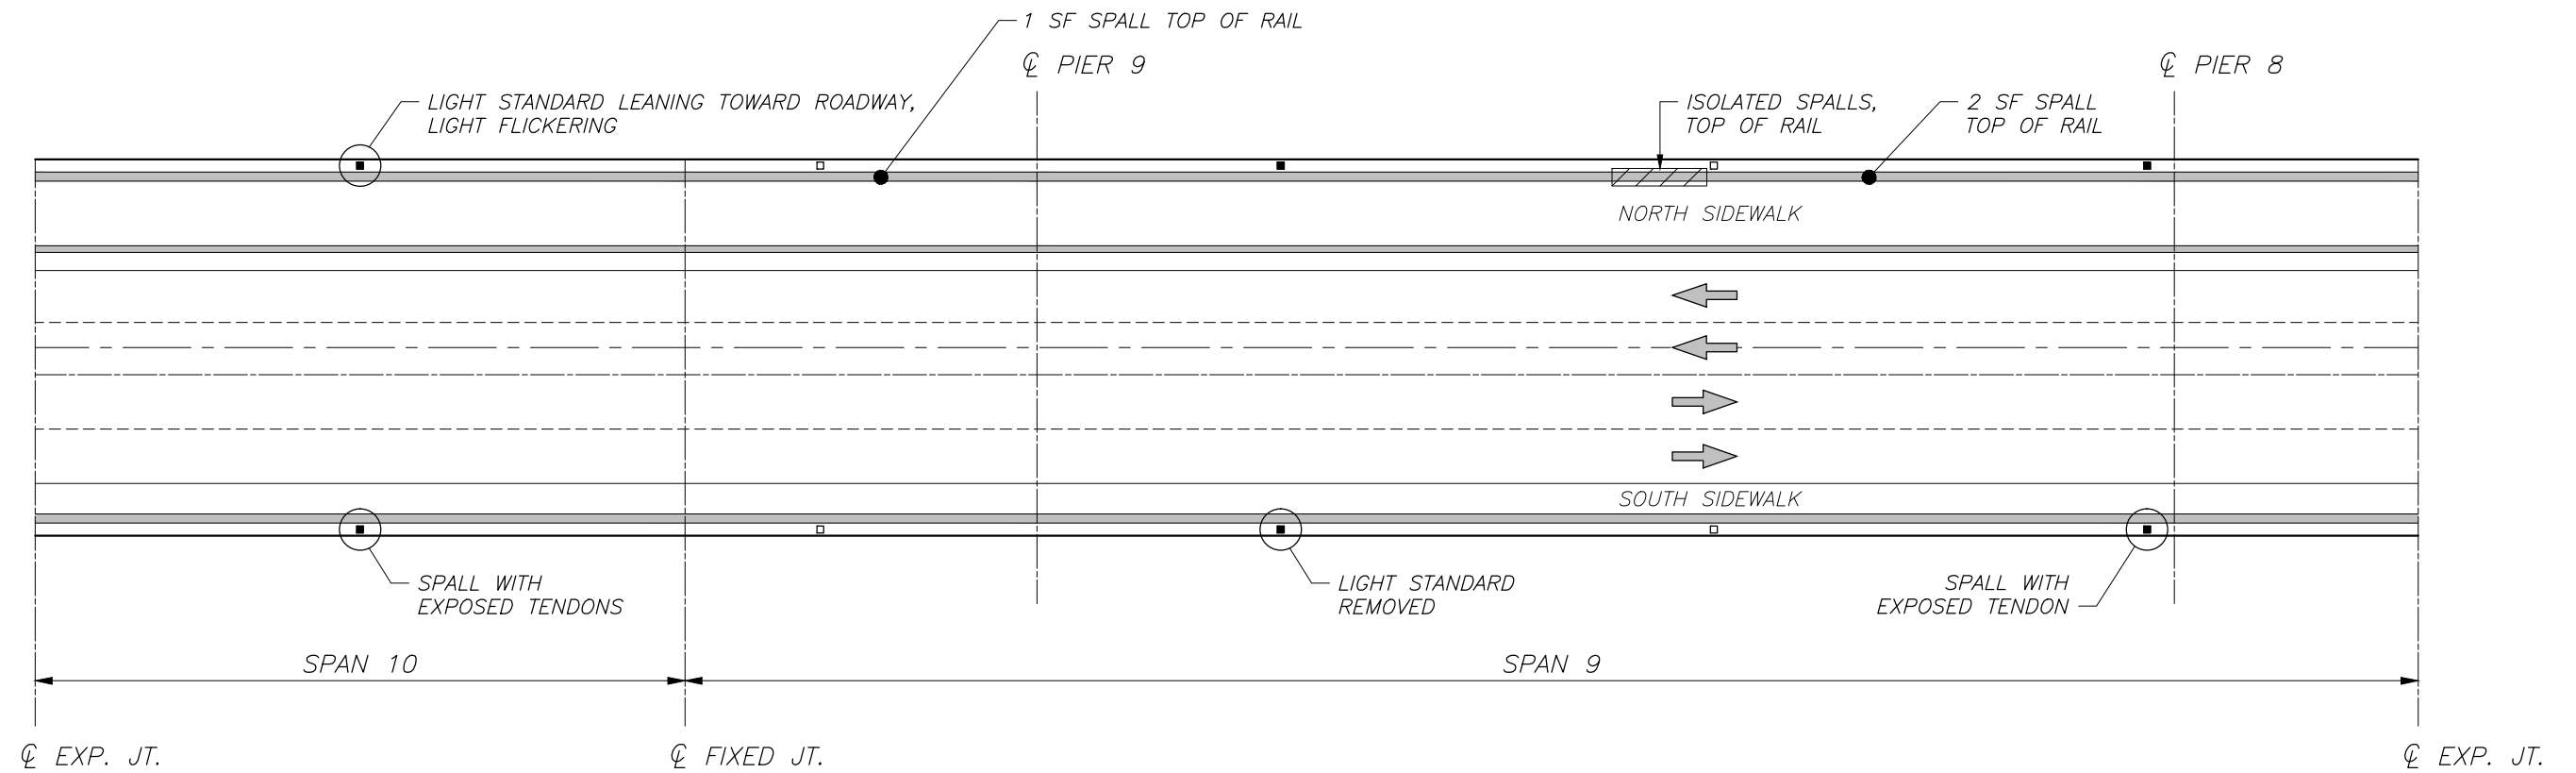
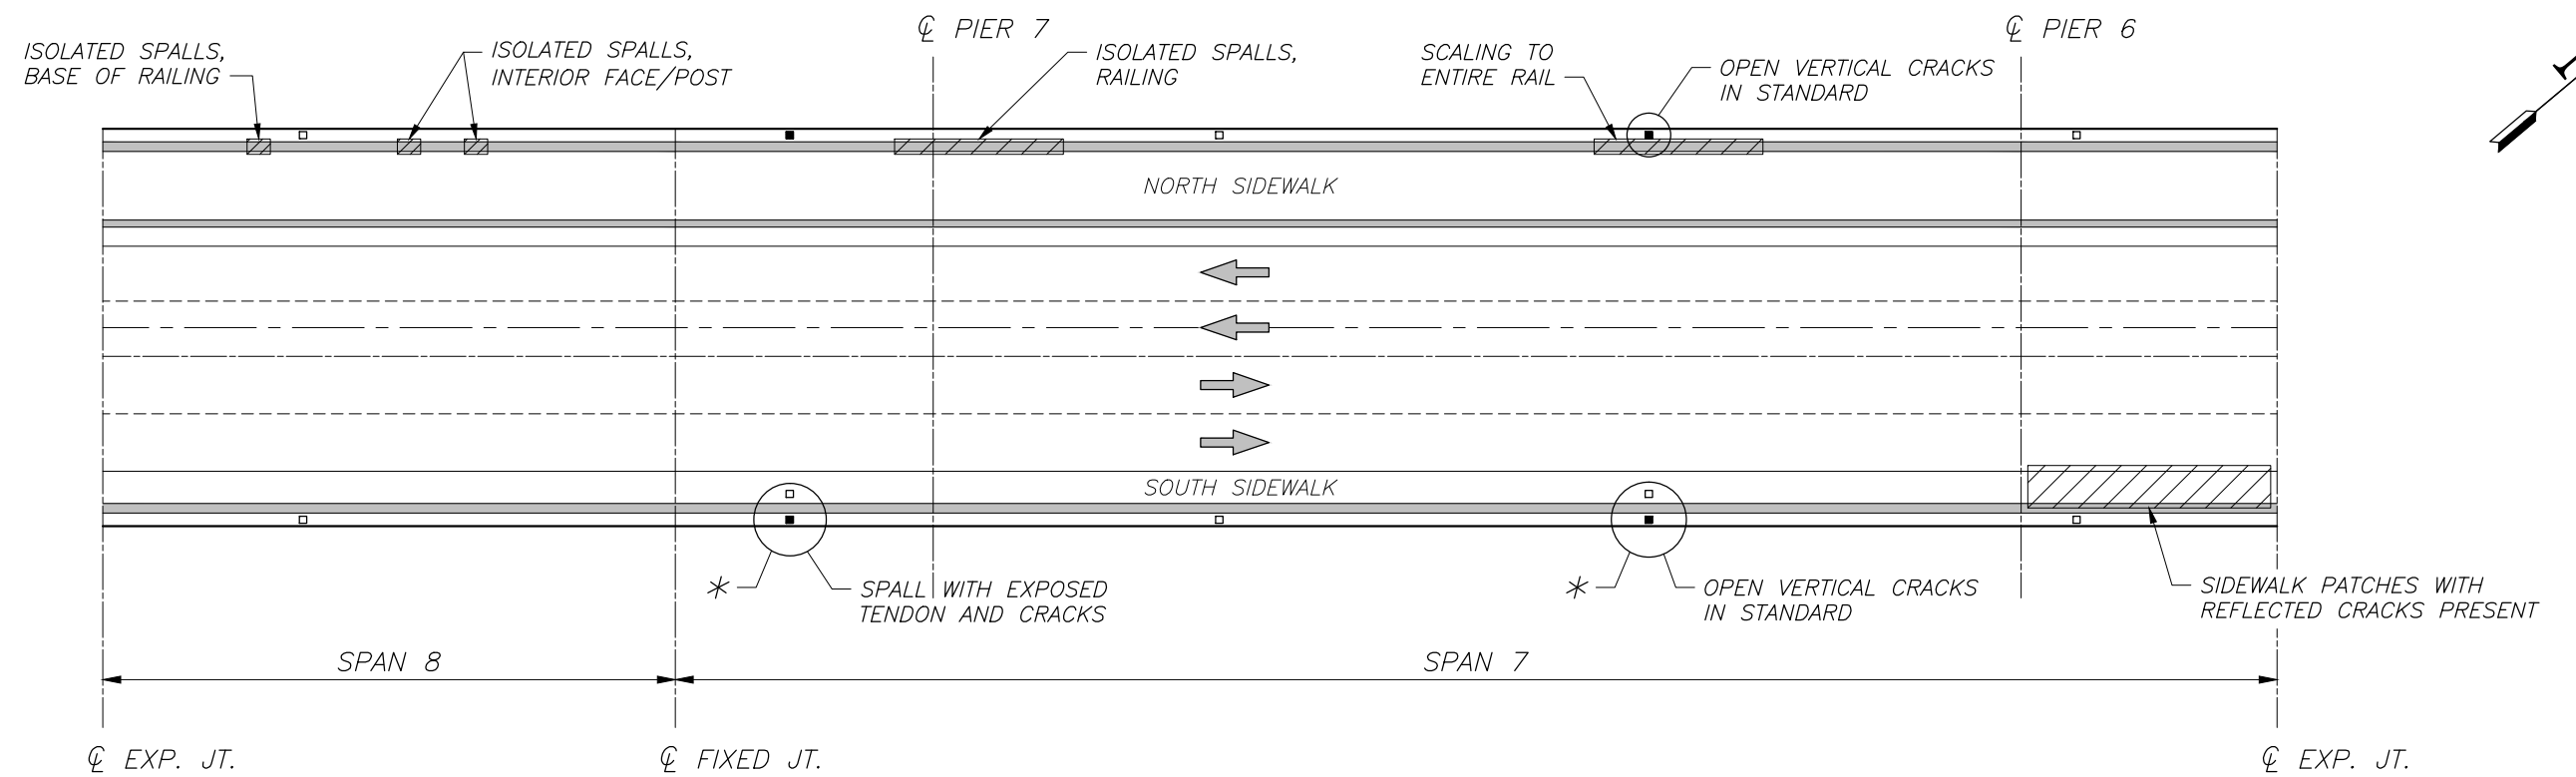
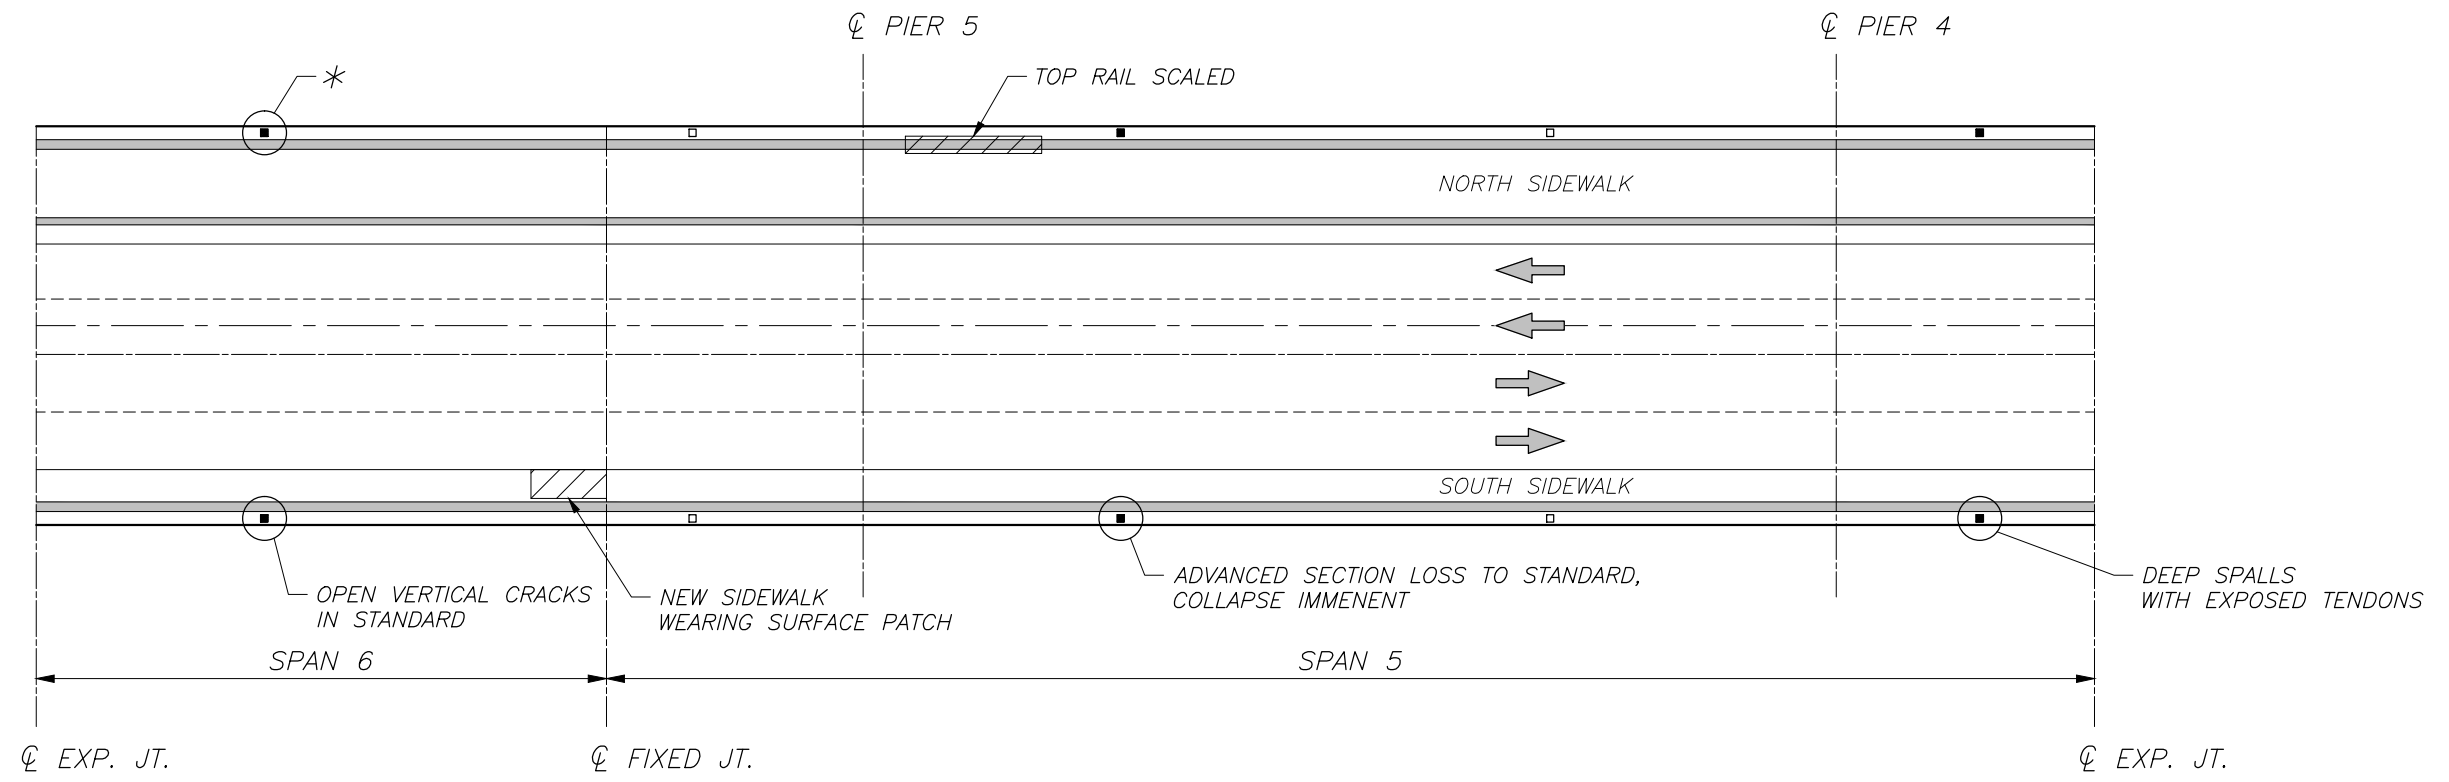
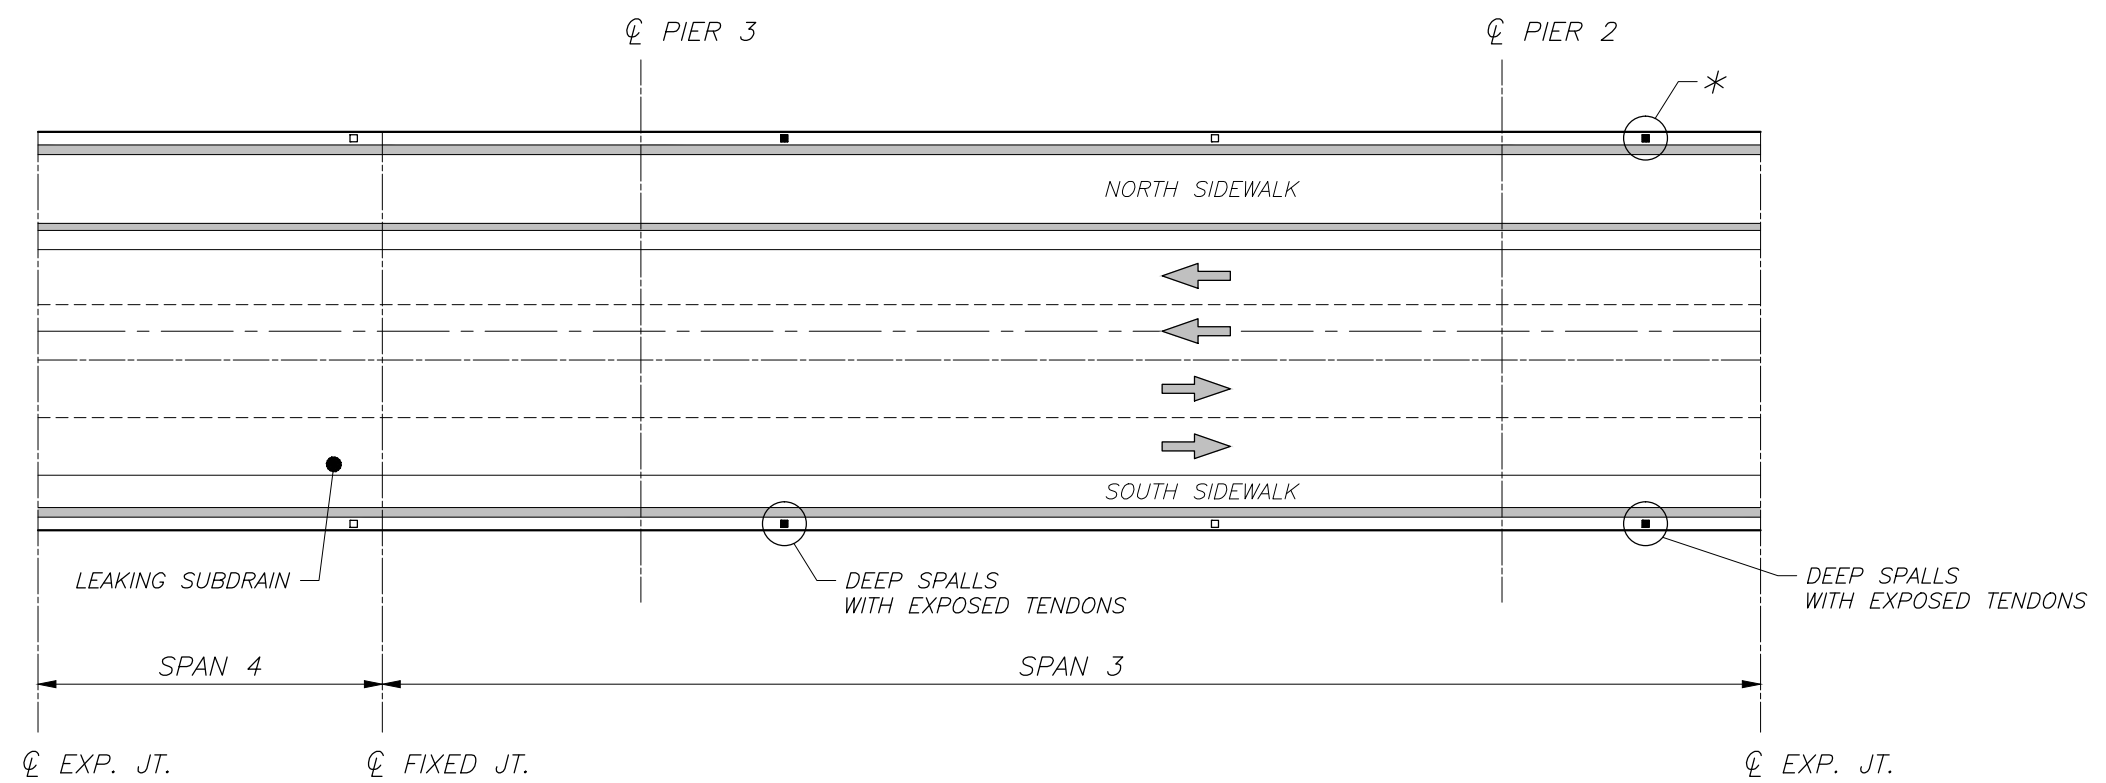
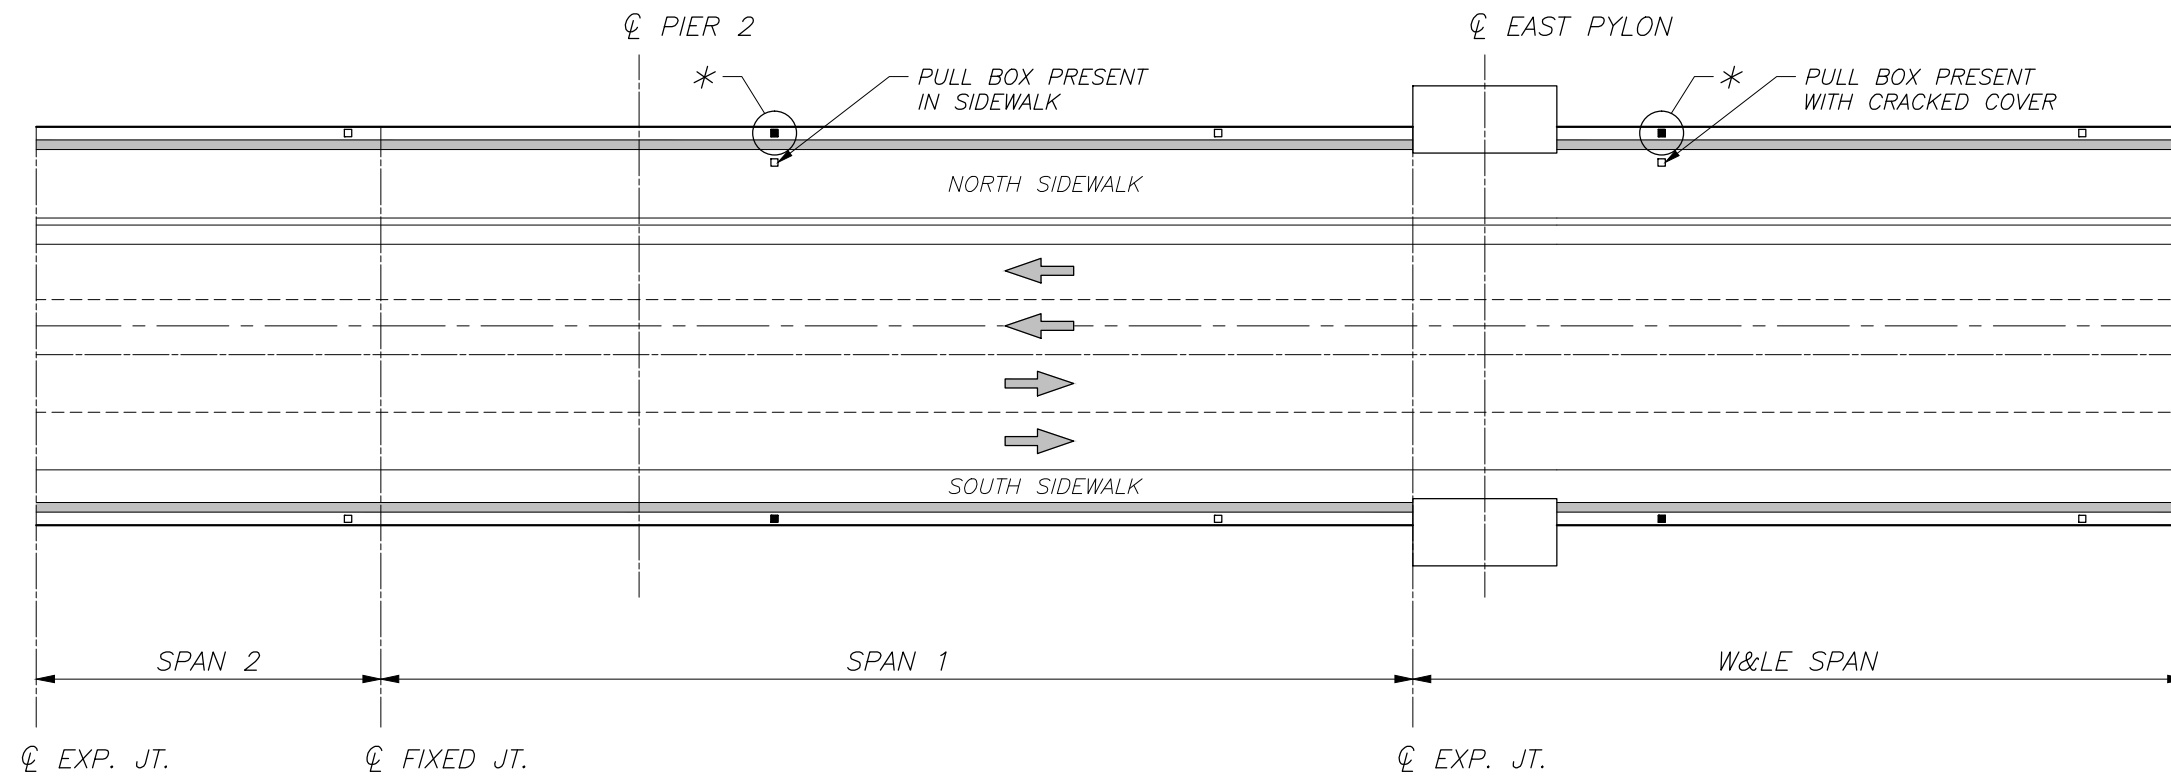
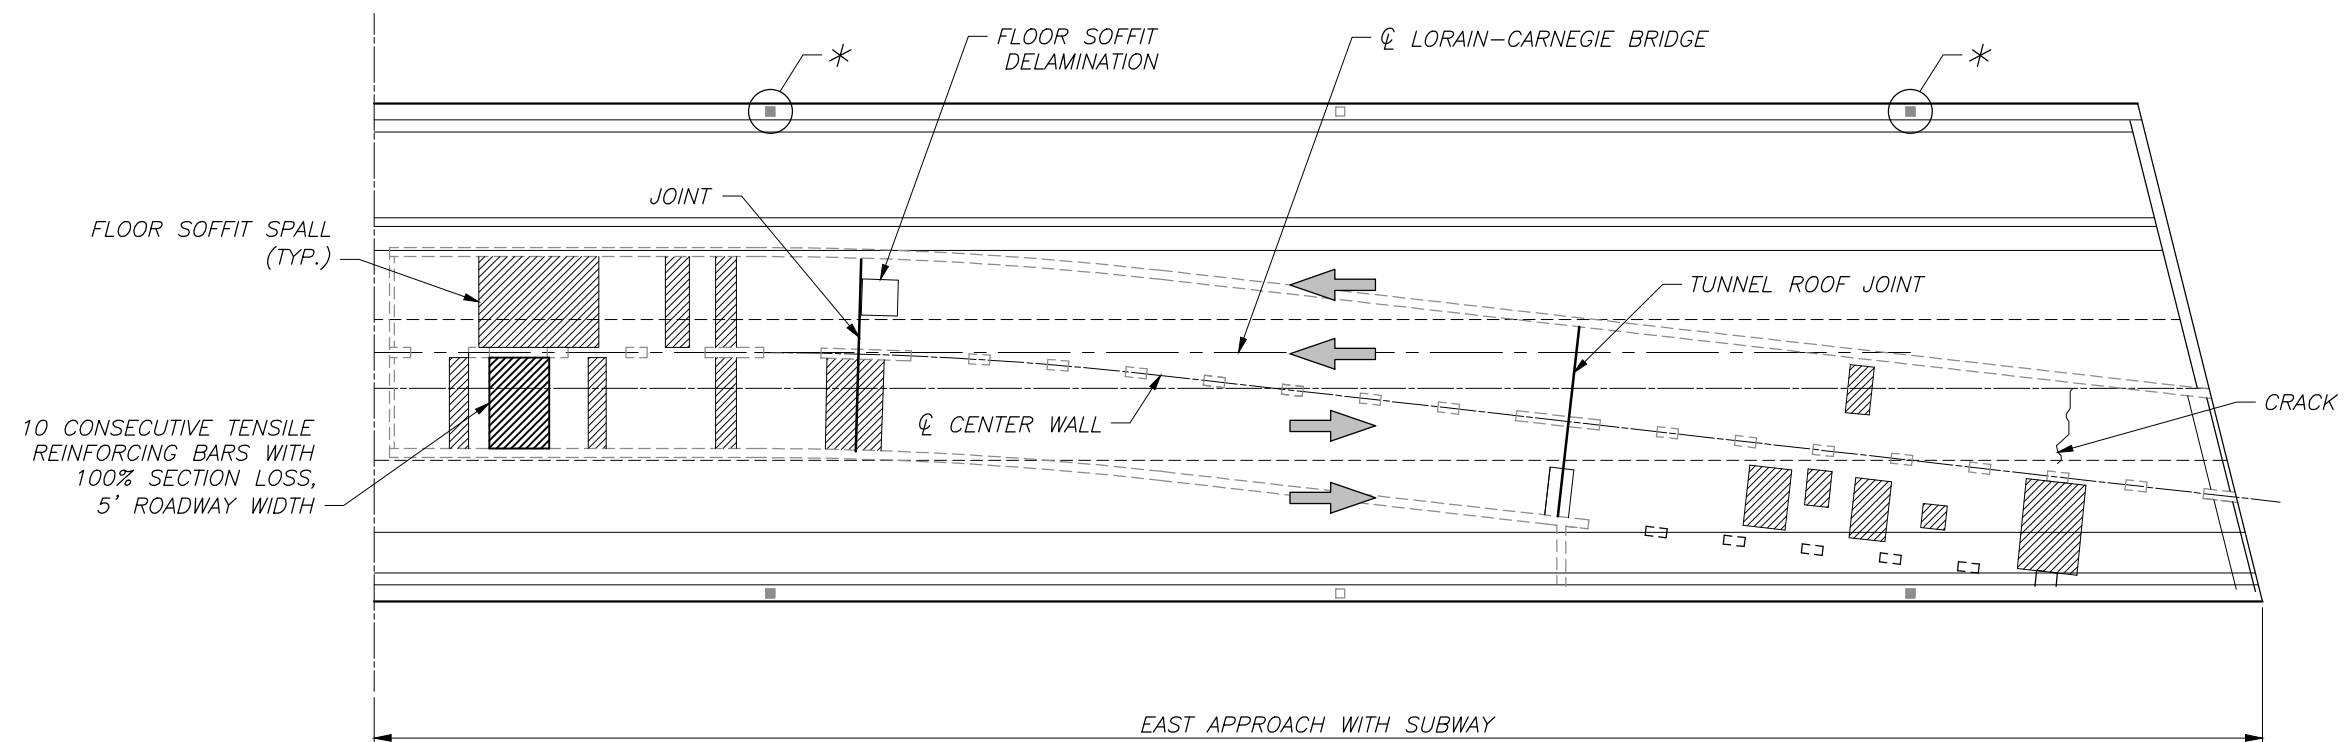
**2014 DECK
INSPECTION FINDINGS**

LOCATION OF FLOOR SOFFIT SPALLS AND DELAMINATIONS ARE SHOWN FOR EAST SUBWAY ONLY FOR REFERENCE PURPOSES.
