BRIDGE INSPECTION REPORT

BRIDGE NUMBER CUY 00020 2295

Inspection Report for:

West Branch of Dugway Brook under U.S. Route 20 below Lake View Cemetery in Cleveland, Ohio (Stone Arch and Reinforced Concrete Culvert)

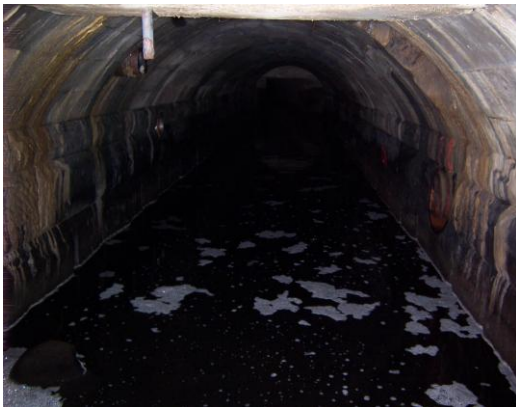
General View of Stone Arch Culvert

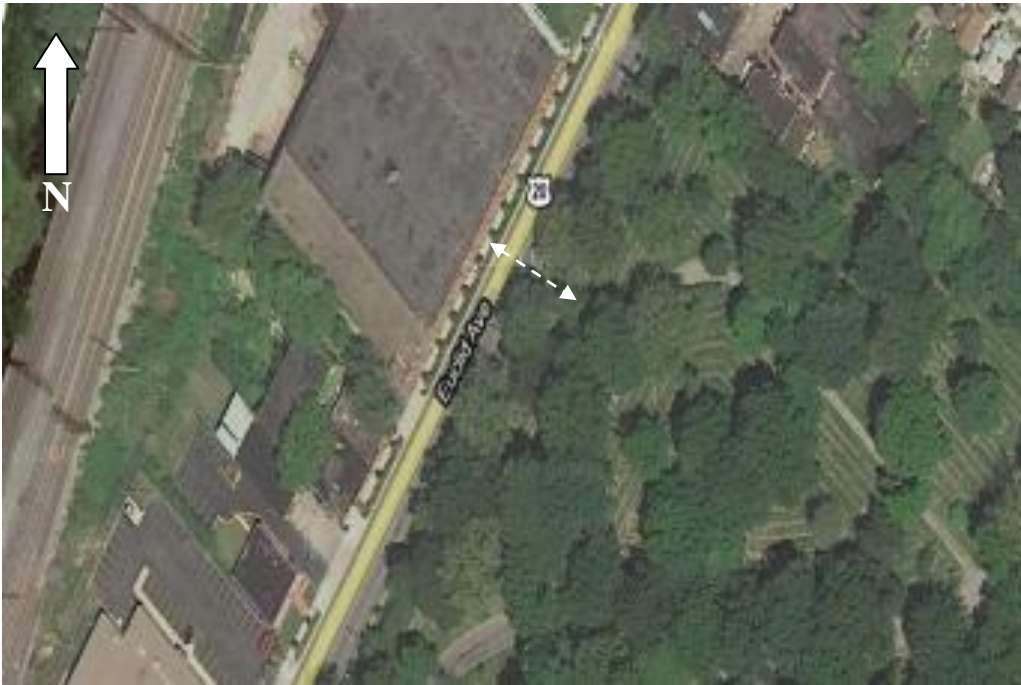
Photo 1 – Facing Down. Aerial view showing approximate location of Culvert.

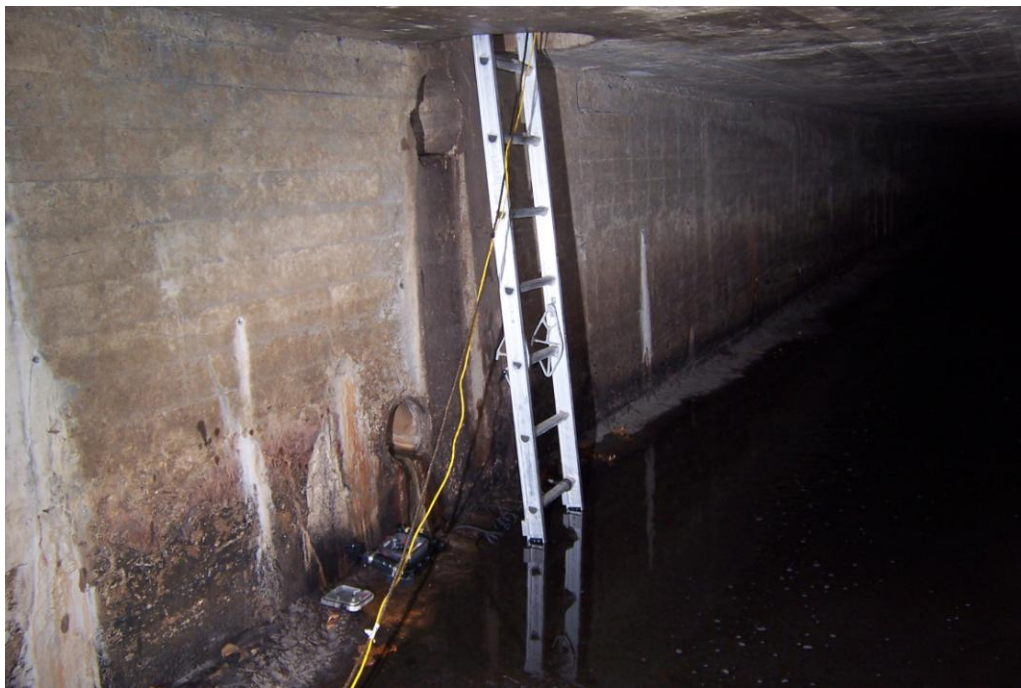
Photo 2 – Facing Southeast. Manhole access below the Lake View Cemetery.

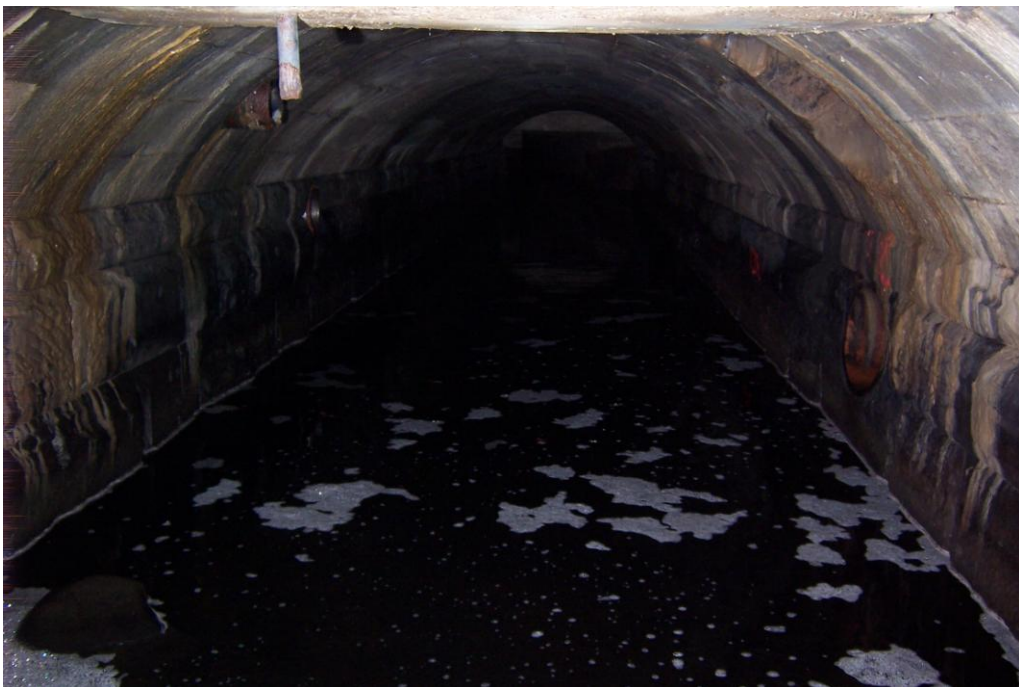
- The arch culvert consists of large stacked cut stones with a smooth stone floor (see Photo 4). There are two large (3' diameter) stones on the floor.

Photo 4 – Facing North. Stone Arch Culvert.

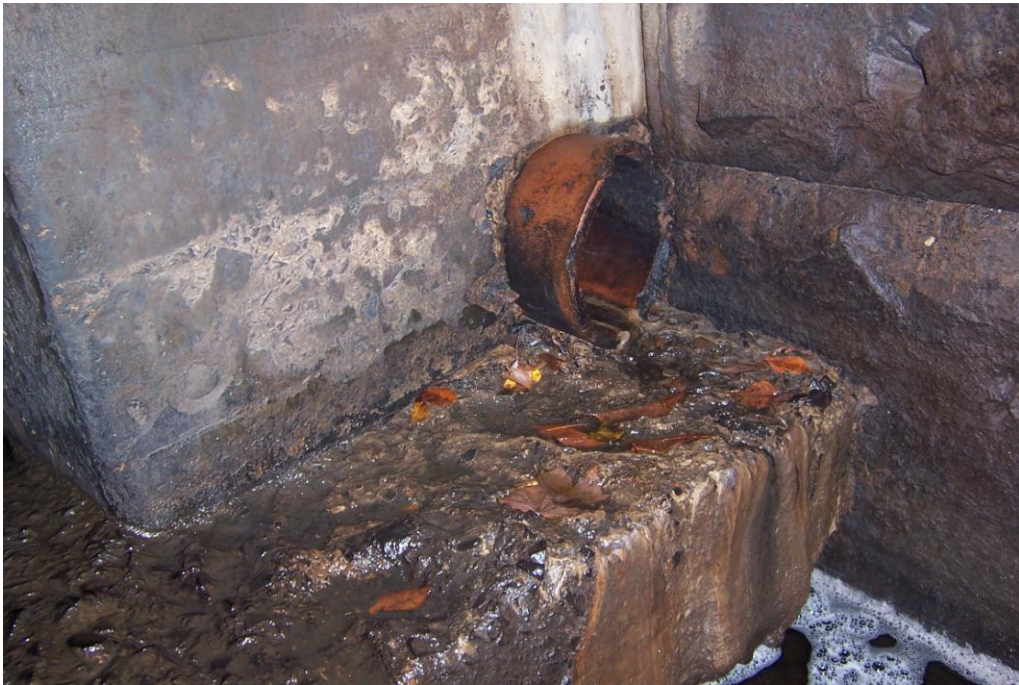
*Photo 11 – Facing West. 106' north of the cemetery entry manhole.
12" diameter inlet pipe in the southwest corner of the stone arch culvert.*

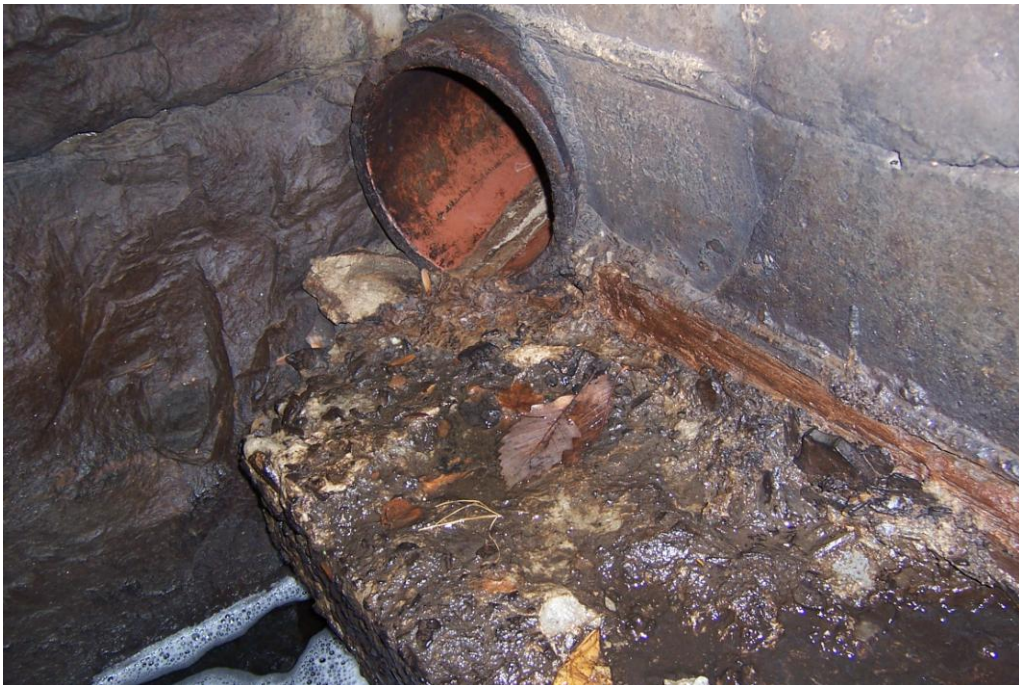
*Photo 12 – Facing East. 106' north of the cemetery entry manhole.
12" diameter inlet pipe in the southeast corner of the stone arch culvert*

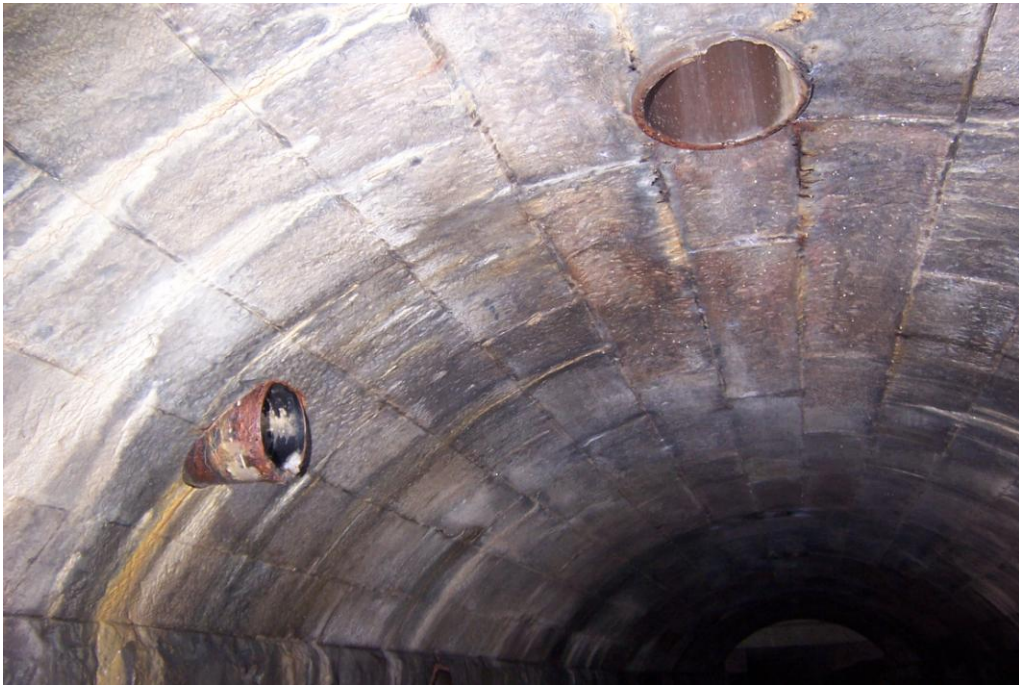
Photo 13 – Facing Northwest. 122’ north of the cemetery entry manhole. 12” diameter pipe in the west wall and 18” diameter pipe in the crown.

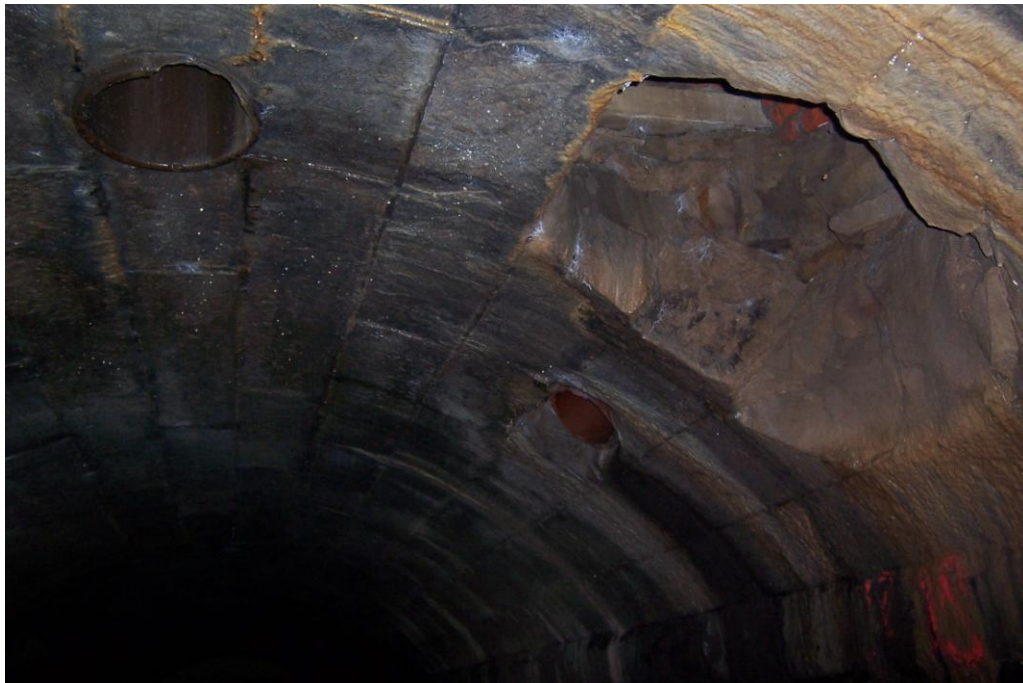
Photo 14 – Facing Northeast. 122’ north of the cemetery entry manhole. 12” diameter pipe in the east wall and 18” diameter pipe in the crown.

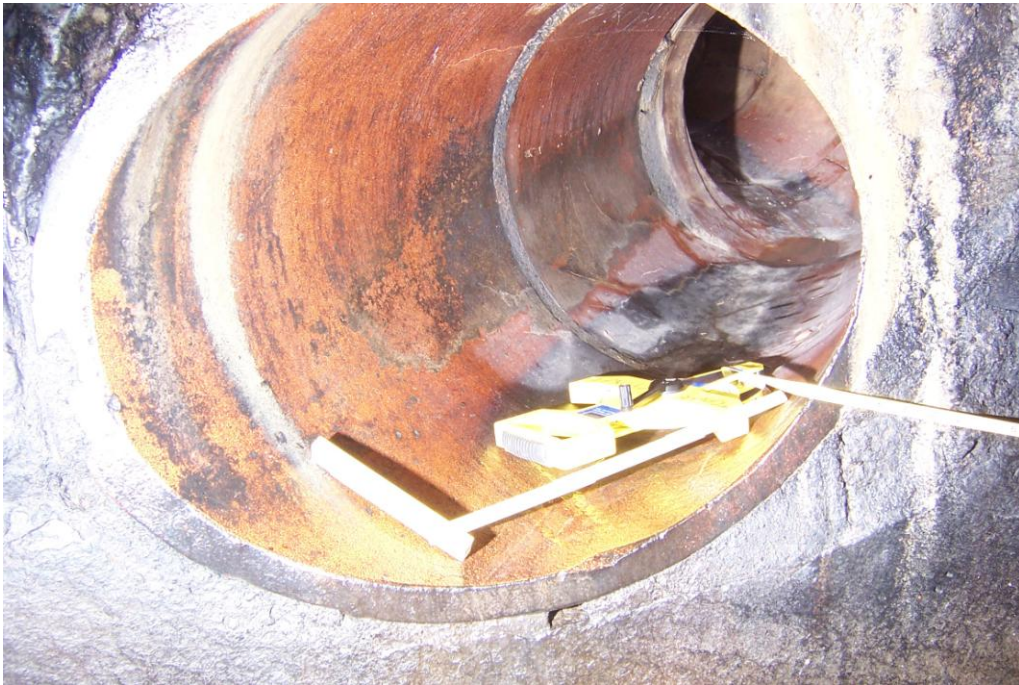
*Photo 15 – Facing East. 122' north of the cemetery entry manhole.
18" diameter inlet pipe in the east wall of the stone arch culvert*

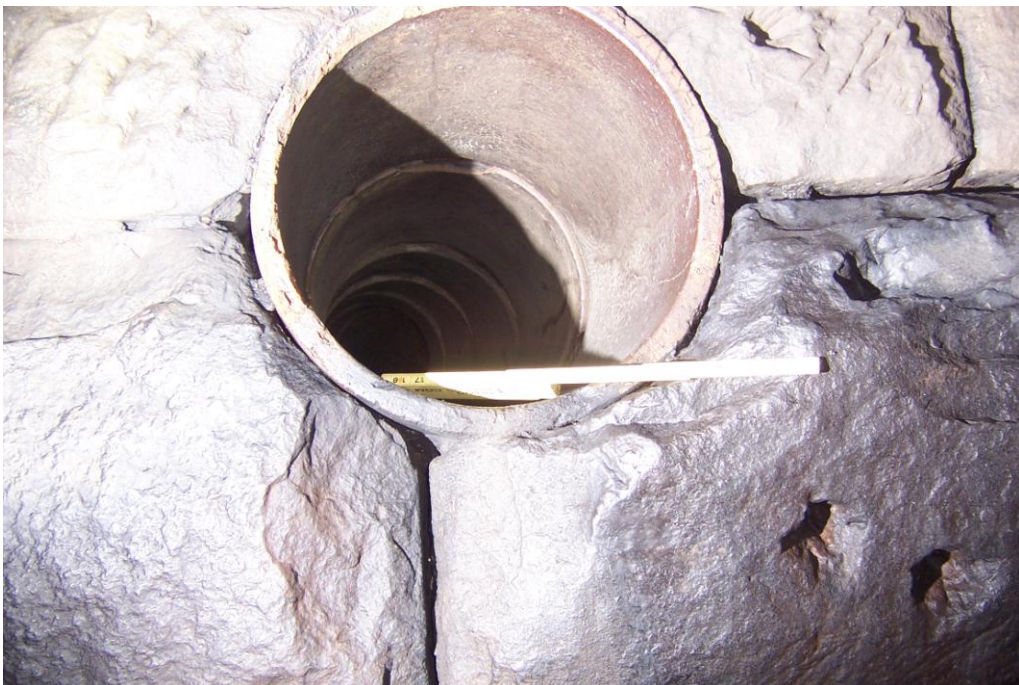
*Photo 16 – Facing West. 136' north of the cemetery entry manhole.
20" diameter inlet pipe in the west wall of the stone arch culvert*

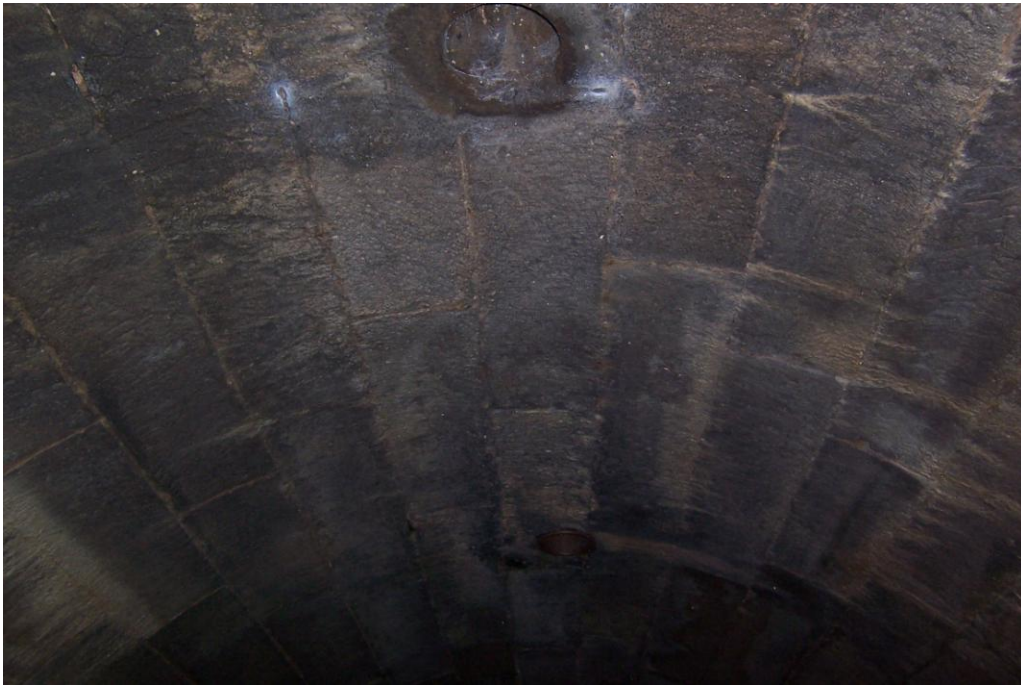
*Photo 17 – Facing North. 145' and 155' from the cemetery entry manhole.
12" diameter inlet pipes in the crown of the stone arch culvert.*

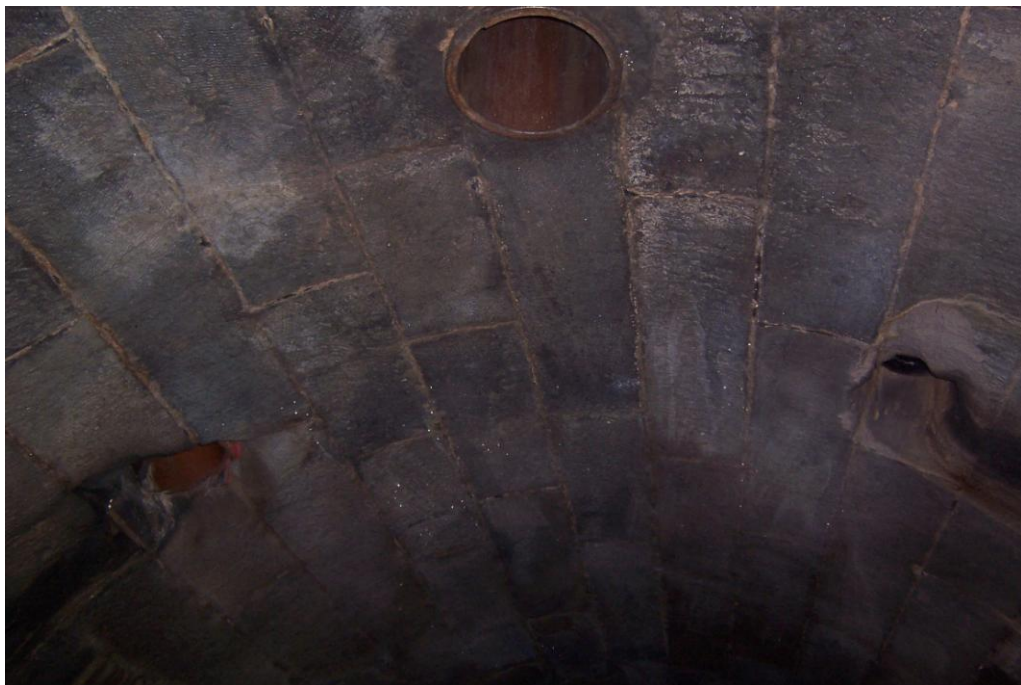
*Photo 18 – Facing South. 170' north of the cemetery entry manhole.
12" diameter pipes in the sides and 18" diameter pipe in the top of the stone arch culvert
crown.*
