BRIDGE INSPECTION REPORT

BRIDGE NUMBER CUY 00020 2295

**Inspection Report for:**

West Branch of Dugway Brook under U.S. Route 20 below Lake View Cemetery in Cleveland, Ohio (Stone Arch and Reinforced Concrete Culvert)

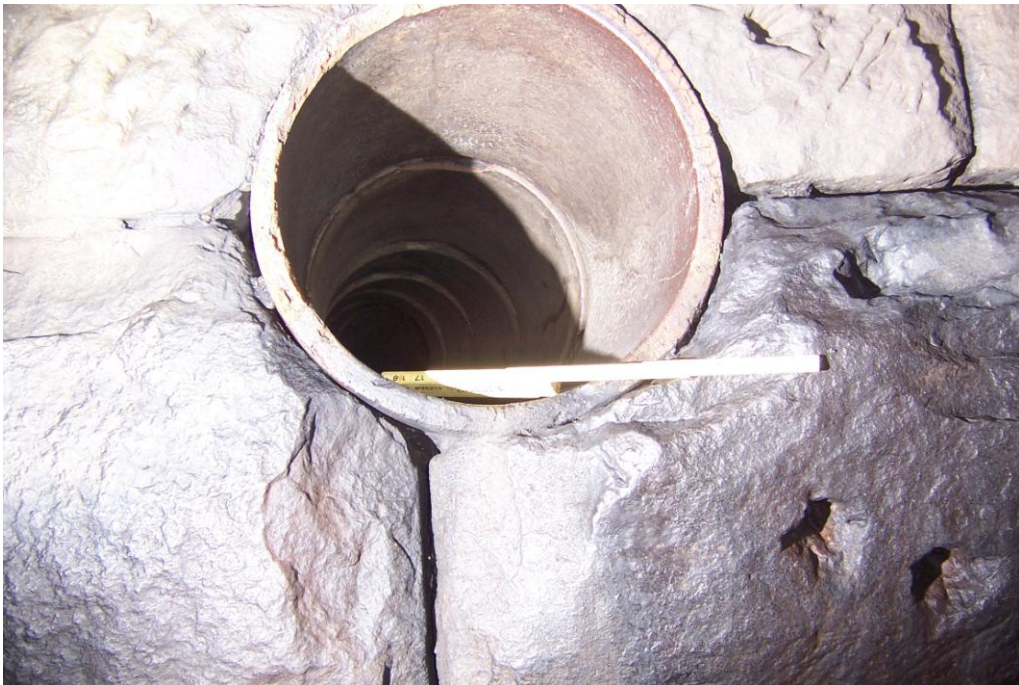
*Photo 16 – Facing West. 136’ north of the cemetery entry manhole.  
20” diameter inlet pipe in the west wall of the stone arch culvert*

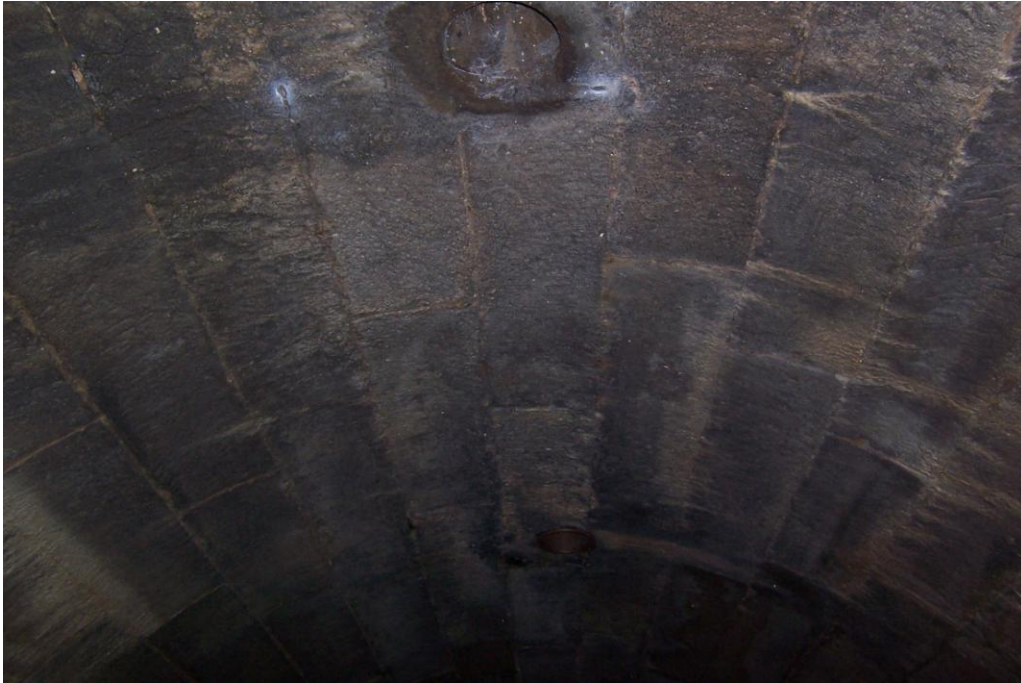
*Photo 17 – Facing North. 145' and 155' from the cemetery entry manhole.  
12" diameter inlet pipes in the crown of the stone arch culvert.*

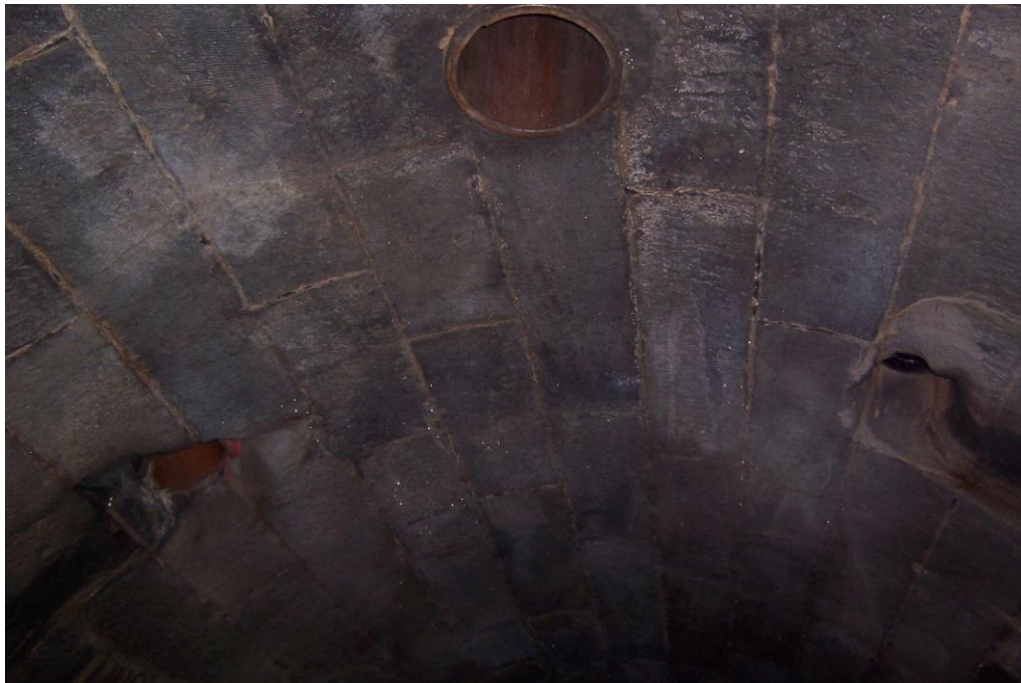
*Photo 18 – Facing South. 170' north of the cemetery entry manhole.  
12" diameter pipes in the sides and 18" diameter pipe in the top of the stone arch culvert  
crown.*
