BRIDGE INSPECTION REPORT

BRIDGE NUMBER CUY 00071 1791 R

CUY-71-1791 R; SFN 1805371

I-71 over SR 176

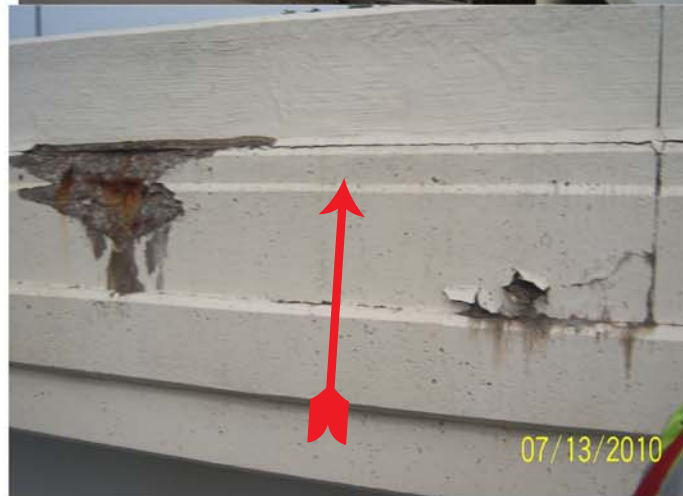
RAILING: SPALLS & DELAMINATED AREAS. 6' LONG DETERIORATED AREA IN RIGHT RAIL OF RAMP TO WEST 14TH/WB 90 (UNIT 4AE). TROWLEABLE MORTAR WEDGE DELAMINATING FROM PARPET RETROFIT (1990) FORMING POSSIBLE SPALLS OVER TRAFFIC. IMPACT ATTENUATOR DAMAGED @ GORE RAMP AE.

Trowelable Mortar delaminating from
parapet, full length, all retrofitted
parapets.. Additional Spalls forming
along outside parapet .
