## **2012 In-Depth Inspection Report**

### **I-71/SR 176 Double Decker Bridge – (I-71 Upper Deck)**

**CUY-00071-1791  
(SFN 1805371)**

**Inspection Dates: 07/30/2012 to 08/10/2012**

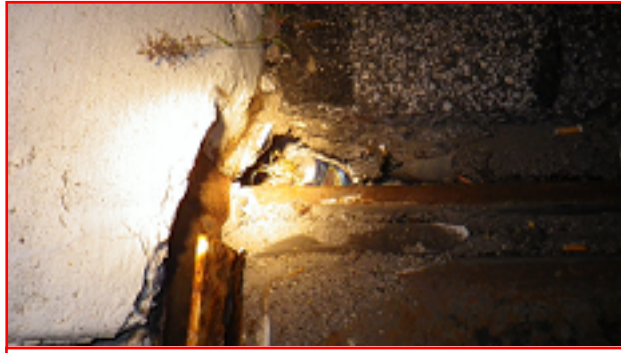
*APPROACH SLABS:* The approach slabs are in good condition. There is a 6" diameter erosion hole developing at the west end of the abutment joint at the North Abut AW.

Large erosion hole at approach slab near North Abutment AW.
