2012 In-Depth Inspection Report

I-71/SR 176 Double Decked Bridge – (SR 176 Lower Deck)

**CUY-00176-1334
(SFN 1805436)**

Inspection Dates: 07/30/2012 to 08/10/2012

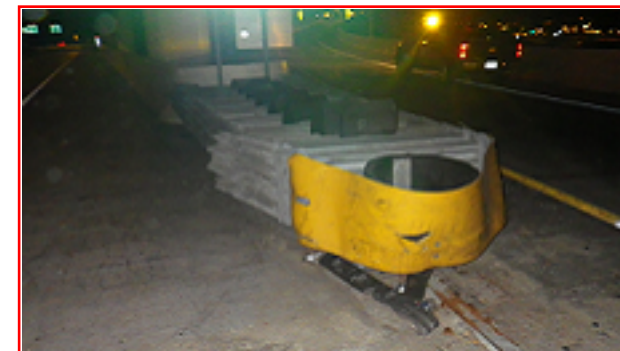
PLAN VIEW

Impact attenuator has been hit by vehicle.

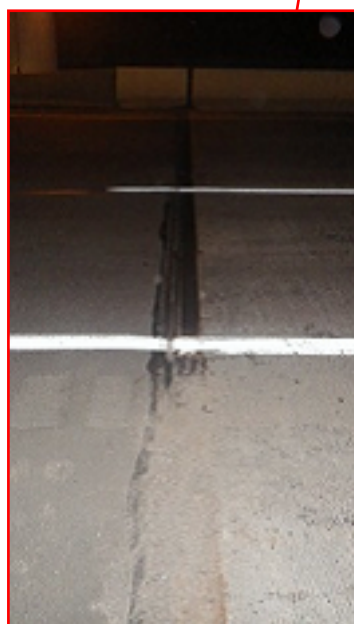
Abutment joint has debris covering part of joint.
