UNDERWATER BRIDGE INSPECTION REPORT

Bridge Number: CUY-00090-2043L
Inspection Date: 12/5/2012
Division: District 12
River: CEI Outlet

Engineer of Record: David Reser
Team Leader: Fred Meek
Substructures Inspected: Bents 1 and 2
Team Members:
KRR, JML

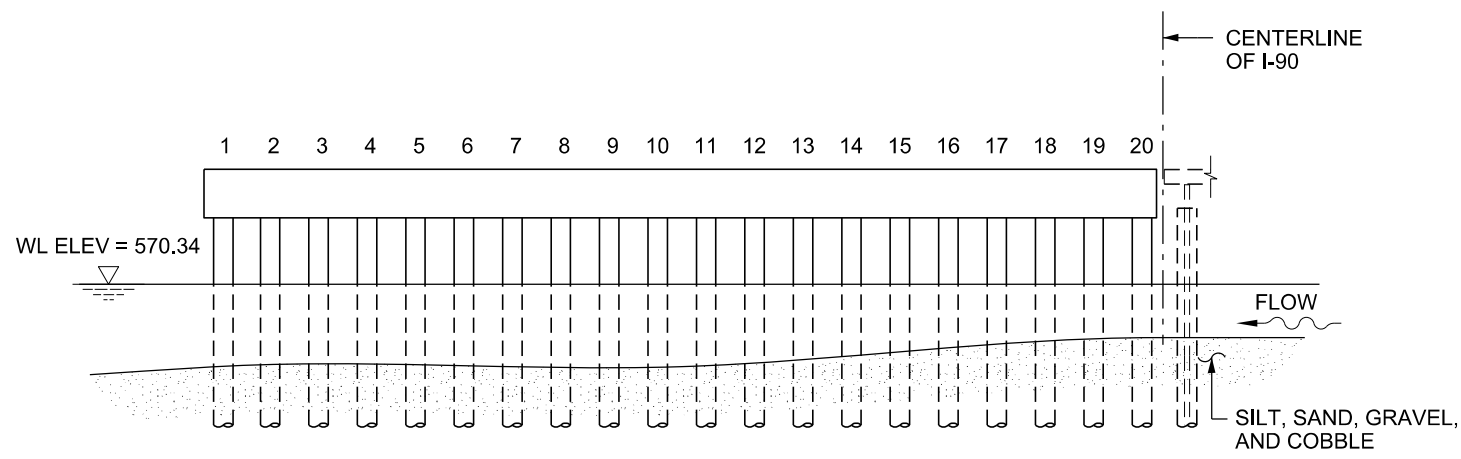
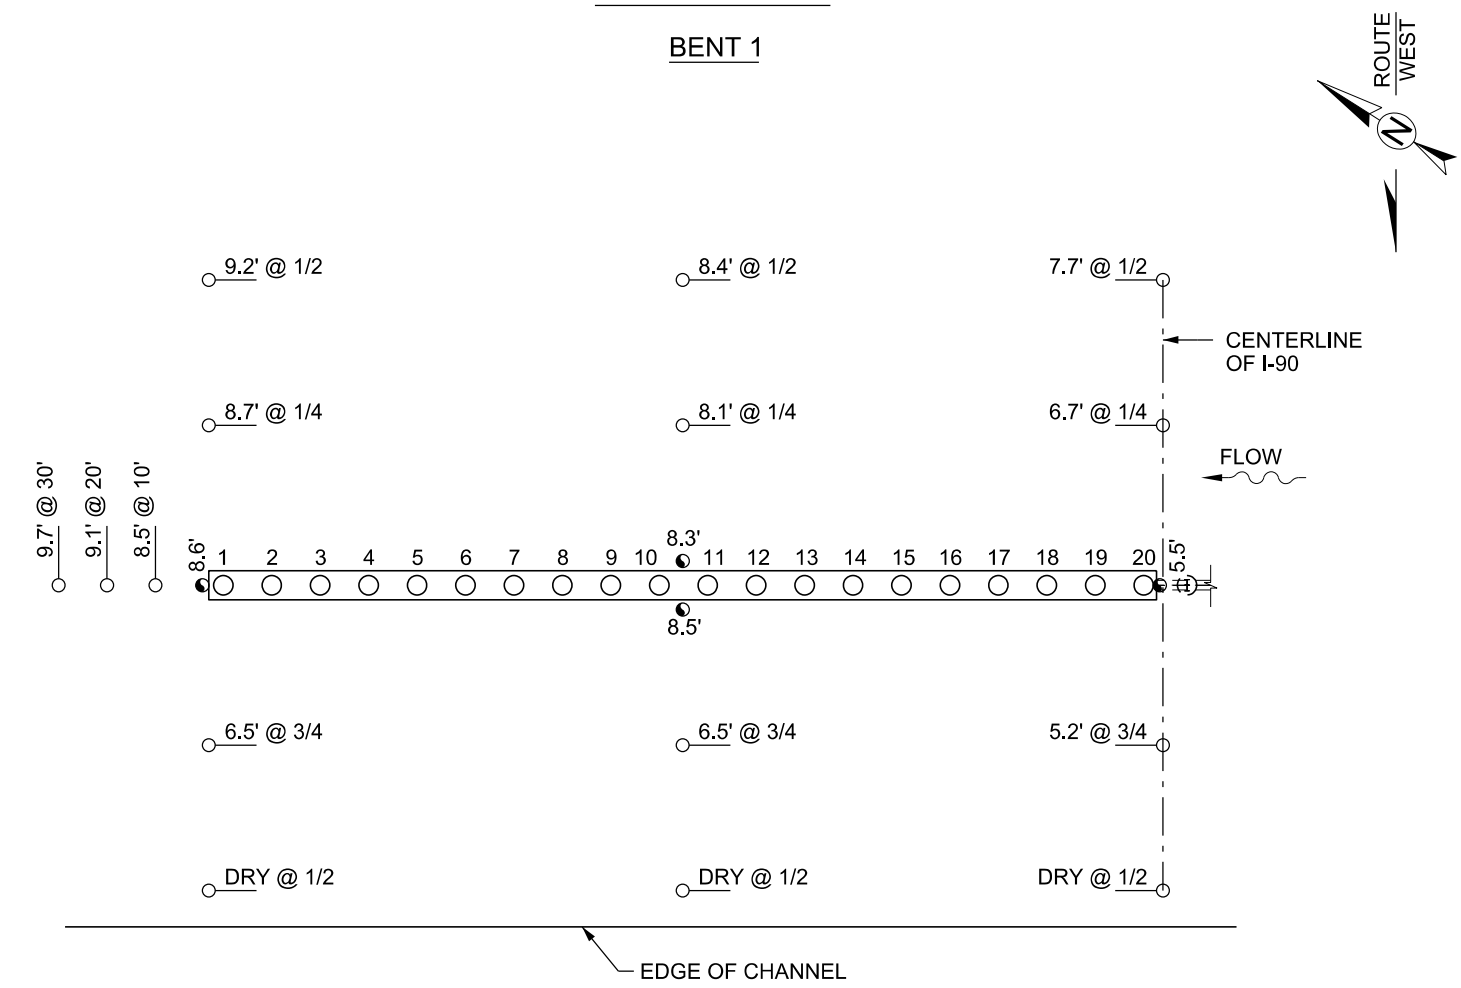
B1P1 has an abrasion/spall up to 11" H x full circumference x 1 1/2" D, located at the waterline, with one (1) piece each of exposed vertical and horizontal reinforcement, 3' below the cap. Refer to Photo 5.

B1P19 has a spall that extends from the southeast to the southwest face, 6" H x 2' W x 1/2" D, 5' below the cap. Refer to Photo 6.

B1P20 has a vertical crack on the south face, 1/32" wide, with light efflorescence, extending 4' down from the cap.

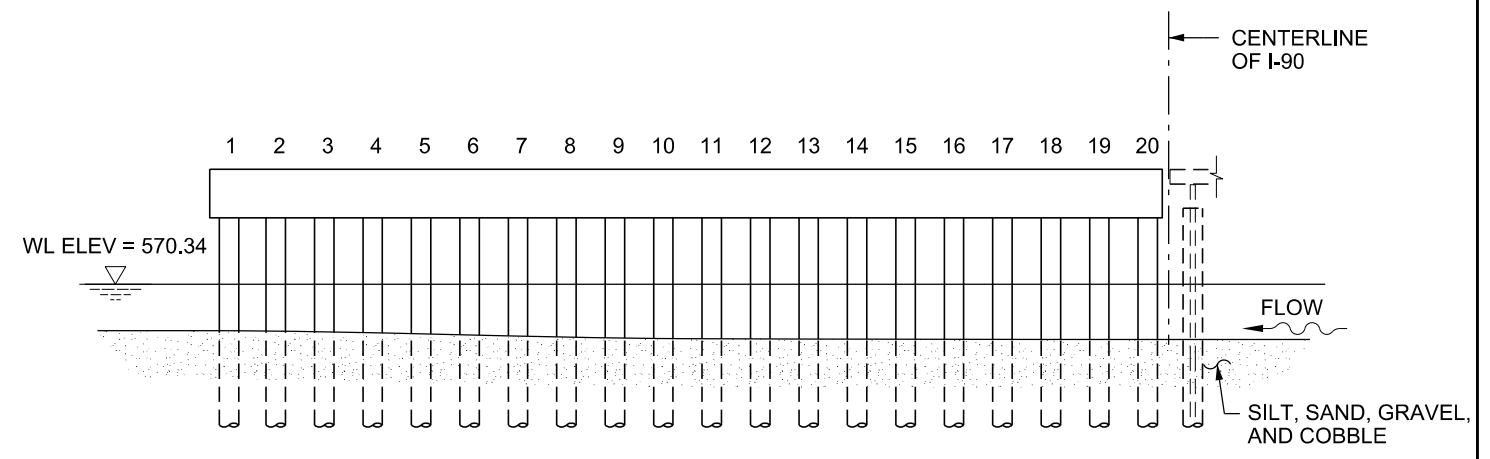
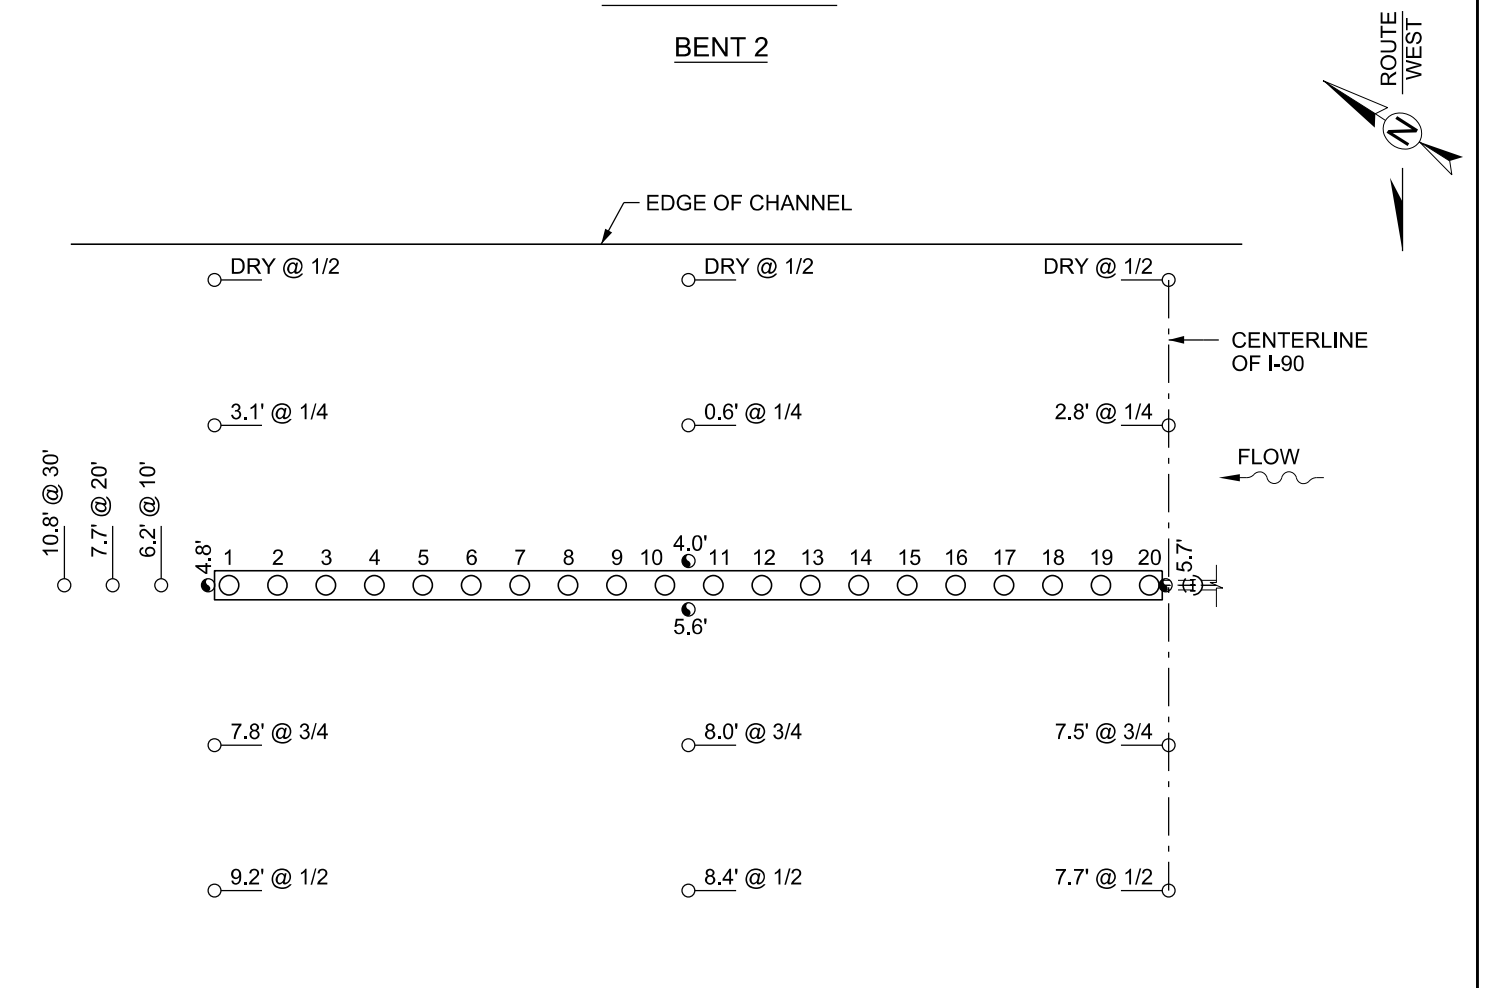
B2P2 has a void at the bottom of the concrete encasement on the northwest quadrant, 8" H x 6" W x up to 4" D, with 8" of H-Pile flange exposed. The portion of the exposed H-Pile is in good condition.

B2P4 has a spall at the bottom of the north quadrant extending around the west side to the south face, 6" H x 7" D, with no exposed H-pile observed.

B2P5 has a spall at the bottom of the north face extending around the west side to the south face, 4" H x 1'-2" W x 3 1/2" D, with one (1) piece of exposed reinforcement. The exposed reinforcement is in good condition.

B2P6 has a spall, 3' H x 3 1/2" D, with four (4) pieces of exposed vertical reinforcement on the west, northwest, northeast, and east quadrants, 1'-3" below the cap. Maximum reinforcement exposure is 10" high, with loss of epoxy coating (reinforcement is still in good condition). Secondary horizontal reinforcement is exposed at all quadrants within the spall. Refer to Photo 7. B2P6 has another spall at the south quadrant at the channel bottom, 2" H x 6" W x 3" D with no exposed H-pile or steel. This pile is surrounded by sand bags on the channel bottom.

B2P12 has a spall in the east quadrant due to insufficient cover, 8" H x 1'-3" W x 1" D, 3'-6" below the cap. There is another spall at the channel bottom, starting in the west face and extending around to the southeast quadrant, 10" H x 8" D, with no H-pile exposure.

Restore concrete cover to the areas of exposed reinforcement at the spalled areas of the concrete encasements. Place fill material, rip rap, or sand bags to abate scour at Bent 2.
