BRIDGE INSPECTION REPORT

BRIDGE NUMBER CUY 00090 2046 R

Underwater Inspection Report for:

Interstate 90 over C.E.I Outlet
Cuyahoga County, Ohio
(Three Span Steel Beam Bridge)

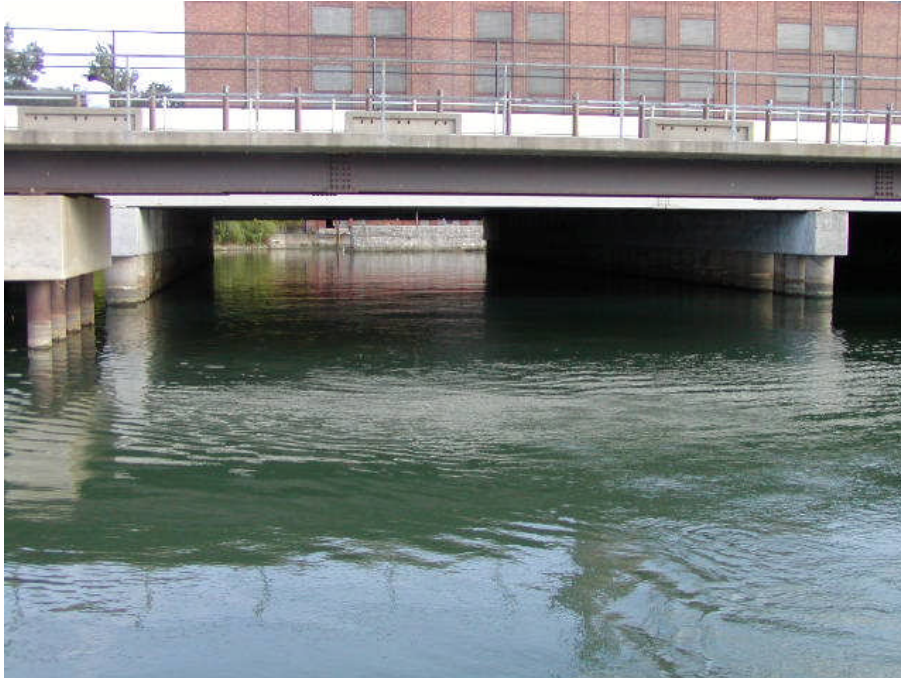
Photo 1. Elevation view looking upstream (south).

The condition of the bridge during the 2007 inspection was consistent with the 2006 inspection report. The bridge is in good condition with only minor deficiencies noted.
