**Underwater Inspection of
SFN - 2801744
State Route 422 over the La Due Reservoir
(GEA-422-0986 R)
July 25, 2014
For
Ohio Department of Transportation
District-12**

(South Elevation of Bridge)

By
GPI/Greenman-Pedersen, Inc.

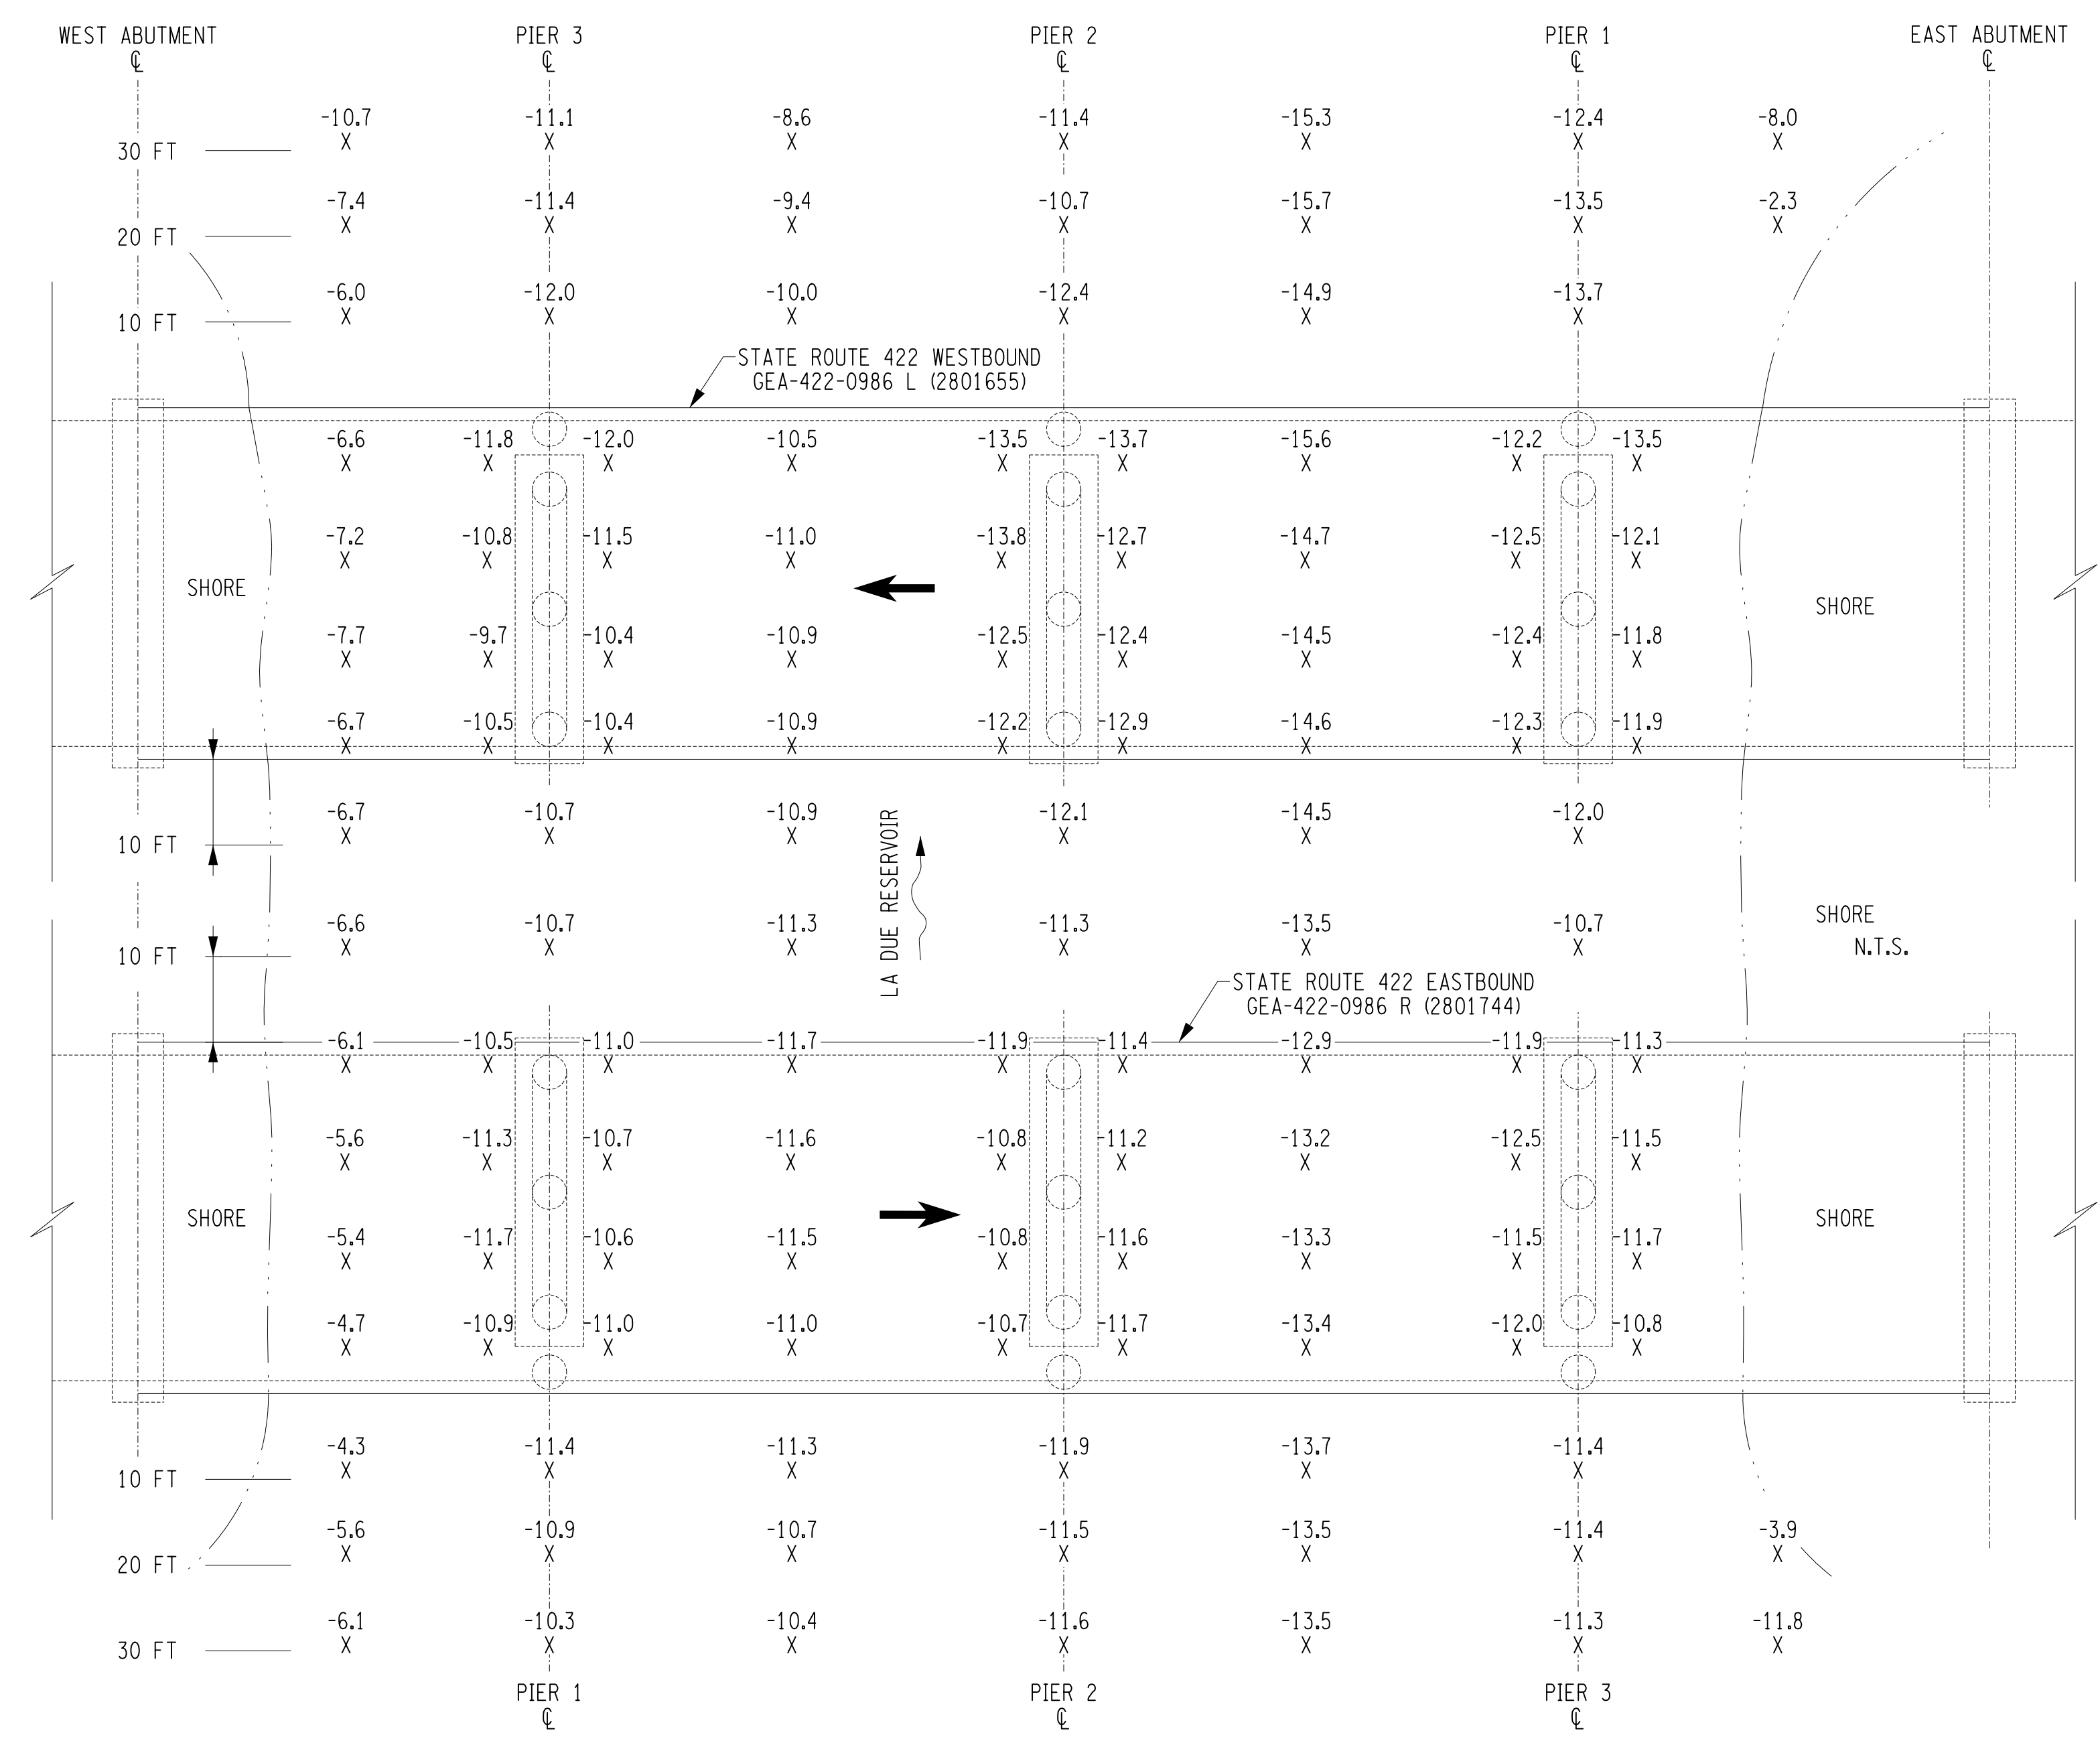
SOUNDING PLAN
NTS

The La Due Reservoir flows south to North under this structure. The thalweg of this river runs between Pier 2 and Pier 3 midspan. A maximum depth of 13.7 feet was found under the structure in the thalweg. Flow at this bridge was less than 1 foot per second.
