**Underwater Inspection of
SFN - 4301714
State Route 2 over the Grand River
(LAK-2-1656R)
July 23, 2014
for
Ohio Department of Transportation
District-12**

(North Elevation of Bridge)

By
GPI/Greenman-Pedersen, Inc.

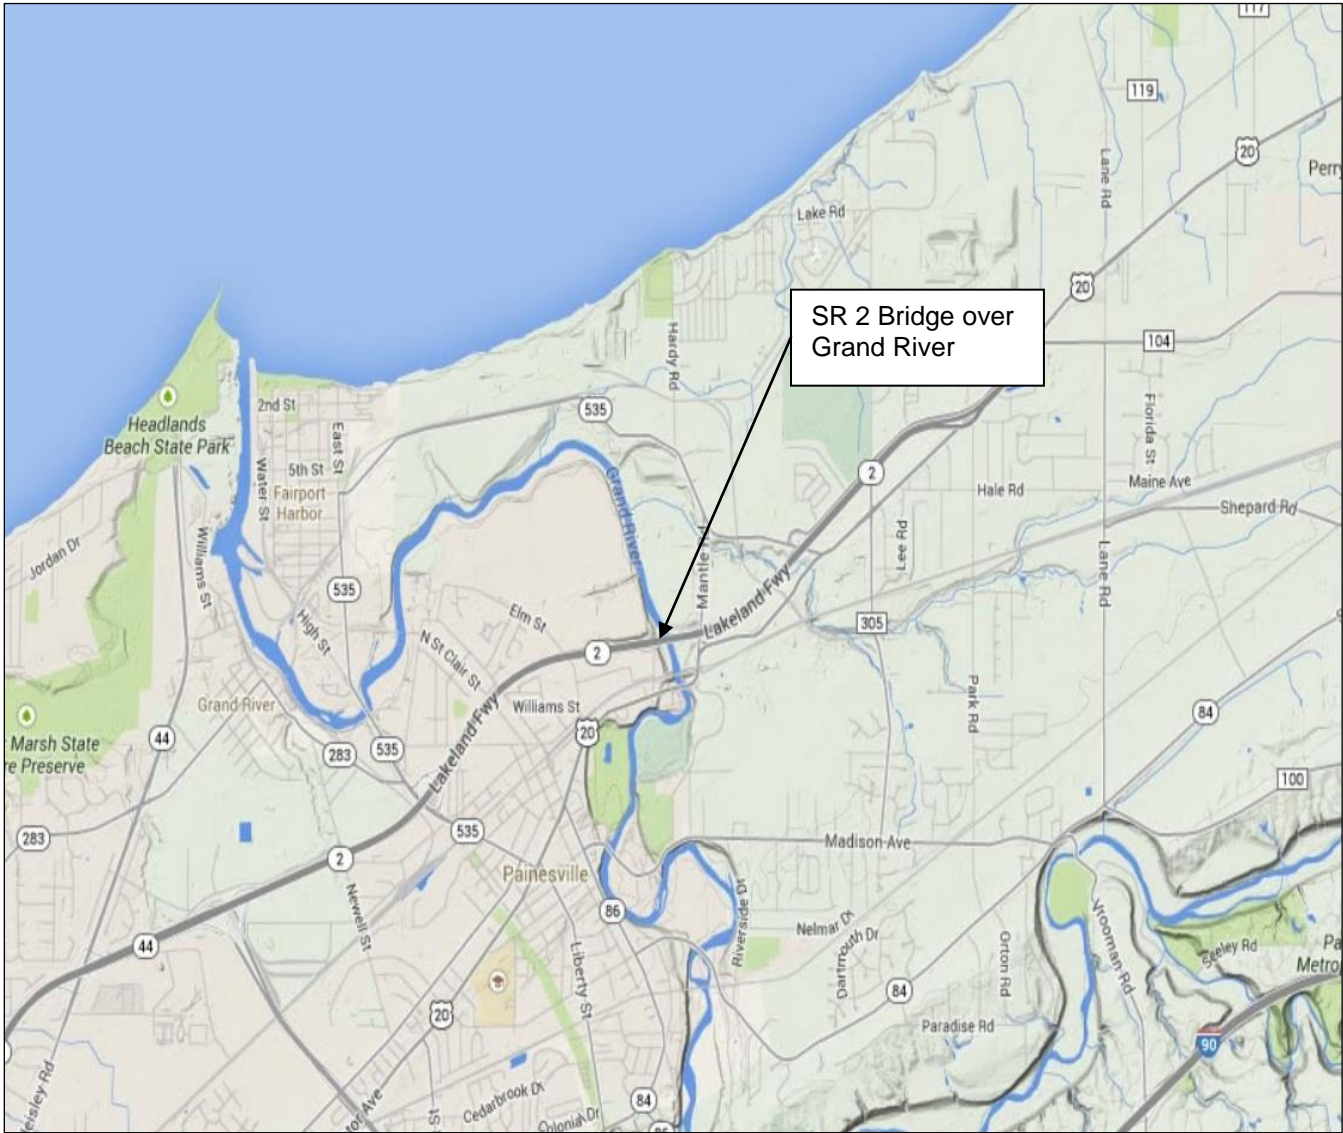
SOUNDING PLAN

The Grand River flows South to North under this structure. The thalweg of this river runs between Pier 1R and rear abutment. A maximum depth of 6.0 feet was found under the structure in the thalweg. Flow at this bridge was approximately 1 foot per second.
