**Baker Slope Stability Study Report
(Reference Document)**

**Innerbelt Bridge
Construction Contract Group 1 (CCG1)**

Slope Stability Evaluation Report of the West Bank

CUY-90-14.92
PID 77332

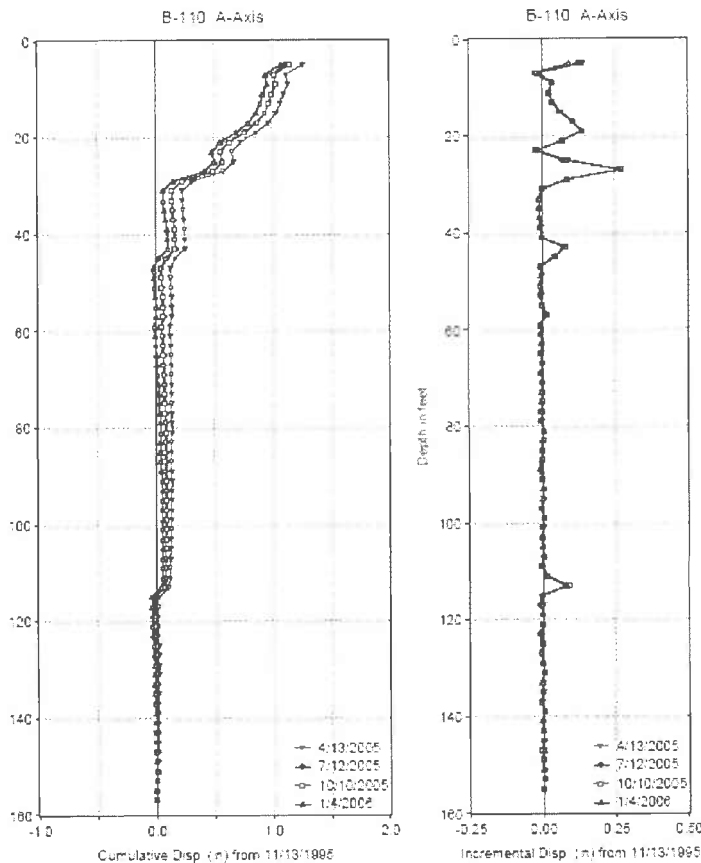
Response: The rate of movement (0.15 in/yr) provided in the BBC&M report, page 39, was taken from Table 1a of the 2005-2006 annual monitoring report. The value of 0.15 in/yr was determined by summing the displacement from 7 to 25 feet, 25 to 31 feet and 43 to 47 feet (see displacement time history plot for B-110 of the 2005-2006 annual monitoring report). This was done to quantify the total displacement as is shown in the B-110 displacement figure below.

Stating the rate of movement of 0.15 in/yr may be misleading as it includes displacement along at least two slip planes and indicates cantilever deflection. However, it was done in an attempt to quantify the total relative shallow movement observed in inclinometer B-110. Presenting the relative displacement between the ground surface and a depth of 47 feet is more relevant than simply presenting the displacement along one slip plane as all of this shallow movement would be transferred to a pier if it were placed in the vicinity of inclinometer B-110.

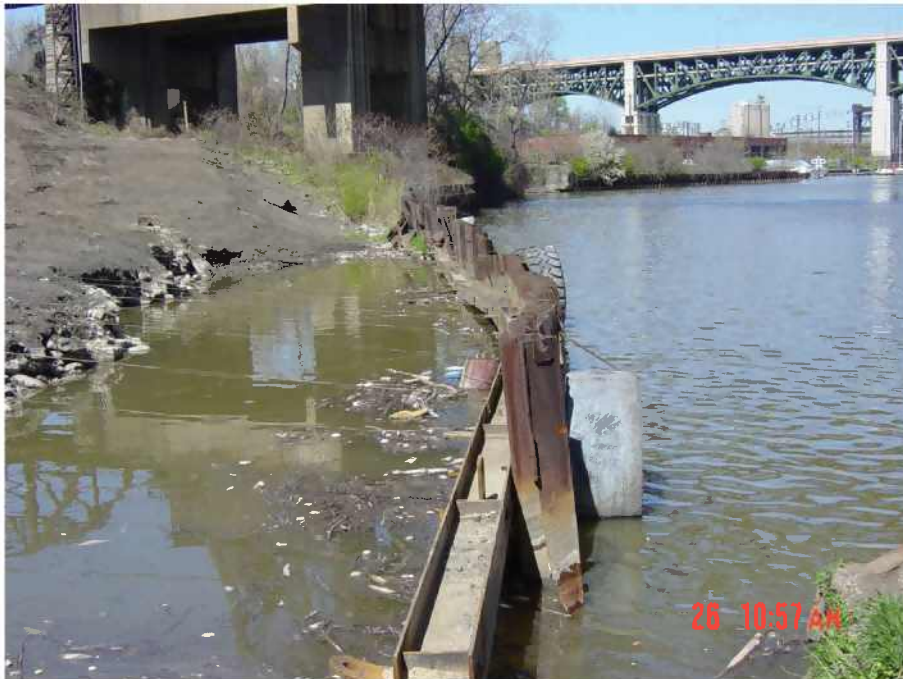
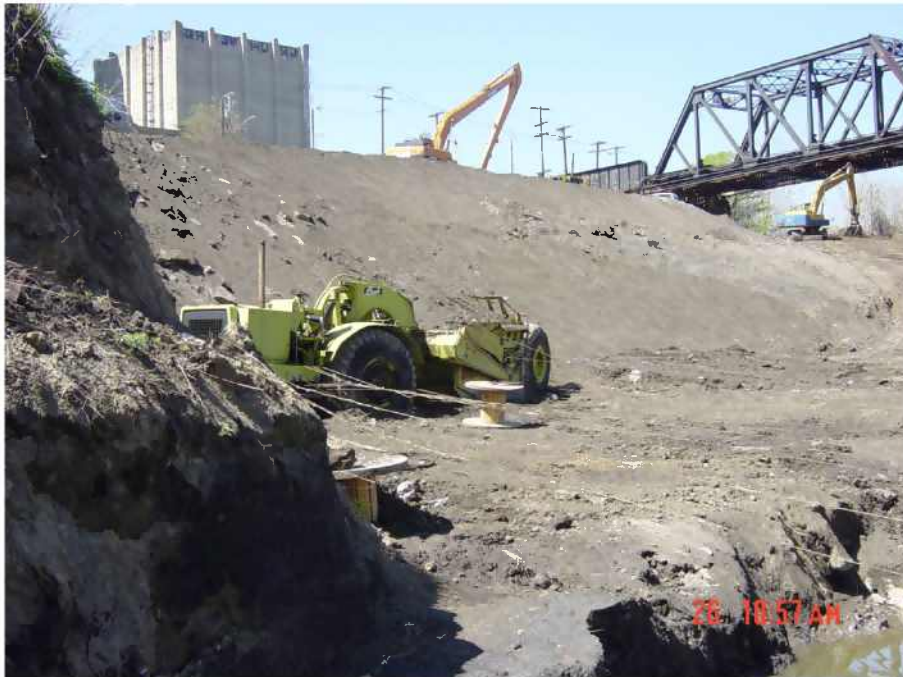
A sheet pile revetment wall exists at the toe of the slope. It is required by the US Army Corps of Engineers to help maintain a navigable water way. The sheets are 65 feet long. Horizontal steel rods spaced at 8 ft intervals extend from the top of the sheeting to anchor located approximately 40 ft behind the sheeting. These tiebacks failed over time with the consequence that soil and water pressures acting on the back of the sheeting caused the sheeting to displace outward by several feet as shown in the pictures in Figure 3.1. The current owner has excavated soil from behind the sheeting with the hope that the sheeting can be pulled back into place, new tiebacks placed and the slope backfilled. This operation has reduced the overall factor of safety of the existing slope approximately 0.13. This revetment wall should be replaced with a strong, reliable revetment. A new pier should be located to avoid the sheet pile wall tie-backs.

Figure 3.1: Pictures showing the failed sheet pile wall.

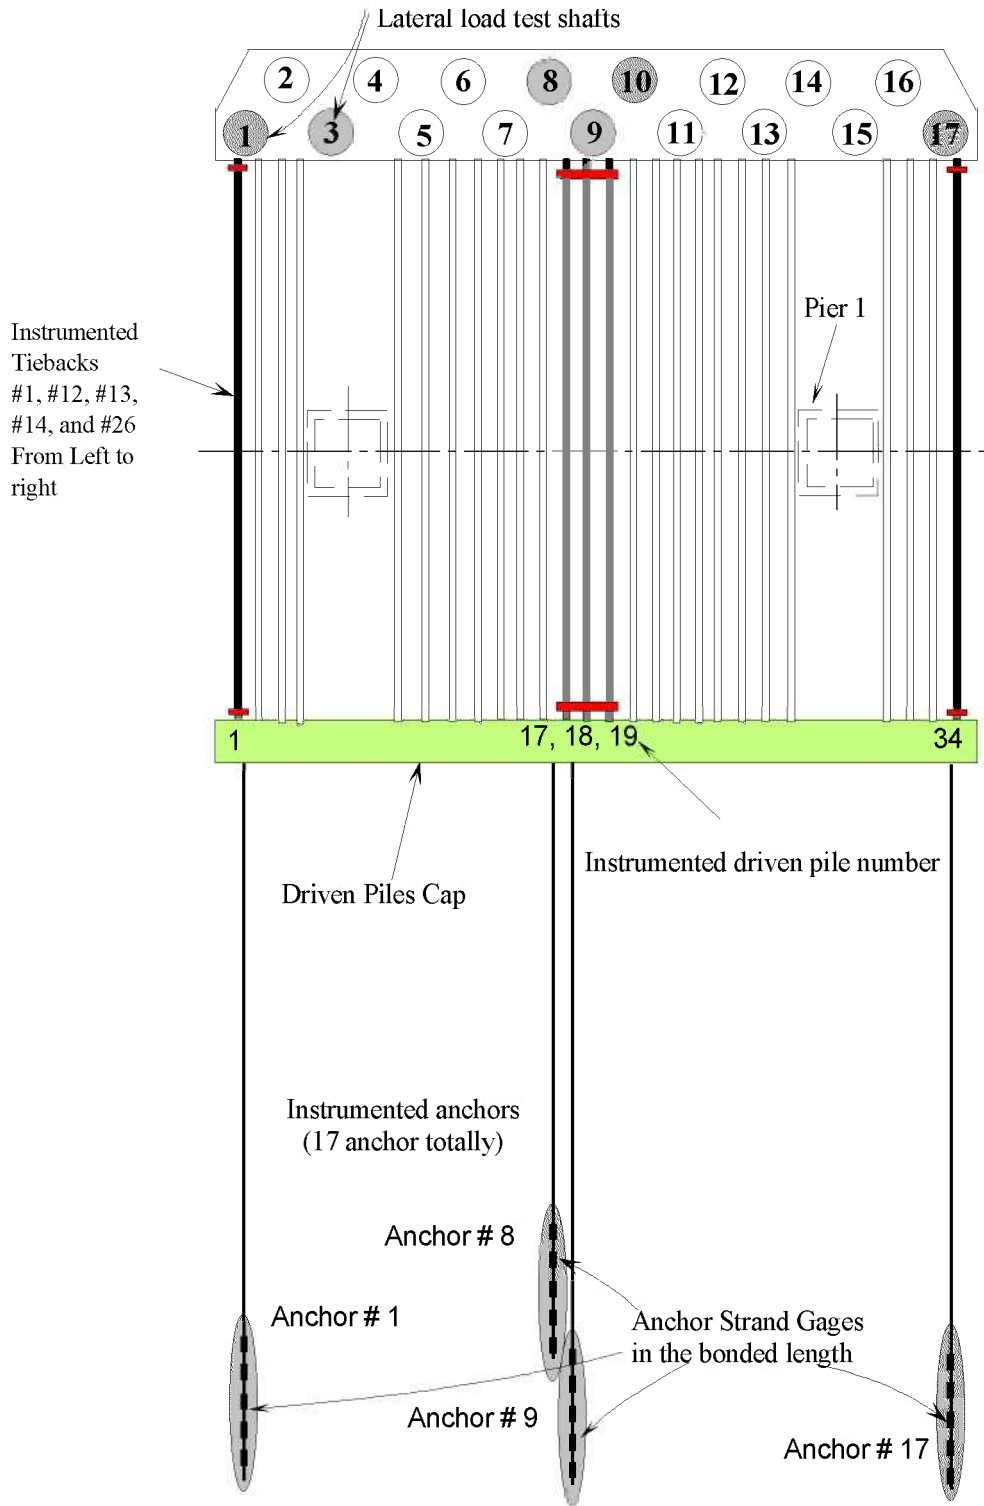
Figure 5.1 Plan view of the stabilization structure and instrumentation layout

The stabilization system consisted of two rows of drilled shafts with a reinforced concrete cap, tension tieback beams, driven piles with a reinforced concrete cap, and relatively long rock anchors. The drilled shaft reinforced concrete cap was tied to the pile cap with steel W 8x35 members. Figure 5.1 shows a plan view of the stabilization system.

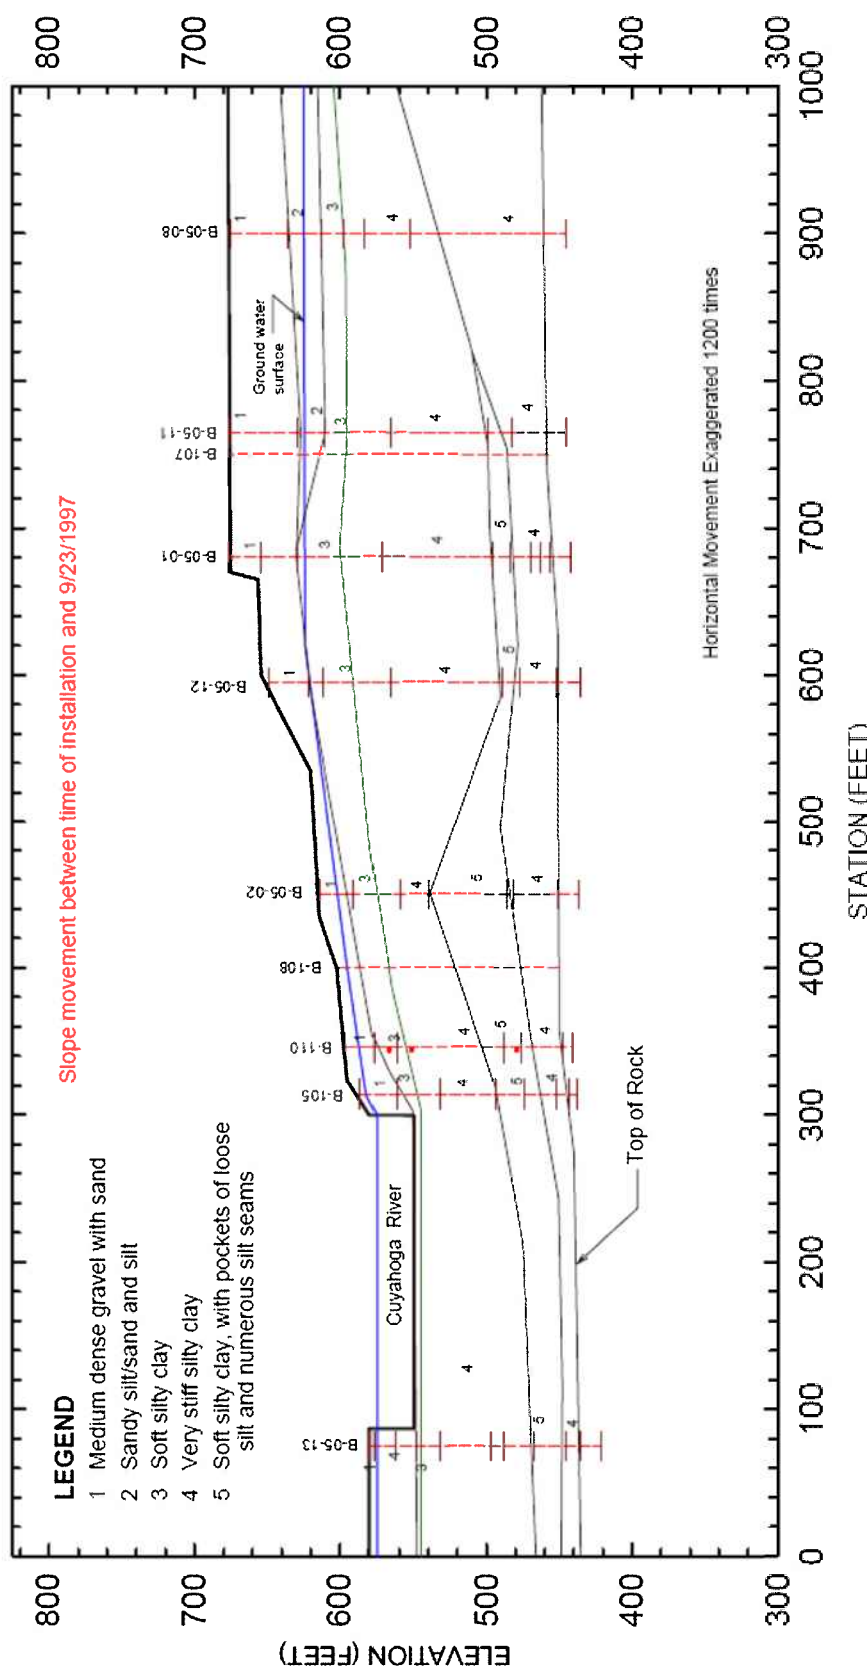
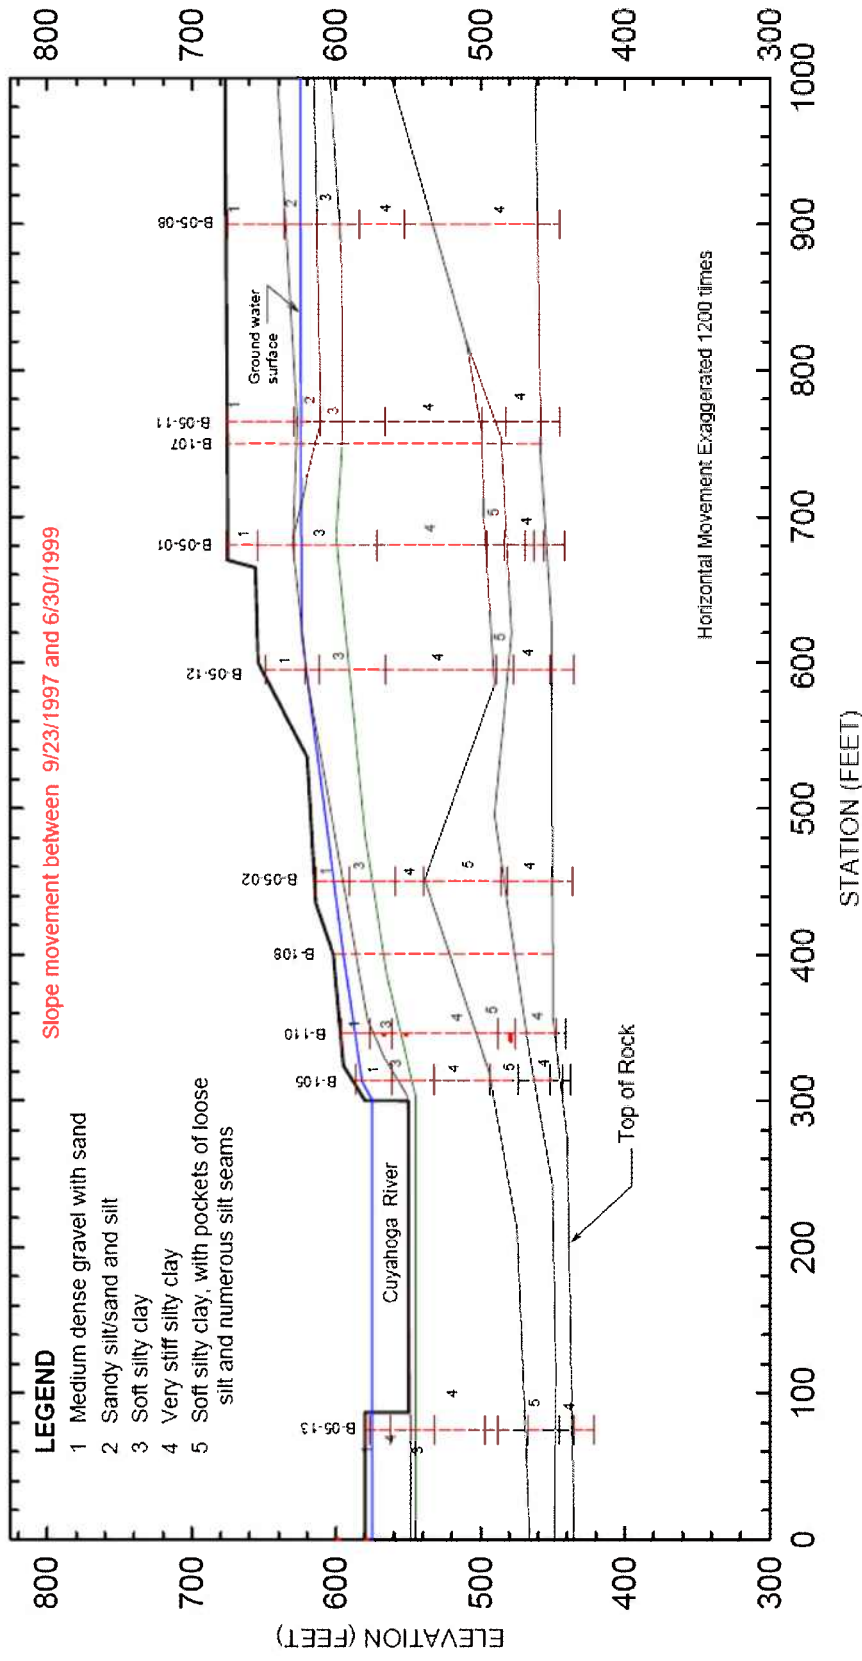
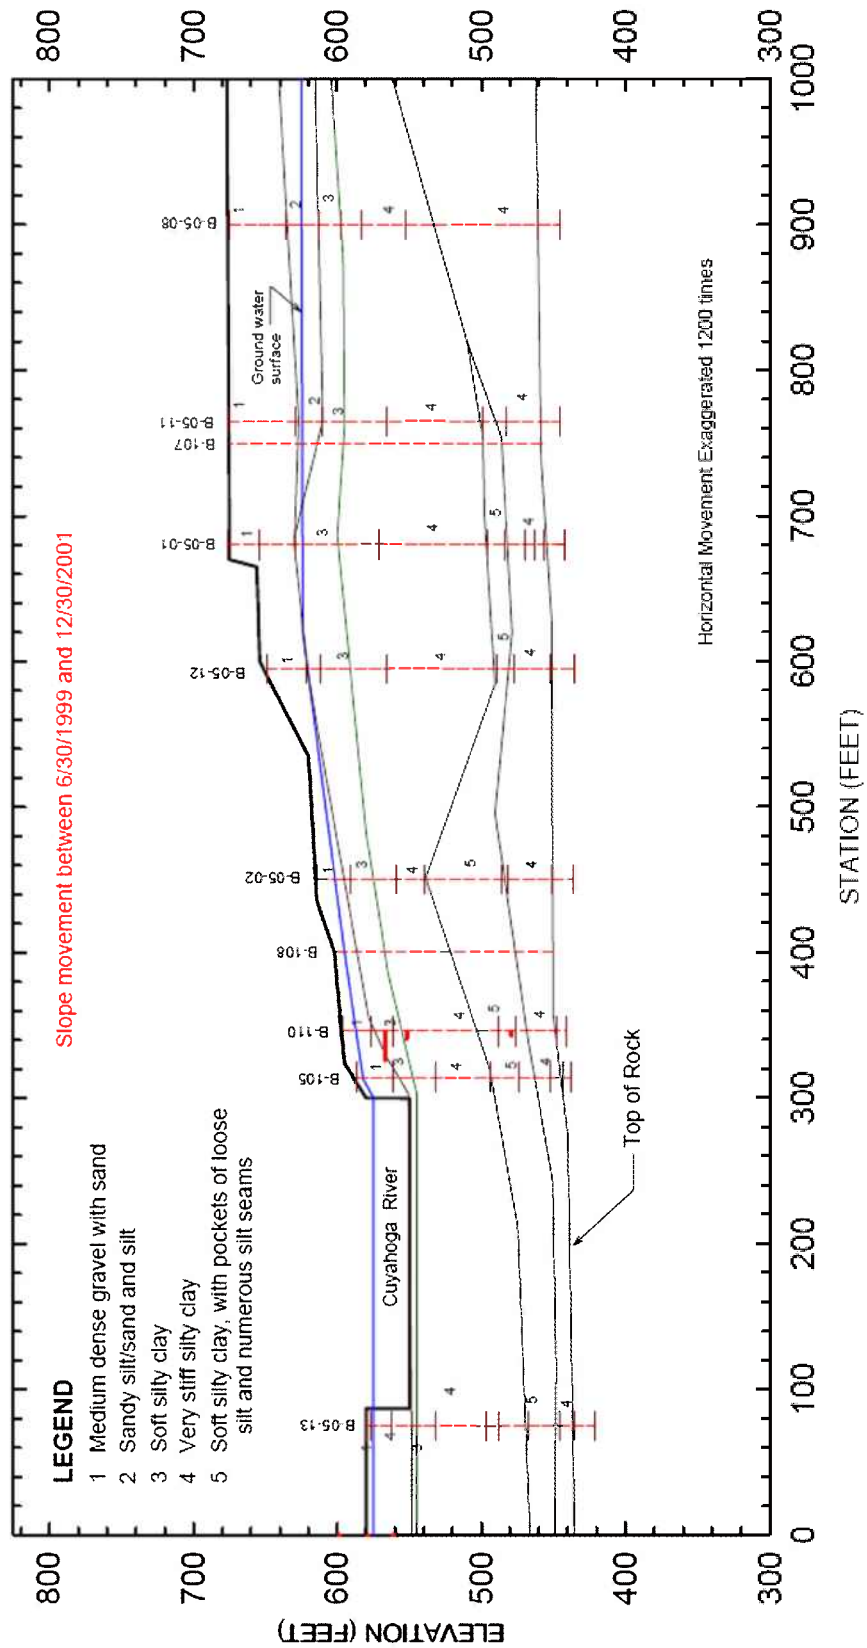
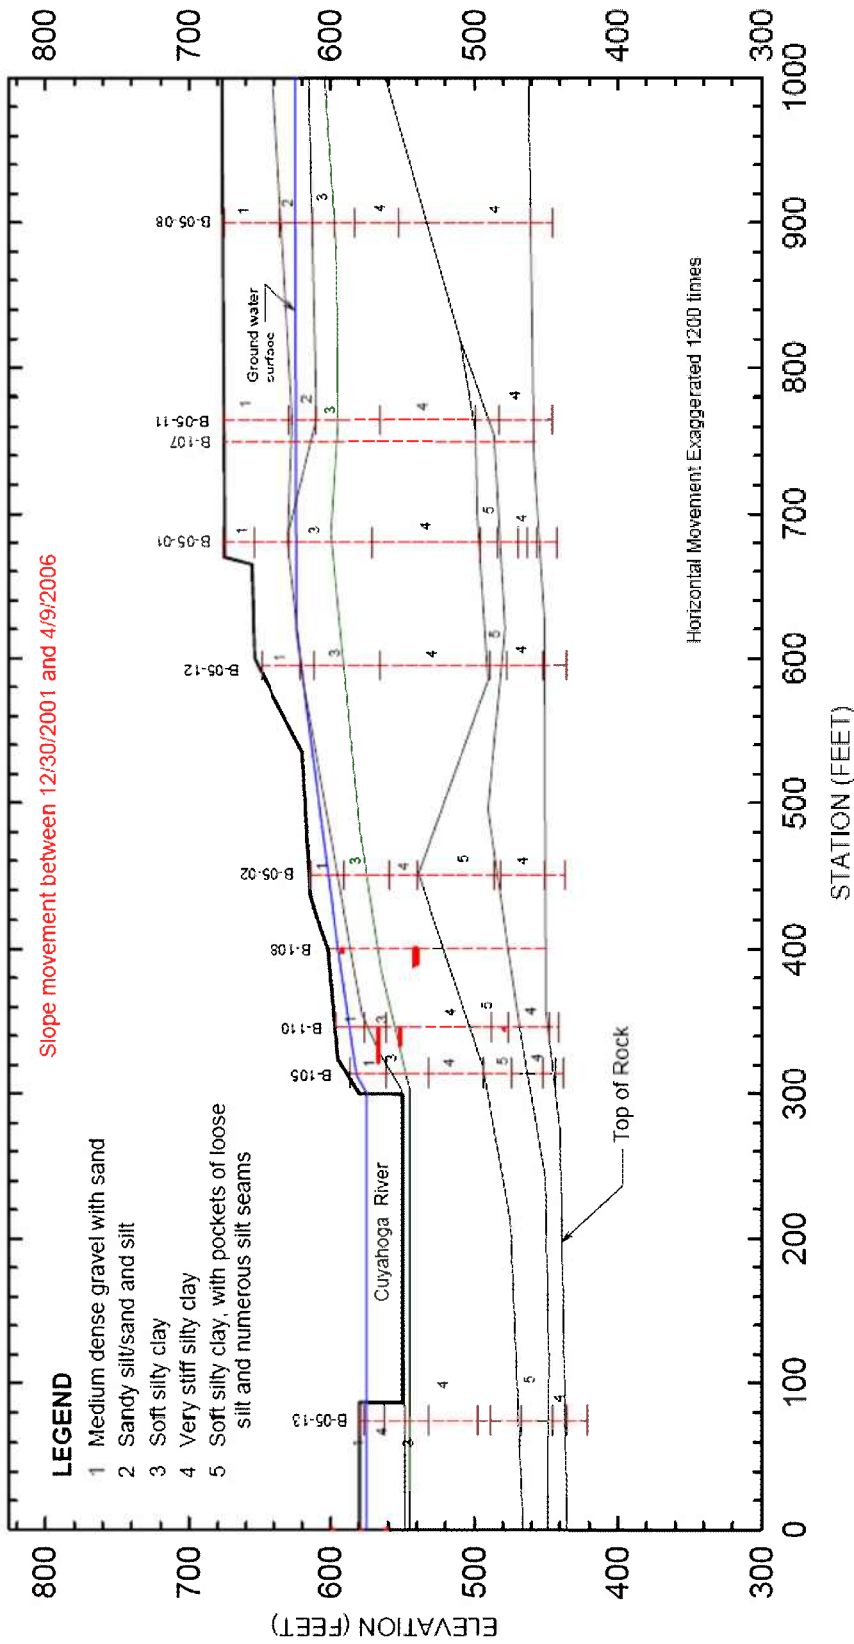
Soil profiles developed from old and new boring information was used to show the movement along the center line of the proposed structure (Section A-A) and to the south of the existing structure (Section D-D). The movement along Section A-A is shown in Figures 5.7 through 5.10, respectively for the four phases mentioned earlier. Figures 5.11 through 5.14 present the movements along section D-D. Table 5.1 summarizes the total movement and the rate of movement during each of the four phases.

Figure 5.7 Ground movement along section A-A during phase I

Figure 5.8 Ground movement along section A-A during phase 2

Figure 5.9 Ground movement along section A-A during phase 3

Figure 5.10 Ground movement along section A-A during phase 4

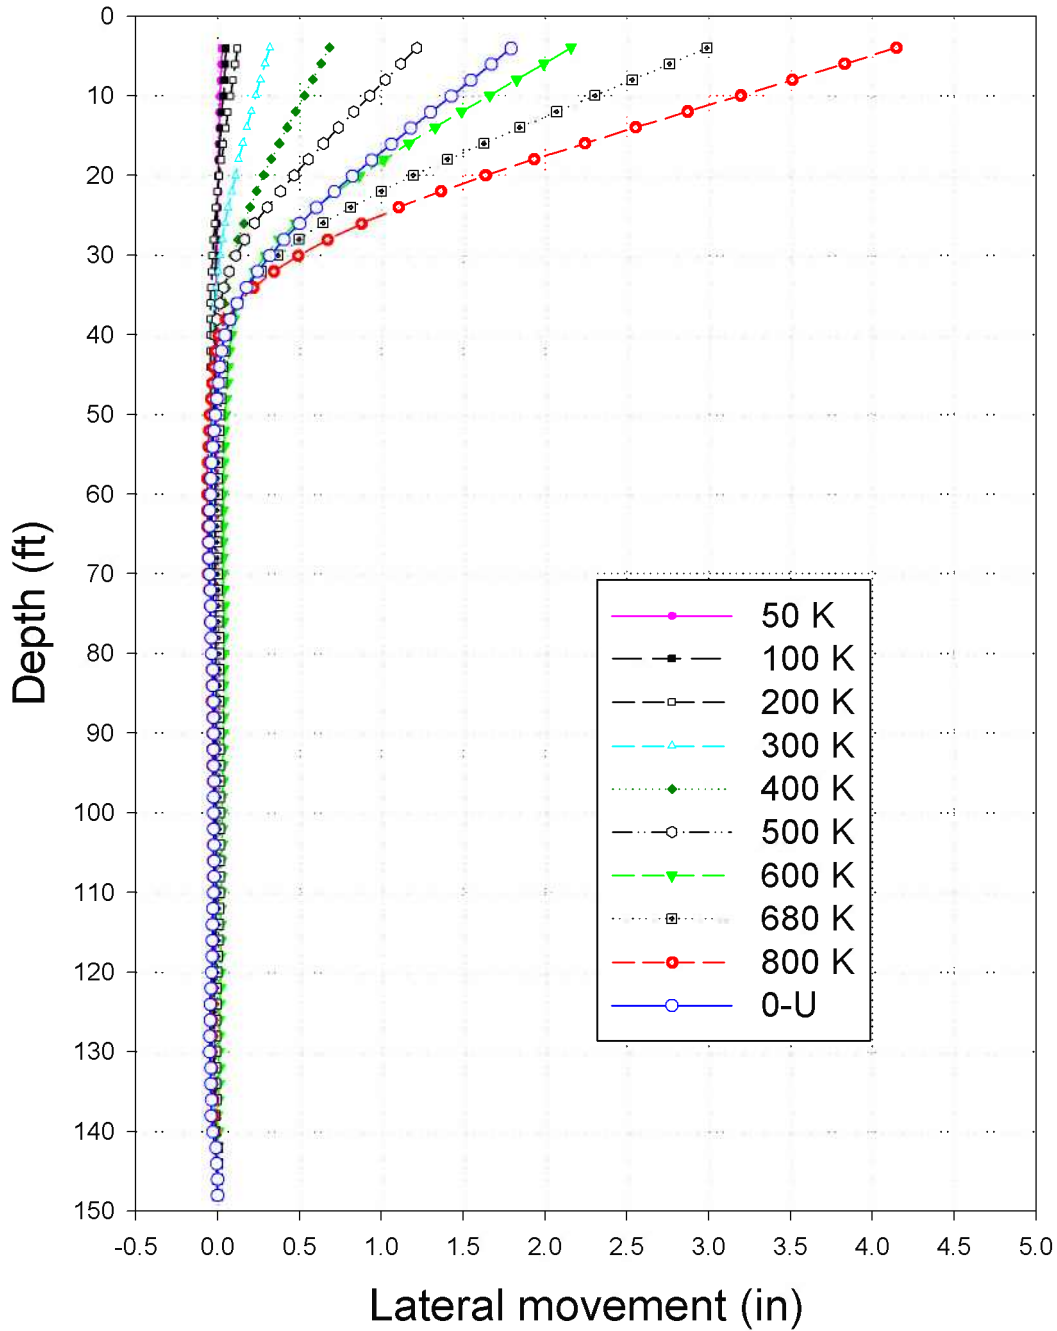
During construction of the drilled shafts for the stabilization structure, a lateral load test was conducted between shafts #1 and #3. The maximum applied lateral load was 800 kips. The deflection associated with a lateral load of 800 kips was 5 inches as shown in Figure 5.15. The maximum bending strain along the depth of shaft #1 associated with the 800 kips lateral load was 1614 micro strains as shown in Table 5.2. From long term monitoring data obtained from instrumentation installed in drilled shaft #9, measurements indicated a maximum bending strain located at a depth of 95 feet to have a magnitude equal to 151 micro strains. This value is 10% of the 1614 value measured during the lateral load test.

Figure 5.15 Deflection vs. Depth from Shaft #1 during the lateral load test.

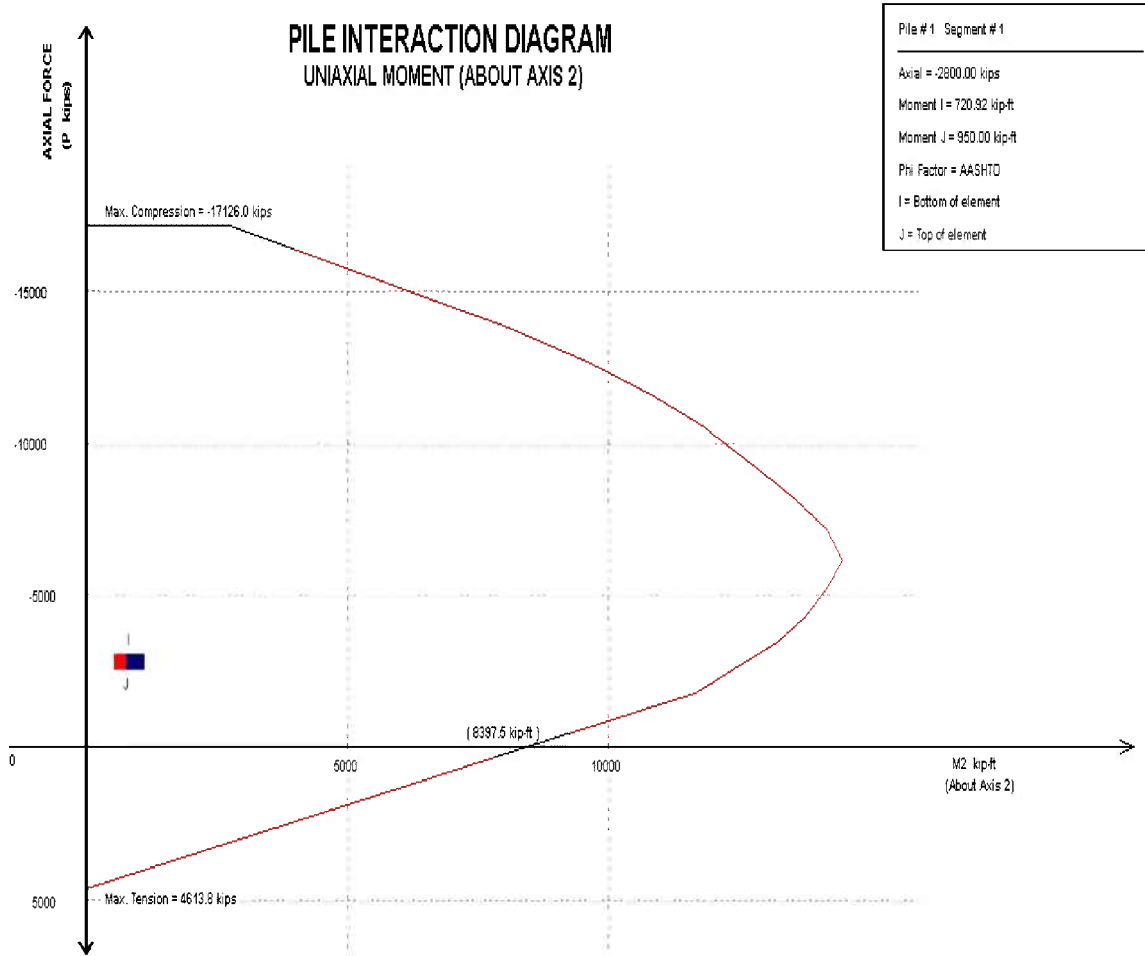
For shaft #17, which experienced a maximum movement of 1.7 inches, the strain equivalent to this value from the lateral load test is equal to 231 micro strains. Figure 5.16 shows the interaction diagram for the stabilization drilled shafts. The concrete strength used was 6000 psi, which was taken from the drilled shaft inspection record attached at the end of this chapter.

Based on the findings from the lateral load test, the drilled shafts have the ability to move up to 5 inches elastically (which was the maximum movement reported in the lateral load test). The rate of movement in drilled shaft #17 was the highest (i.e. 0.12 inch/yr). Assuming a constant rate of 0.12 inch/yr, it will take 15 years to reach a total movement of 3.5 inches (1.7 + 1.8). Assuming a constant rate of 0.12 inch/yr, it will take 28 years to reach a total movement of 5 inches (1.7 + 3.3). This indicates that the safe life of the stabilization shafts is approximately 30 years before getting beyond the condition as tested in 1998. From the long term monitoring data, the rate of increase in the moment and axial force in shaft #9 at a depth of 95 feet appears to have decreased as shown in Figures 5.17 and 5.18. The recently collected data from the July 2006 readings show minimal increase in the strain in the shaft.

Figure 5.16 Interaction Diagram for Drilled shafts in the stabilization structure.

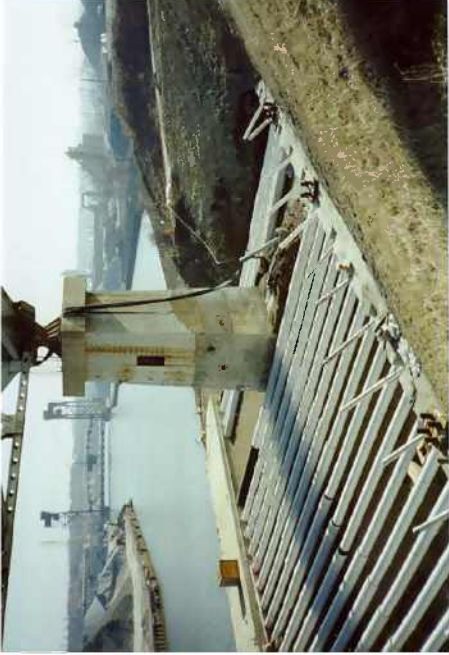
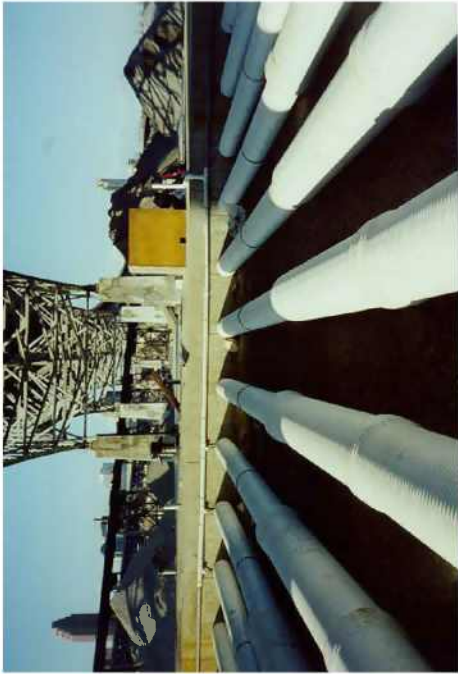
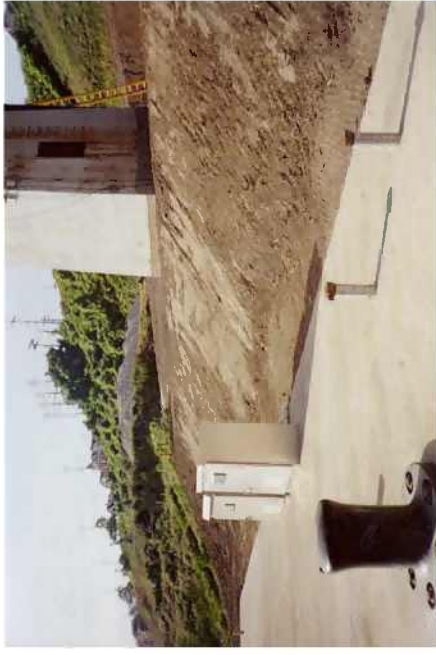
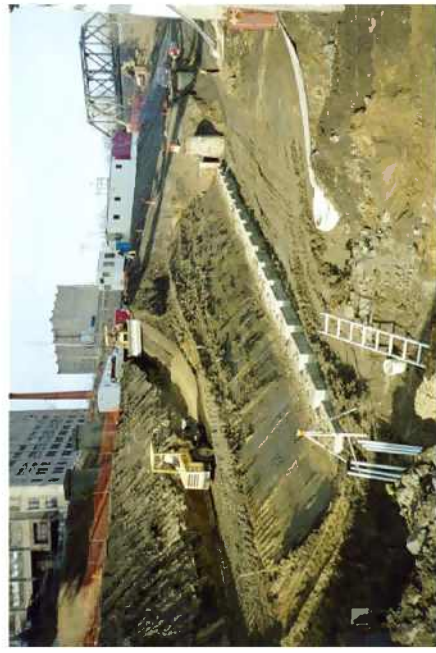
Tie beam measurements are experiencing a steady state condition with no indication of any trend to vary with time except for slight stress changes which are most likely a result of changes in temperature. Note that there is a relatively high frictional resistance from the soil around and on top of the beams. The tie beams were insulated in a 24" diameter corrugated PVC, which was filled with concrete after tensioning of the anchors. Due to the corrugated pipe and the concrete filling, the tie beams are acting as a composite 24" diameter corrugated section. The steel beam inside the section is not indicating any increase in stress in response to the movement of the caps. The force transmitted through the PVC composite sections has to overcome the friction of the surrounding soil. It appears that the drilled shaft cap and the pile cap are moving similar distances laterally, which allows the tie beams to remain in a constant state of stress. Pictures in Figure 5.19 show the construction of the tie beams and the

Figure 5.19 Photo showing the construction of the tie beams and the buildup of fill on top

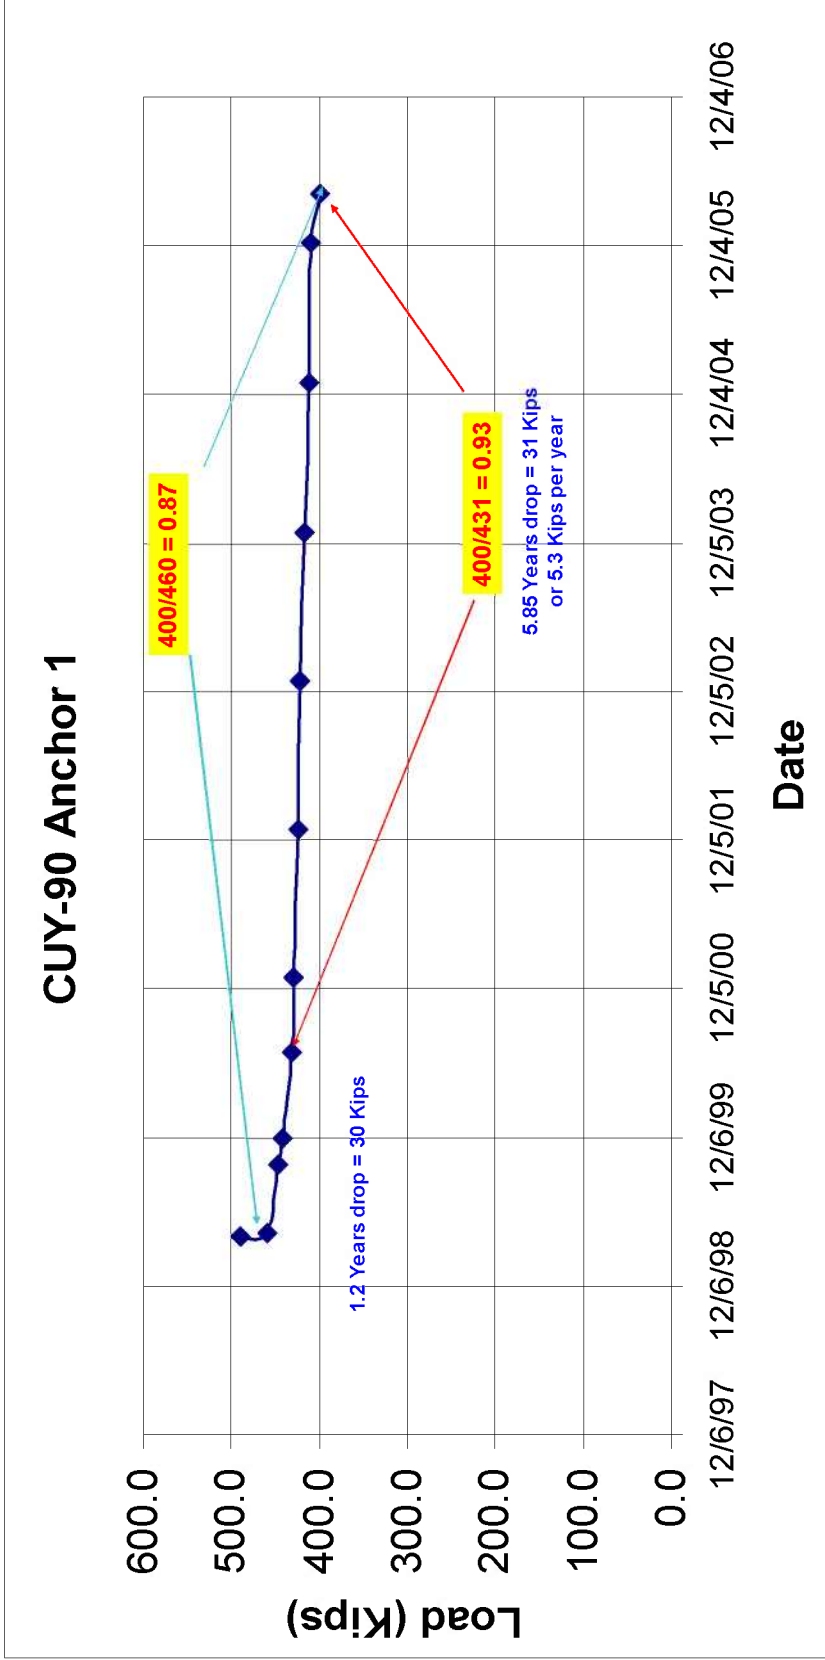
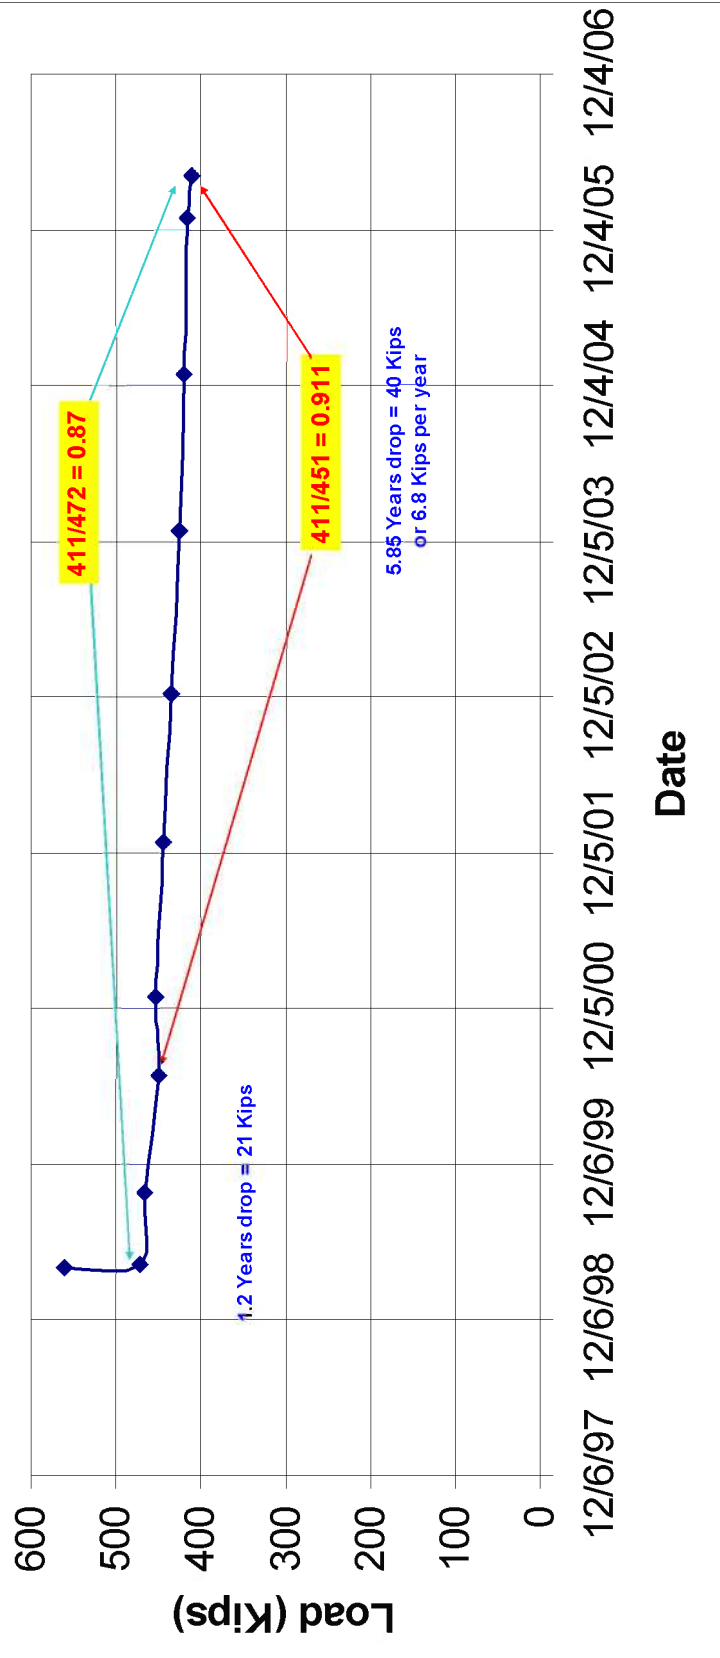
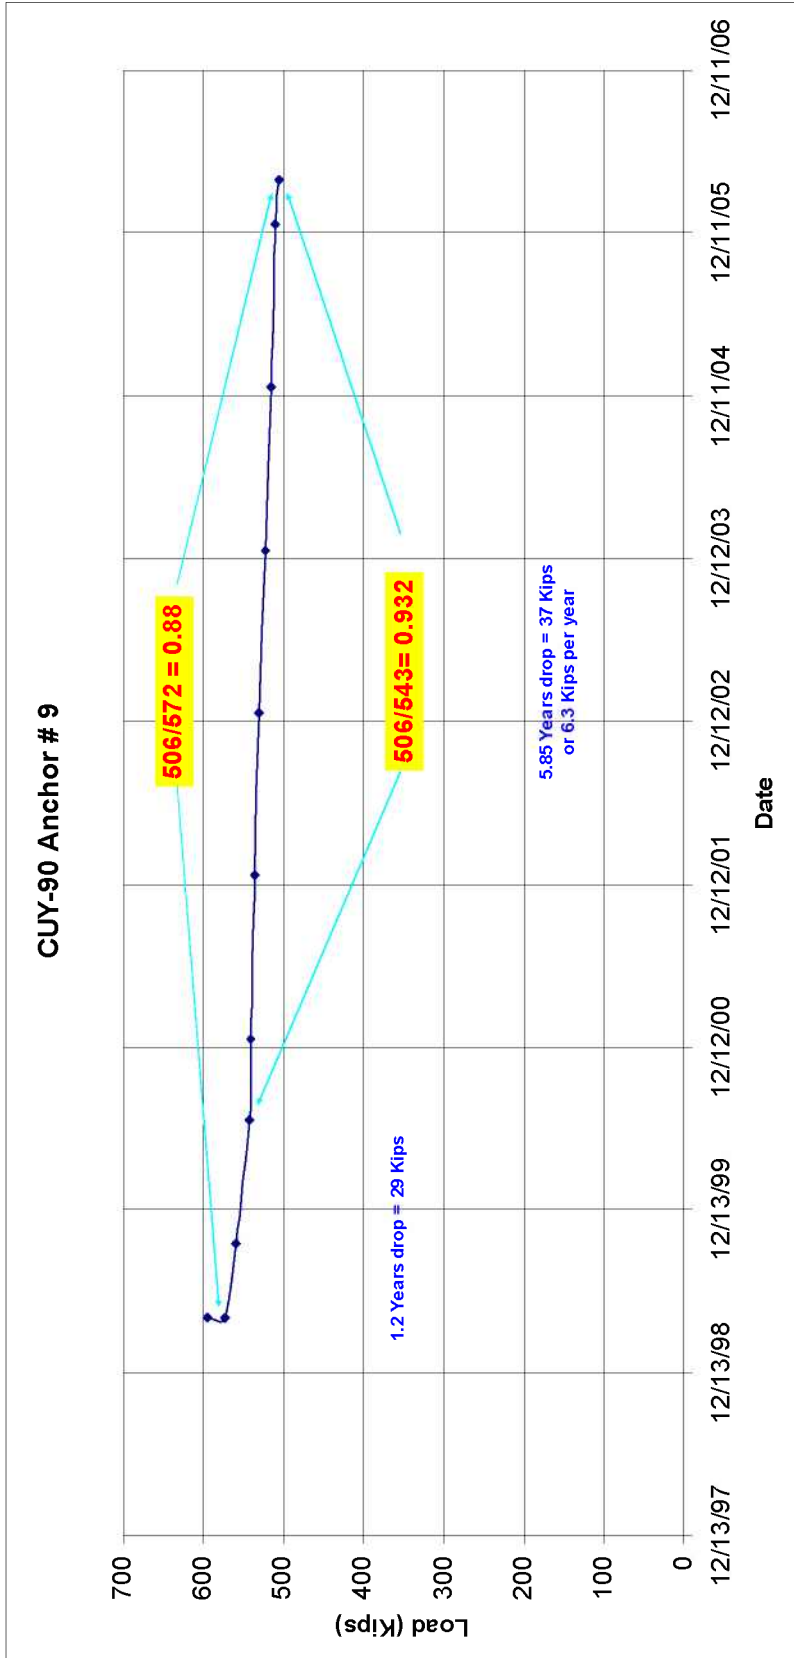
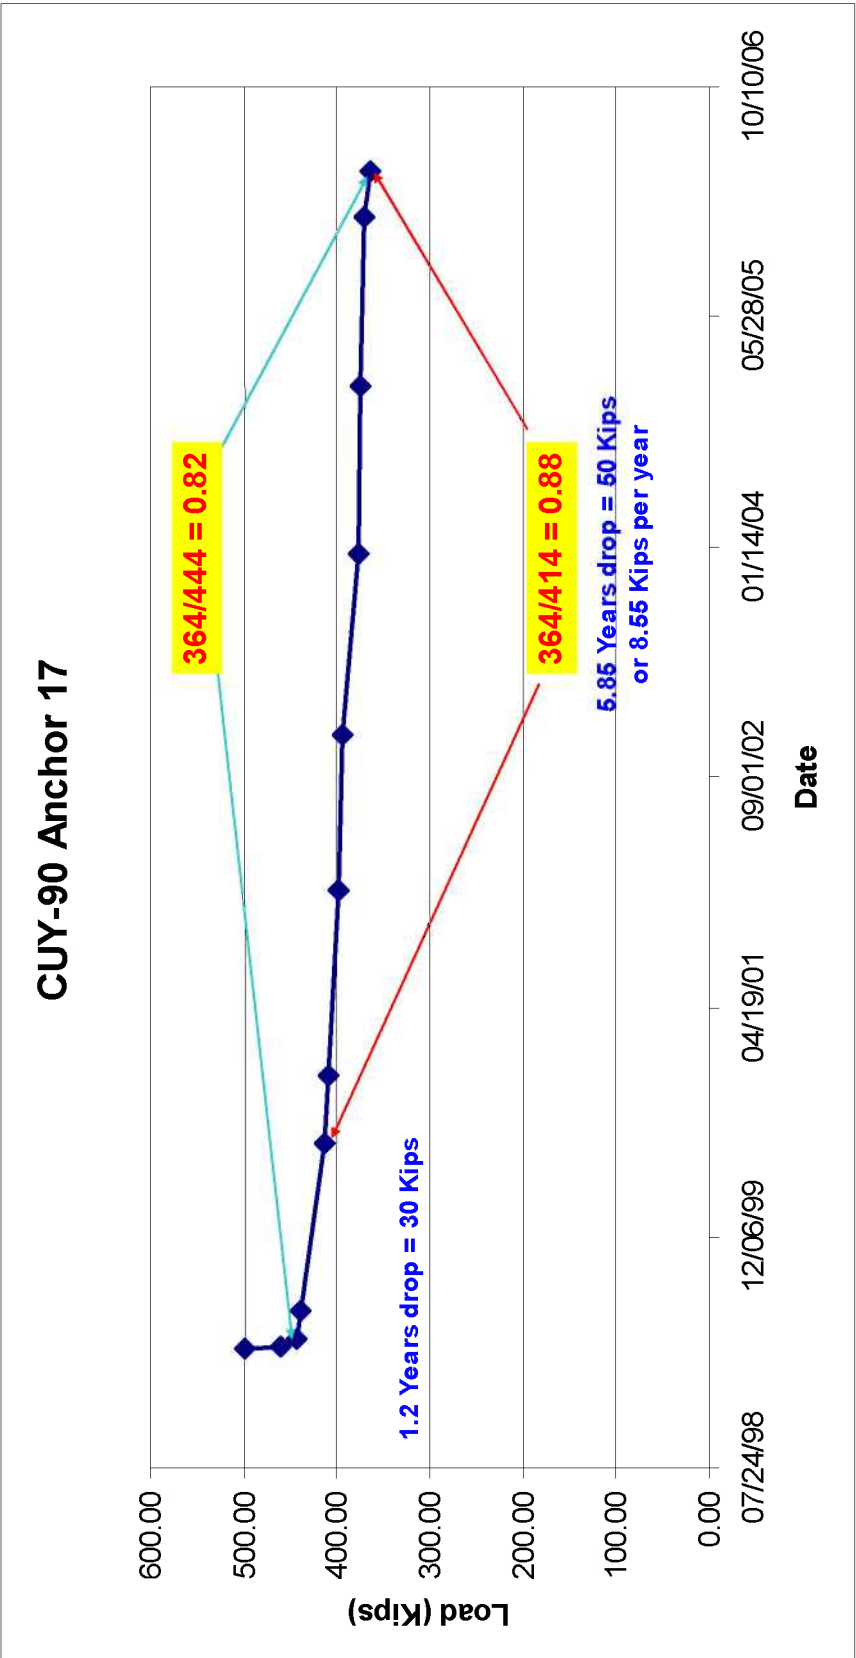
The plots of anchor load vs. time since lock-off in 1999 until April 2006 are shown in Figures 5.20 thru 5.23 for anchors 1, 8, 9, and 17, respectively.

Figure 5.20 Anchor # 1: Force vs. time plot

Figure 5.21 Anchor # 8: Force vs. time plot

Figure 5.22 Anchor # 9: Force vs. time plot

Figure 5.23 Anchor # 17: Force vs. time plot

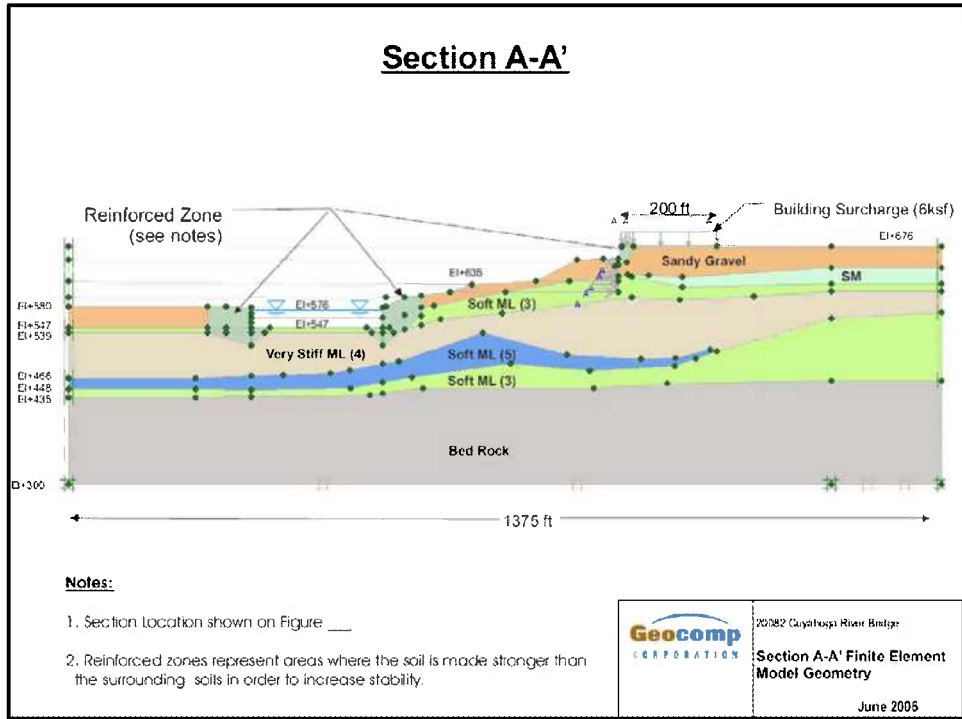
The geometry and soil properties used to analyze section A-A along the new bridge alignment were the same for GSTABL7, UTEXAS4 and PLAXIS. Figure 7B.1 shows the geometry in the PLAXIS analysis.

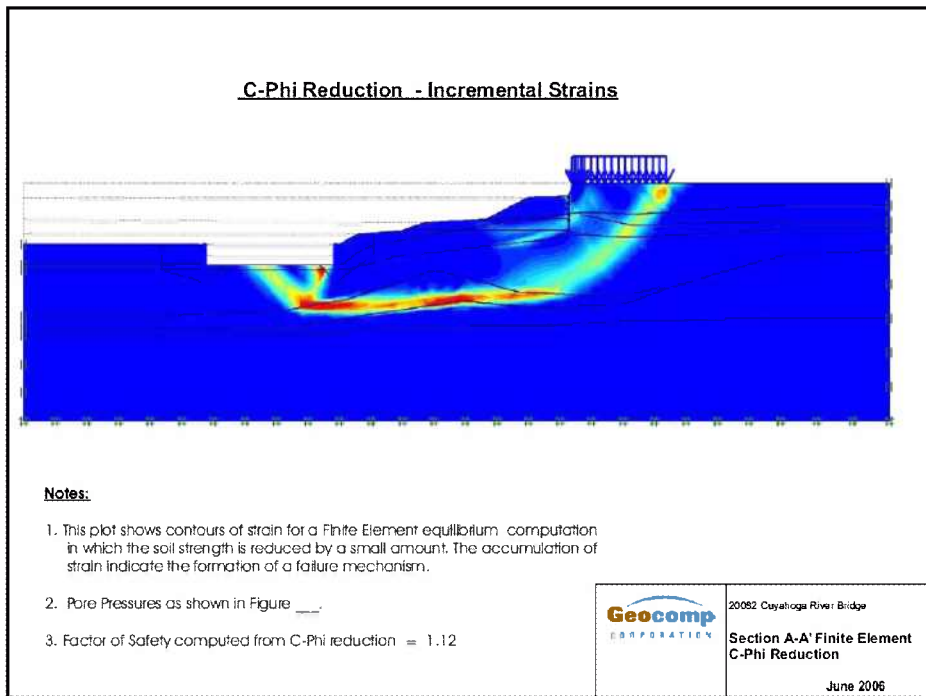
Figure 7B.2: Results of Stability Analysis of Existing Slope with PLAXIS

Figure 7B.2 shows the results of a PLAXIS strength reduction analysis on the as-is slope. The contours show incremental shear strains that develop in the strength reduction analysis. Blue is low strain and red is high strain. The zones of high strain indicate the shape of the failure mode that PLAXIS determines. These early results were very useful to the Team's work for four reasons:

1. The PLAXIS analysis confirmed that the factor of safety for the slope is low.
2. The PLAXIS analysis showed that a non-circular failure surface was the most critical.
3. The PLAXIS results showed that the existing building is clearly involved in the most critical failure mode.
4. The PLAXIS analysis suggested that removing the building and the soil beneath the building might be very effective to improve the stability of the slope.

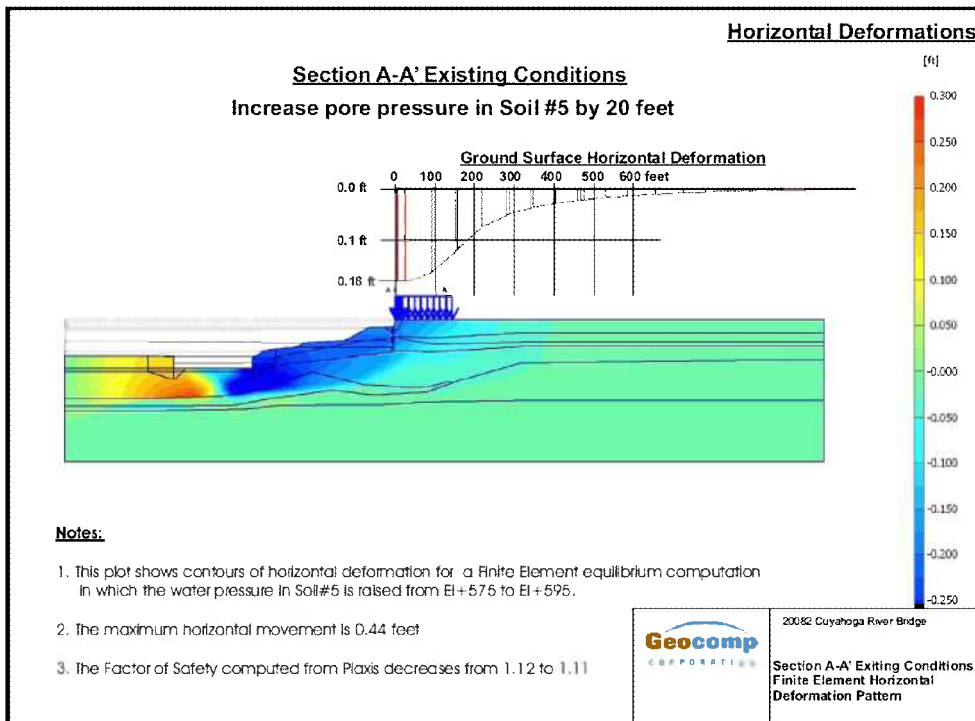
Figure 7B.3: Horizontal Movements in Existing Slope from Increasing Pore Pressure in Soil #5 by 20 ft

Figure 7B.3 shows the horizontal displacements computed with PLAXIS for a 20 ft increase of pore pressure in Soil #5 (the blue horizontal clay layer with residual strength of 15°). Figure 7B.4 shows the vertical displacements for the same analysis. The calculated horizontal movements are about 2 inches at the edge of University Avenue and decrease to about 1 inch beyond a distance of 200 ft from University Avenue. Likewise, the vertical deformations are about 1 inch at the edge of University Avenue and decrease to less than $\frac{1}{2}$ inch beyond a distance of 100 ft from University Avenue. These results indicate that a bridge foundation could be located anywhere beyond a distance of 200 ft back from the river side of University Avenue and not be affected by the current condition of the slope, assuming that condition does not further degrade.
