**Baker Slope Stability Study Report
(Reference Document)**

**Innerbelt Bridge
Construction Contract Group 1 (CCG1)**

Slope Stability Evaluation Report of the West Bank

CUY-90-14.92
PID 77332

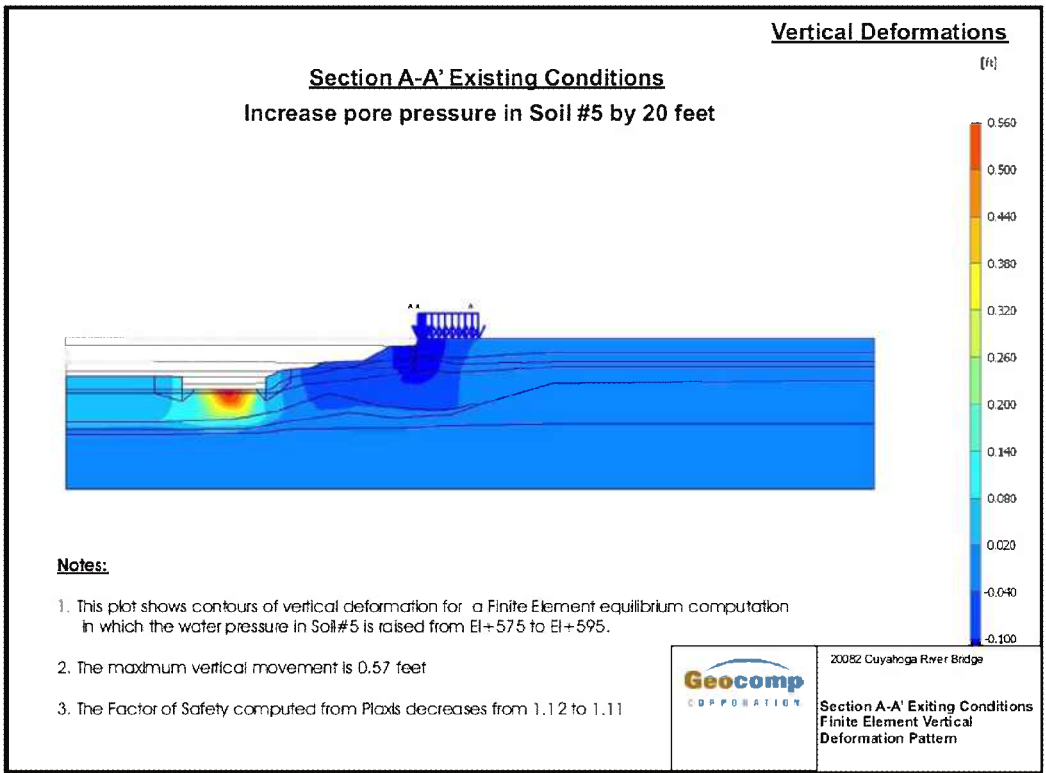
Figure 7B.4: Vertical Movement in Existing Slope from Increasing Pore Pressure in Soil #5 by 20 ft.

Figure 7B.3 shows the horizontal displacements computed with PLAXIS for a 20 ft increase of pore pressure in Soil #5 (the blue horizontal clay layer with residual strength of 15°). Figure 7B.4 shows the vertical displacements for the same analysis. The calculated horizontal movements are about 2 inches at the edge of University Avenue and decrease to about 1 inch beyond a distance of 200 ft from University Avenue. Likewise, the vertical deformations are about 1 inch at the edge of University Avenue and decrease to less than $\frac{1}{2}$ inch beyond a distance of 100 ft from University Avenue. These results indicate that a bridge foundation could be located anywhere beyond a distance of 200 ft back from the river side of University Avenue and not be affected by the current condition of the slope, assuming that condition does not further degrade.

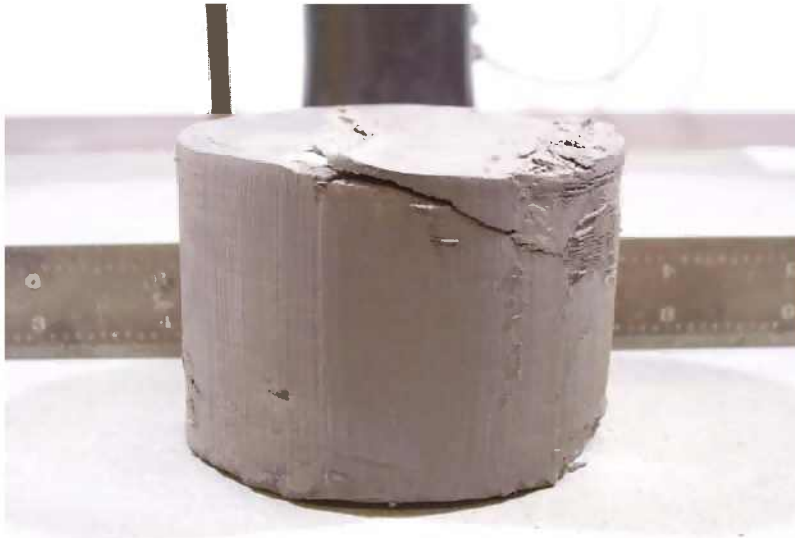
Extruded sample showing in-situ shear plane. Side view.
Direct Simple Shear test, DSS-2 was trimmed from this piece.

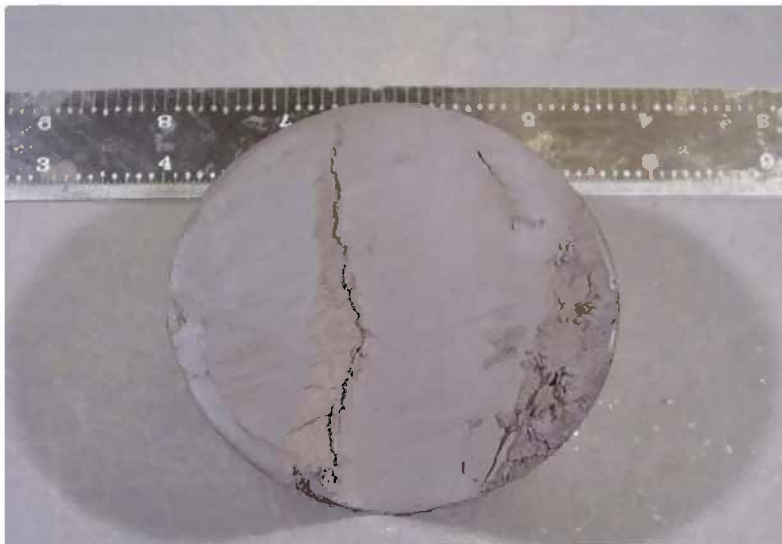
Same extruded sample showing in-situ shear plane. Top view.

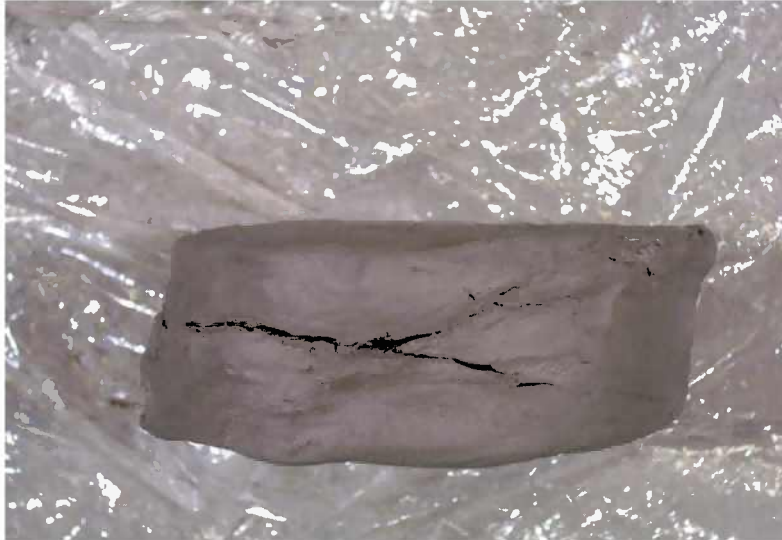
Post test picture, after pulling apart and putting back together. Shows development of an angular shear plane. Direct Simple Shear (DSS-2) test sample.

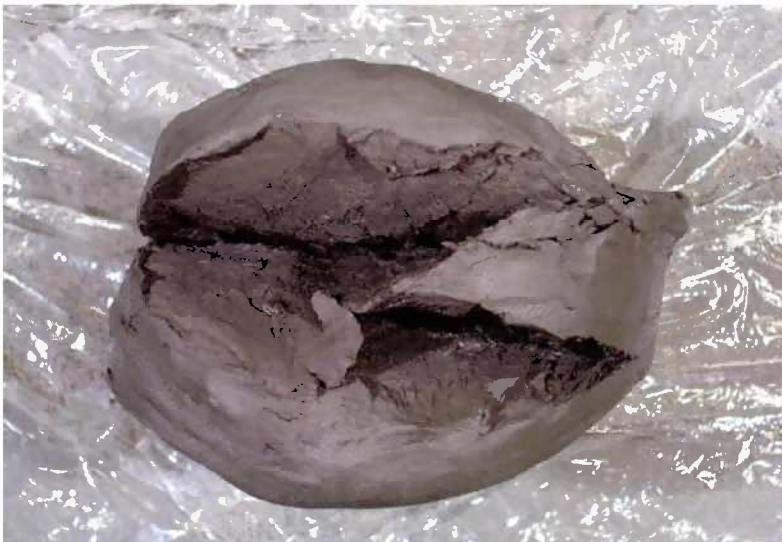
Same sample, pulled apart view of the internal structure along horizontal planes. The material appeared rough. There were no visible polished surfaces.

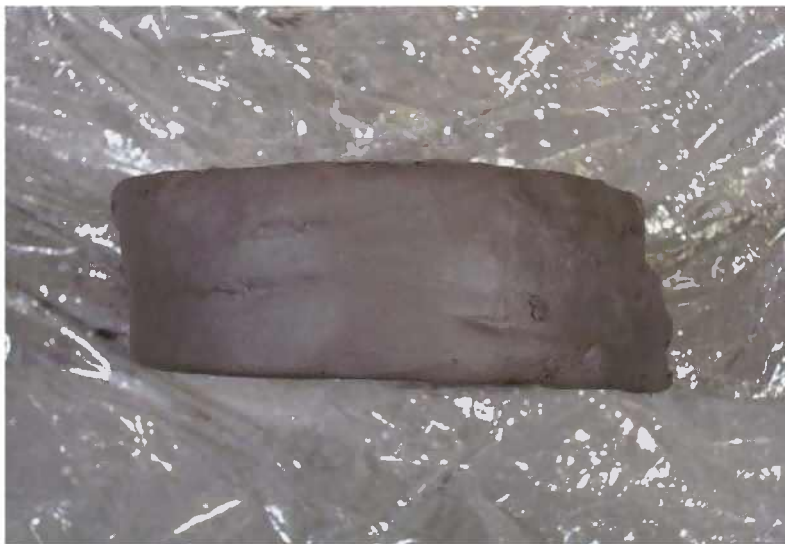
Post test showing failure lean to the left. Slight shear plane developing angling back. Direct Simple Shear (DSS-2) test specimen.

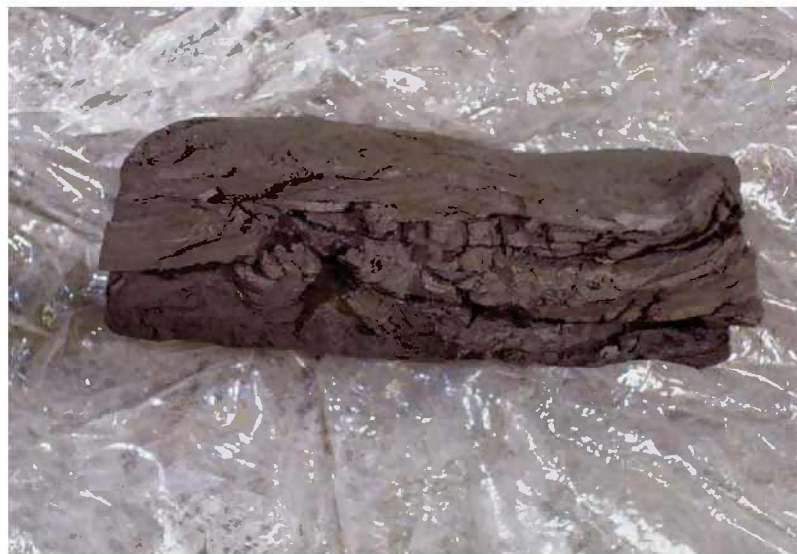
Same sample, broken to show the cross section through the middle of specimen. Shows horizontal layers, some with an almost blocky structure at a very small scale.

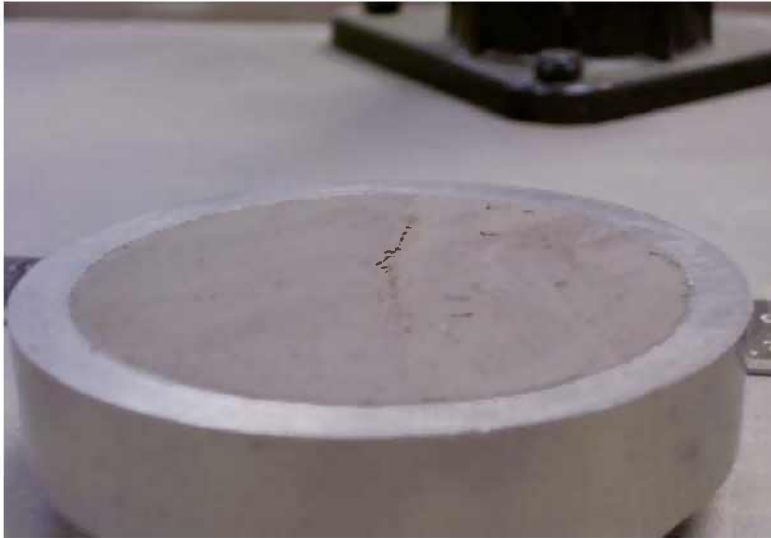
Sample in trimming ring showing an in-situ shear plane in the material as received. Residual Shear test (RS-2), angled view.

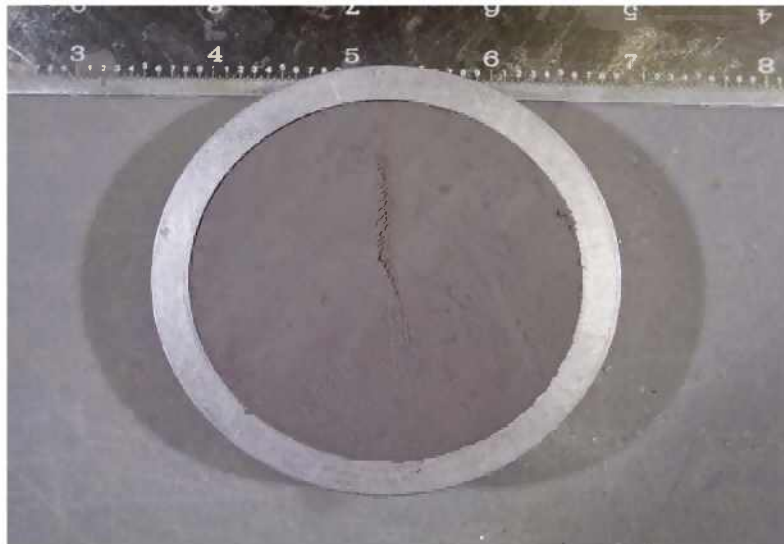
Same sample, in trimming ring showing an in-situ shear plane in the material as received. Residual Shear test (RS-2), top view.

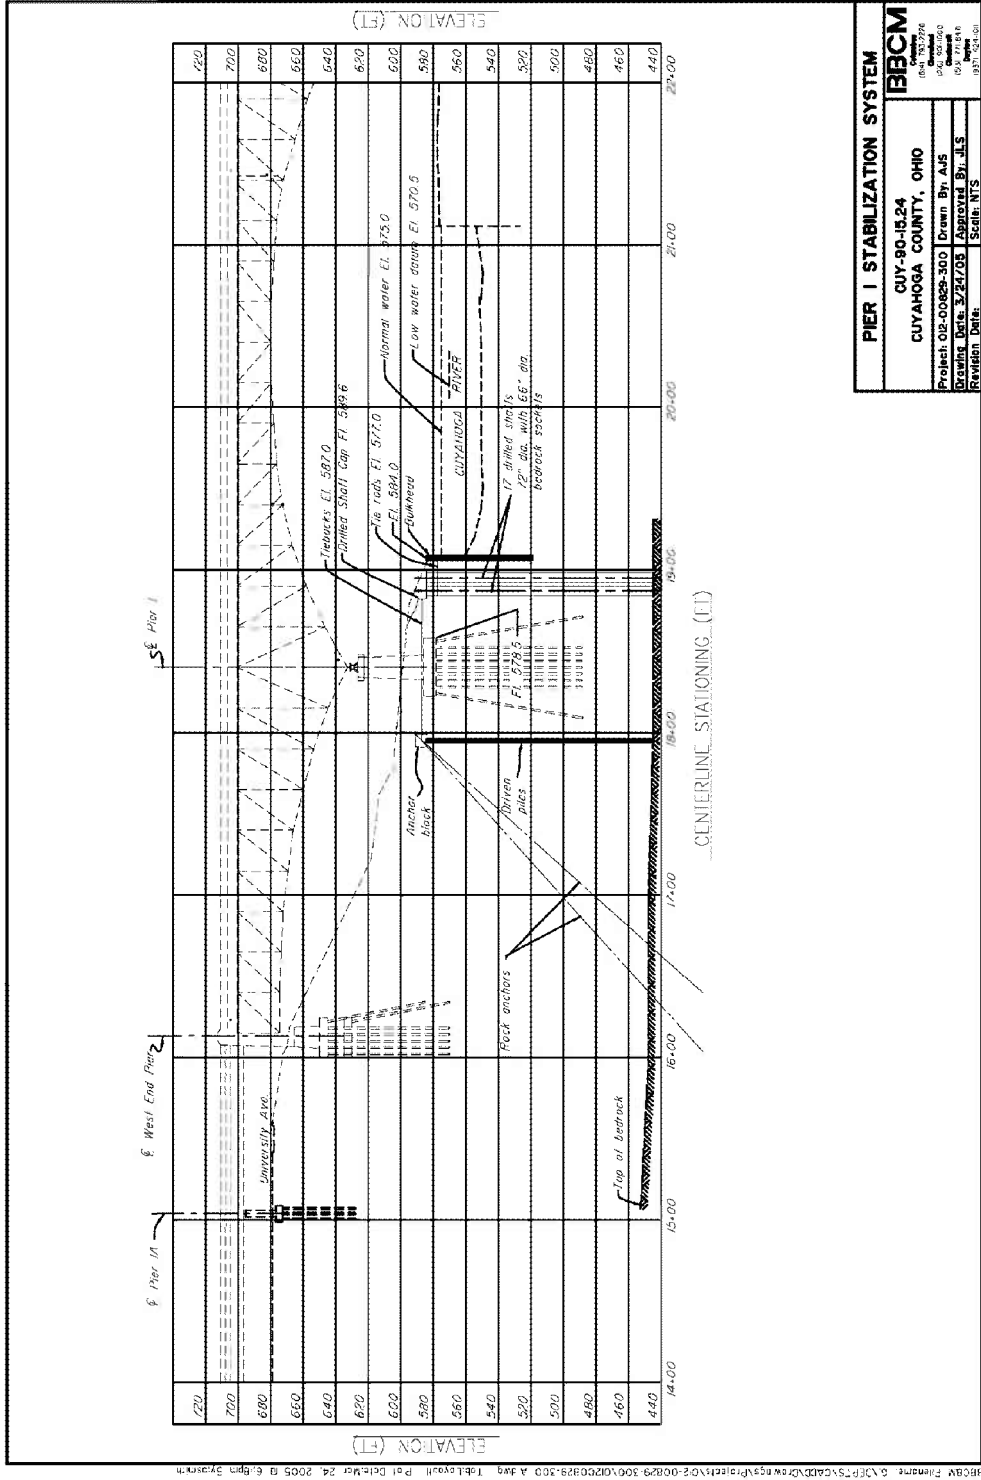
Figure 2: Existing I-90 pier system and stabilization structure (BBCM, 2005a).

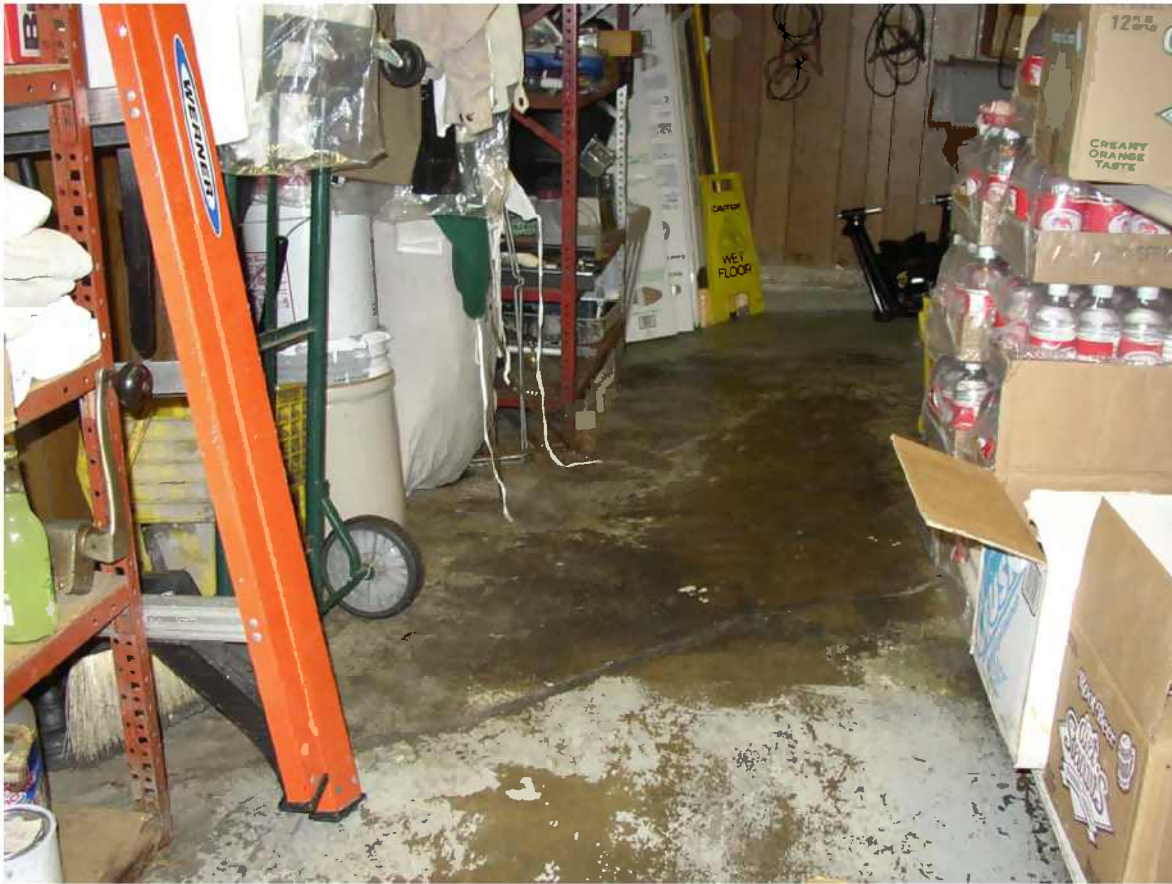
Figure 8: 1201 University Avenue (Sokolowski's University Inn). Photo is taken from inside looking at the north-west corner of the building. This photo illustrates settlement that occurred approximately 5 years ago. The maximum vertical displacement is at least 9-inches (BBCM, 2005b).

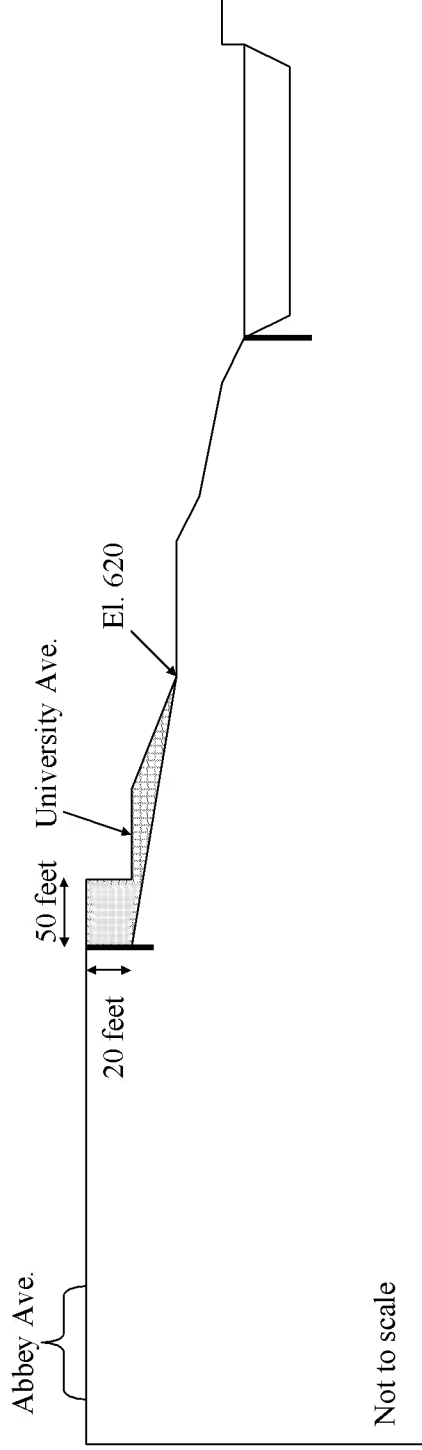
20-foot vertical excavation located approximately 50 feet south of University Avenue as shown in Figure 15a and Plate 13 of Appendix F;

a) Alternative 1. 20-foot vertical excavation located 50 feet behind University Avenue.

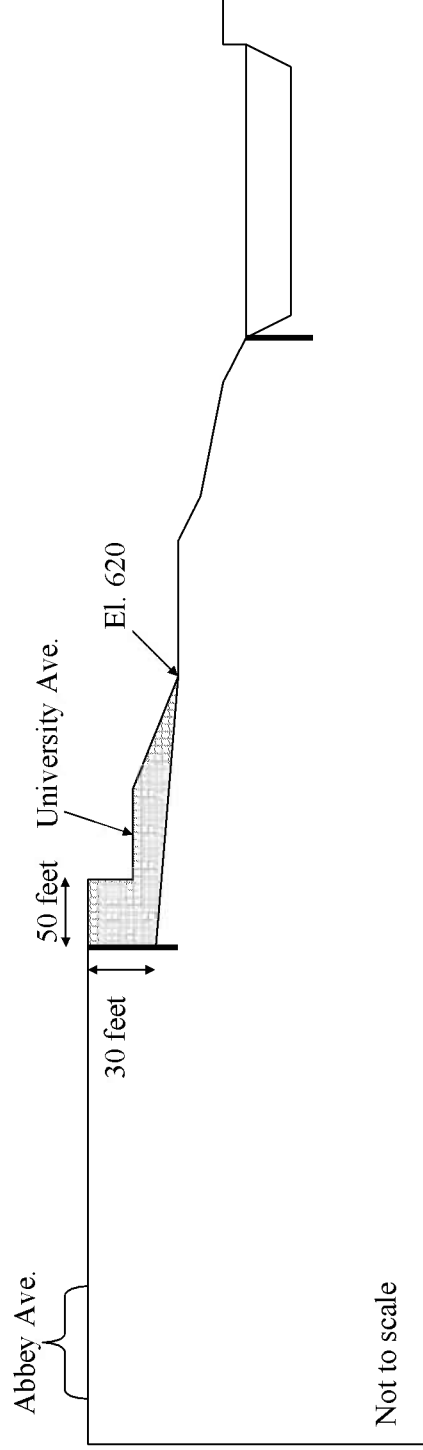
30-foot vertical excavation located approximately 50 feet south of University Avenue as shown in Figure 15b and Plate 14 of Appendix F;

b) Alternative 2. 30-foot vertical excavation located 50 feet behind University Avenue.

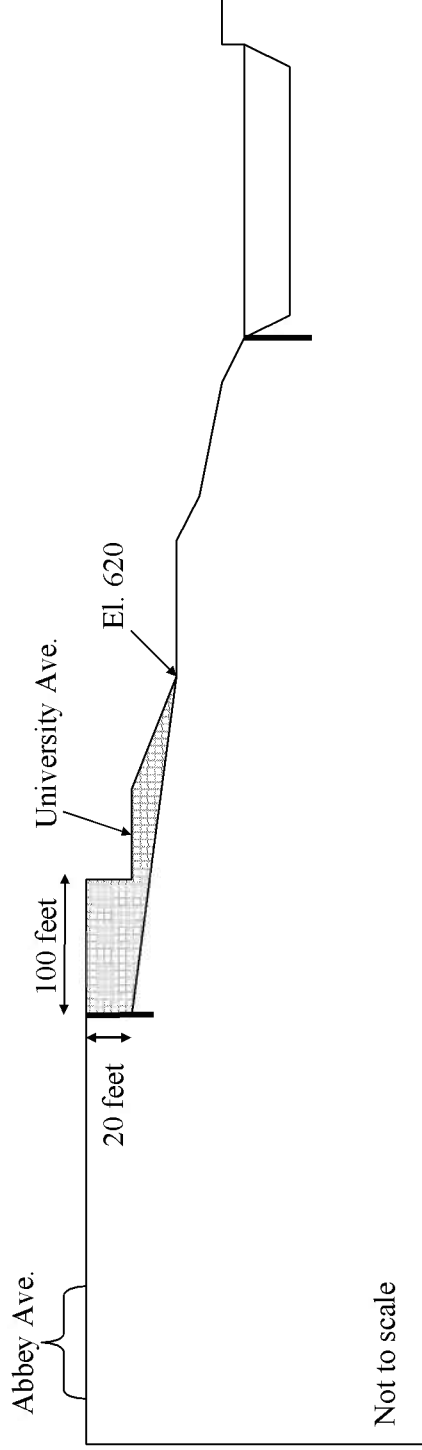
20-foot vertical excavation located approximately 100 feet south of University Avenue as shown in Figure 16a and Plate 15 of Appendix F;

a) Alternative 3: 20-foot vertical excavation located 100 feet behind University Avenue.

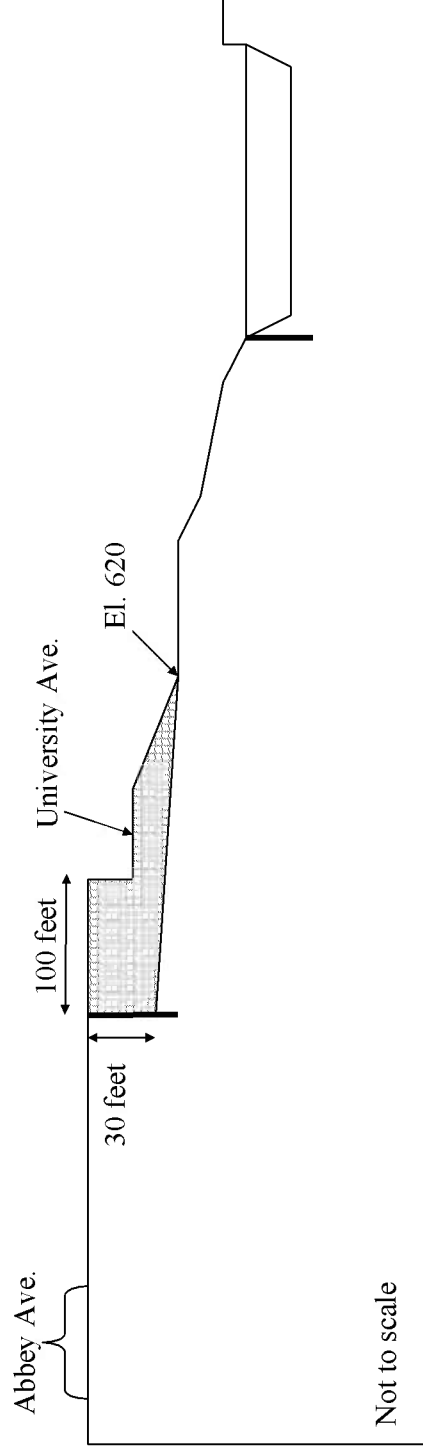
30-foot vertical excavation located approximately 100 feet south of University Avenue as shown in Figure 16b and Plate 16 of Appendix F;

b) Alternative 4: 30-foot vertical excavation located 100 feet behind University Avenue.

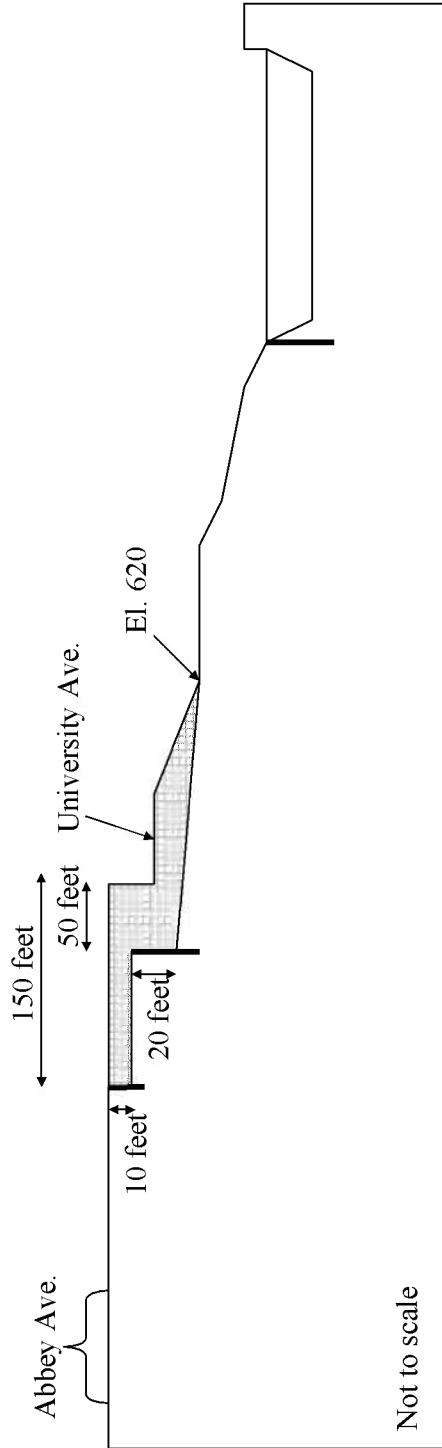
Terraced excavation with a 10-foot vertical excavation located approximately 150 feet south of University Avenue and a 20-foot vertical excavation located approximately 50 feet south of University Avenue as shown in Figure 17a and Plate 17 of Appendix F;

a) Alternative 5: 10-foot vertical excavation located 150 feet behind University Avenue and a 20-foot vertical excavation located 50 feet behind University Avenue.

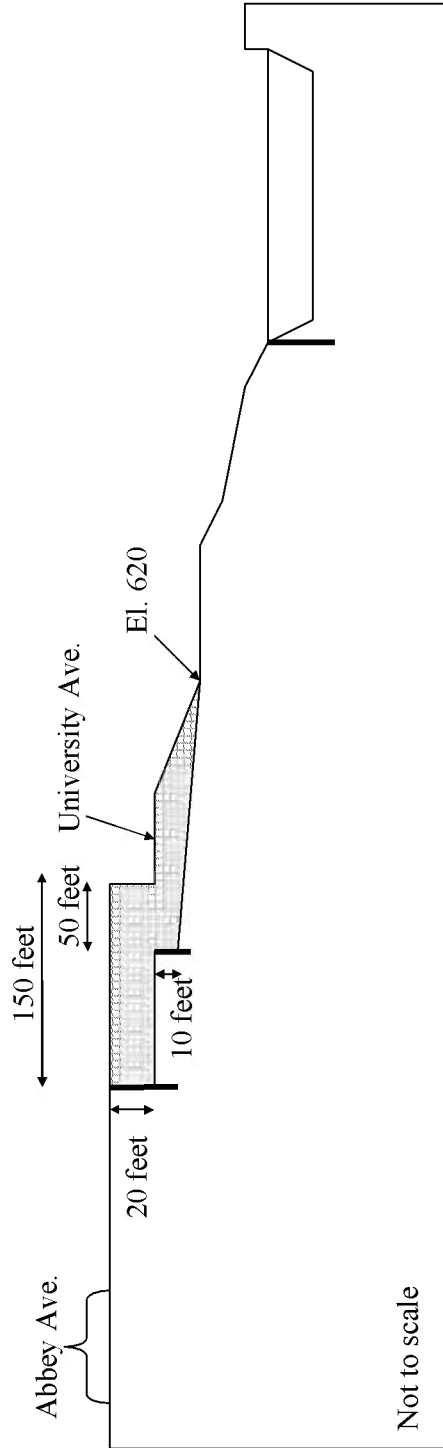
Terraced excavation with a 20-foot vertical excavation located approximately 150 feet south of University Avenue and a 10-foot vertical excavation located approximately 50 feet south of University Avenue, as shown in Figure 17b and Plate 18 of Appendix F;

b) Alternative 6: 20-foot vertical excavation located 150 feet behind University Avenue and a 10-foot vertical excavation located 50 feet behind University Avenue.

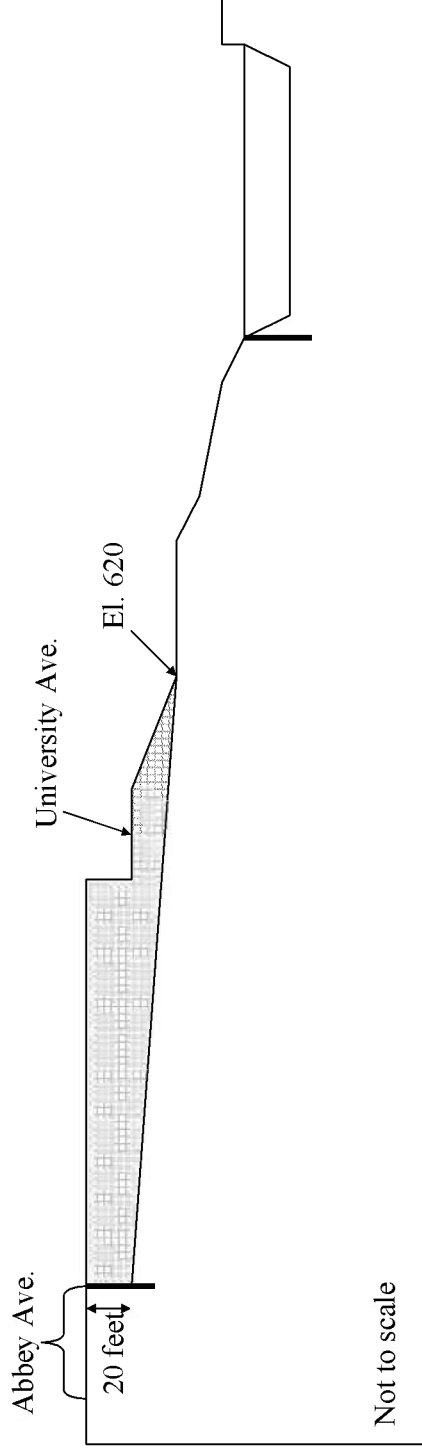
20-foot vertical excavation located on the north side of Abbey Avenue as shown in Figure 18a and Plate 19 of Appendix F;

a) Alternative 7: 20-foot vertical excavation north of Abbey Avenue.

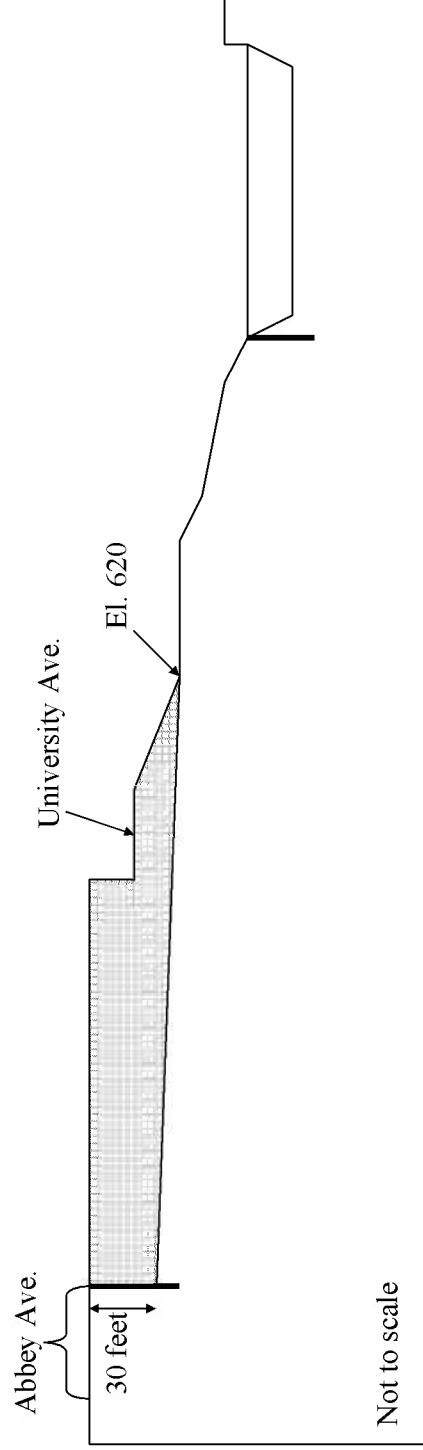
30-foot vertical excavation located on the north side of Abbey Avenue as shown in Figure 18b and Plate 20 of Appendix F;

b) Alternative 8: 30-foot vertical excavation north of Abbey Avenue.

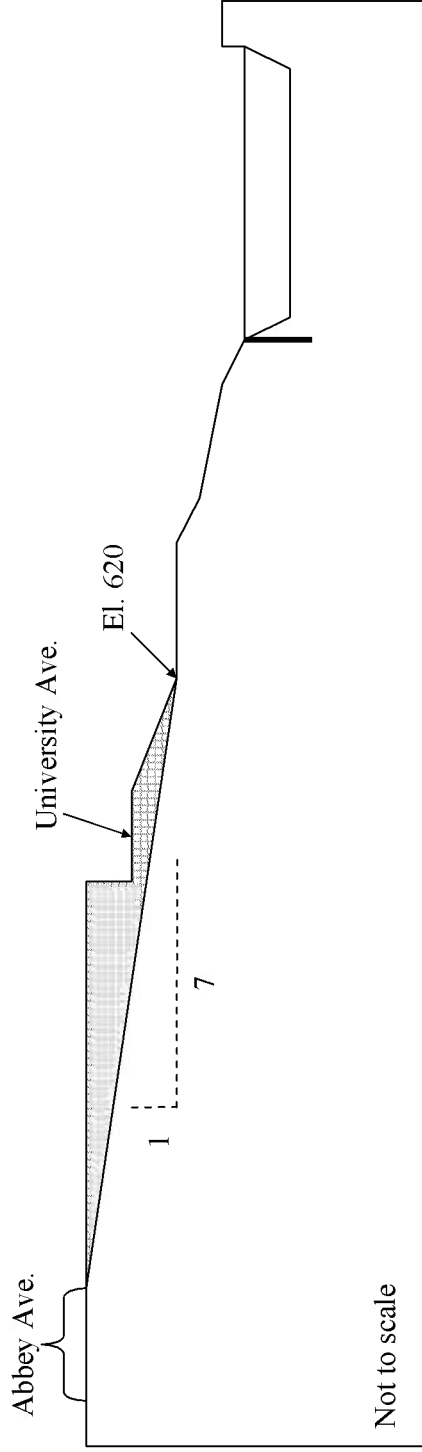
7(H):1(V) slope beginning north of Abbey Avenue extending down to El. 620 feet, as shown in Figure 19a and Plate 21 of Appendix F; and,

a) Alternative 9: 7(H):1(V) slope beginning north of Abbey Avenue.

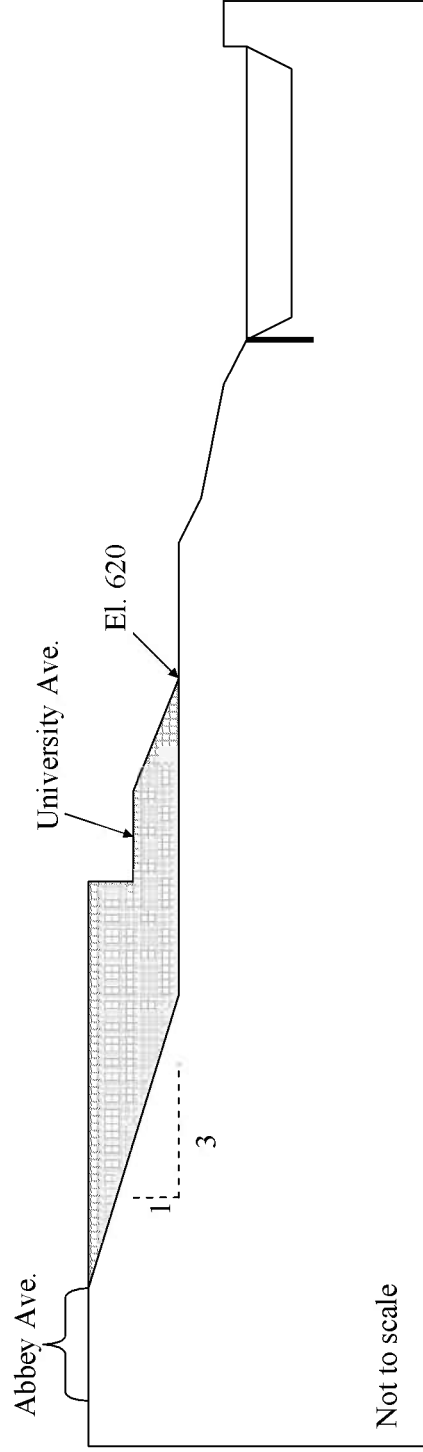
3(H):1(V) slope beginning north of Abbey Avenue extending down to El. 620 feet, as shown in Figure 19b and Plate 22 of Appendix F.

b) Alternative 10: 3(H):1(V) slope beginning at Abbey Avenue extending to El. 620 feet.
