February 3, 2016

Re: January 14 and 15, 2016 Bi-Weekly Readings
CUY-90-15.24 Slope Monitoring
PID 96504
SME Project No. 069032.00

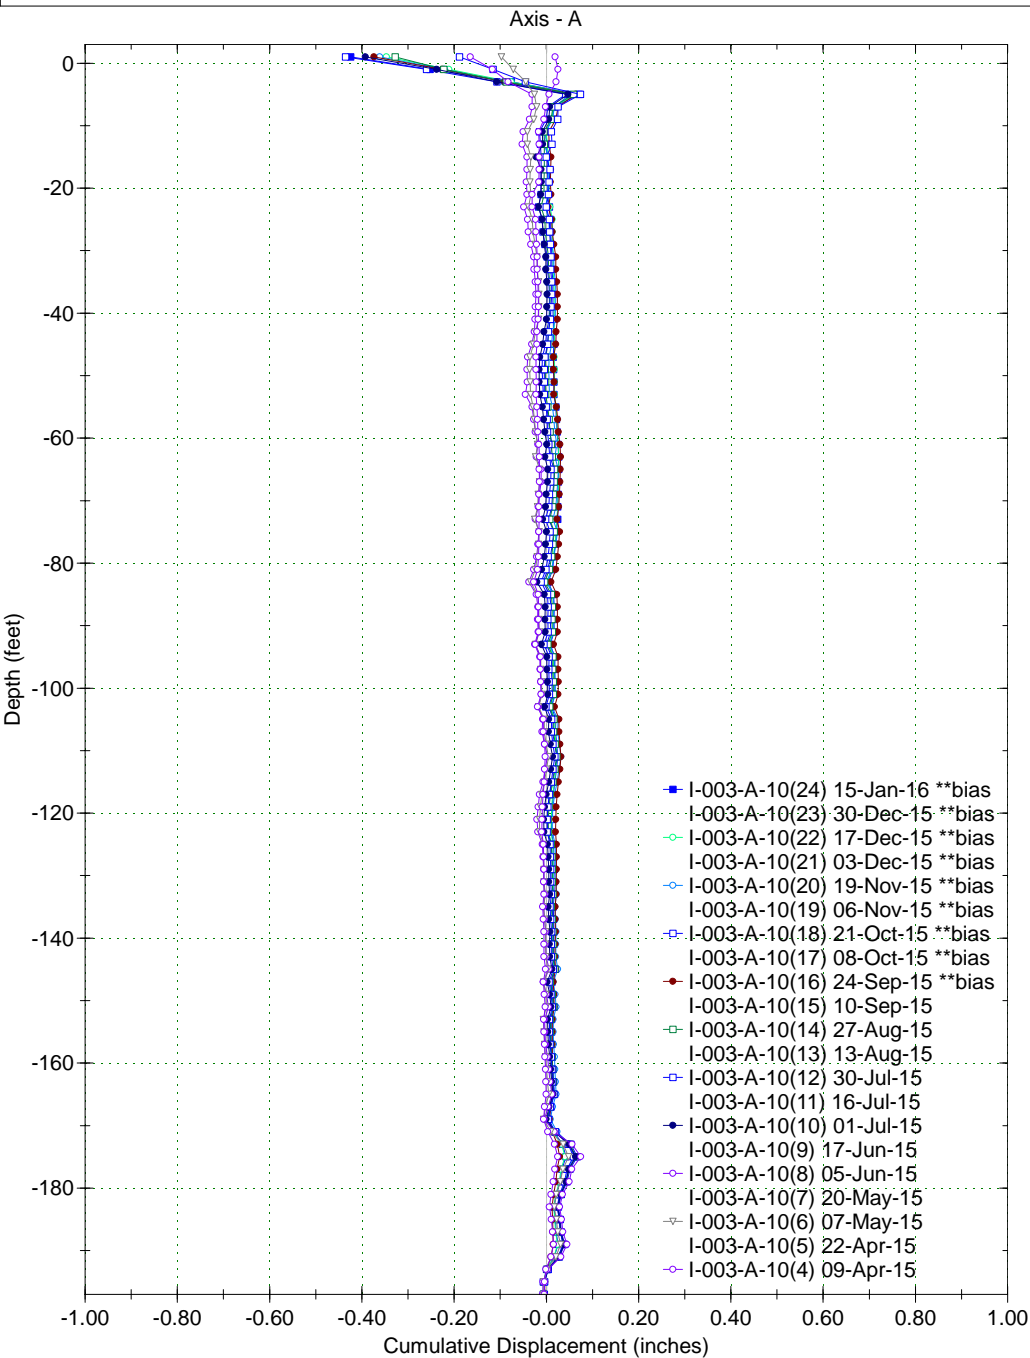
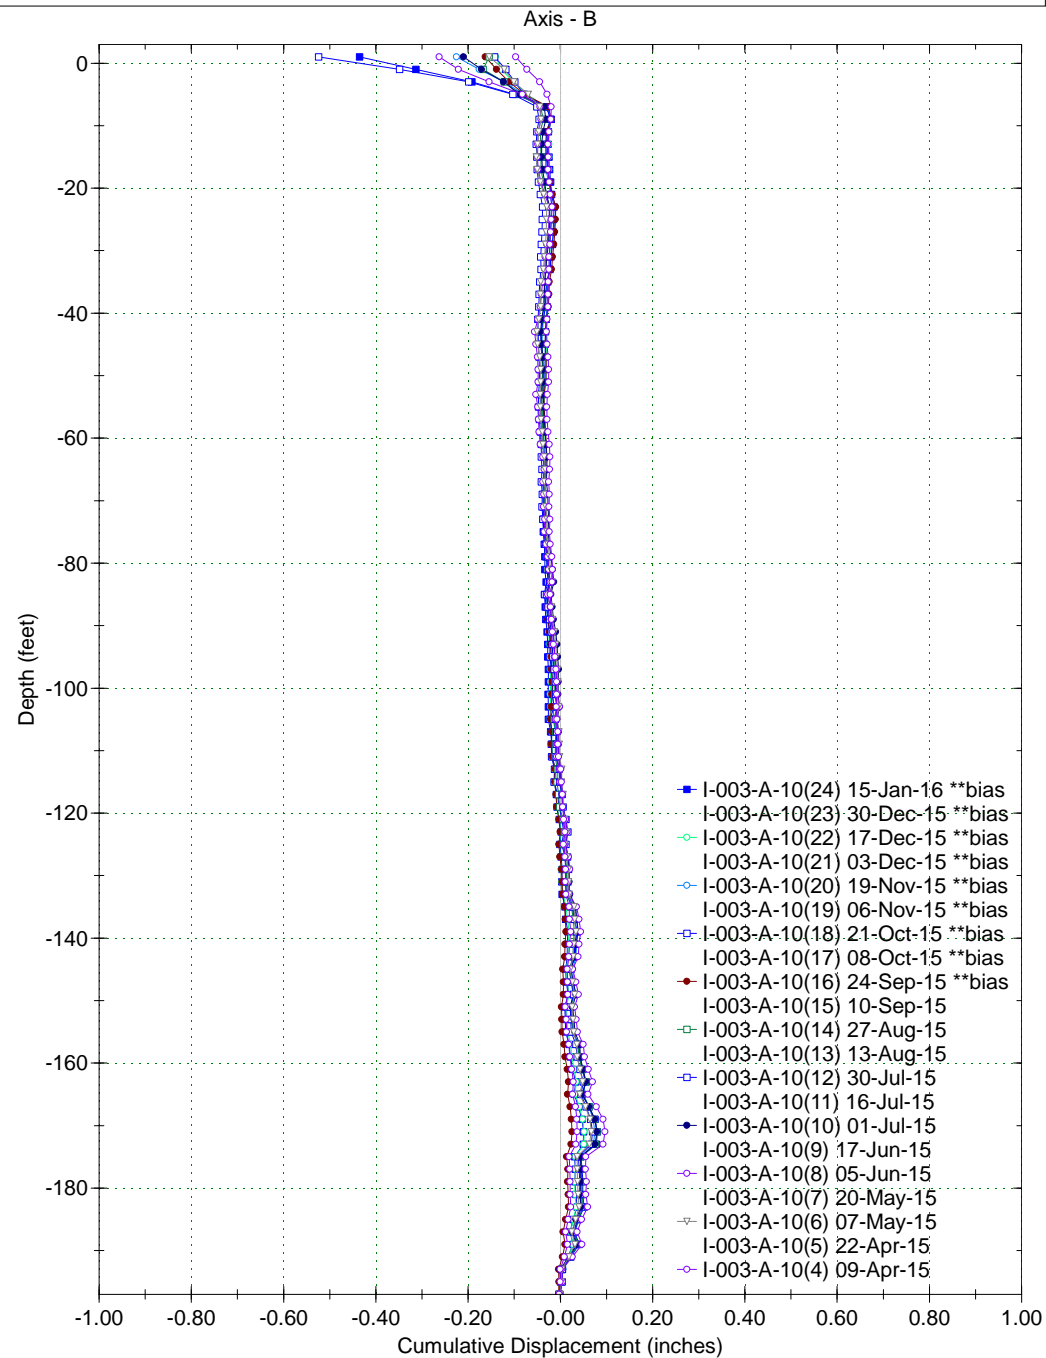
Borehole : I-003-A-10
Project : CUY-90-15-24
Location :
Northing :
Easting :
Collar :

P-003-10 – Total head in the five shallowest piezometers at this location decreased by about 0.5 feet over the past two weeks. The piezometer at 98 feet showed some fluctuations, but virtually no net change. The deepest piezometer, which is read manually, indicated a slight increase in total head.

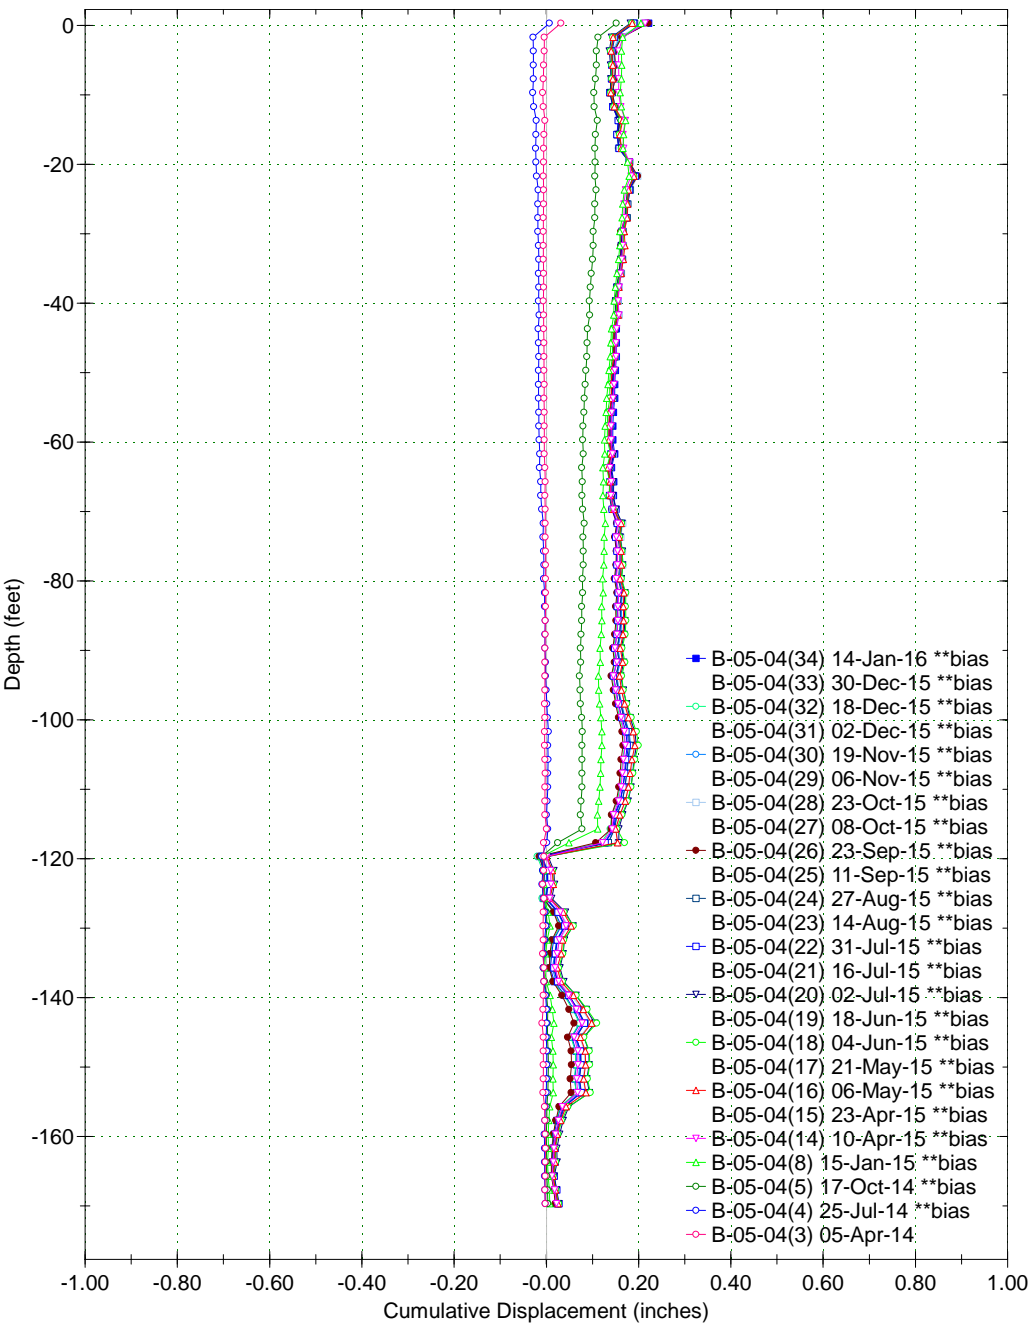
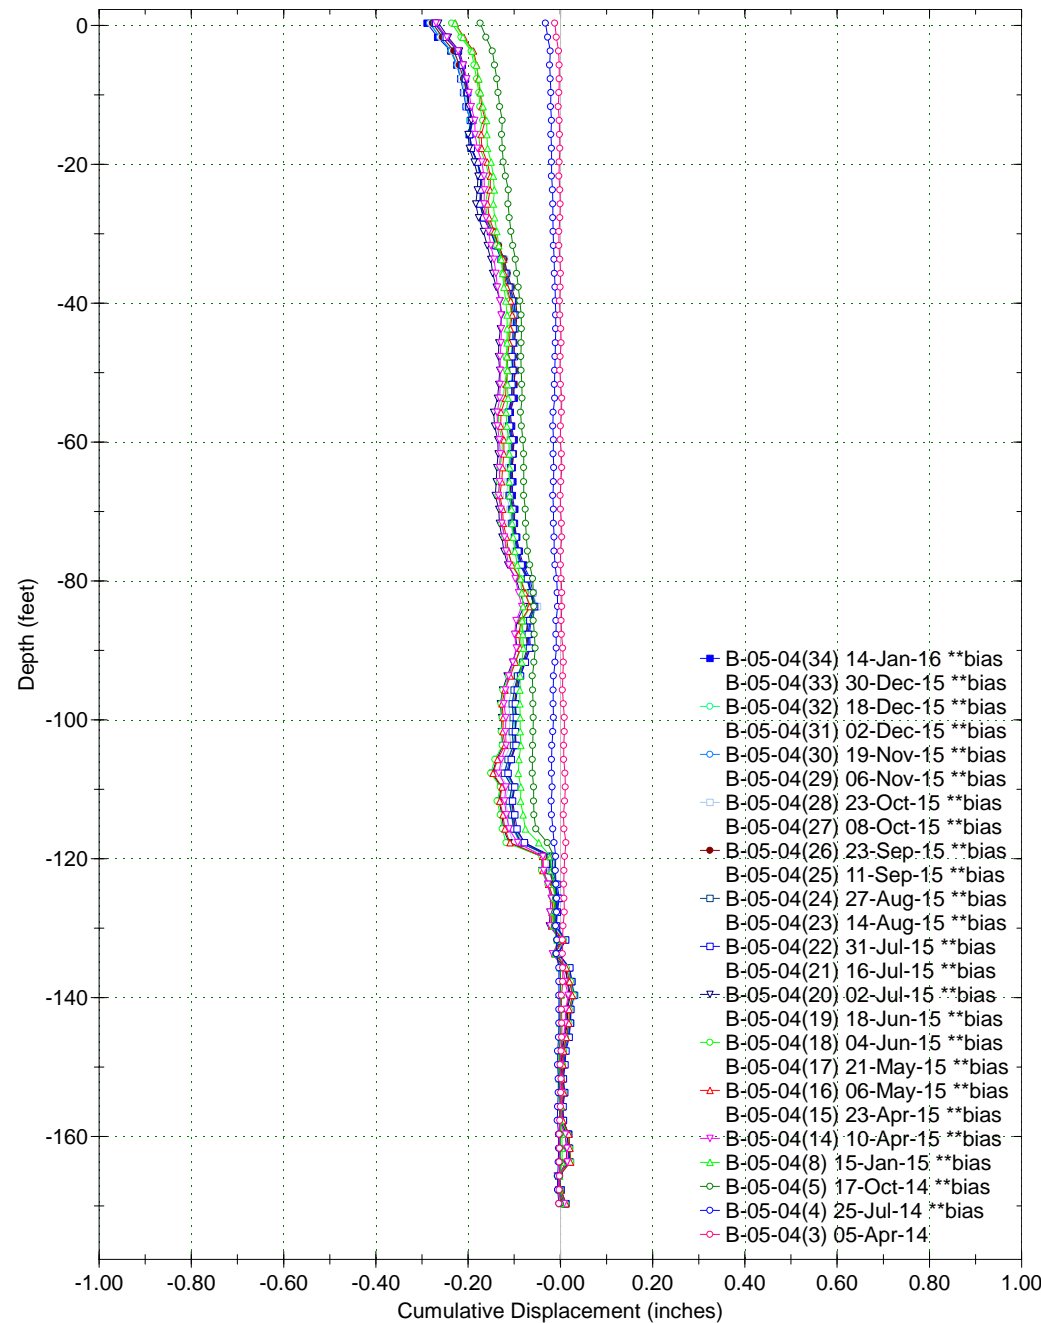
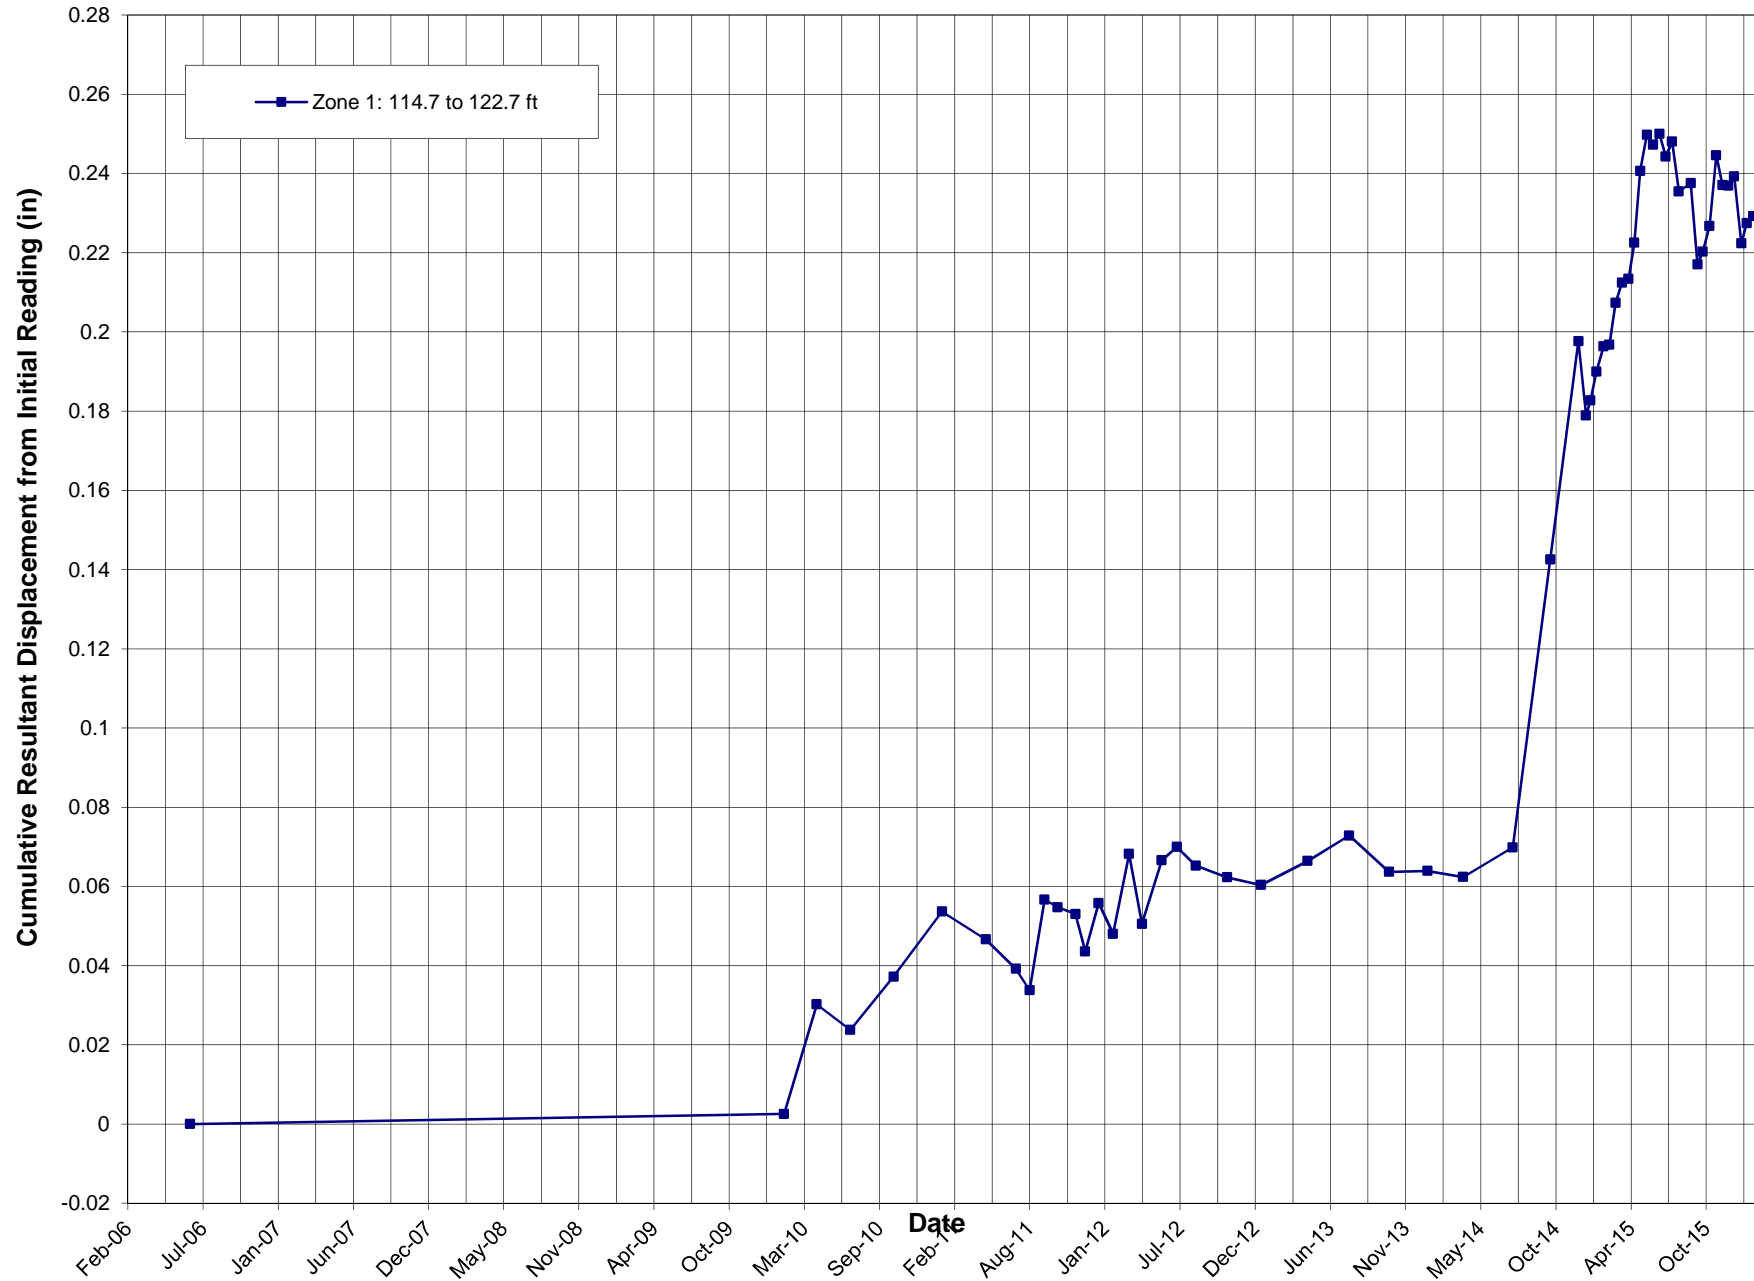
Borehole : B-05-04
 Project : CUY-90-15-24
 Location : Cleveland, Ohio
 Northing : Sta. 133+51.67
 Easting : 242.09' Rt of CL
 Collar :

P-002-13, B-05-04 – Pore pressure readings at these locations indicate minor fluctuations in total head over the past two weeks with virtually no net change.

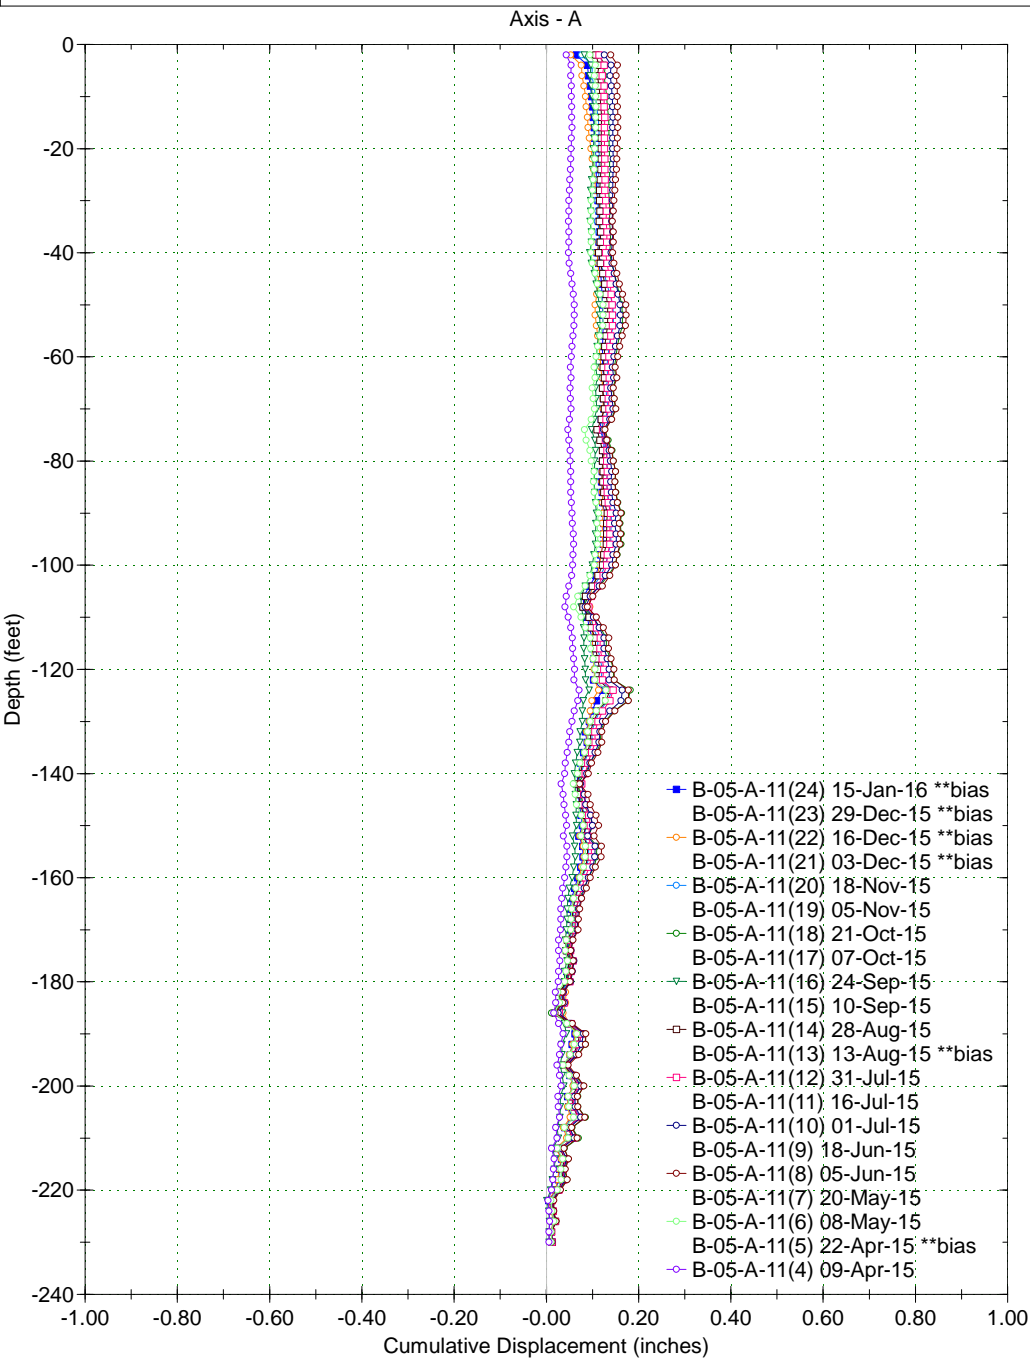
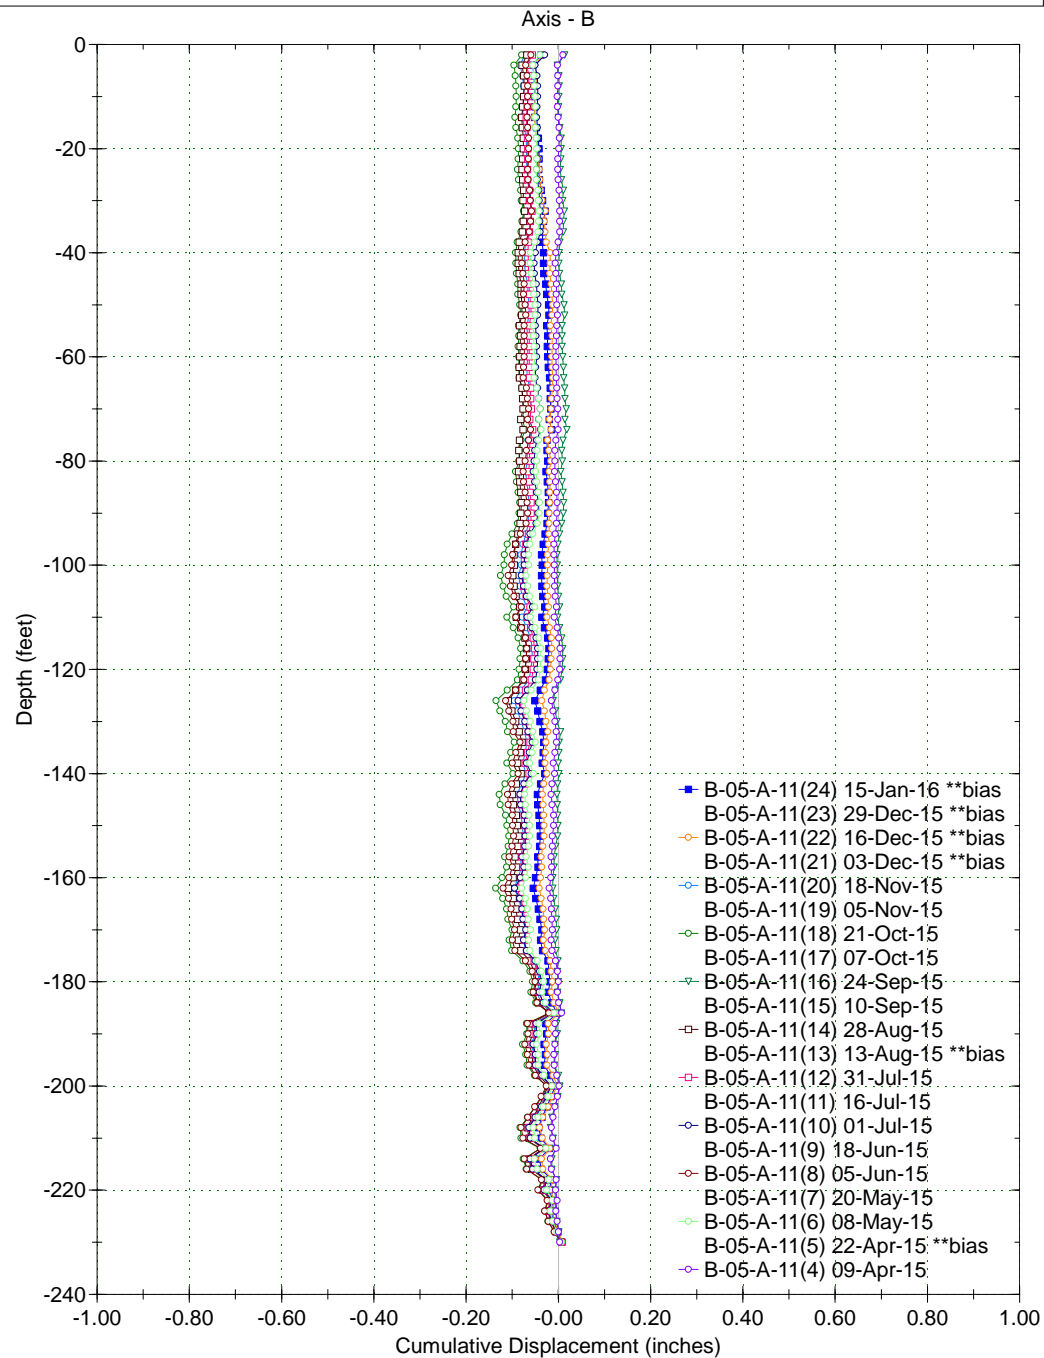
Borehole : B-05-A-11
 Project : CUY-90-15-24
 Location :
 Northing :
 Easting :
 Collar :

P-001-13, P-009-13, B-05-A-11 – Pore pressure readings indicate a decrease in total head of up to about 0.5 feet in all piezometers at these locations over the past two weeks.
