February 4, 2016

Re: January 28 and 29, 2016 Bi-Weekly Readings
CUY-90-15.24 Slope Monitoring
PID 96504
SME Project No. 069032.00

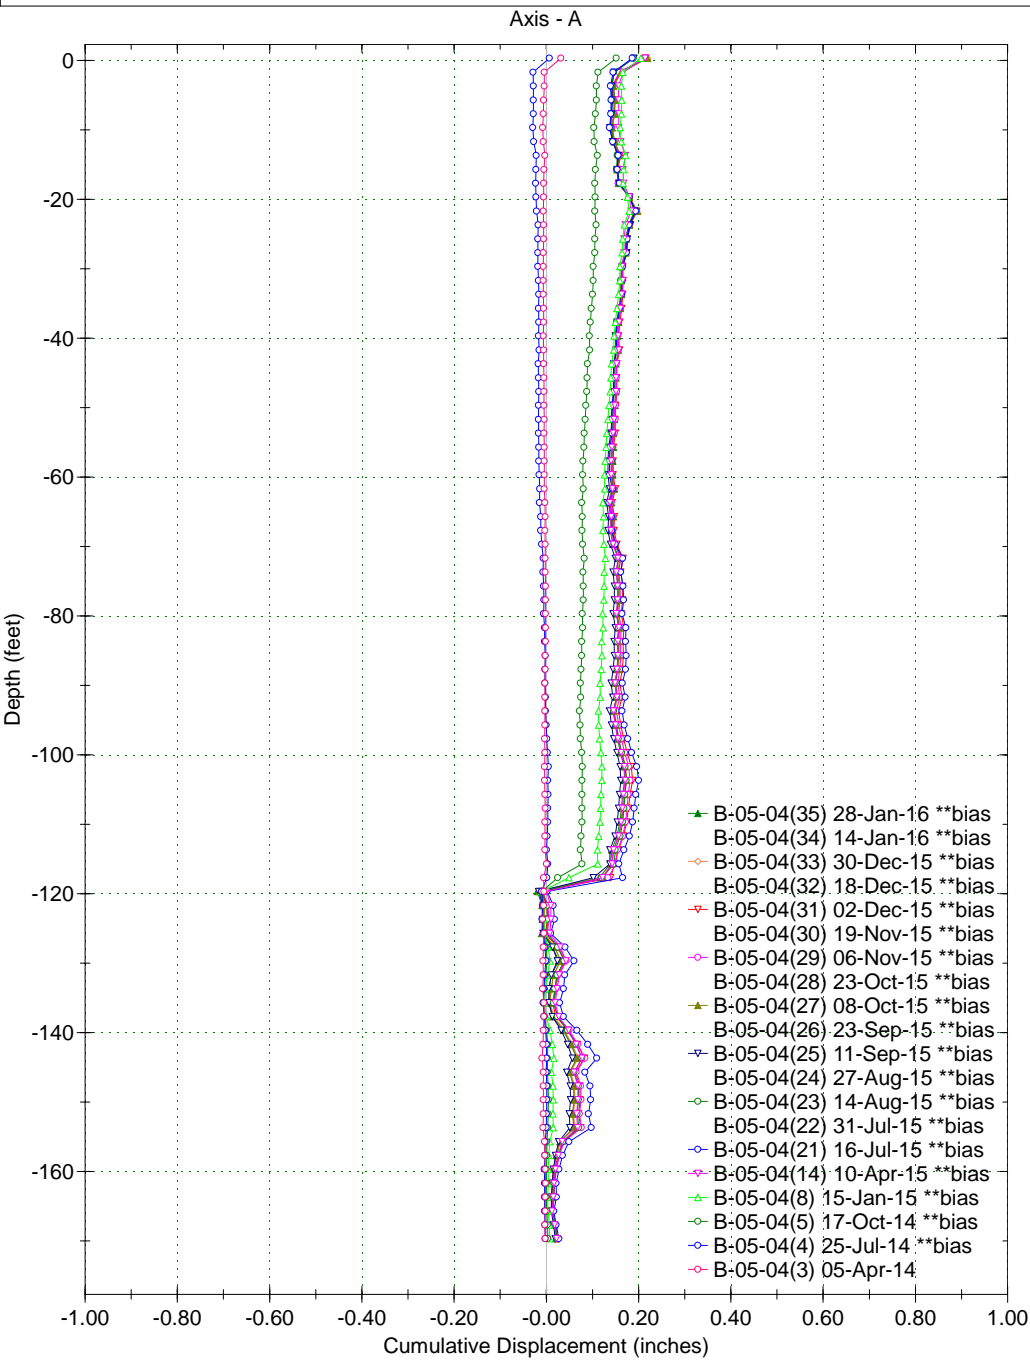
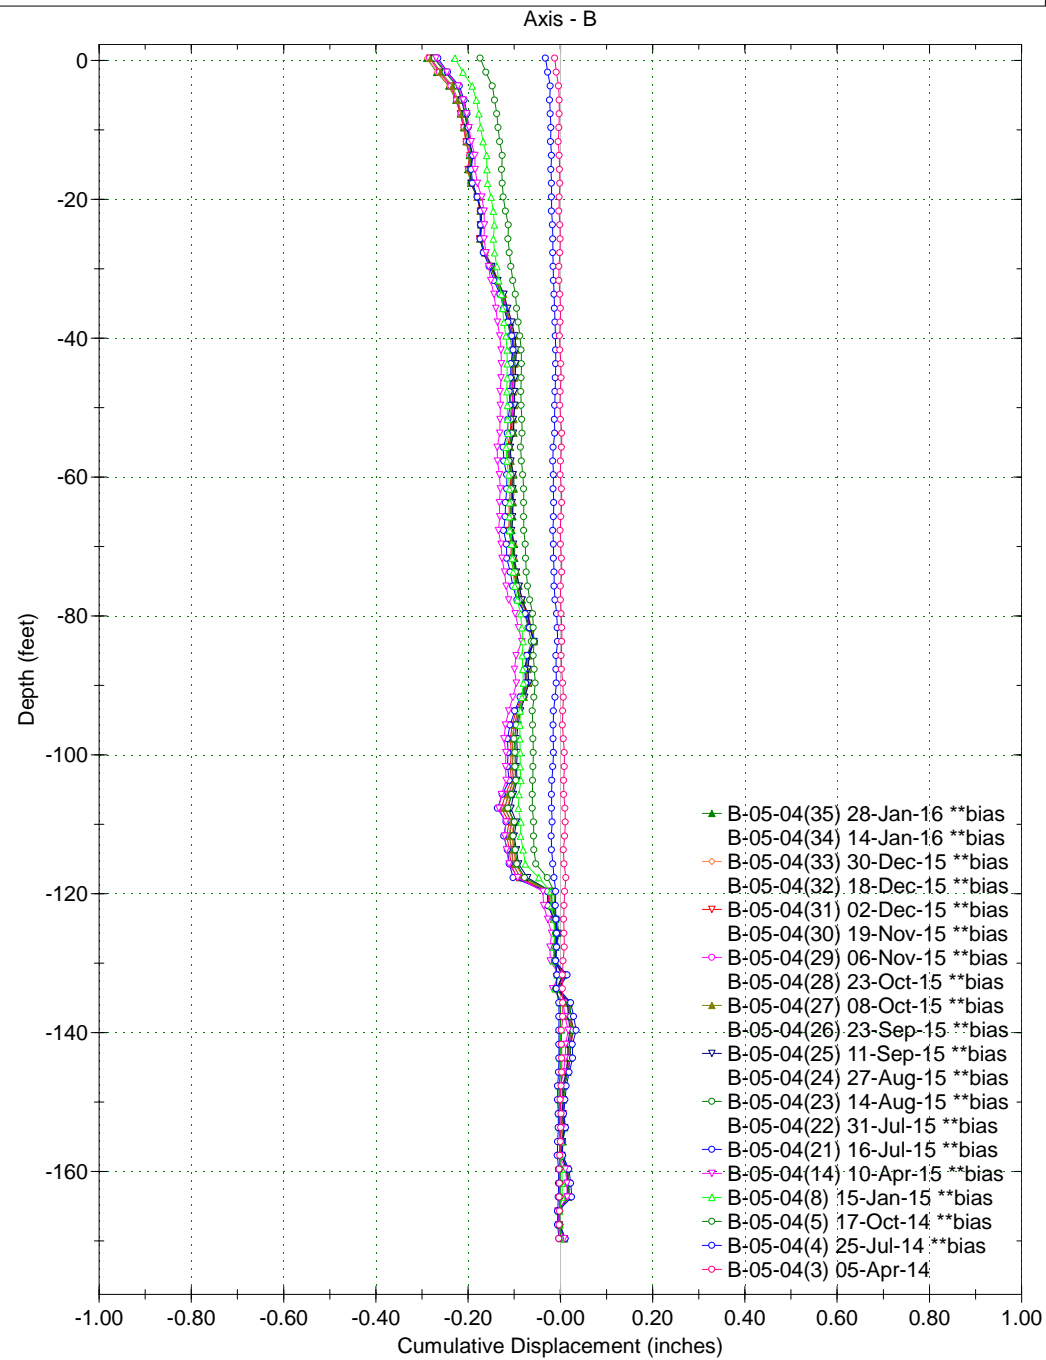
Borehole : B-05-04
Project : CUY-90-15-24
Location : Cleveland, Ohio
Northing : Sta. 133+51.67
Easting : 242.09' Rt of CL
Collar :

P-001-13, P-002-13, P-003-10, B-05-04, B-05-A-11 –Pore pressure readings at these locations indicate slight fluctuations in total head throughout this reading period but virtually no net change.
