Re: January 2016 Quarterly Report
CUY-90-15.24 Slope Monitoring
PID 96504
EDP Project No. 069032.00

JANUARY 2016 QUARTERLY REPORT

CUY-90-15.24 SLOPE MONITORING
PID 96504
CLEVELAND, OHIO
SME PROJECT NO. 069032.00

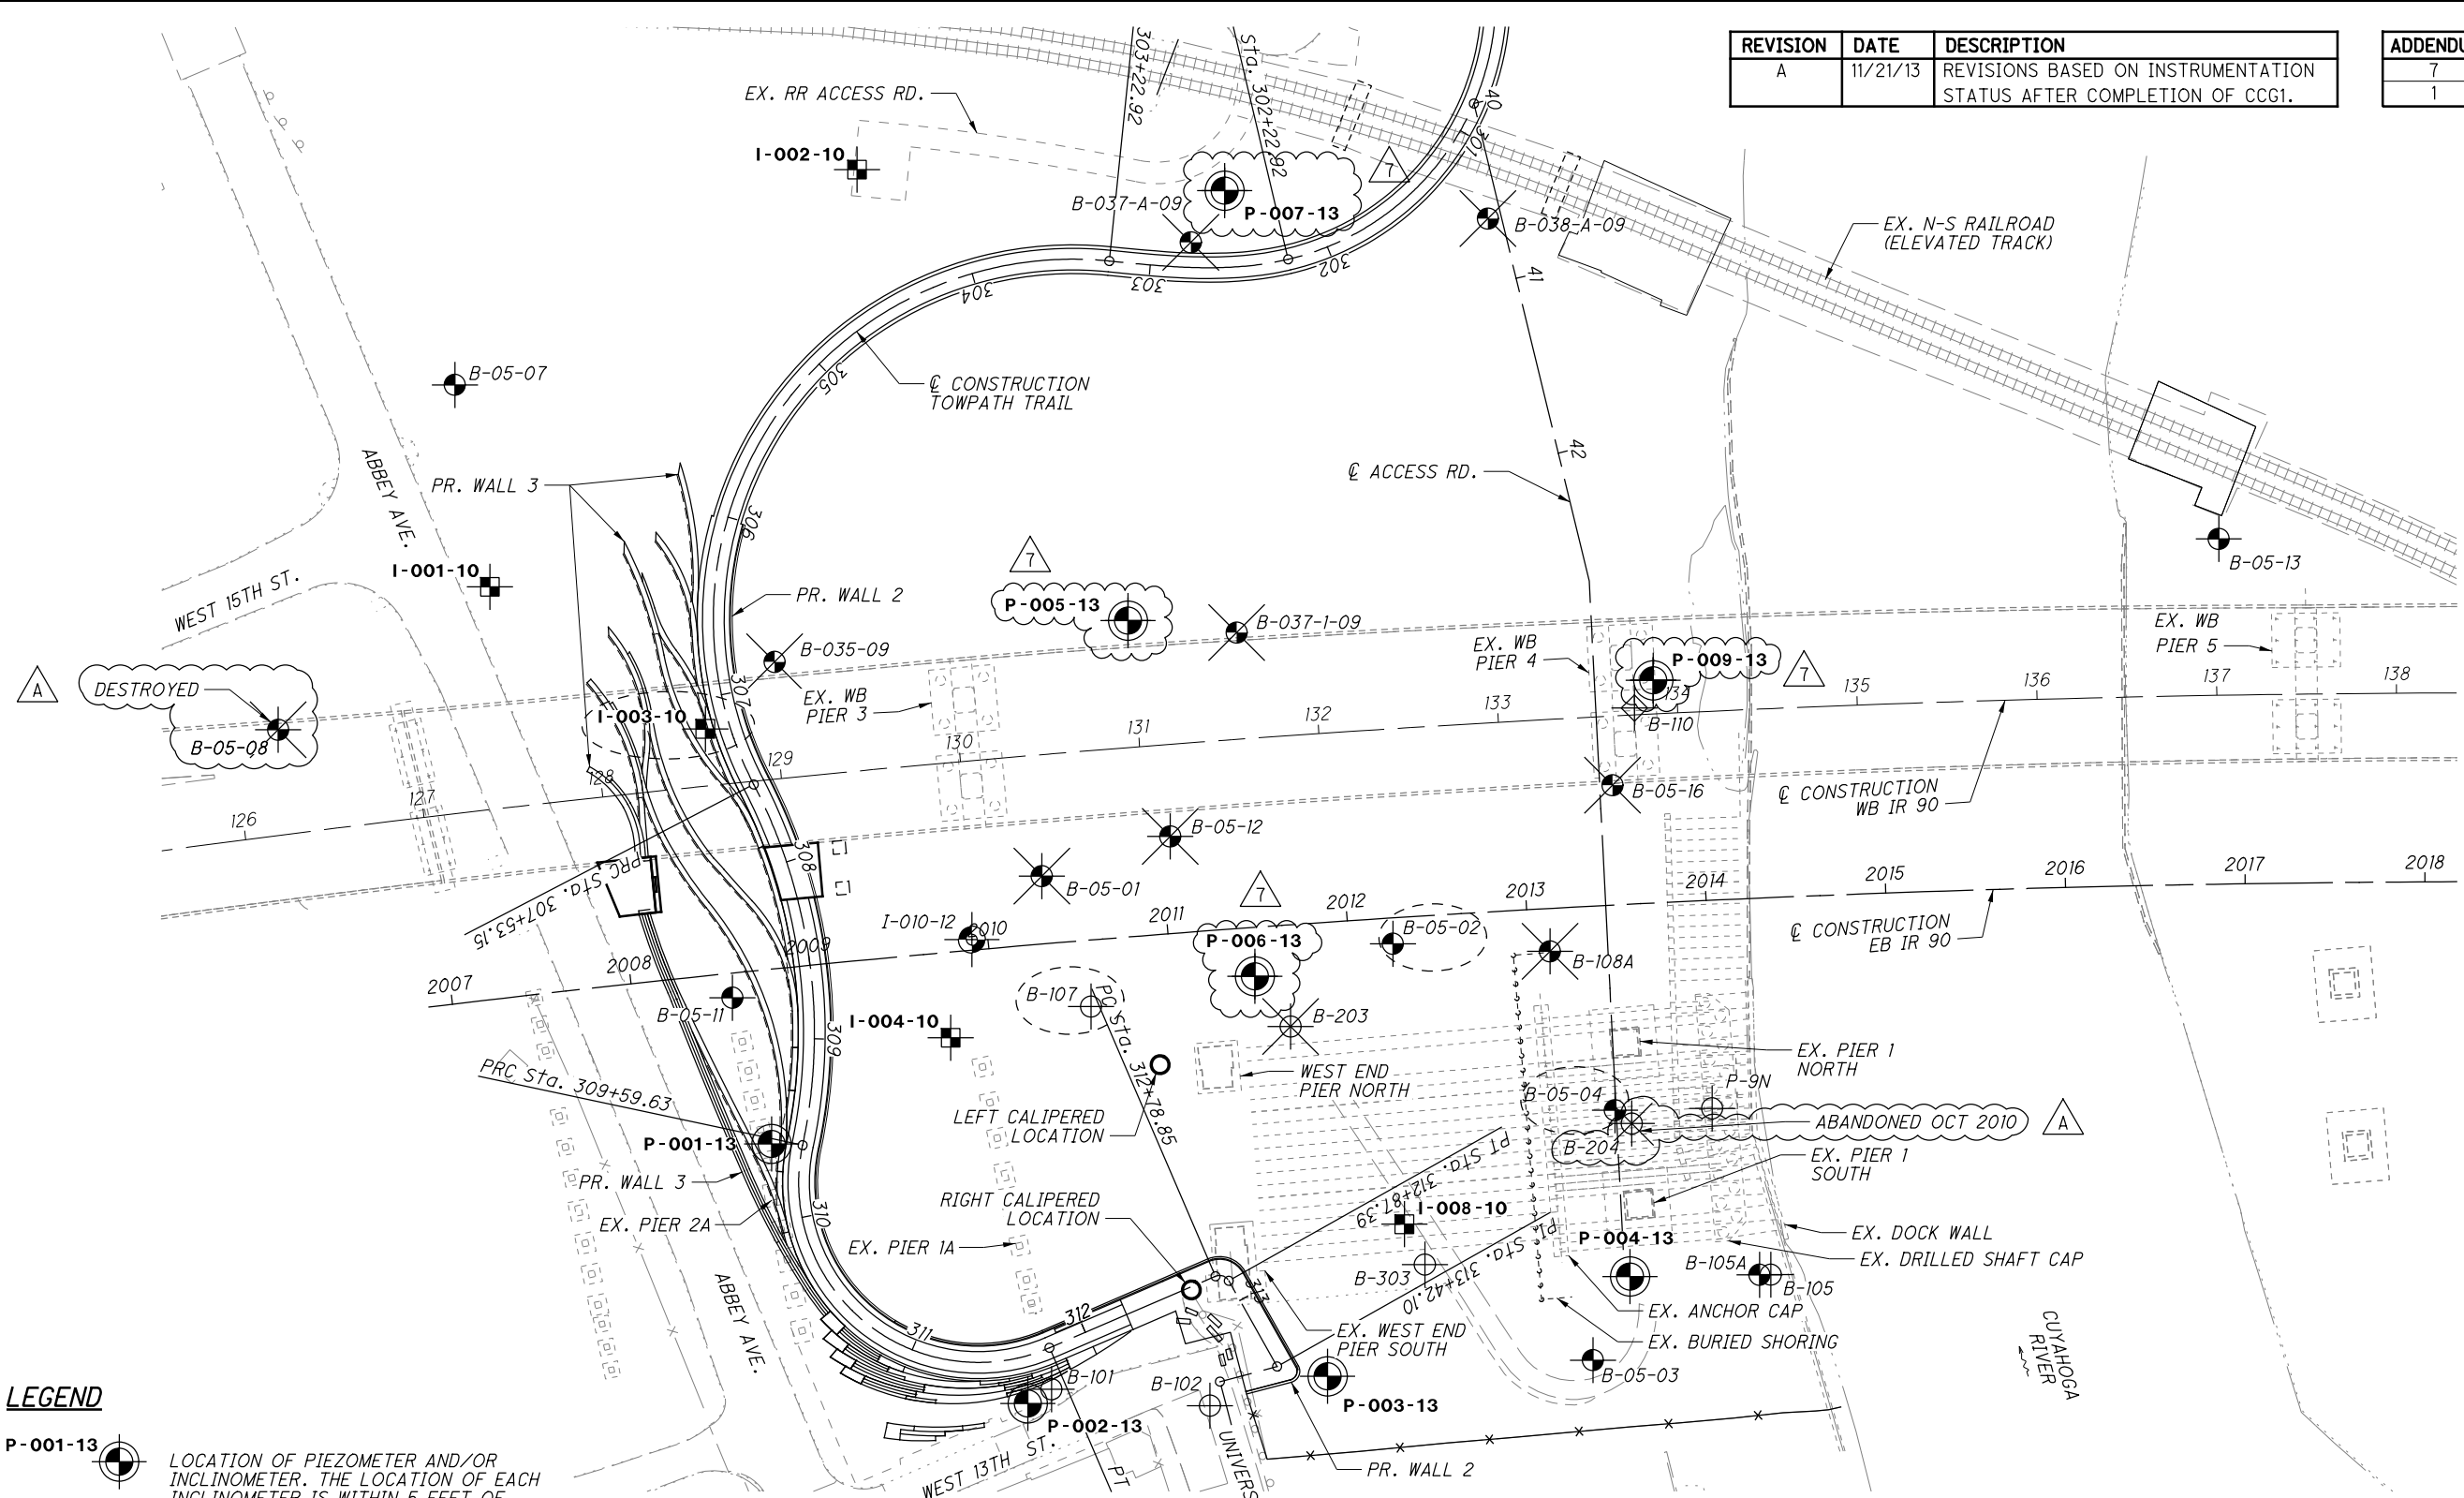
B-105 – Tubing to the pneumatic piezometers at this location was damaged during excavation for repair of the bulkhead. We worked with TGR to locate the tubing, but were unable to find any trace of it. These piezometers should be considered destroyed and permanently out of service.

B-105A. The inclinometer casing at this location was damaged during excavation behind the bulkhead. We were able to lower a dummy probe to the bottom of the remaining slope tube to verify that it was undamaged and free of debris. Fortunately, the casing separated cleanly at a joint and we were able to attach a short section of casing so that readings can continue until the area is backfilled.

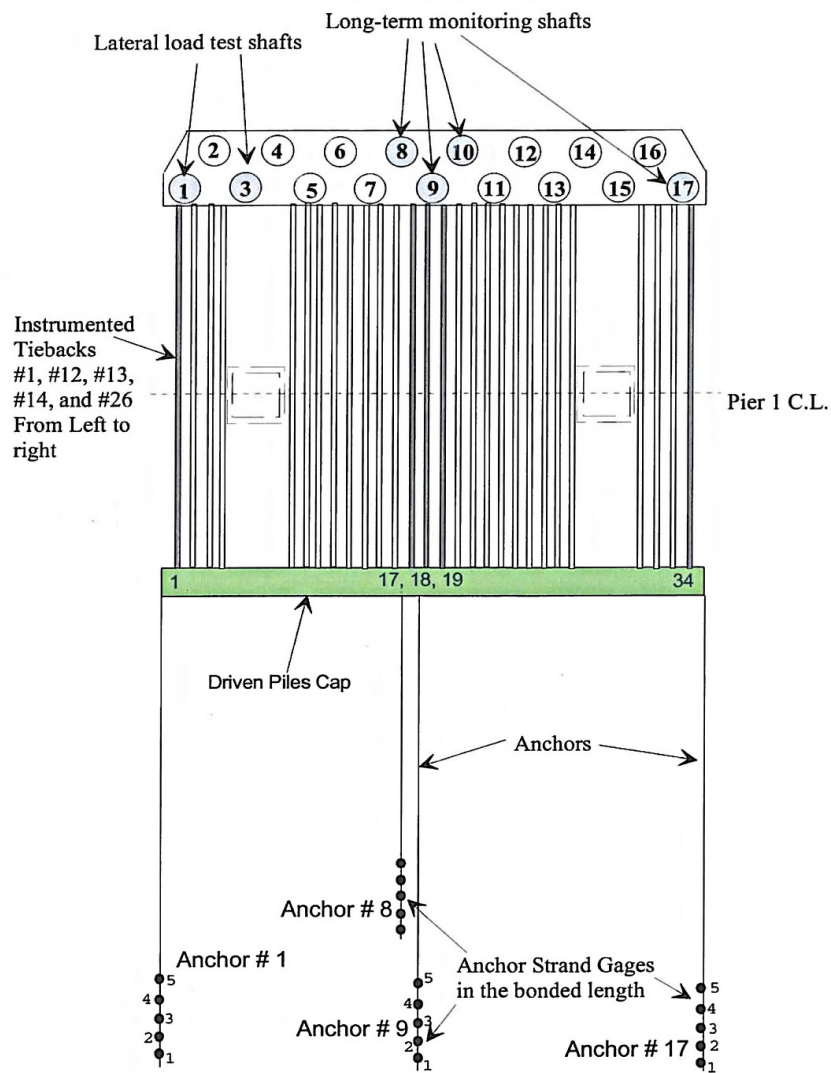
Figure 3. Plan of the stabilization system showing the locations of the instrumented foundation elements.

The general arrangement of the stabilization structure and its instrumentation is shown in Figures 2 and 3 in Appendix A. Both data loggers failed to record during part of this quarter. In Box 1, which stores data from the load cells, ground anchors, and driven piles, this occurred between September 12 and December 16, 2015. In Box 2, which stores data from the tiebeams and drilled piers, this occurred between October 19 and November 16, 2015. We are not sure what caused the data loggers to stop recording and or the reason for the different date ranges.
