August 23, 2016

Re: August 11, 12, and 15, 2016 Bi-Weekly Readings  
CUY-90-15.24 Slope Monitoring  
PID 96504  
SME Project No. 069032.00

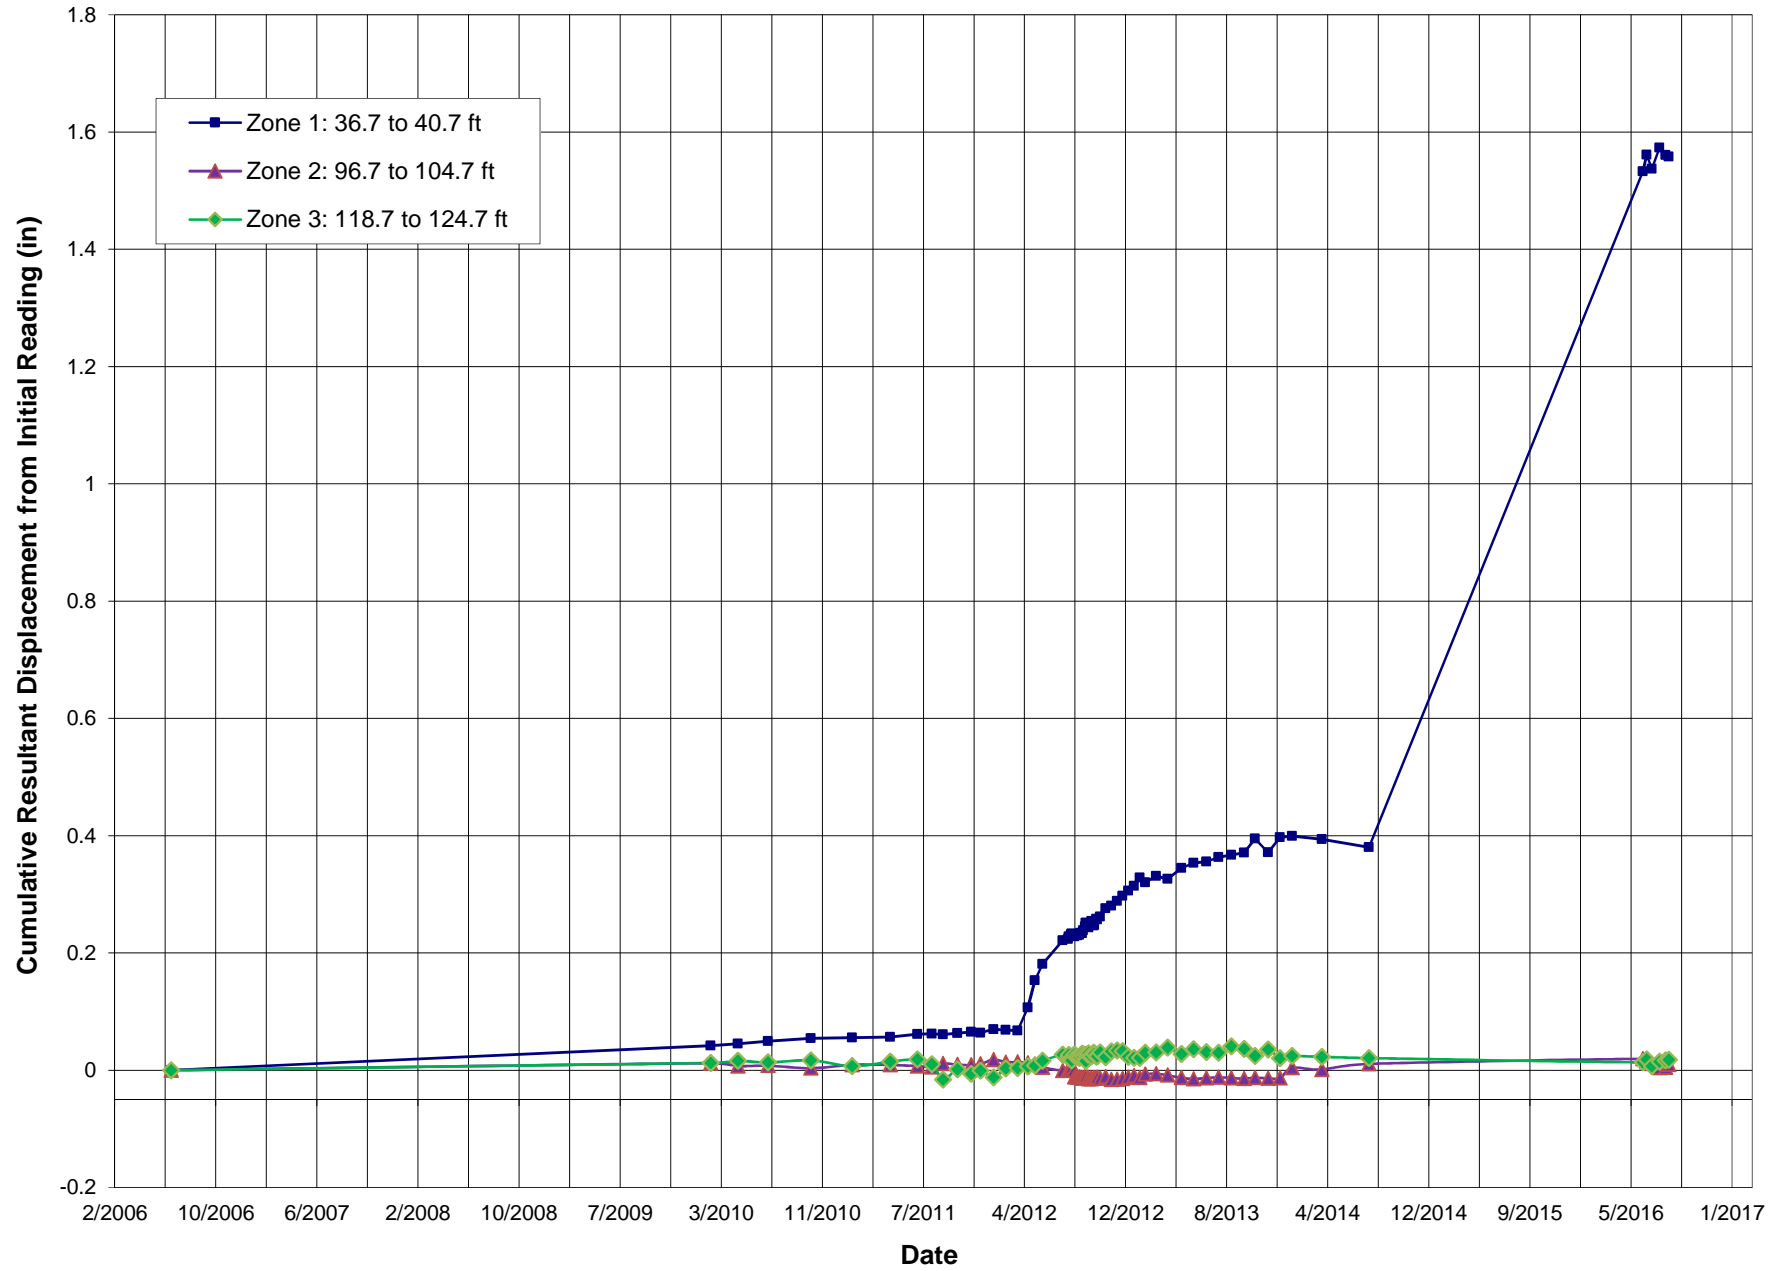
### B-05-02

P-002-13, P-004-13, B-05-02, B-05-A-03, B-05-04 – Pore pressure readings at these locations fluctuated by less than 0.5 feet, but show virtually no net change in total head.
