November 8, 2016

Re: October 20, 25 and 26, 2016 Bi-Weekly Readings
CUY-90-15.24 Slope Monitoring
PID 96504
SME Project No. 069032.00

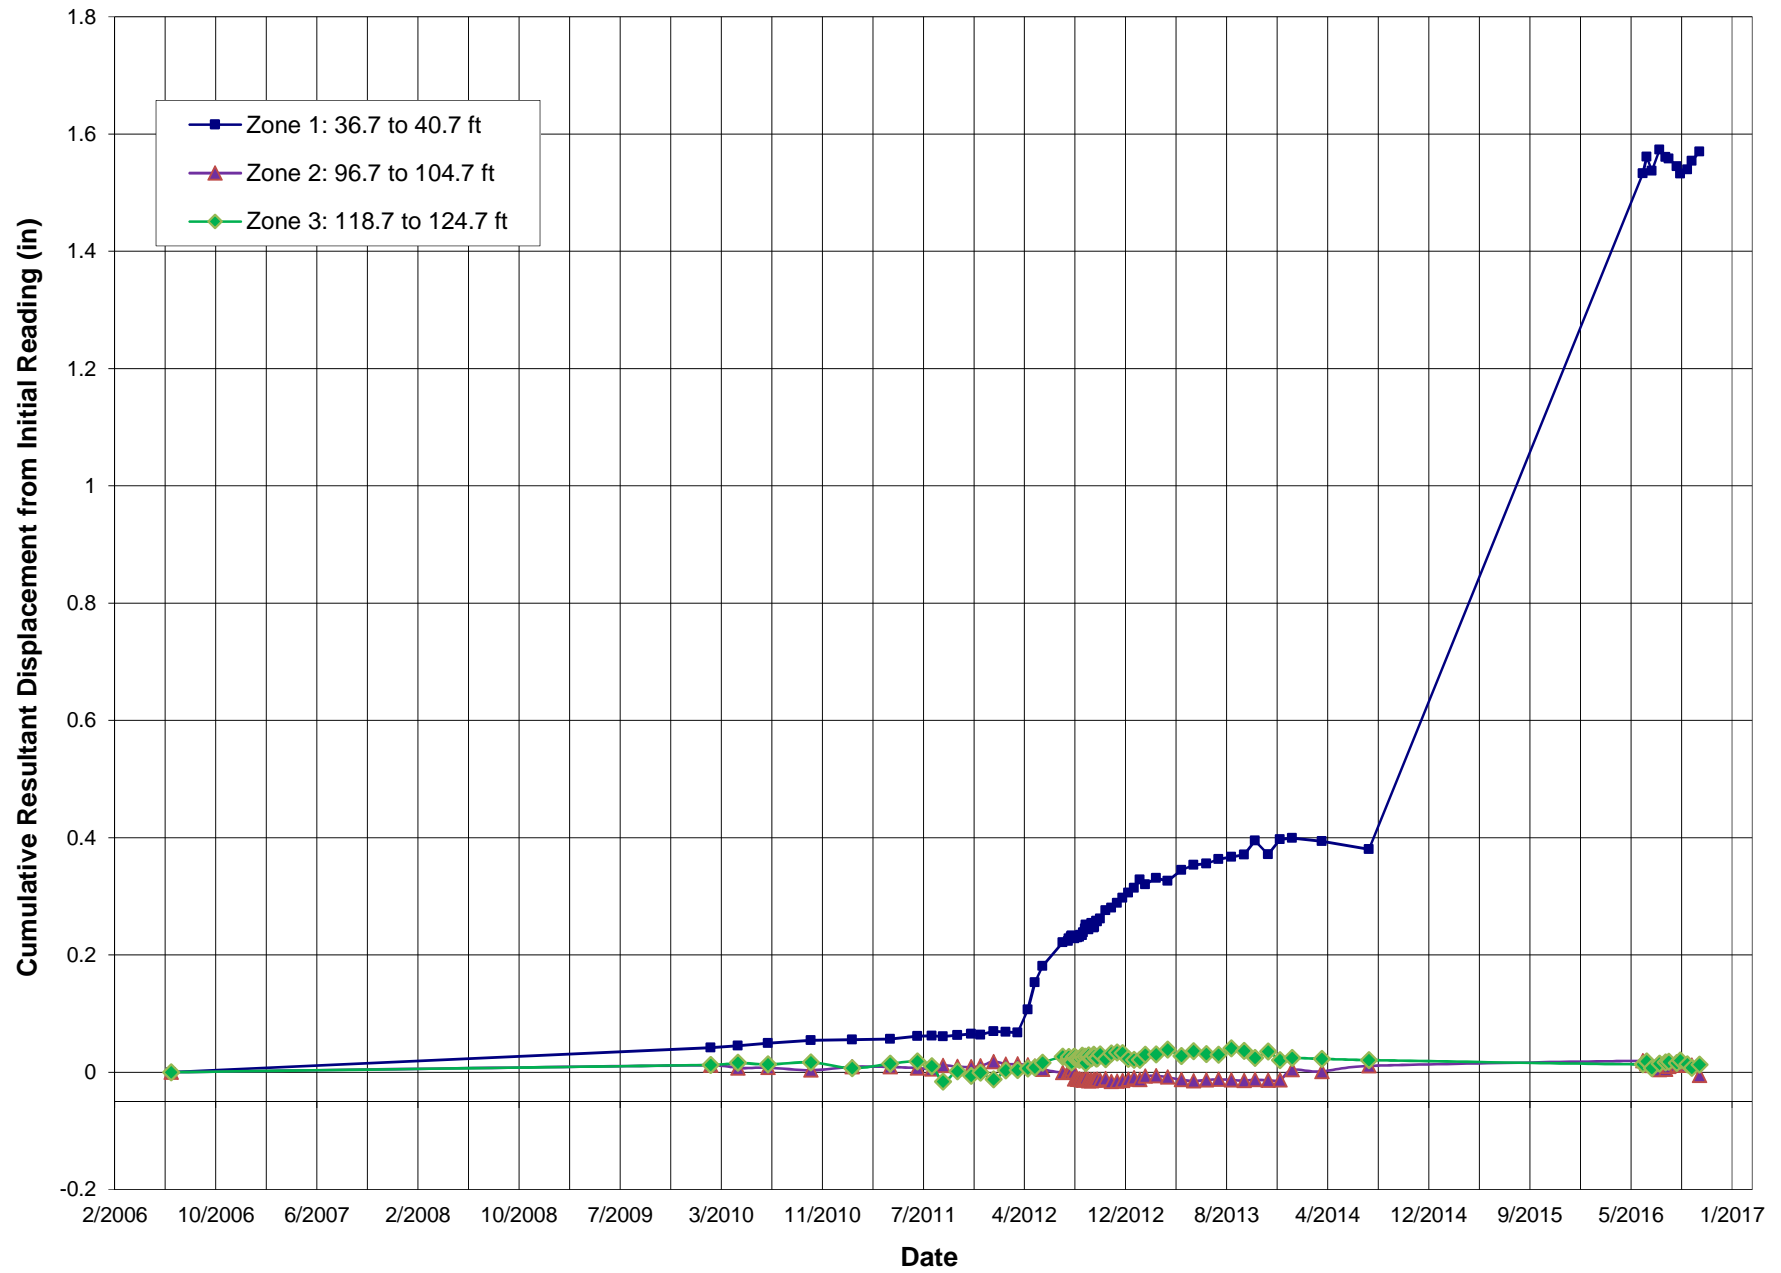
B-05-02

P-001-13, P-002-13, P-003-10, P-004-13, B-05-02, B-05-04 – Pore pressure readings at these locations fluctuated by less than 0.5 feet and show virtually no net change in total head for the period.
