Re: April 2017 Quarterly Report
CUY-90-15.24 Slope Monitoring
PID 96504
EDP Project No. 069032.00

APRIL 2017 QUARTERLY REPORT

CUY-90-15.24 SLOPE MONITORING
PID 96504
CLEVELAND, OHIO
SME PROJECT NO. 069032.00

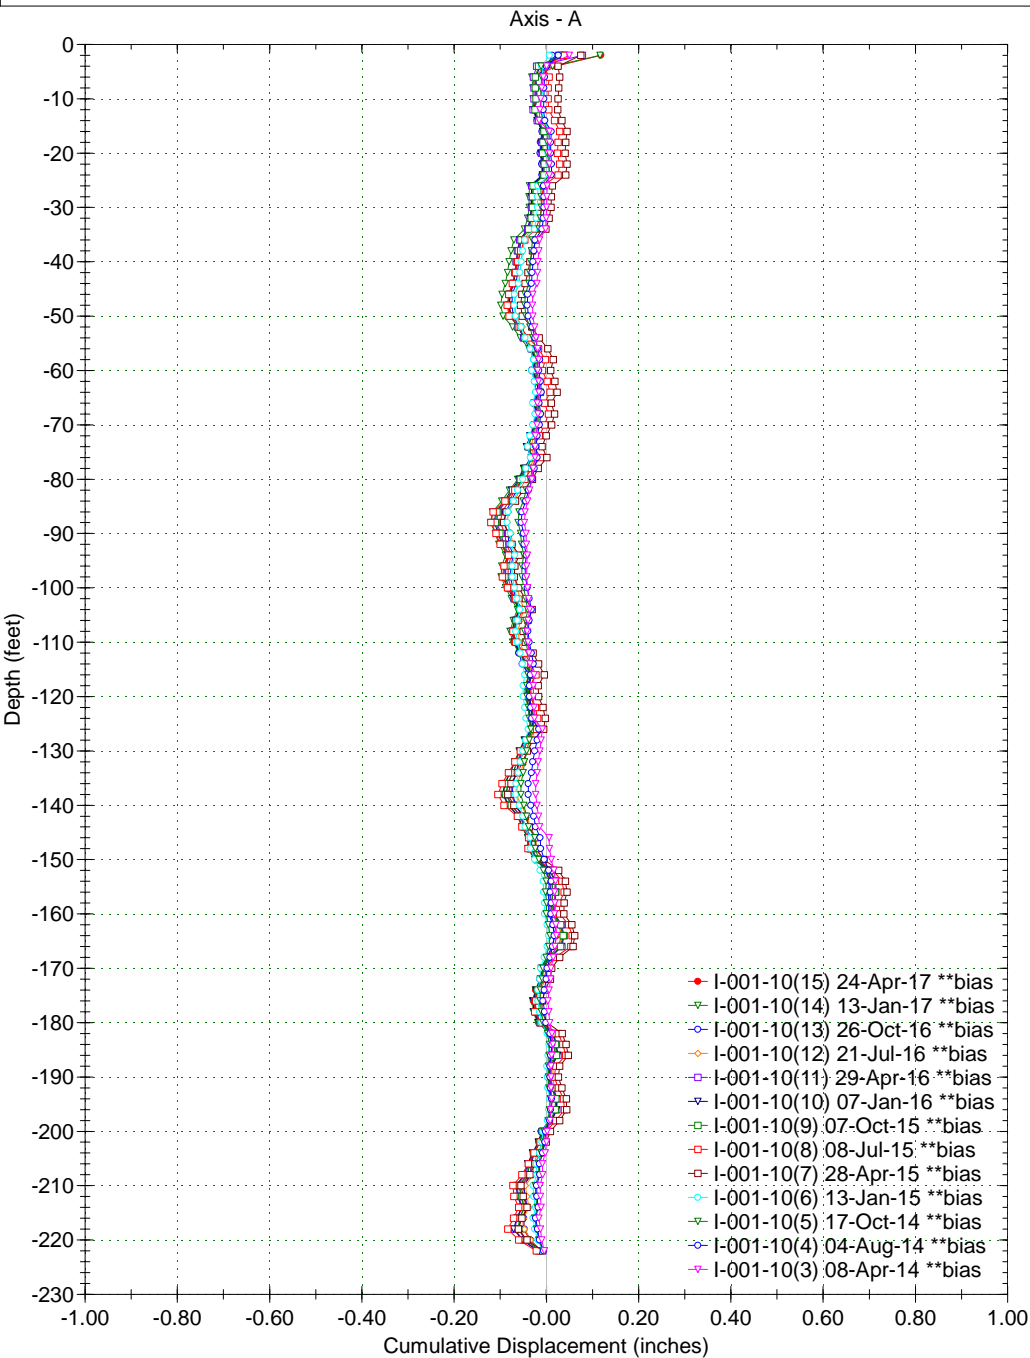
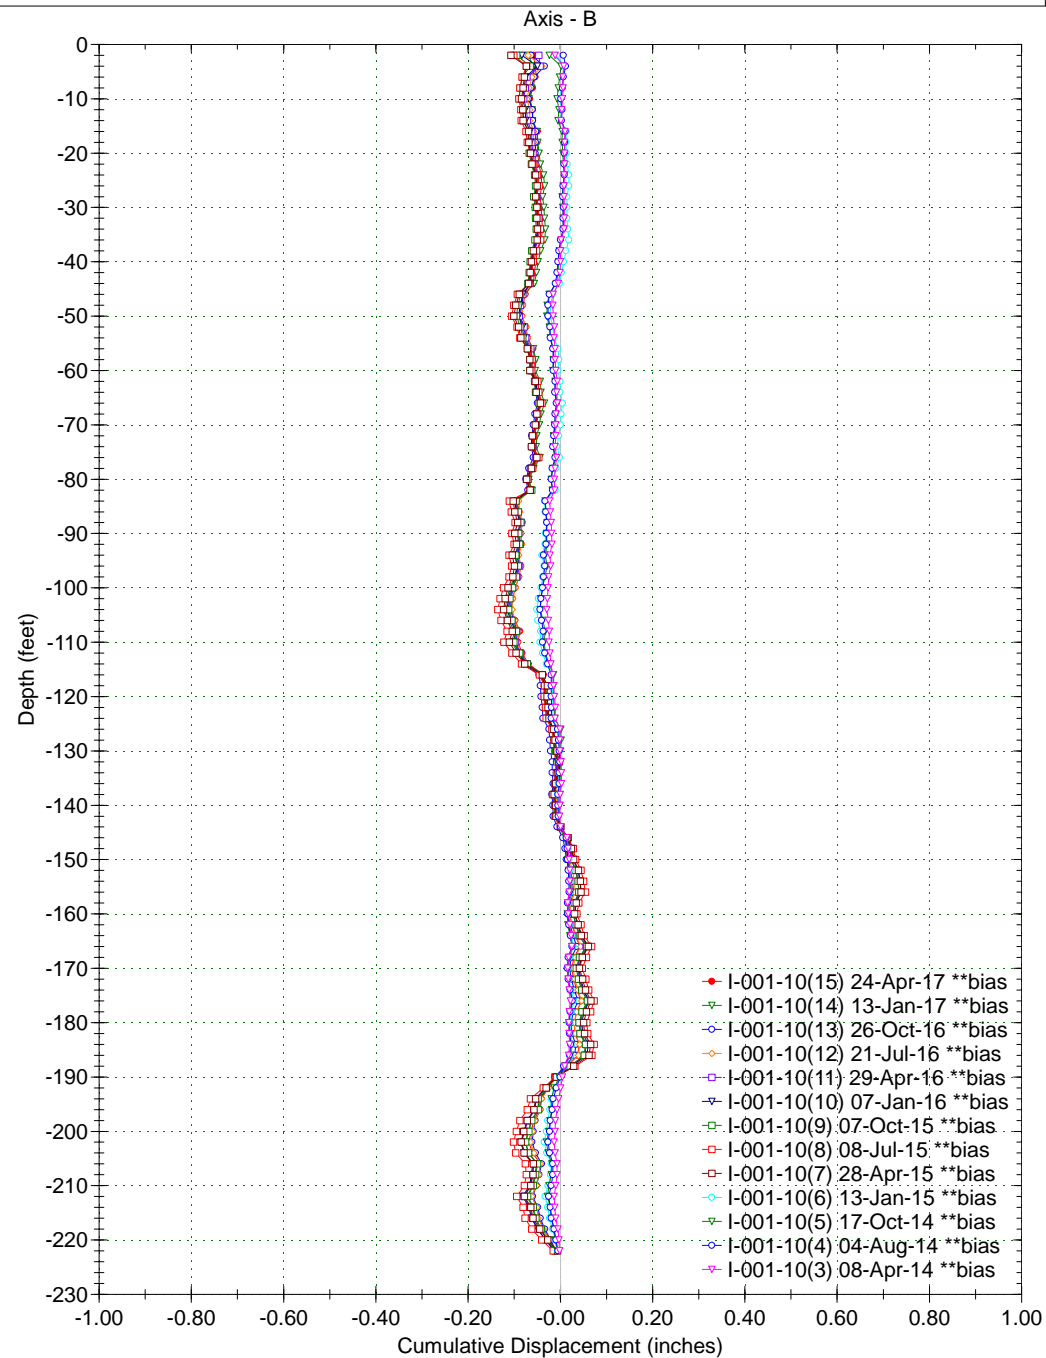
I-001-10, I-002-10, B-05-07, and inclinometers is pier **P-3, P-8, P-10,** and **P-17.** Inclinometer readings at these locations indicate virtually no movement this quarter.

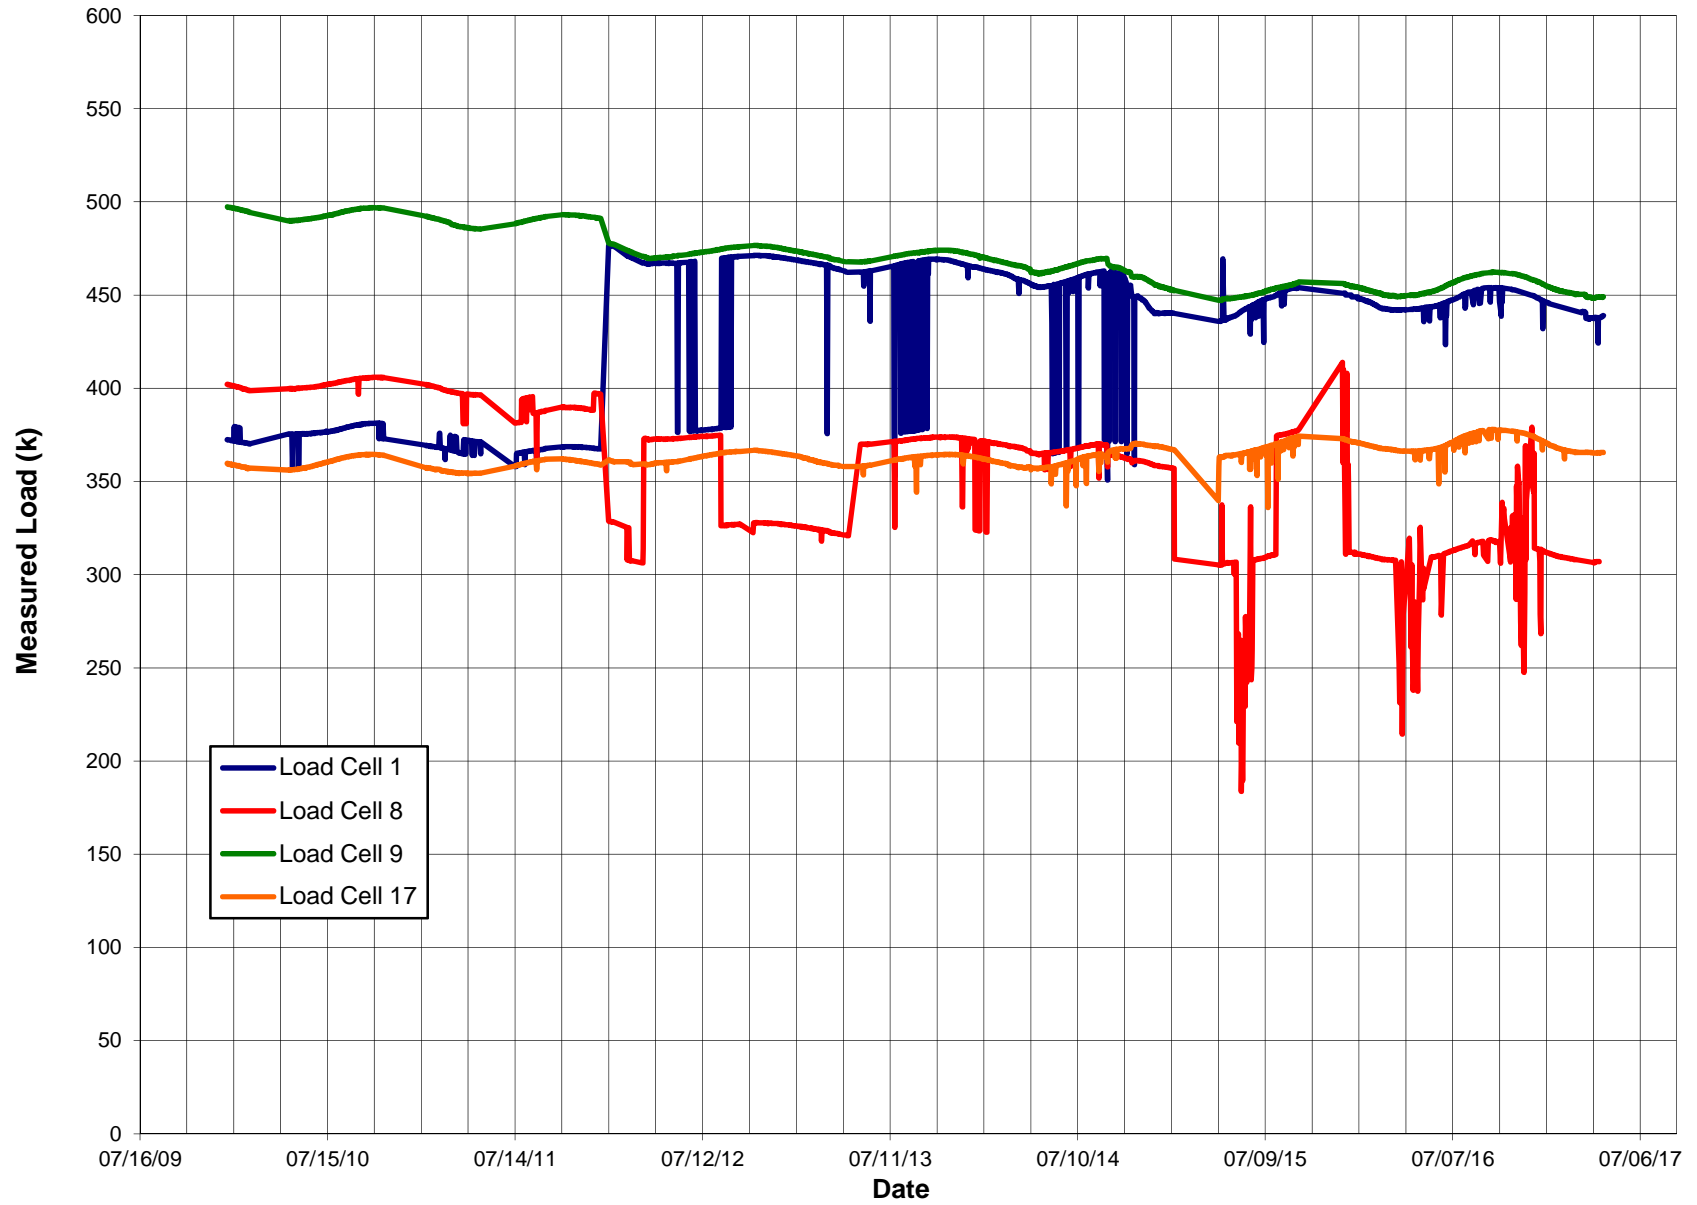
Load Cell Measurements

Seasonal variations are apparent in the plots for all the load cells with the usual decrease in load occurring during the winter months. The random spikes shown in the plots occur when one or more of the gages in the load cell fail to record. These spikes are occurring in all load cells with the exception of Load Cell 9. Gage 4 in Load Cell 1 failed from January 12 to March 14, 2017, then started recording again. Gage 3 in Load Cell 8 started intermittently giving erroneous readings after March 5, 2017. These erroneous readings were deleted to "clean up" the plots. Table 2 shows which gages were active in each of the load cells this quarter. A plot of the load cell data is included in Appendix B.
