July 11, 2017

Re: May 23, 24, and 25, 2017 Monthly Readings
CUY-90-15.24 Slope Monitoring
PID 96504
SME Project No. 069032.00

INSTRUMENTATION PLAN
CUYAHOGA RIVER WEST BANK

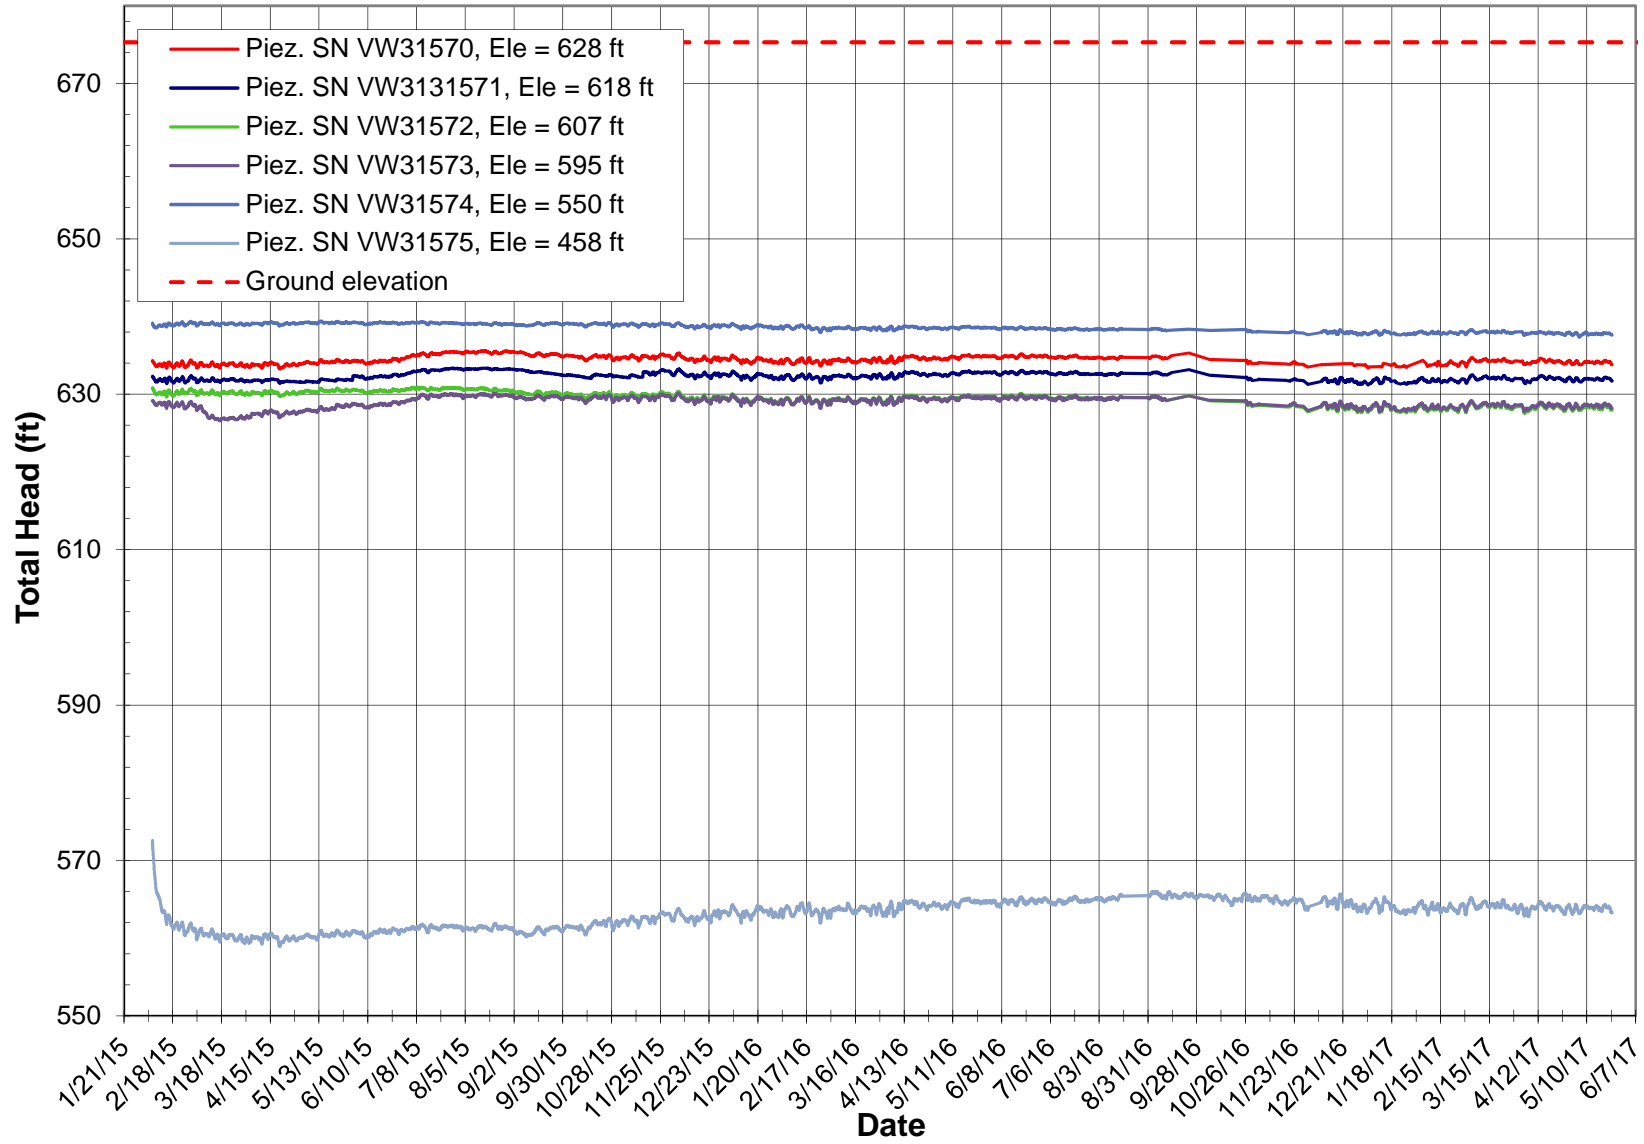
P-002-13 VW Piezometer Readings

Pore pressure readings at P-002-13, P-003-13, P-009-13, and B-05-A-11 show variations in total head of less than 0.5 feet for the period.
