**PID 101682**

**CUY-17-02.83**  
*Fairview Park, Ohio*

# DRAFT DECK CONDITION SURVEY

**April 2016**

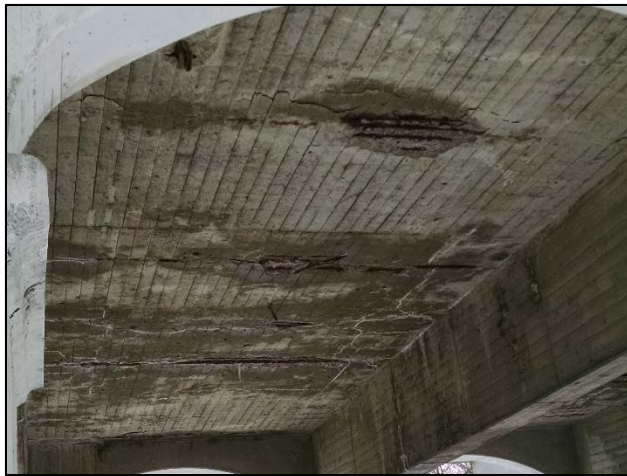
The Arch A deck underside is in Serious Condition with large areas of exposed, corroding rebar (see *Photos 19 through 21*). There are various locations in the two west bays where water constantly drips a day after rainfall. This area coincides with the failed and settling patches in the deck surface above. This area should be monitored for a future, potential through-hole.

Photo 20 – Interior Bay 2 of Arch A viewed from the south.

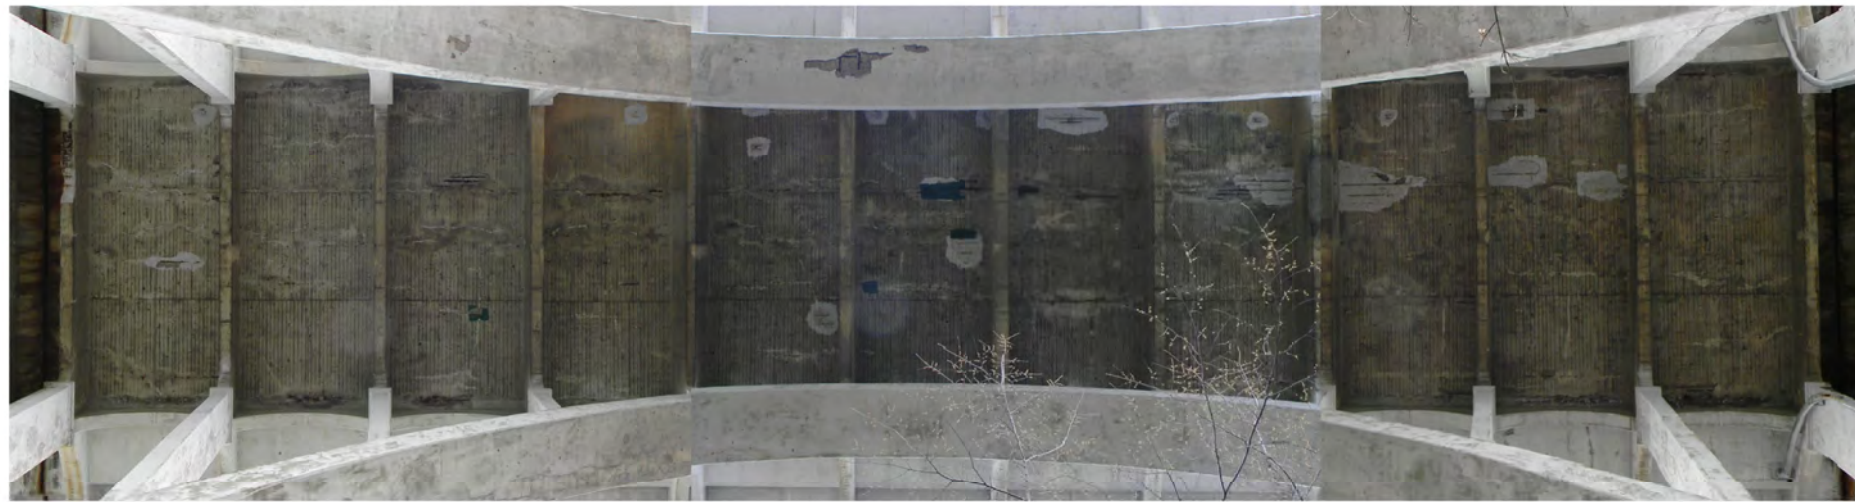
**ARCH C - BOTTOM OF DECK PHOTO**

119 SF
35 SF
111 SF
71 SF
94 SF
145 SF
109 SF
210 SF
134 SF
175 SF
106 SF

TOTAL ORIGINAL DECK UNDERSIDE AREA NOT COUNTING FLOOR BEAMS = 6247 SF  
 TOTAL AREA OF DETERIORATION = 1309 SF  
 21% DETERIORATION

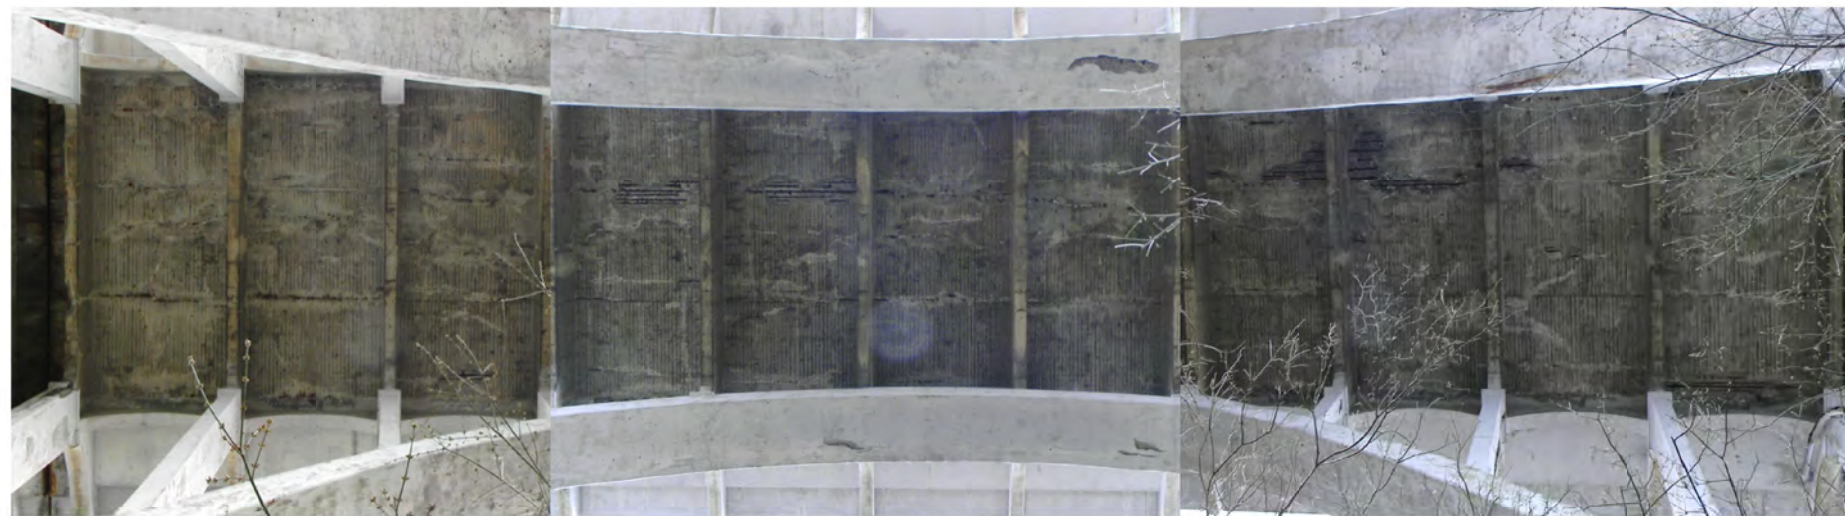
**ARCH D - BOTTOM OF DECK PHOTO**

TOTAL ORIGINAL DECK UNDERSIDE AREA NOT COUNTING FLOOR BEAMS = 6247 SF  
 TOTAL AREA OF DETERIORATION = 1597 SF  
 26% DETERIORATION

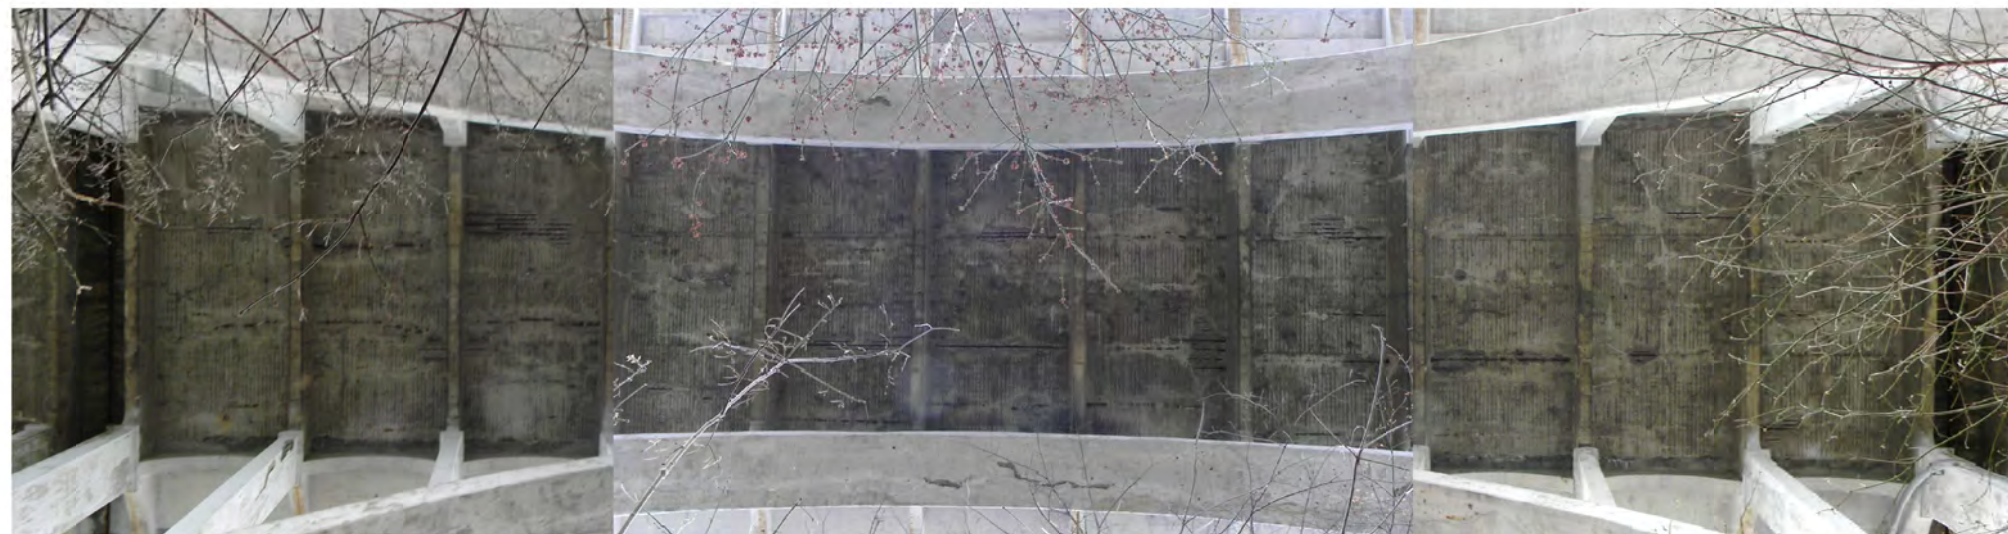
**ARCH E - BOTTOM OF DECK PHOTO**

114 SF    111 SF    186 SF    92 SF    86 SF    112 SF    160 SF    132 SF    154 SF    117 SF    128 SF

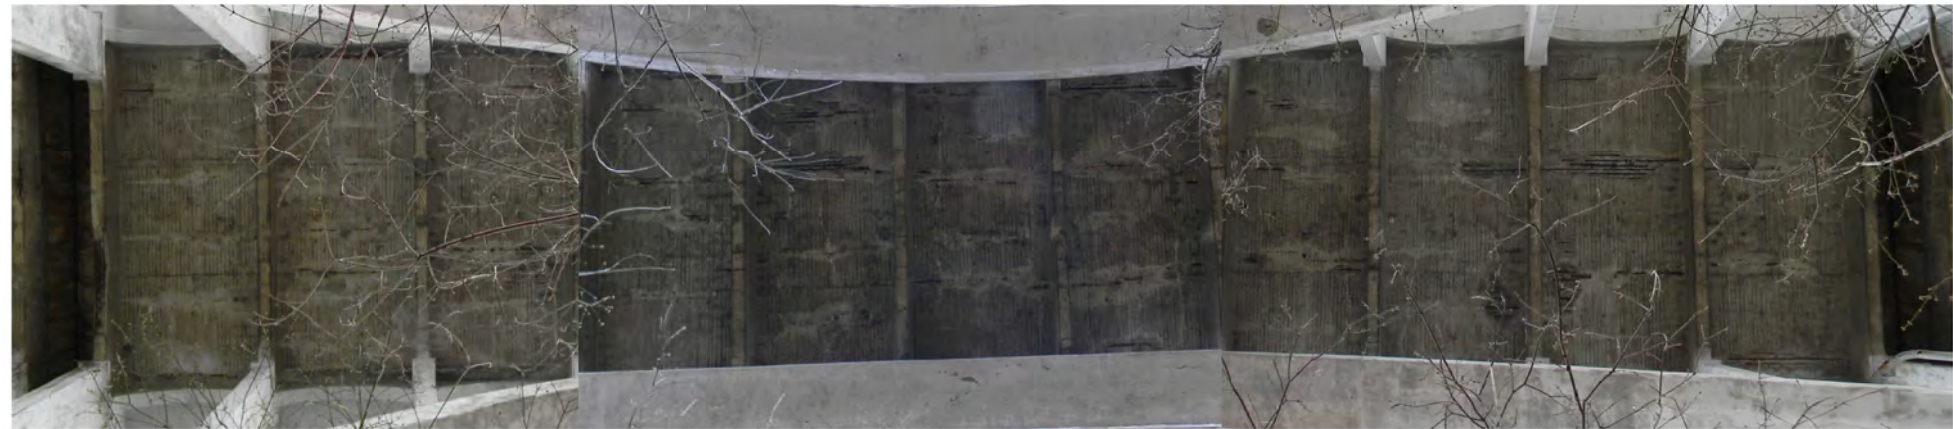
**ARCH F - BOTTOM OF DECK PHOTO**

90 SF    90 SF    88 SF    133 SF    200 SF    110 SF    146 SF    113 SF    119 SF    182 SF    119 SF

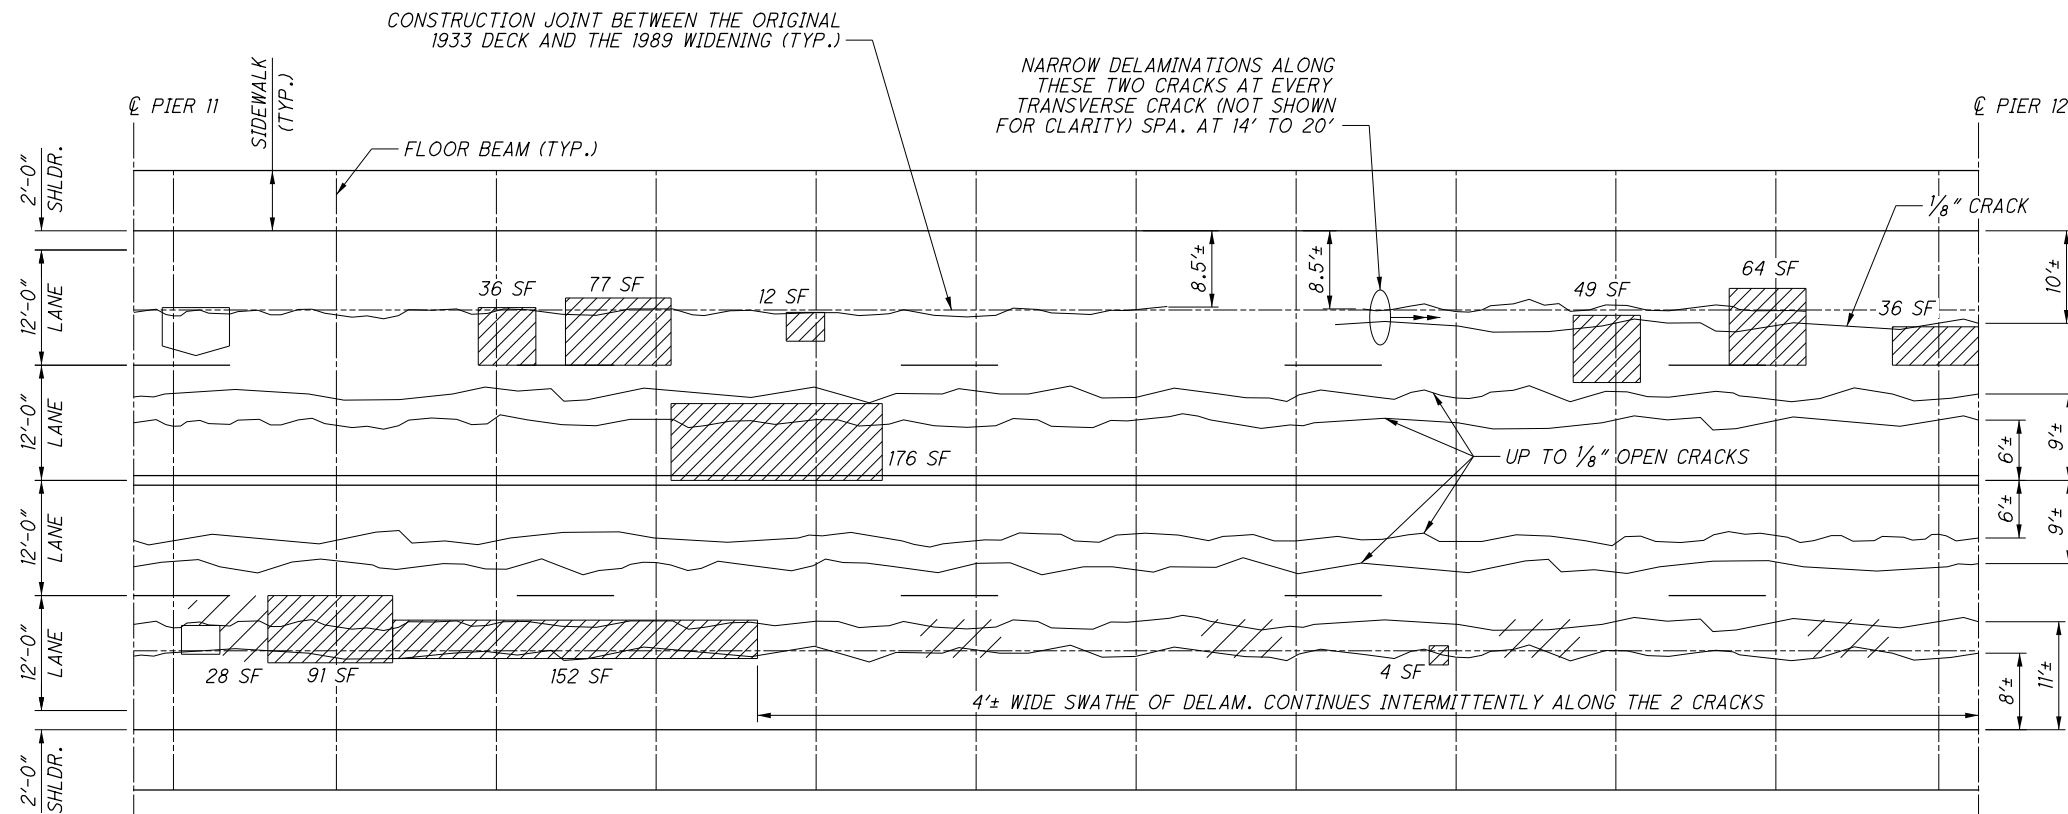
**ARCH G - TOP OF DECK**

TOTAL AREA OF OVERLAY = 9997 SF  
 TOTAL AREA OF DETERIORATION (SPALLS AND DELAMINATIONS ONLY) = 987 SF  
 10% DETERIORATION EXCLUDING CRACKS

TYP. MAP CRACKING WITH SMALL SPOT DELAMS (<1 SF) ADJ. TO CRACKS

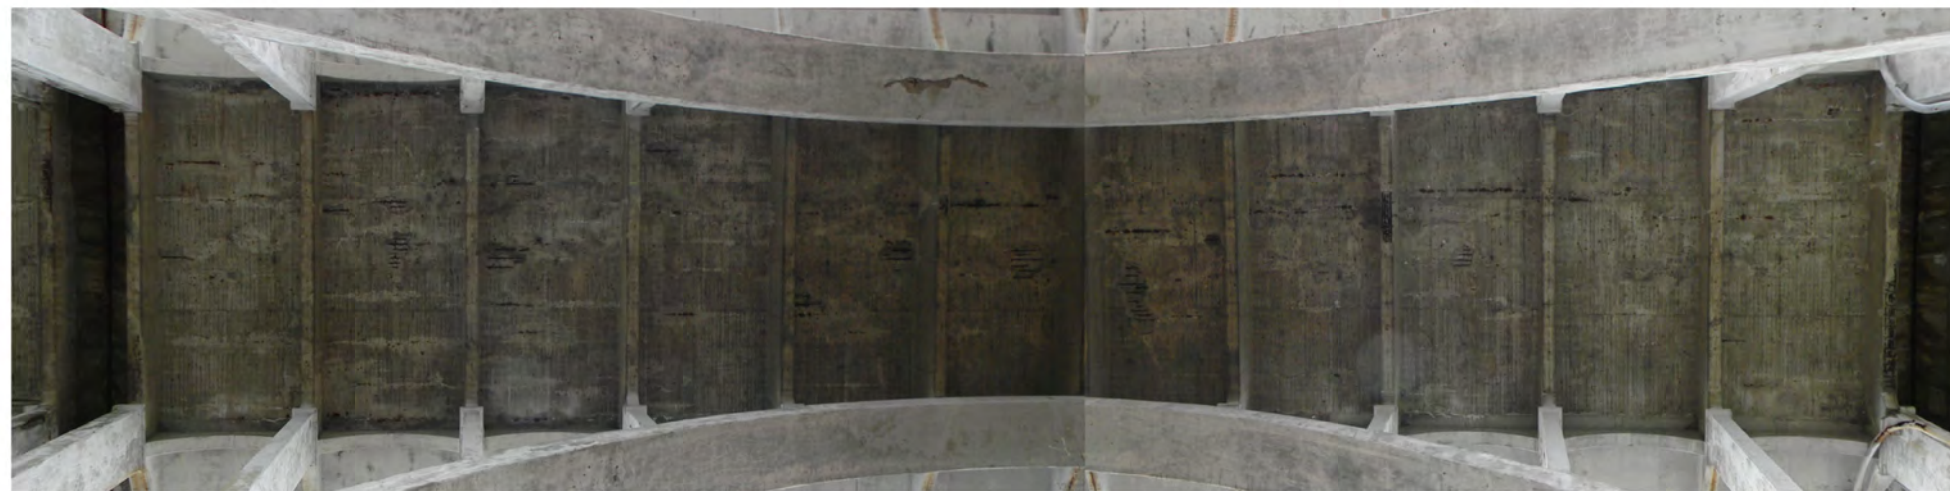
**ARCH G - BOTTOM OF DECK PHOTO**

163 SF    221 SF    173 SF    101 SF    80 SF    77 SF    89 SF    113 SF    116 SF    84 SF    131 SF

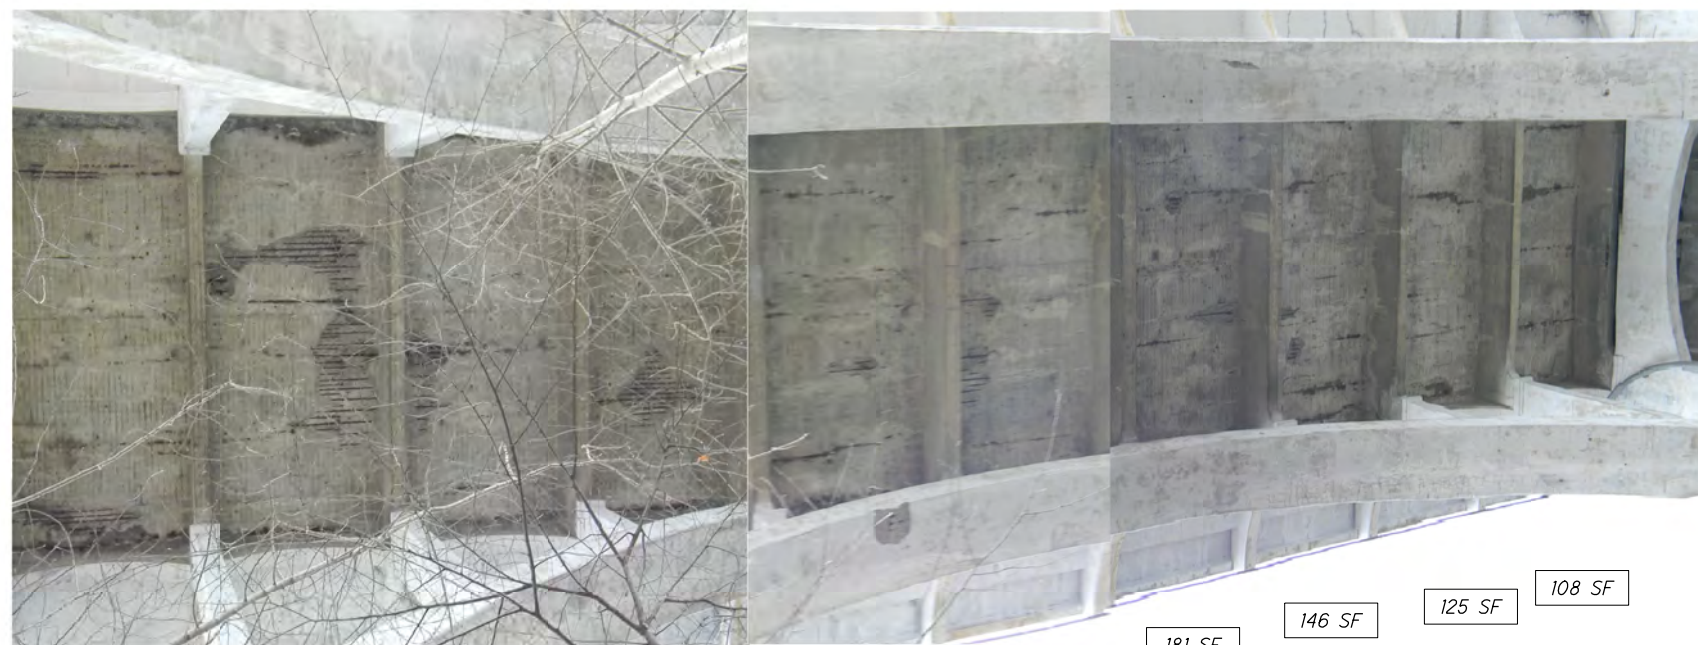
**ARCH H - BOTTOM OF DECK PHOTO**

UNABLE TO SCALE PICTORIALY, DUE TO EXTREME ANGLE OF PHOTOS. PHOTOS ARE ANGLED SINCE ARCH H SPANS OVER THE ROCKY RIVER. SCALED BY COUNTING REBAR WHERE POSSIBLE AND ESTIMATING. (TYP.)

162 SF    460 SF    158 SF    225 SF    177 SF    168 SF    181 SF    146 SF    125 SF    108 SF

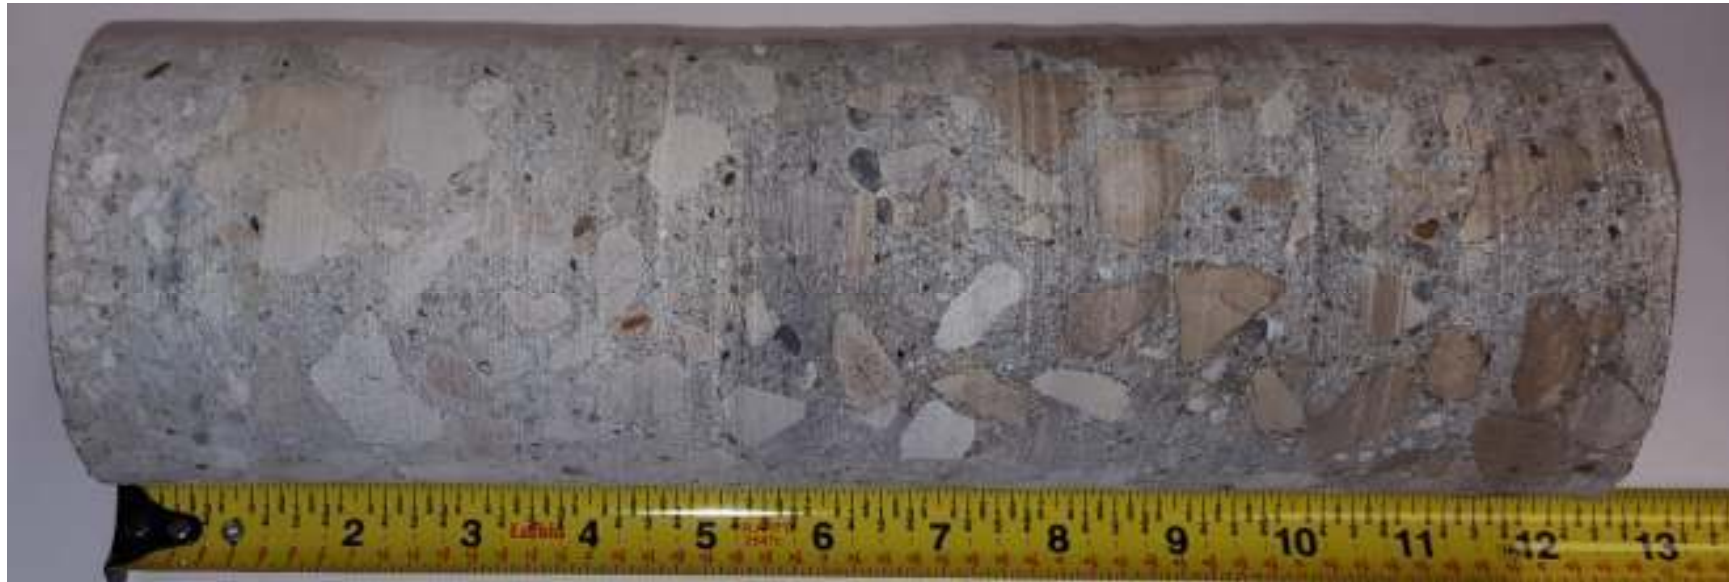
Core Number	Location	Layers	Core Composition		Remarks
			LMC Overlay	Bridge Deck	
C-1	<b>CUY-17-2.83</b> <b>WB-RL-MOL</b> Latitude : 41.4196888° Longitude : -81.8582516°	A	1 ½"	--	Good Condition
		B	--	11"	Good Condition

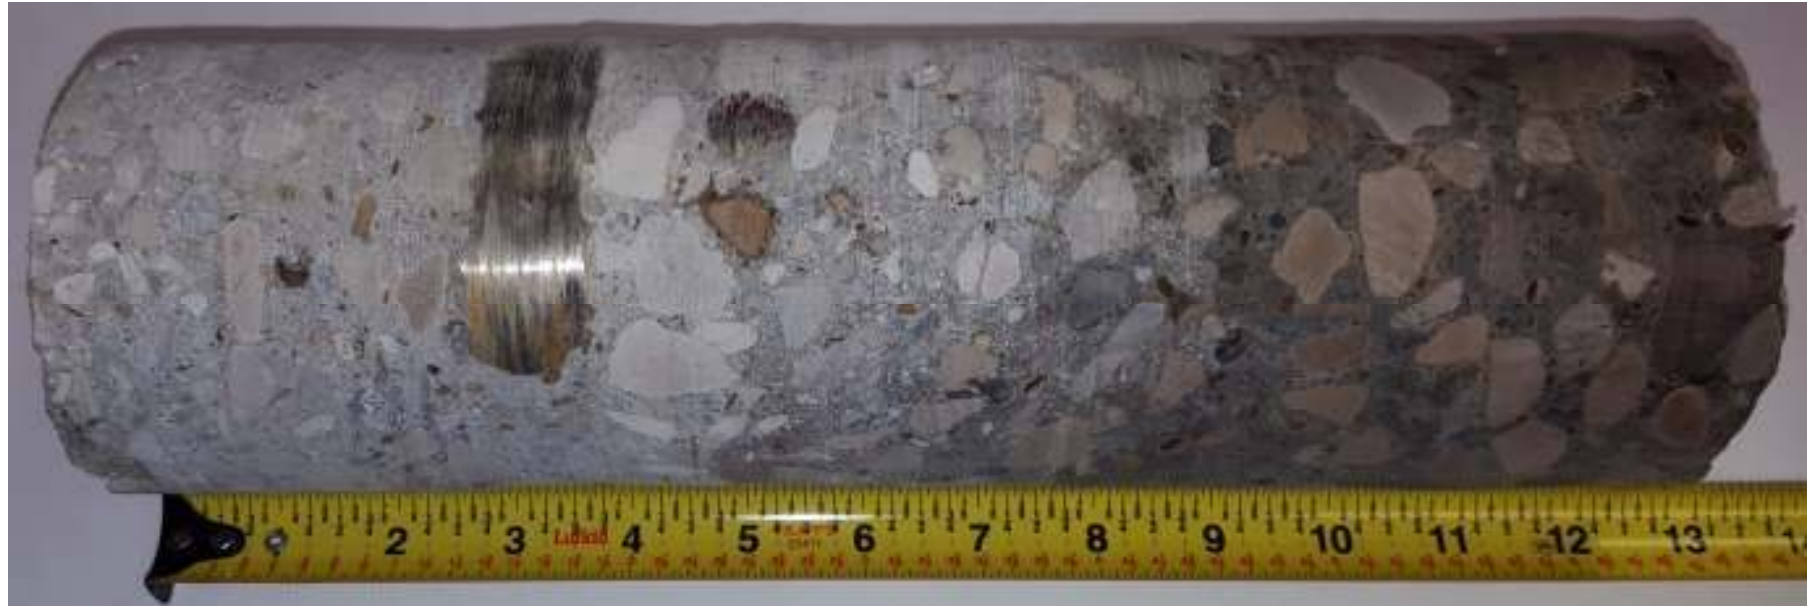
Core Number	Location	Layers	Core Composition		Remarks	
			LMC Overlay	Bridge Deck		
C-2	<b>CUY-17-2.83 WB-RL-LWT</b> Latitude : 41.4196888° Longitude : -81.8582516°	A	1 ½"	--	Good Condition	
		B	--	11"	Good Condition

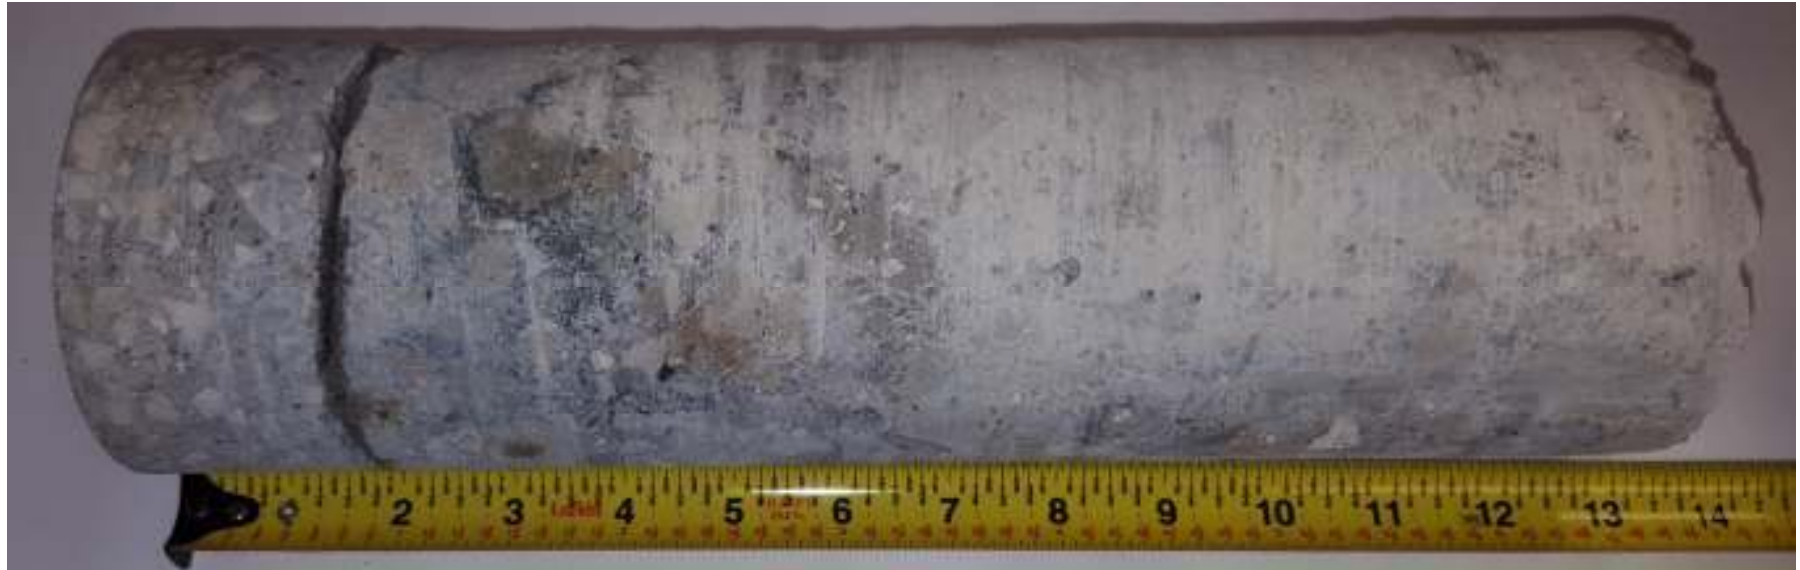
Core Number	Location	Layers	Core Composition		Remarks
			LMC Overlay	Bridge Deck	
C-3	<b>CUY-17-2.83</b> <b>WB-RL-LWT</b> Latitude : 41.4201411° Longitude : -81.8599976°	A	2"	--	Good Condition, Separated During Coring
		B	--	11"	Good Condition

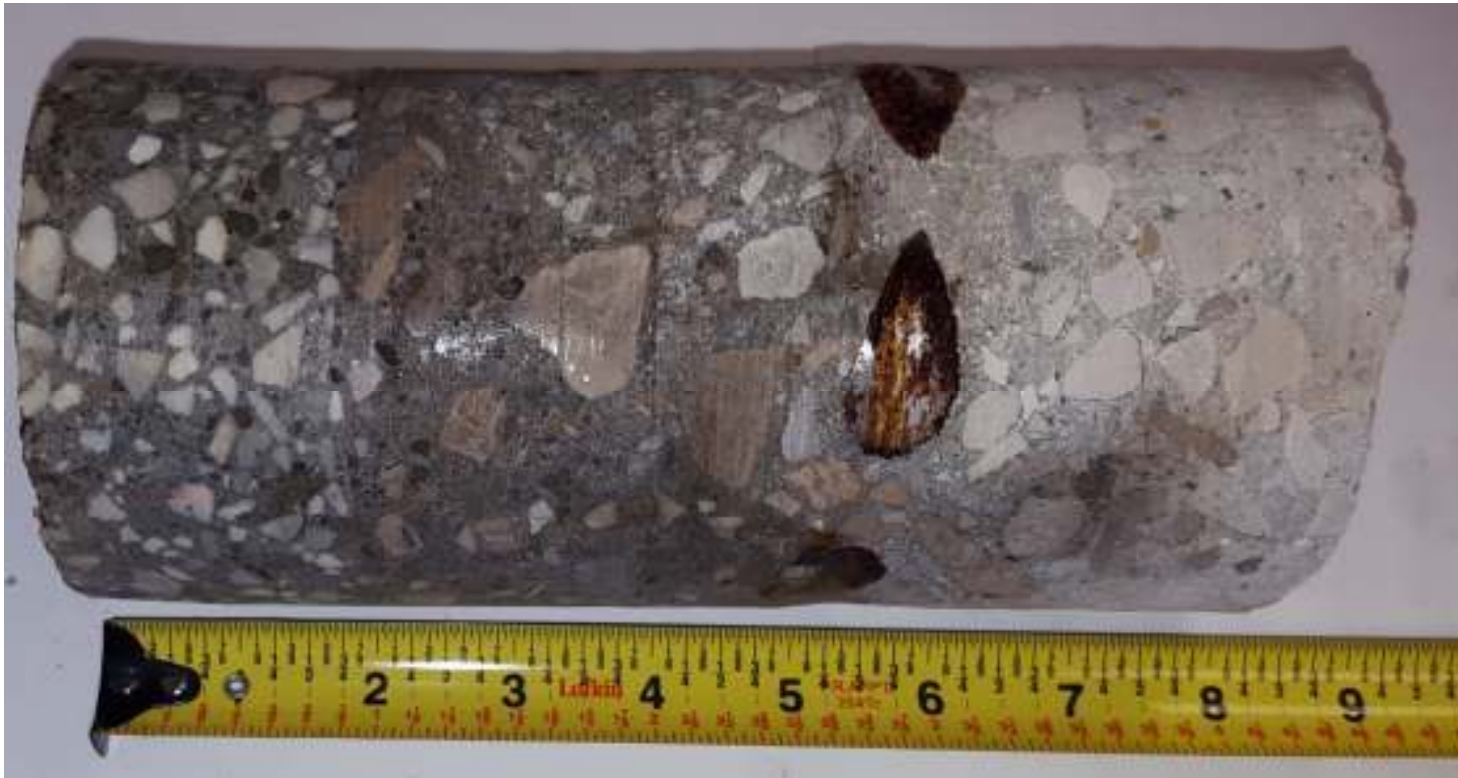
Core Number	Location	Layers	Core Composition		Remarks	
			LMC Overlay	Bridge Deck		
C-4	<b>CUY-17-2.83 EB-RL-MOL</b> Latitude : 41.4203670° Longitude : -81.8612659°	A	2"	--	Good Condition	
		B	--	6 ½"	Good Condition

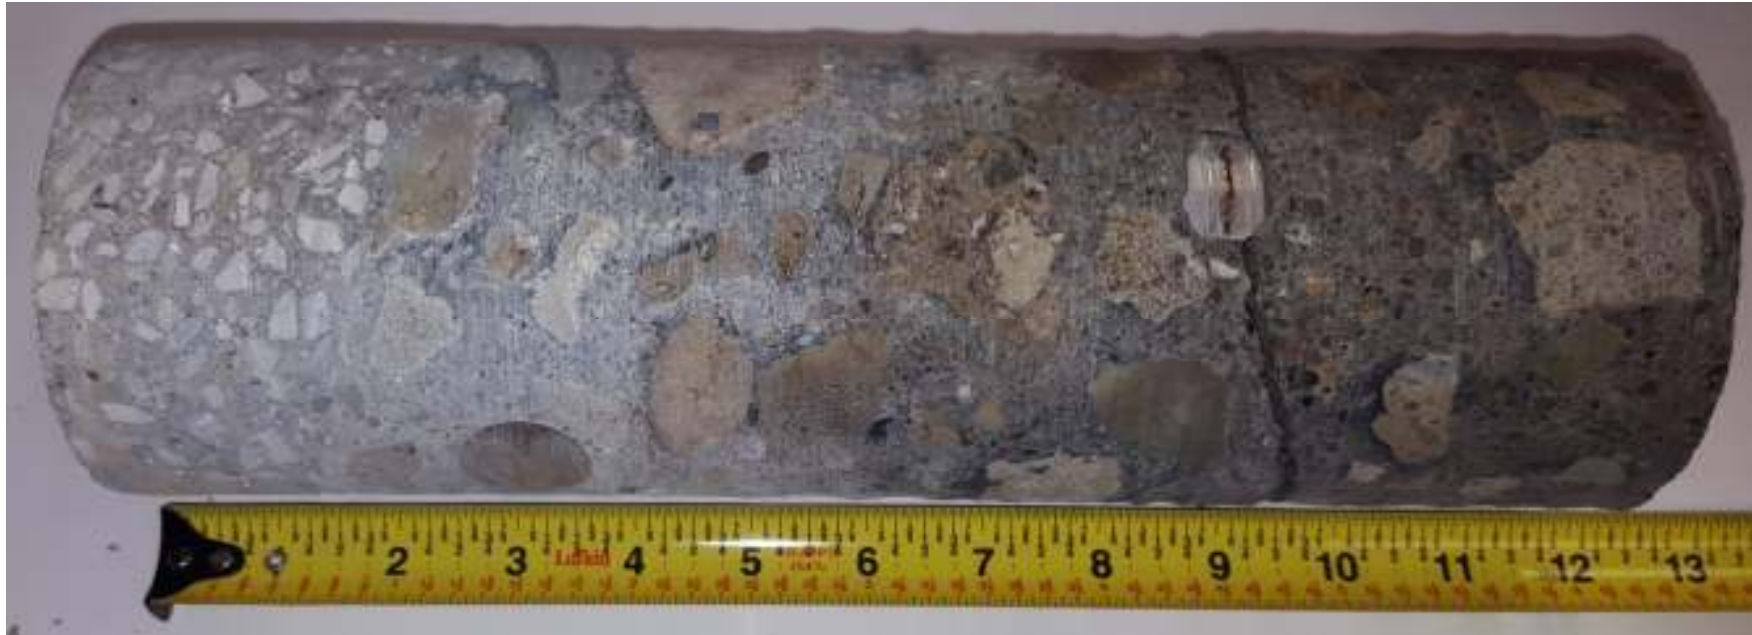
Core Number	Location	Layers	Core Composition		Remarks
			LMC Overlay	Bridge Deck	
C-5	<b>CUY-17-2.83 EB-RL-LWT</b> Latitude : 41.4201703° Longitude : -81.8604578°	A	2 ¼"	--	Good Condition
		B	--	10 ¾"	Good Condition, Cracked During Coring

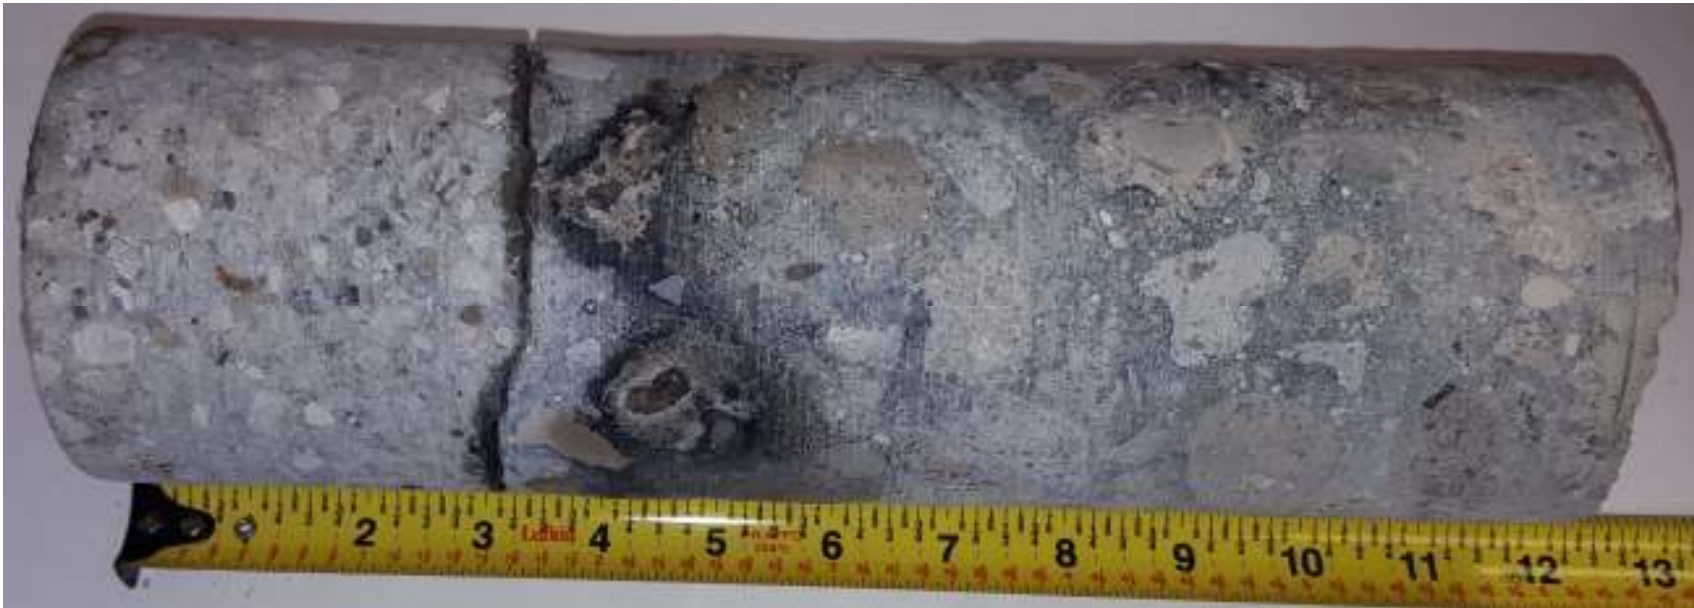
Core Number	Location	Layers	Core Composition		Remarks	
			LMC Overlay	Bridge Deck		
C-6	<b>CUY-17-2.83</b> <b>EB-RL-RWT</b> Latitude : 41.4196973° Longitude : -81.8586651°	A	3 ½"	--	Good Condition, Separated During Coring	
		B	--	8 ½"	Good Condition

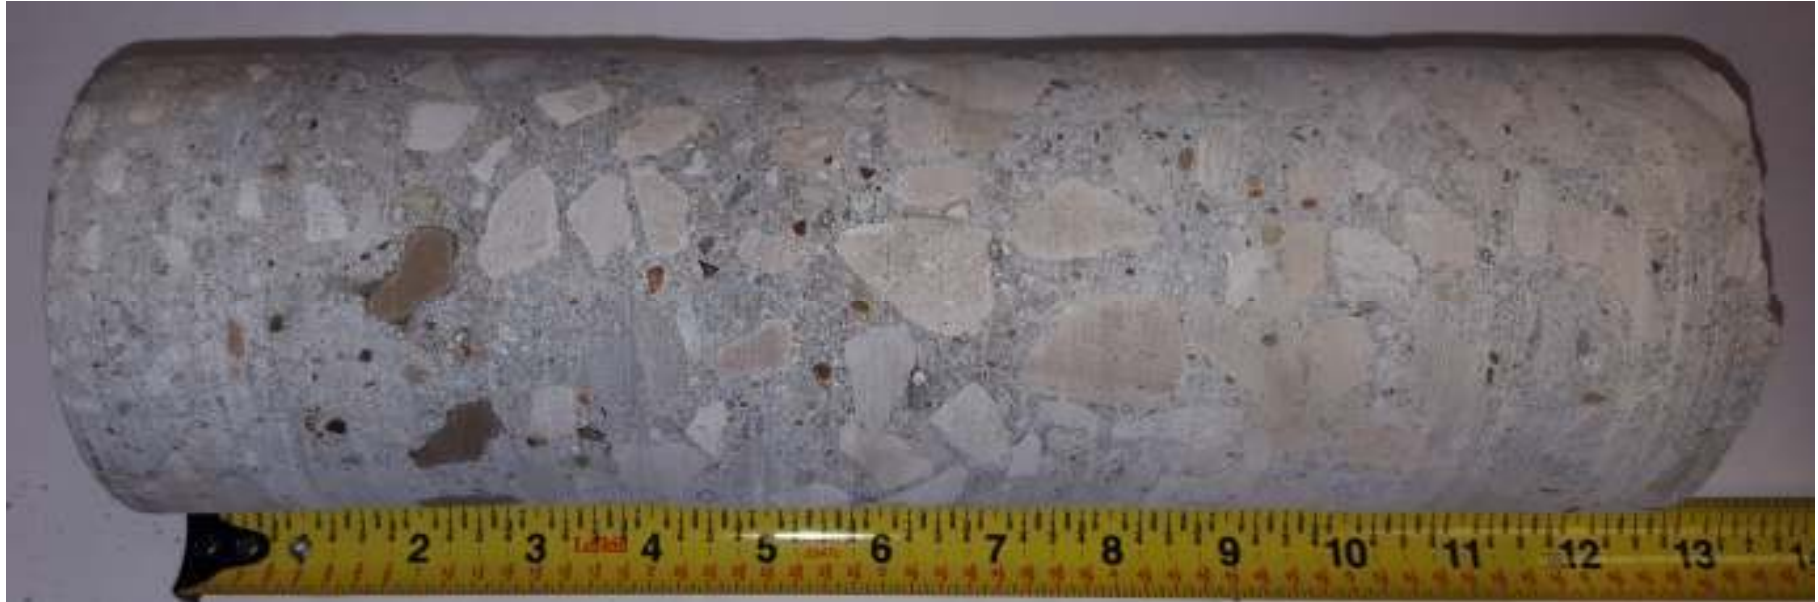
Core Number	Location	Layers	Core Composition		Remarks
			LMC Overlay	Bridge Deck	
C-7	<b>CUY-17-2.83 EB-RL-MOL</b> Latitude : 41.4192599° Longitude : -81.8570190°	A	1 ½"	--	Good Condition, Separated During Coring
		B	--	10 ½"	Good Condition

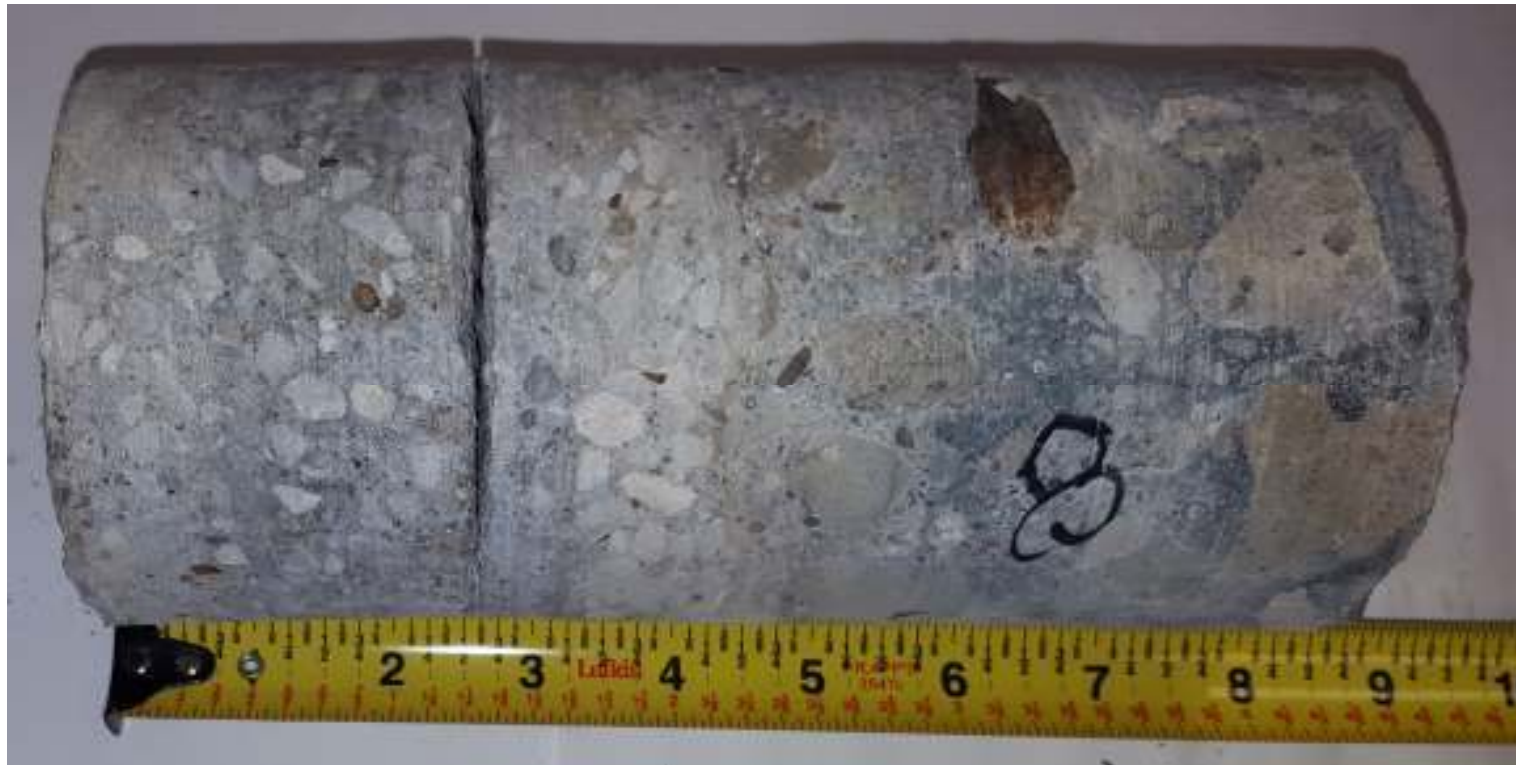
Core Number	Location	Layers	Core Composition		Remarks	
			LMC Overlay	Bridge Deck		
C-8	<b>CUY-17-2.83 WB-LL-LWT</b> Latitude : 41.4189748° Longitude : -81.8556629°	A	4 ¼"	--	Good Condition, Cracked During Coring	
		B	--	4 ½"	Good Condition

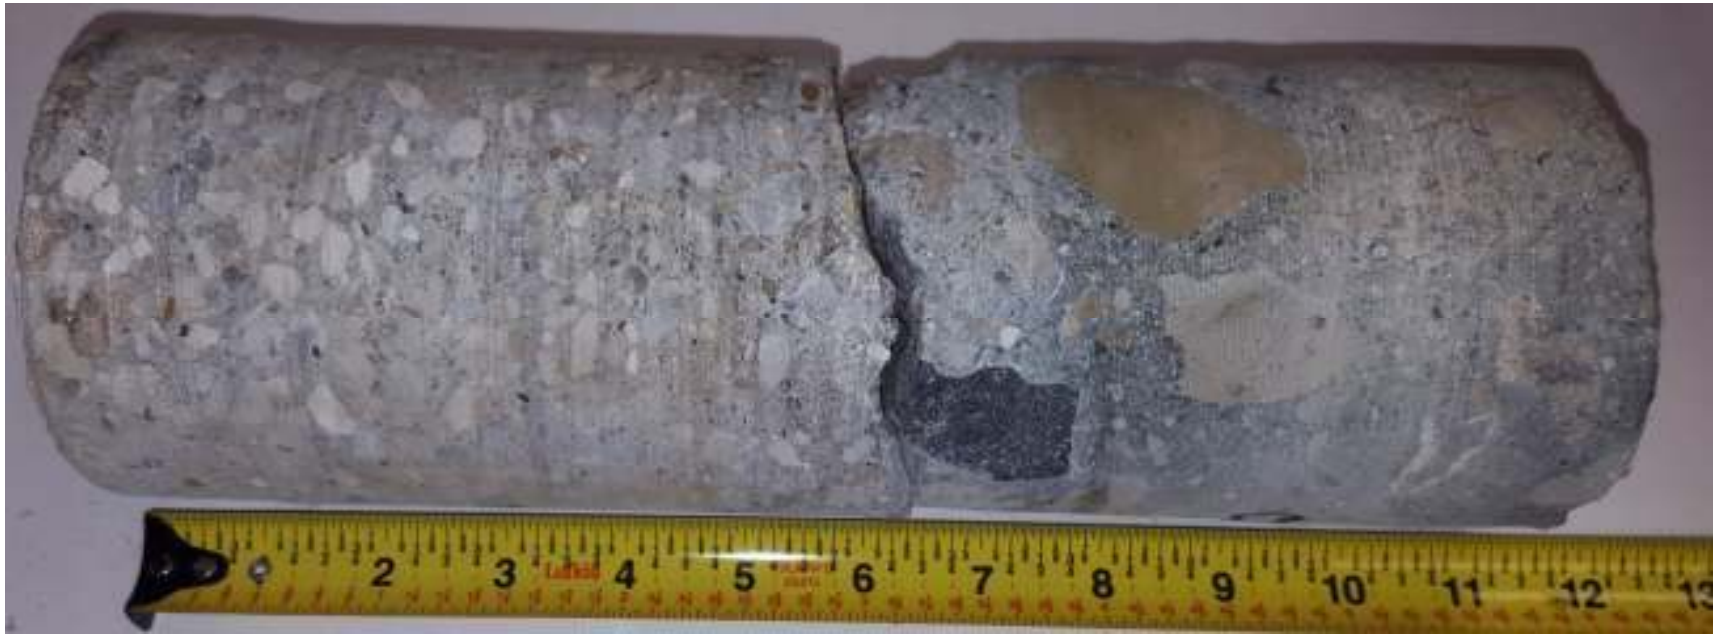
Core Number	Location	Layers	Core Composition		Remarks	
			LMC Overlay	Bridge Deck		
C-9	<b>CUY-17-2.83 EB-LL-LWT</b> Latitude : 41.4190941° Longitude : -81.8562100°	A	6"	--	Good Condition	
		B	--	5 ½"	Fair Condition, Cracked Prior to Coring

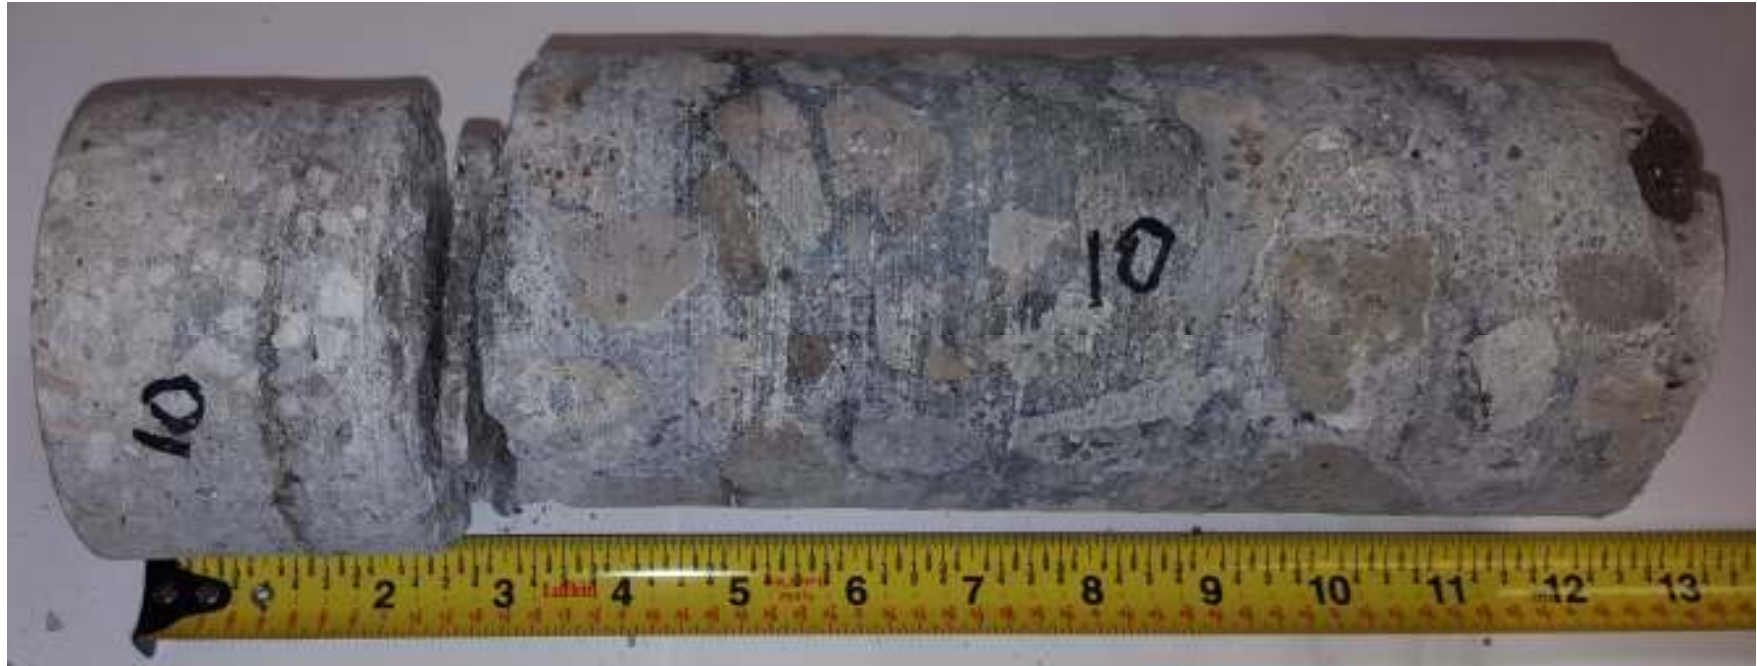
Core Number	Location	Layers	Core Composition		Remarks	
			LMC Overlay	Bridge Deck		
C-10	CUY-17-2.83 WB-LL-MOL Latitude : 41.4194450° Longitude : -81.8574588°	A	2 ½"	--	Good Condition	
		B	--	9 ¾"	Fair Condition, Cracked Prior to Coring

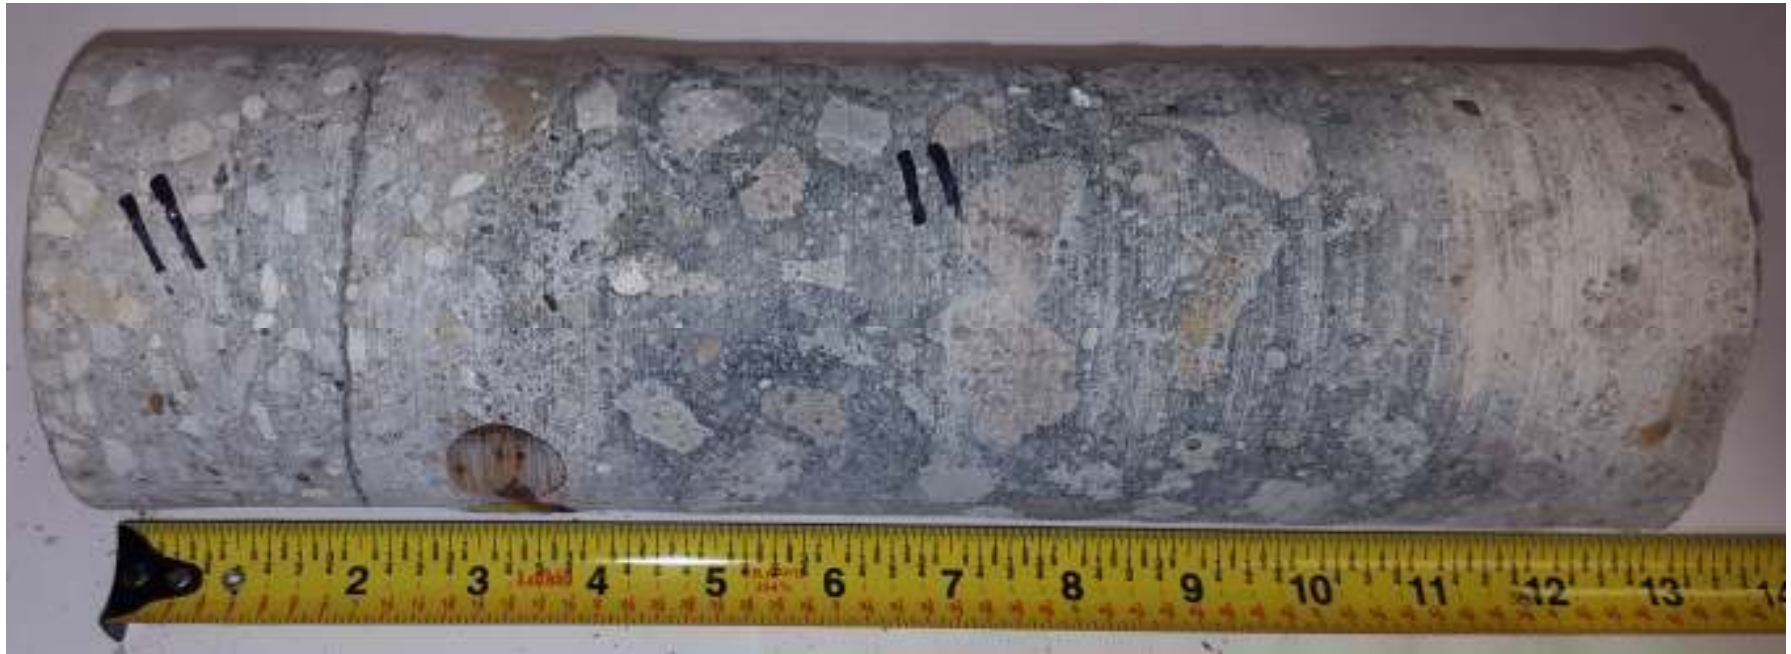
Core Number	Location	Layers	Core Composition		Remarks	
			LMC Overlay	Bridge Deck		
C-11	<b>CUY-17-2.83</b> <b>EB-LL-MOL</b> Latitude : 41.4195077° Longitude : -81.8578268°	A	3"	--	Good Condition, Cracked Prior to Coring	
		B	--	10"	Good Condition

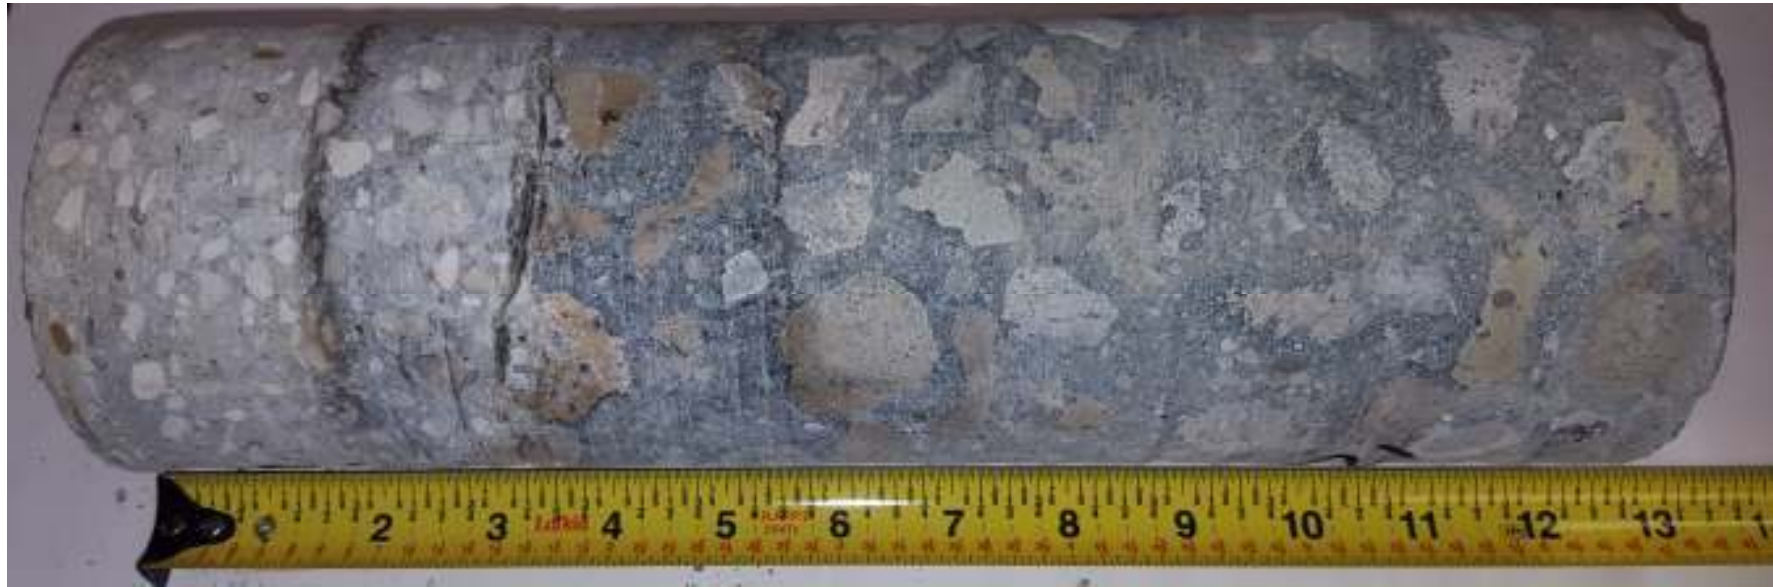
Core Number	Location	Layers	Core Composition		Remarks
			LMC Overlay	Bridge Deck	
C-12	<b>CUY-17-2.83</b> <b>WB-LL-MOL</b> Latitude : 41.4198822° Longitude : -81.8591331°	A	3 ¾"	--	Good Condition, Separated Prior to Coring
		B	--	9"	Good Condition
