**PID 101682**

**CUY-17-02.83**  
*Fairview Park, Ohio*

# DRAFT DECK CONDITION SURVEY

**April 2016**

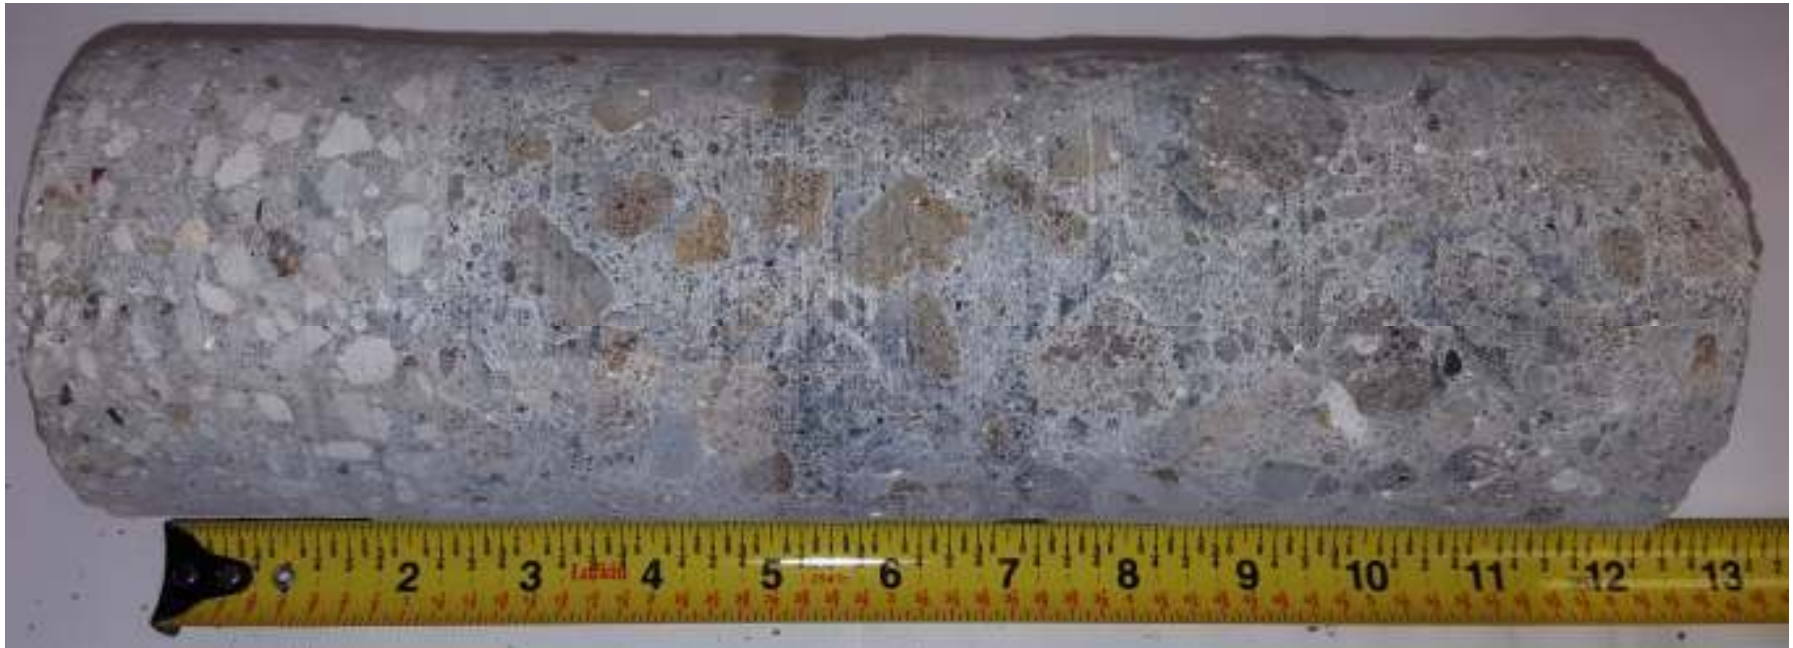
Core Number	Location	Layers	Core Composition		Remarks
			LMC Overlay	Bridge Deck	
C-13	<b>CUY-17-2.83 EB-LL-LWT</b> Latitude : 41.4199421° Longitude : -81.8594755°	A	3 ¾"	--	Good Condition
		B	--	8 ½"	Good Condition

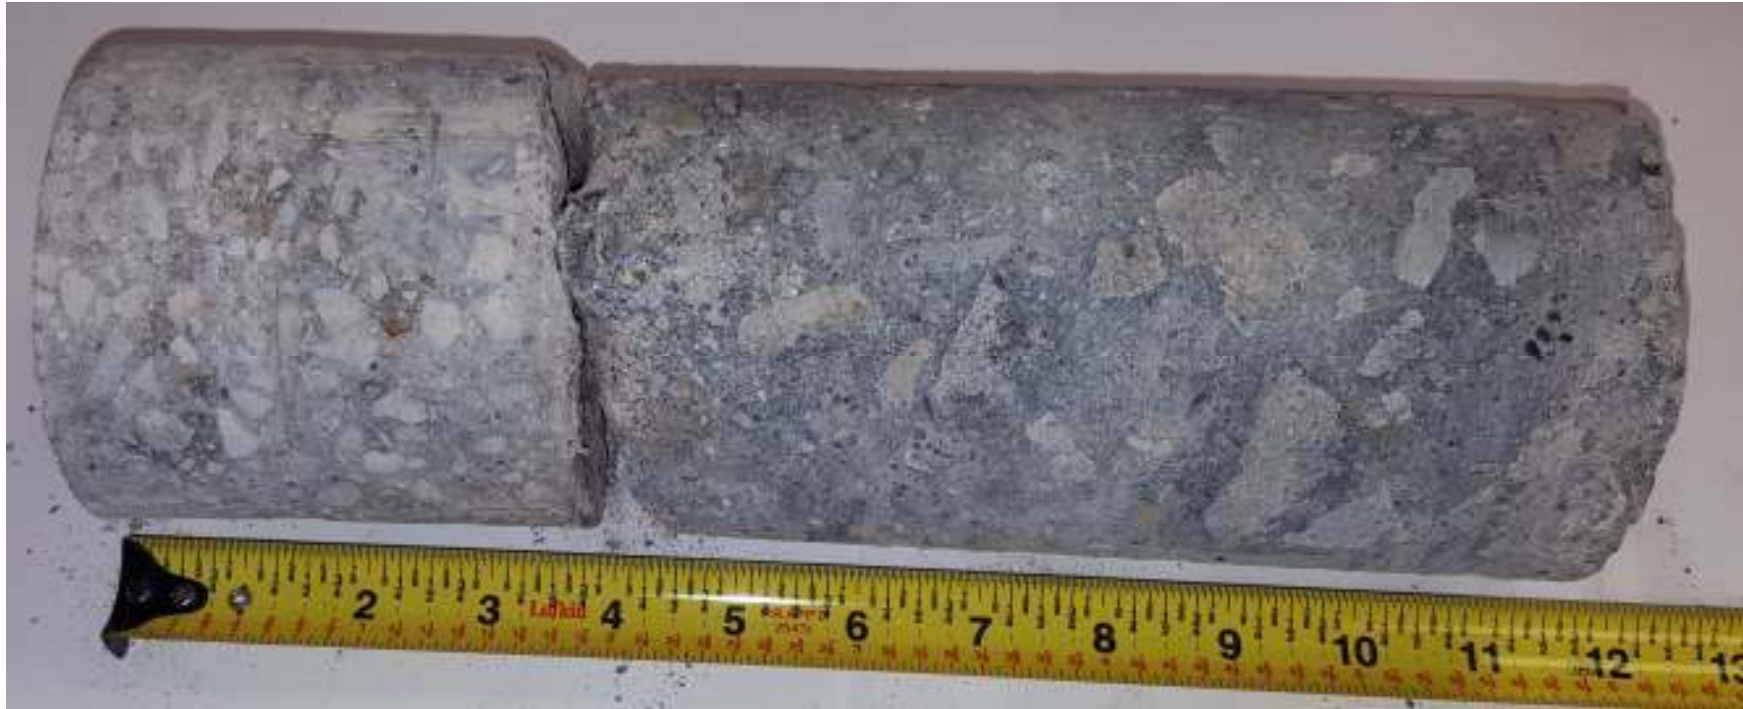
Core Number	Location	Layers	Core Composition		Remarks	
			LMC Overlay	Bridge Deck		
<b>C-14</b>	<b>CUY-17-2.83</b> <b>WB-LL-LWT</b> Latitude : 41.4203146° Longitude : -81.8608126°	A	3 ¾"	--	Good Condition, Separated Prior to Coring	
		B	--	7 ¾"	Good Condition

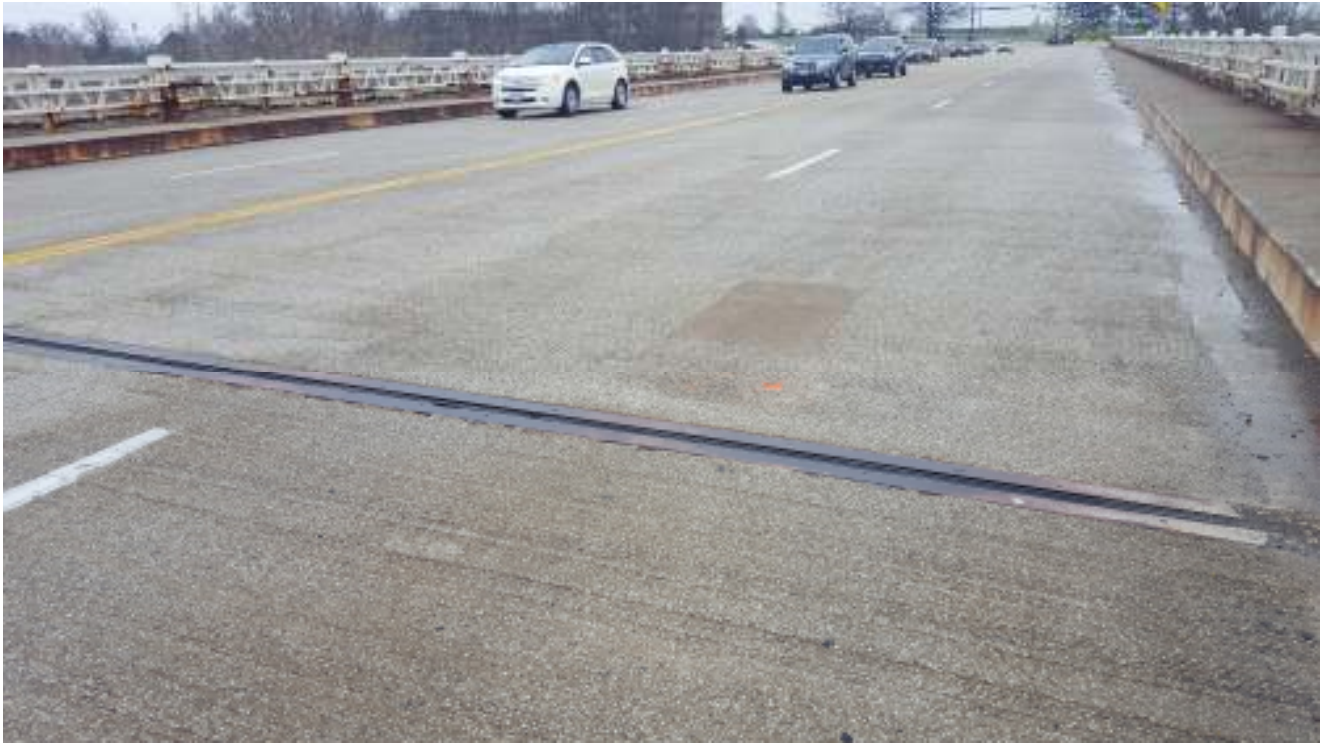
Pavement Photo C-7

Core Number	Location	Layers	Core Composition		Remarks
			LMC Overlay	Bridge Deck	
C-7	<b>CUY-17-2.83 EB-RL-MOL</b> Latitude : 41.4192599° Longitude : -81.8570190°	A	1 ½"	--	Good Condition, Separated During Coring
		B	--	10 ½"	Good Condition

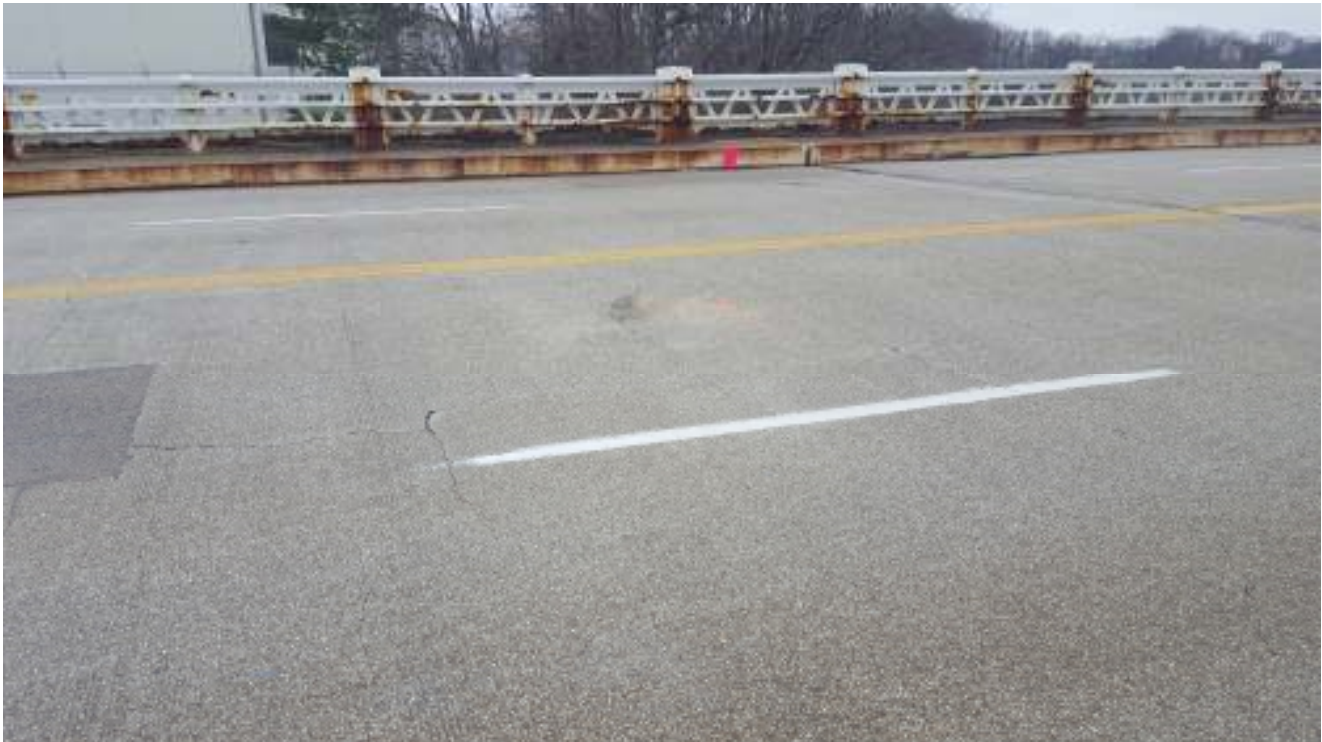
Pavement Photo C-8

Core Number	Location	Layers	Core Composition		Remarks	
			LMC Overlay	Bridge Deck		
C-8	<b>CUY-17-2.83 WB-LL-LWT</b> Latitude : 41.4189748° Longitude : -81.8556629°	A	4 ¼"	--	Good Condition, Cracked During Coring	
		B	--	4 ½"	Good Condition

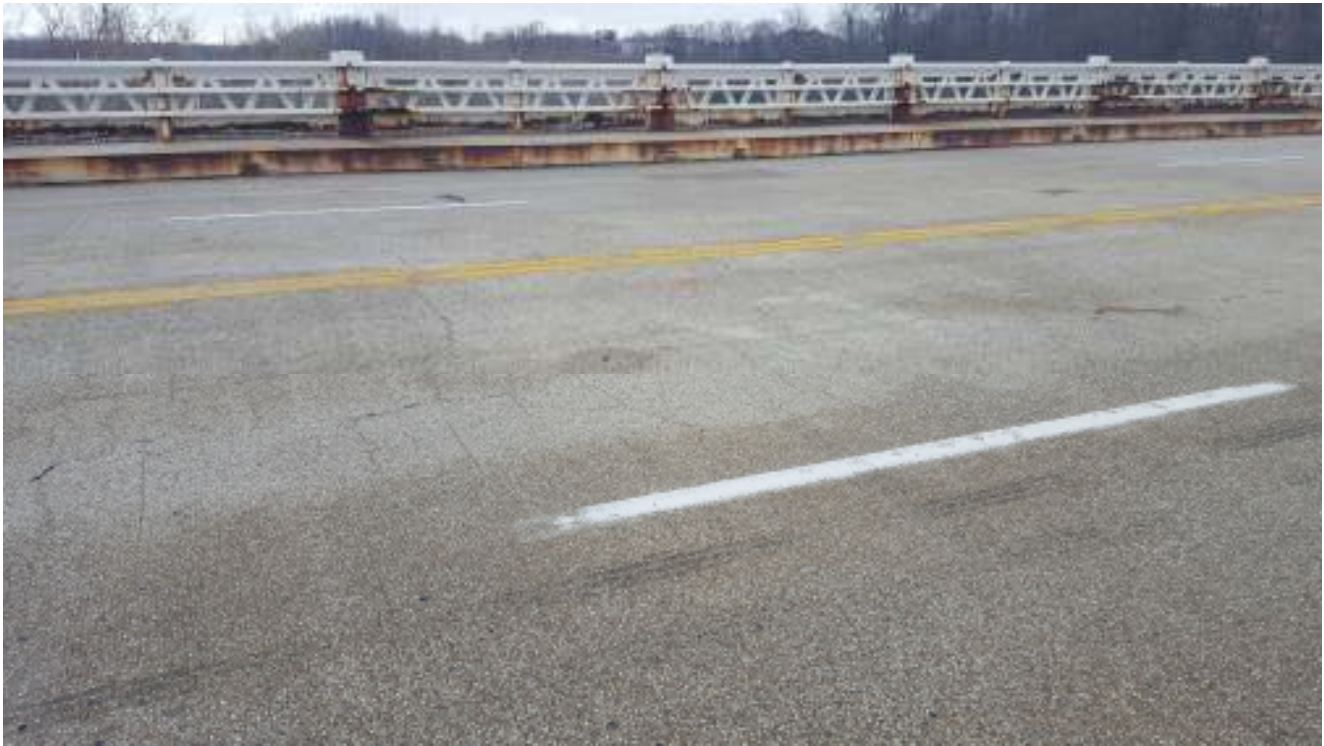
Pavement Photo C-9

Core Number	Location	Layers	Core Composition		Remarks	
			LMC Overlay	Bridge Deck		
C-9	<b>CUY-17-2.83 EB-LL-LWT</b> Latitude : 41.4190941° Longitude : -81.8562100°	A	6"	--	Good Condition	
		B	--	5 ½"	Fair Condition, Cracked Prior to Coring

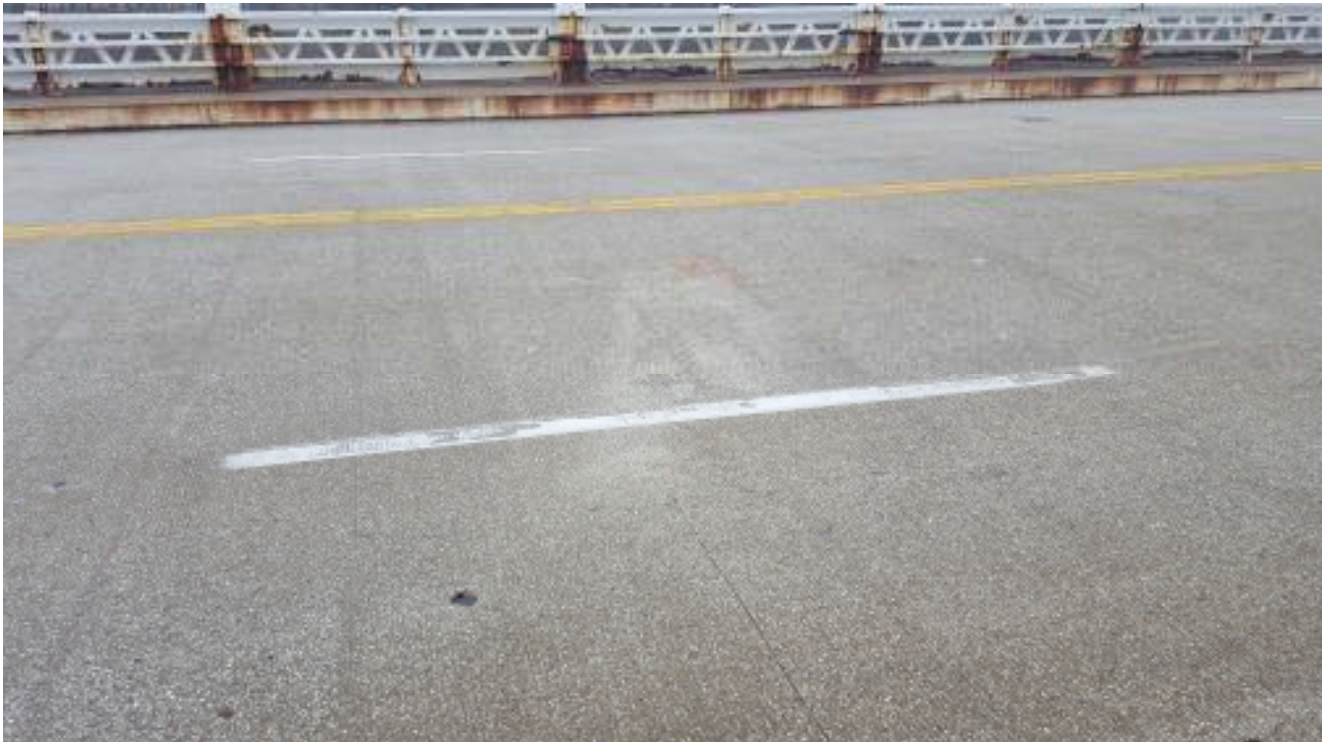
Pavement Photo C-10

Core Number	Location	Layers	Core Composition		Remarks	
			LMC Overlay	Bridge Deck		
C-10	CUY-17-2.83 WB-LL-MOL Latitude : 41.4194450° Longitude : -81.8574588°	A	2 ½"	--	Good Condition	
		B	--	9 ¾"	Fair Condition, Cracked Prior to Coring

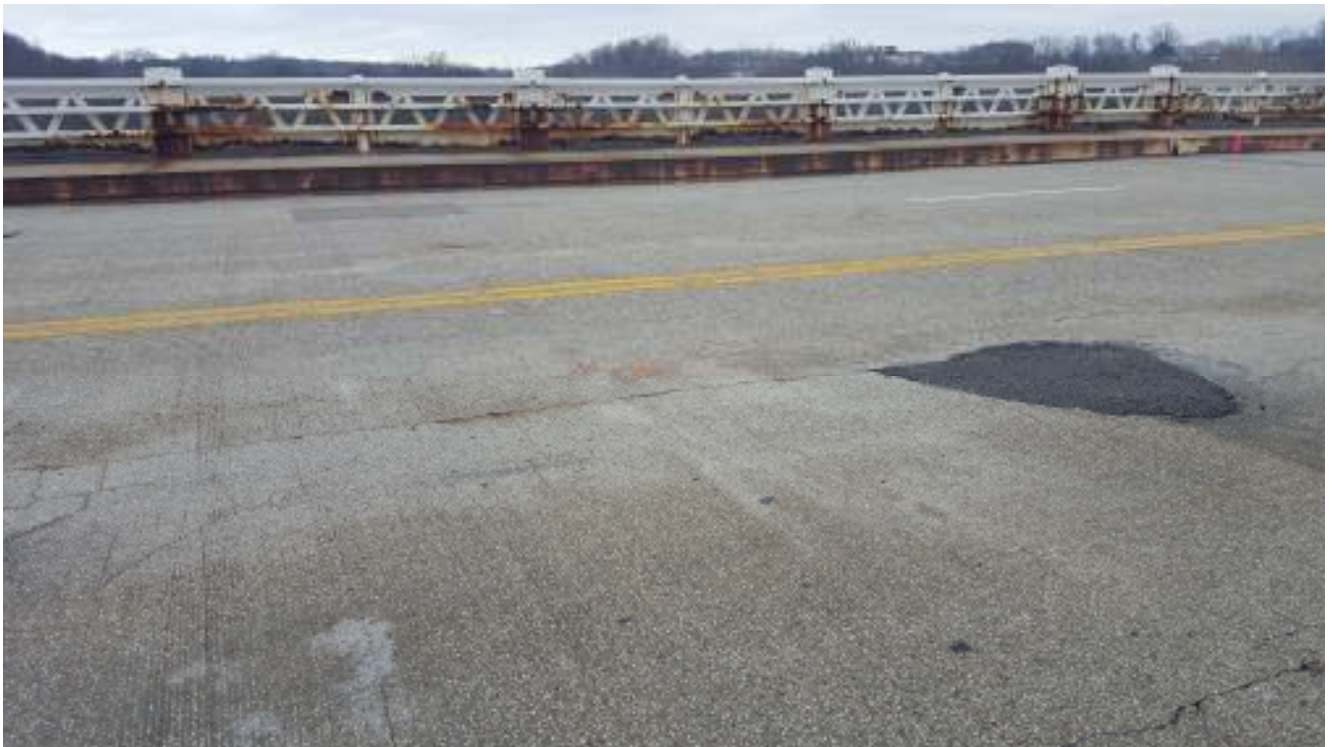
Pavement Photo C-11

Core Number	Location	Layers	Core Composition		Remarks	
			LMC Overlay	Bridge Deck		
C-11	<b>CUY-17-2.83</b> <b>EB-LL-MOL</b> Latitude : 41.4195077° Longitude : -81.8578268°	A	3"	--	Good Condition, Cracked Prior to Coring	
		B	--	10"	Good Condition

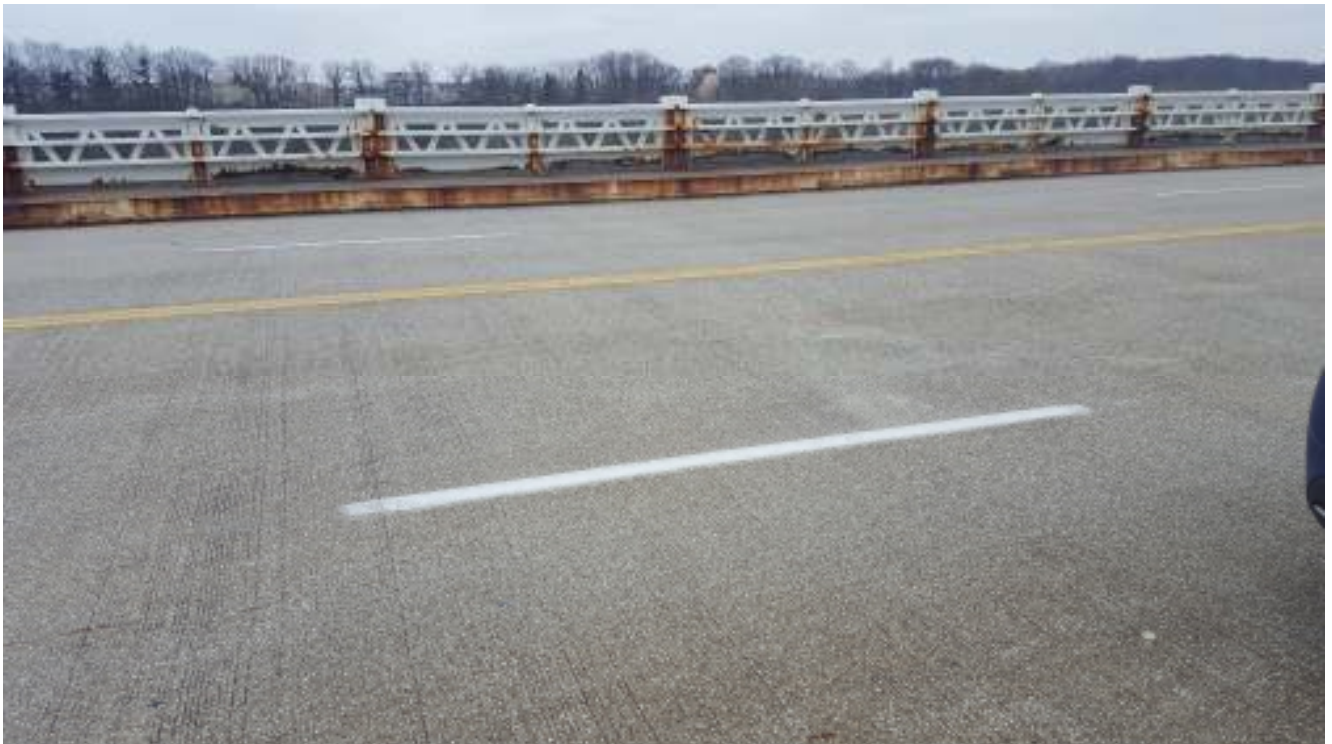
Pavement Photo C-12

Core Number	Location	Layers	Core Composition		Remarks
			LMC Overlay	Bridge Deck	
C-12	<b>CUY-17-2.83</b> <b>WB-LL-MOL</b> Latitude : 41.4198822° Longitude : -81.8591331°	A	3 ¾"	--	Good Condition, Separated Prior to Coring
		B	--	9"	Good Condition
