Re: Report for Bridge Deck Coring
Cuy-17-2.83
PID No.: 101682
Cleveland, Cuyahoga County, Ohio
PSI Project No.: 01412287

Pavement Coring
CUY-17-2.83 (PID No.: 101682)
Cuyahoga County, Ohio

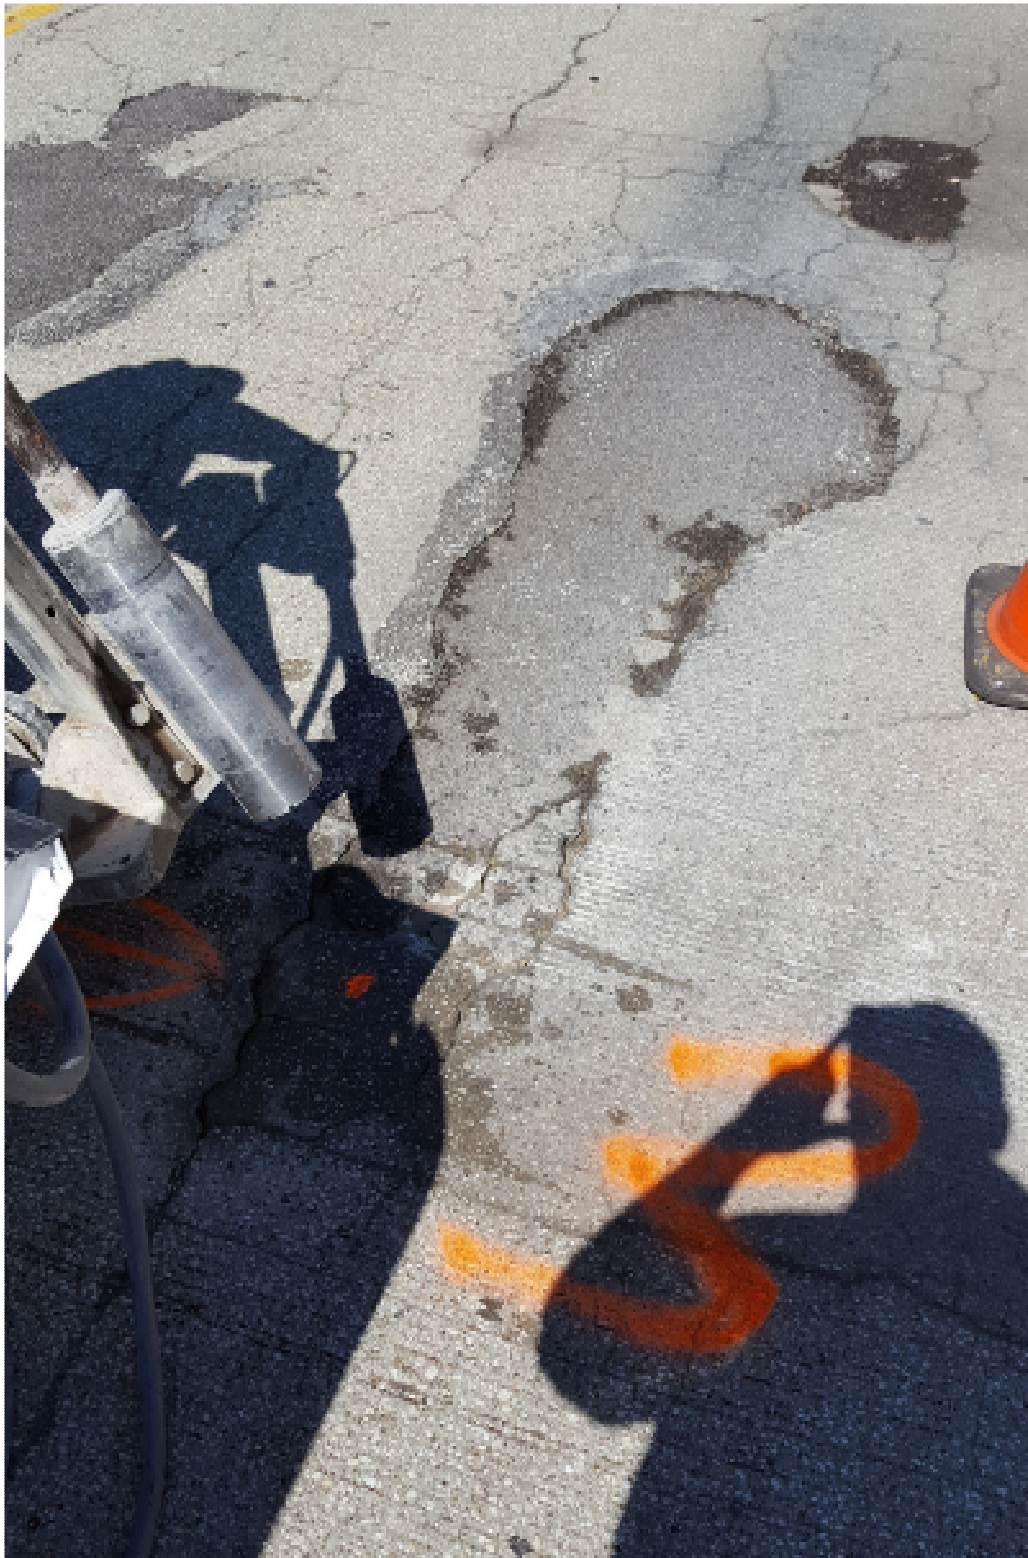
Pavement Photo C-3

Core Number	Location	Layers	Core Composition		Remarks	
			LMC Overlay	Bridge Deck		
C-3	CUY-17-2.83 WB-LL-LWT Latitude : 41.420335° Longitude : -81.860699°	A	2"	--	Good Condition	
		B	--	2 ½"	Poor Condition, Broke Down While Coring

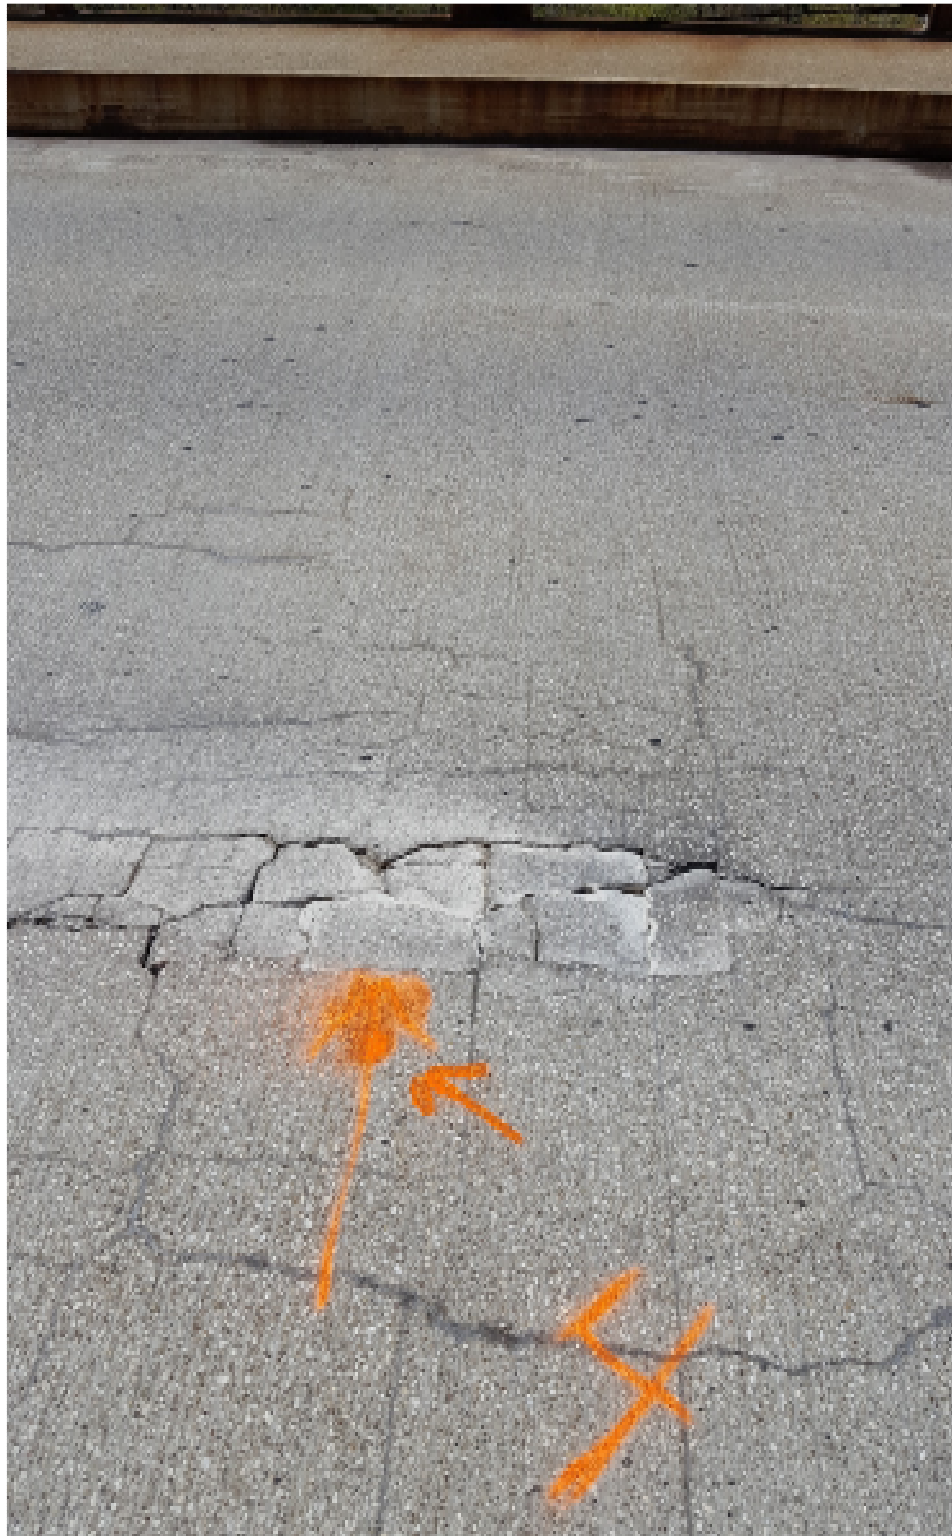
Pavement Photo C-4

Core Number	Location	Layers	Core Composition		Remarks	
			LMC Overlay	Bridge Deck		
C-4	CUY-17-2.83 EB-LL-RWL Latitude : 41.420042° Longitude : -81.859821°	A	1 3/4"	--	Good Condition	
		B	--	2 3/4"	Poor Condition, Broke Down While Coring

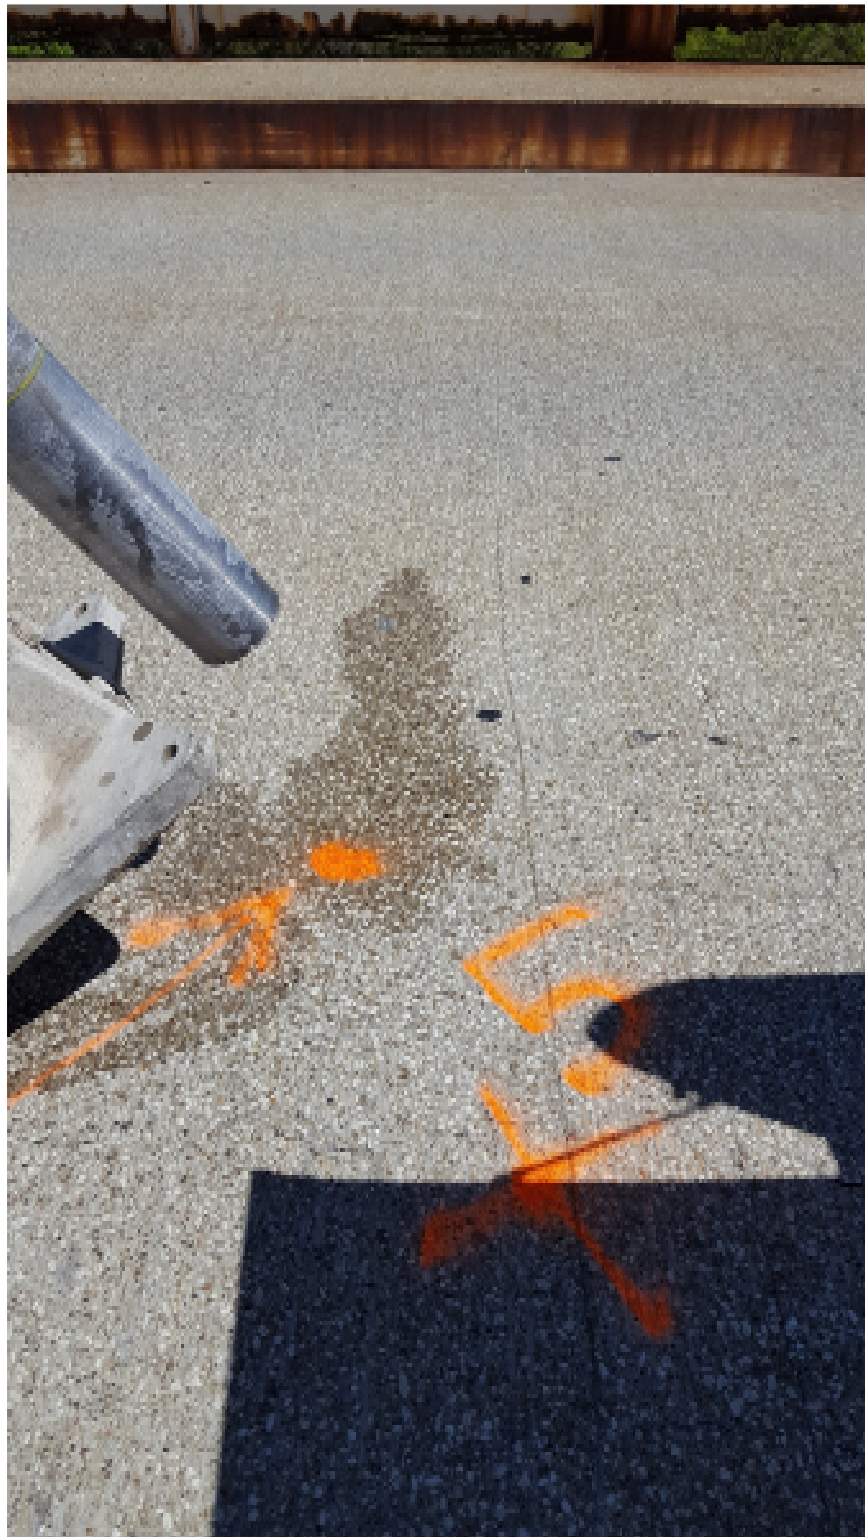
Pavement Photo C-5

Core Number	Location	Layers	Core Composition		Remarks	
			LMC Overlay	Bridge Deck		
C-5	CUY-17-2.83 WB-LL-RWT Latitude : 41.420042° Longitude : -81.859659°	A	1 3/4"	--	Good Condition	
		B	--	10 3/4"	Good Condition, Separated During Coring

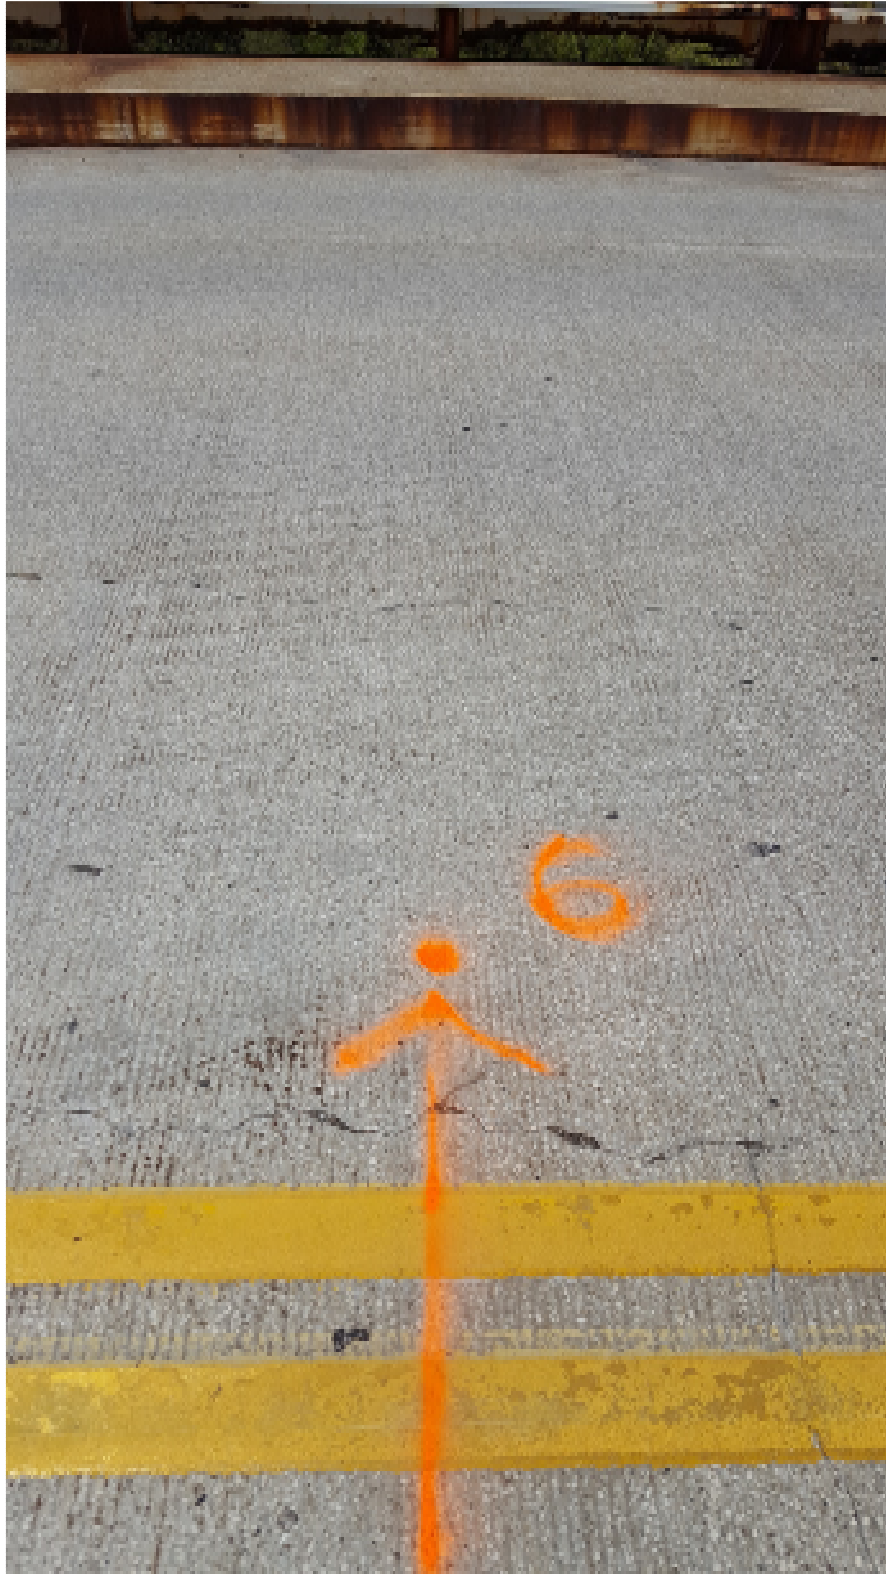
Pavement Photo C-6

Core Number	Location	Layers	Core Composition		Remarks	
			LMC Overlay	Bridge Deck		
C-6	CUY-17-2.83 WB-LL-LWT Latitude : 41.419970° Longitude : -81.859344°	A	6"	--	Good Condition, Separated During Coring	
		B	--	1"	Poor Condition, Broke Down While Coring

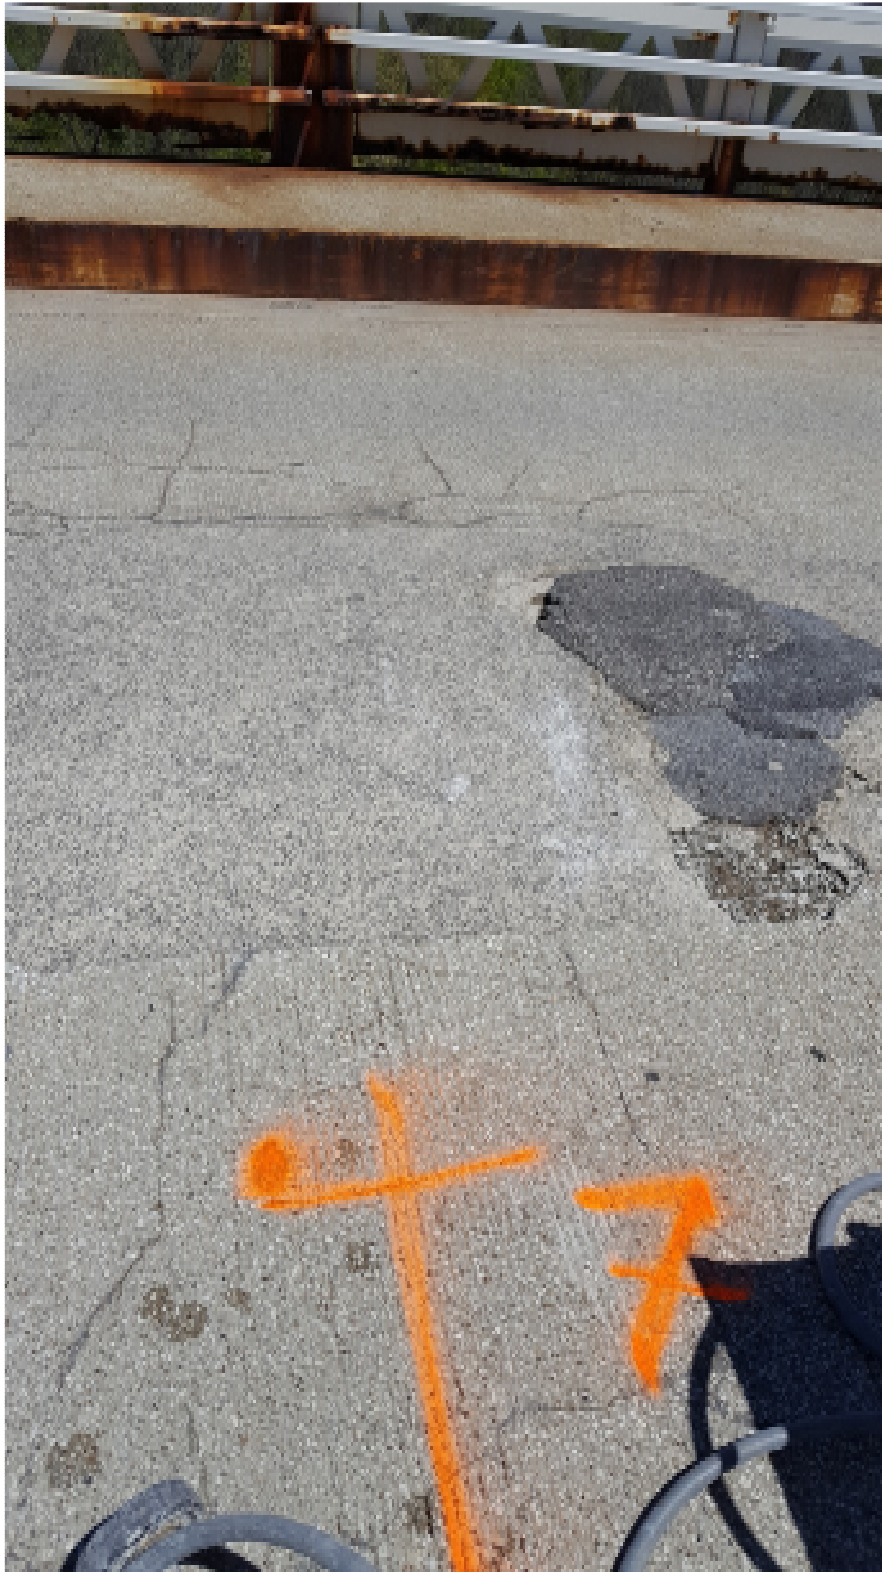
Pavement Photo C-7

Core Number	Location	Layers	Core Composition		Remarks
			LMC Overlay	Bridge Deck	
C-7	CUY-17-2.83 WB-LL-RWT Latitude : 41.419709° Longitude : -81.858395°	A	2 ½"	--	Good Condition, Separated During Coring
		B	--	14"	Fair Condition, Crack Down Middle Prior to Coring

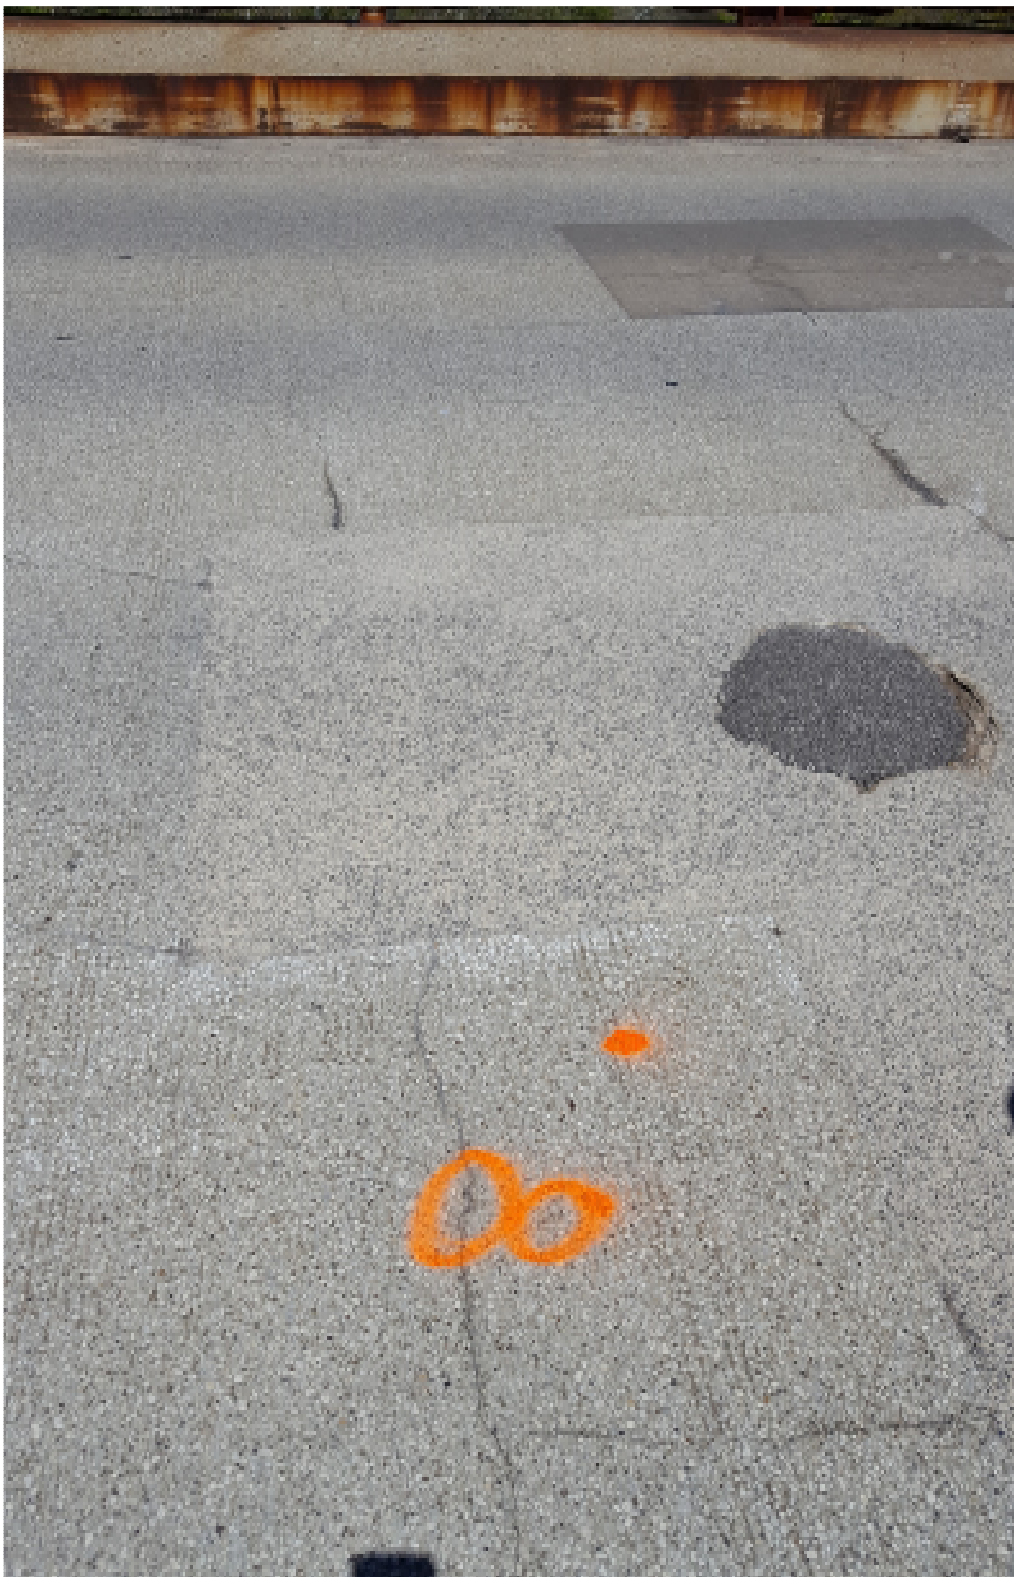
Pavement Photo C-8

Core Number	Location	Layers	Core Composition		Remarks
			LMC Overlay	Bridge Deck	
C-8	CUY-17-2.83 WB-LL-RWT Latitude : 41.418968° Longitude : -81.855589°	A	5 ¼"	--	Good Condition
		B	--	--	--

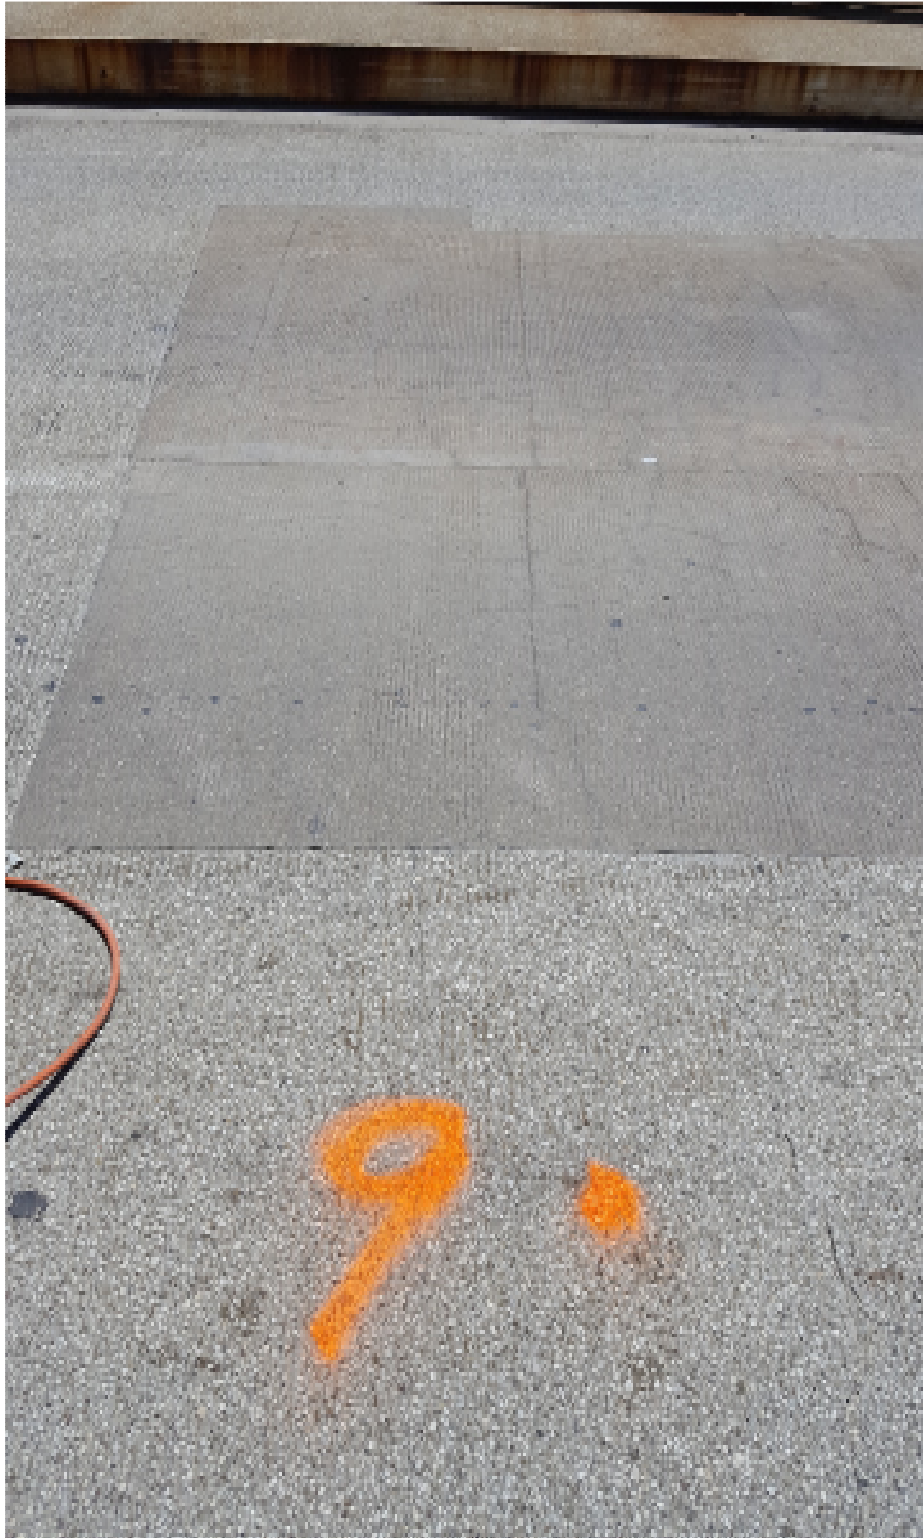
Pavement Photo C-9

Core Number	Location	Layers	Core Composition		Remarks	
			LMC Overlay	Bridge Deck		
C-9	CUY-17-2.83 EB-LL-MOL Latitude : 41.418875° Longitude : -81.855413°	A	5"	--	Good Condition	
		B	--	1"	Poor Condition, Broke Down While Coring
