Final Report

May 1, 2015

# Franklin Hill / Irishtown Bend

## Stabilization and Restoration

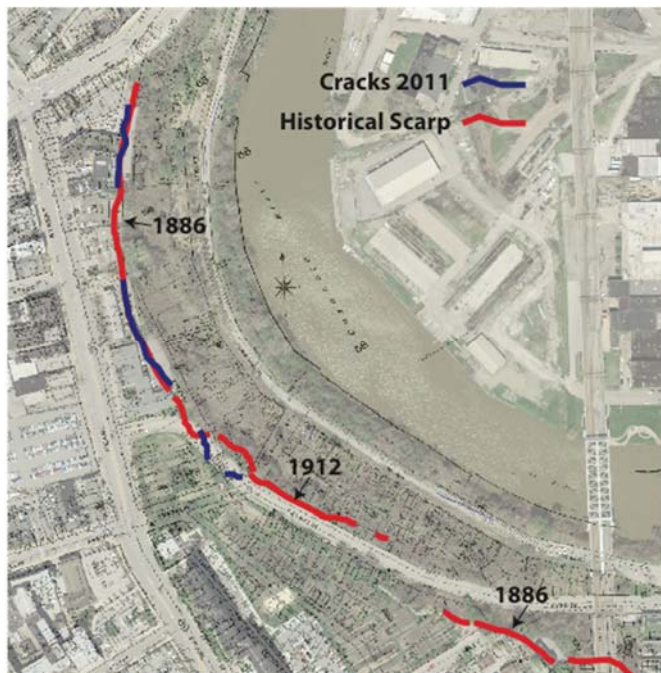
Figure 2: Historic Scarp Line Mapped by Sanborn Insurance

The lower portion of the site was primarily developed to achieve a flat grade for railroad track lines between Columbus Road and Detroit Avenue. Remnants of coal docks still exist on the site and the Lederer building foundation walls. Historical artifacts are still thought to be buried in the hillside despite the massive re-grading of the site that occurred in the early 1960's. The intersection of Franklin Avenue and West 25th Street was relocated to a new location farther north in the 1960's. As a result, the roadway extended over a scarp line, shown in Figure 2. This scarp line is currently visible in the roadway.

Franklin Avenue, parking lots and embankments were constructed over historic scarp line that was mapped by Sanborn Fire Insurance, see Figures 2 and 4 below.

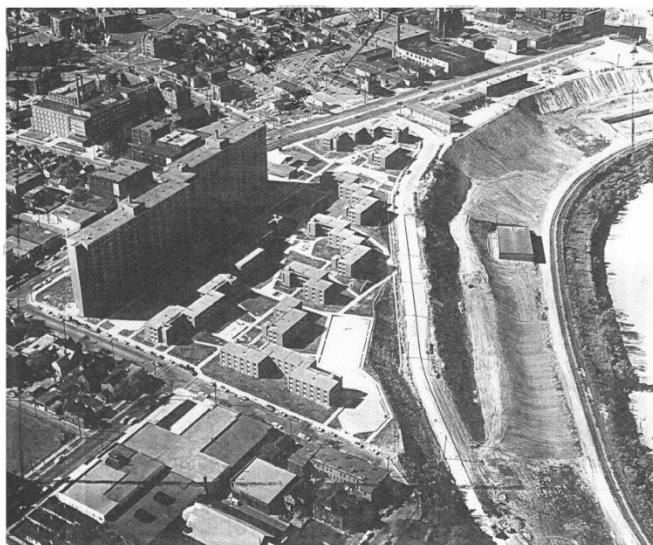
Figure 4: Graded Site with Realigned Franklin Avenue

The finding of categorized wetlands was not anticipated due to the past industrial use of the site and lack of native species that would exist after the significant grading conducted in the 1960’s (see Figure 4). For a wetland, supporting vegetation and hydric soils need to exist, and the site needs to have a continual water source to support non-native vegetation and soil conditions. Therefore, our investigation focused on the water supply to these two areas.

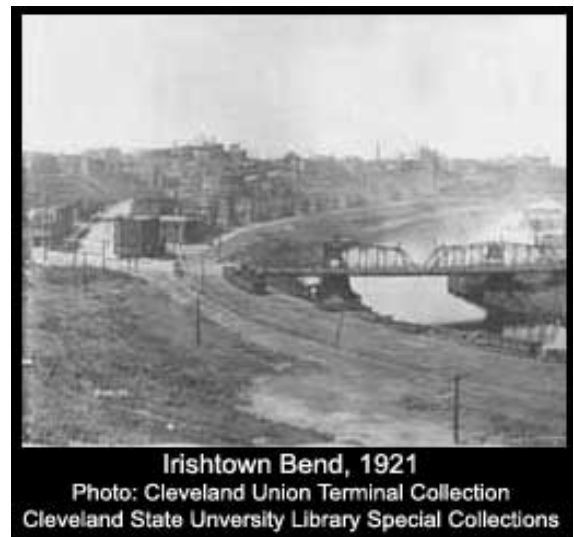
Figure 3: Irishtown Bend Industry

Before dredging activities took place in the 1920's, the Cuyahoga River was only 8' to 10' deep. The original mouth to Lake Erie was located approximately 4,000' to the west of its current location. Figure 3 depicts the development along the hillside; note the narrow width of the river at the Columbus Road crossing. The Cuyahoga River is now dredged to a depth of 23' and widened in some sections to allow passage of freighters. The Irishtown Bend is a very difficult passageway for freighters to navigate. The ships use the full width of the river to navigate the turn and therefore transmit high lateral forces to the outer bend of the river's edge from the use of bow thrusters.

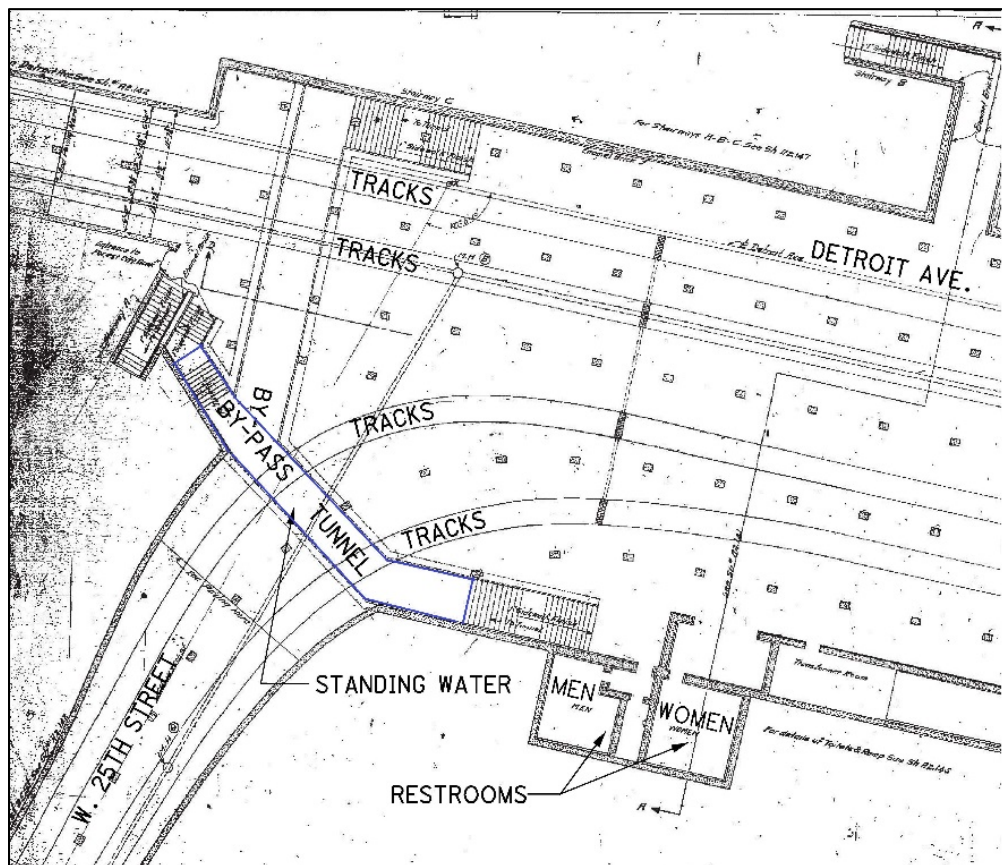
Figure 8: Pedestrian Bypass Tunnel Layout

Figure 8 shows the layout of the pedestrian bypass tunnel in relation to the access to the restrooms. The standing water at this elevation is approximately 20' below the existing grade of Detroit Avenue near the intersection of West 25<sup>th</sup> Street. Although groundwater elevations can fluctuate, an extensive sampling and groundwater monitoring program was conducted south of the tunnel system at 1477 West 25<sup>th</sup> Street between 1999 and 2006 by Hull & Associates and Delta Environmental Consultants. There are more than 25 monitoring wells installed at the property (see Figure 9) for evaluation of the groundwater associated with the underground storage tanks at this site. The groundwater depth measurements averaged 29' below grade, and the closest wells to the tunnel systems, MW-24 and MW-25, were 30.5' and 29' respectively. Therefore, there is a 10' +/- water elevation difference between the monitoring wells and the standing water in the bypass tunnel system. This means that the water in the tunnel is 10' higher than the natural groundwater, indicating an unexplained elevated water condition.

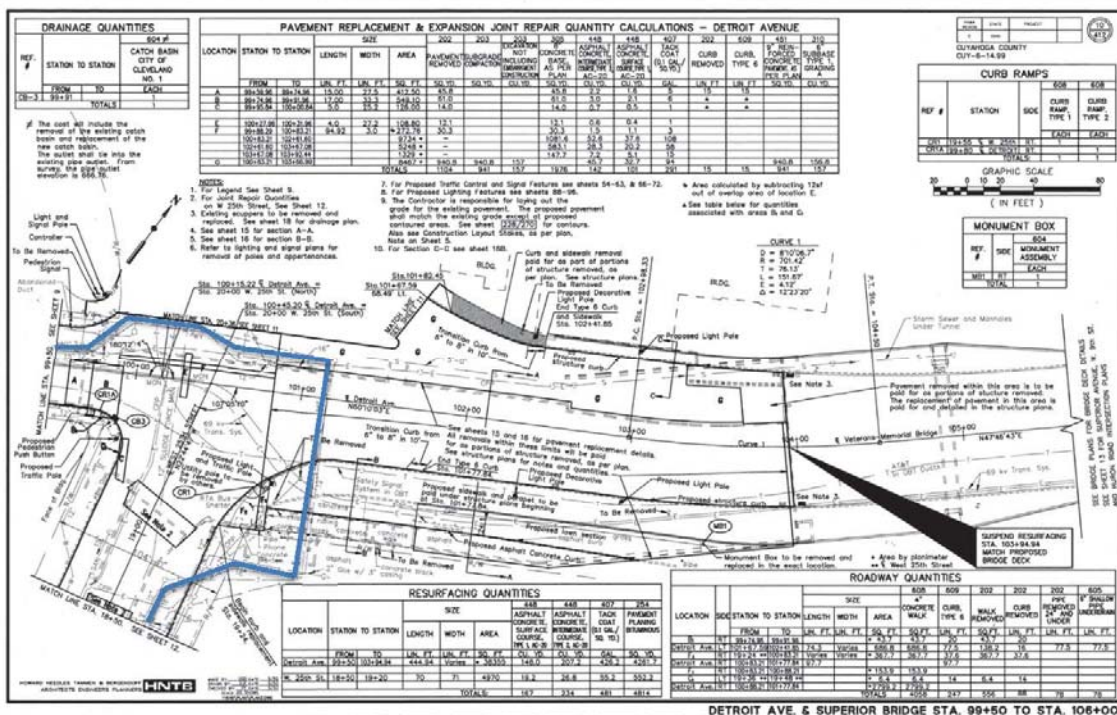
Figure 10: Water Main Alignments

A likely explanation for the water elevation difference can be the presence of two water main systems, 12" and 16" diameter lines, which run parallel to West 25<sup>th</sup> Street and cross under Detroit Avenue through a waterworks tunnel that was constructed under the subway railroad track line. The alignment of the water mains is shown in Figure 10.

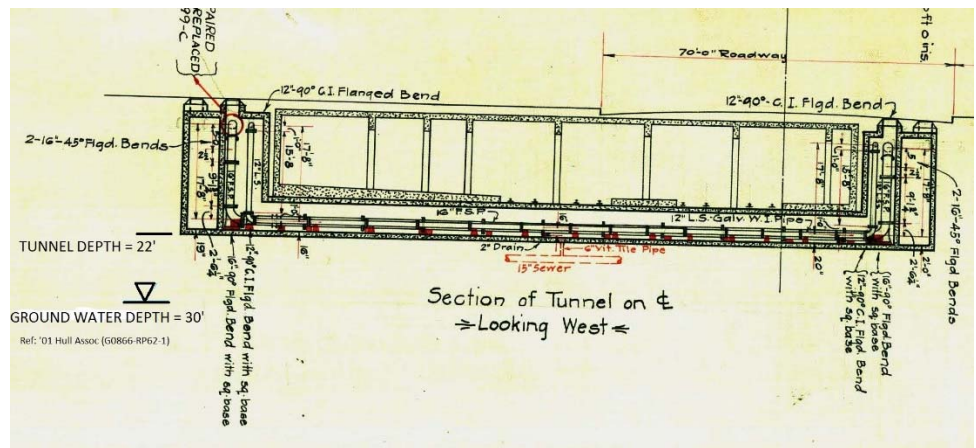
Figure 13: Section View of the Tunnel

The contractor hired by ODOT for CUY-6-14.56 also made an attempt at dewatering the tunnel but could only reduce the water elevation by approximately 2'-4'. A section view of the tunnel is shown in Figure 13. ODOT decided to abandon the operation and cease the work associated with draining and inspecting these tunnel systems. Inspection of the waterworks tunnel could not be performed for this phase because access was blocked and flooded with high pressure water.

The fact that the tunnels have a combined drainage system that share an outlet that is partially plugged allows water to back up into the tunnel systems. Therefore, the tunnels serve as large holding reservoirs allowing water to slowly discharge through the partially plugged manhole.

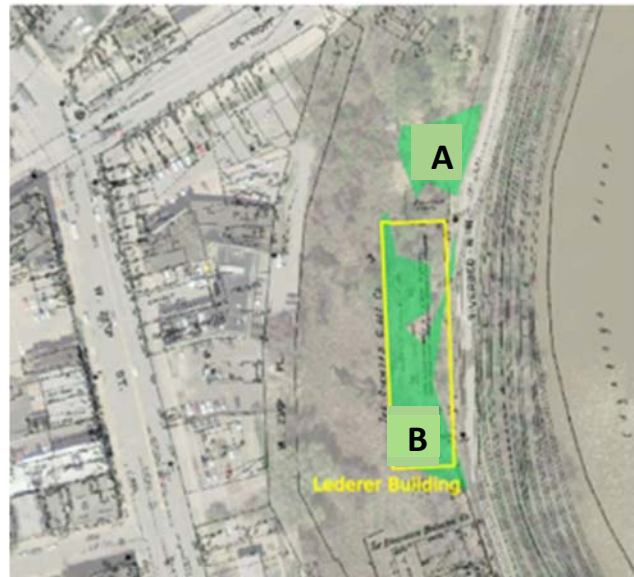
Figure 19: Mapped Wetland Areas A and B

It is clear from overlaying the survey mapping with the wetland delineation that Wetland A resides at the bottom of a concrete drainage chute that was constructed in 1966 to carry parking lot surface drainage to the toe of the slope. The condition of the concrete chute has deteriorated, however there is a natural swale that has developed that carries parking lot and slope drainage to Wetland A. The overlay of the map also helps identify the water source for Wetland B. The area associated with this wetland is within the confines of the foundation remnants of the Lederer building. As shown in Figure 20, the Lederer building foundation is trapping water and creating a pond effect enabling wetland vegetation to grow and hydric soils to develop.

The result of the presence of two wetlands within the project area that exceeds 0.5 acres means that completion of a USACE Section 404 Individual Permit and an OEPA Section 401 Water Quality Certification will be required prior to remediation of the site. However, if the source of water that feeds the soil and vegetation can be eliminated and the presence of each are reduced, then wetland permits may not be necessary.

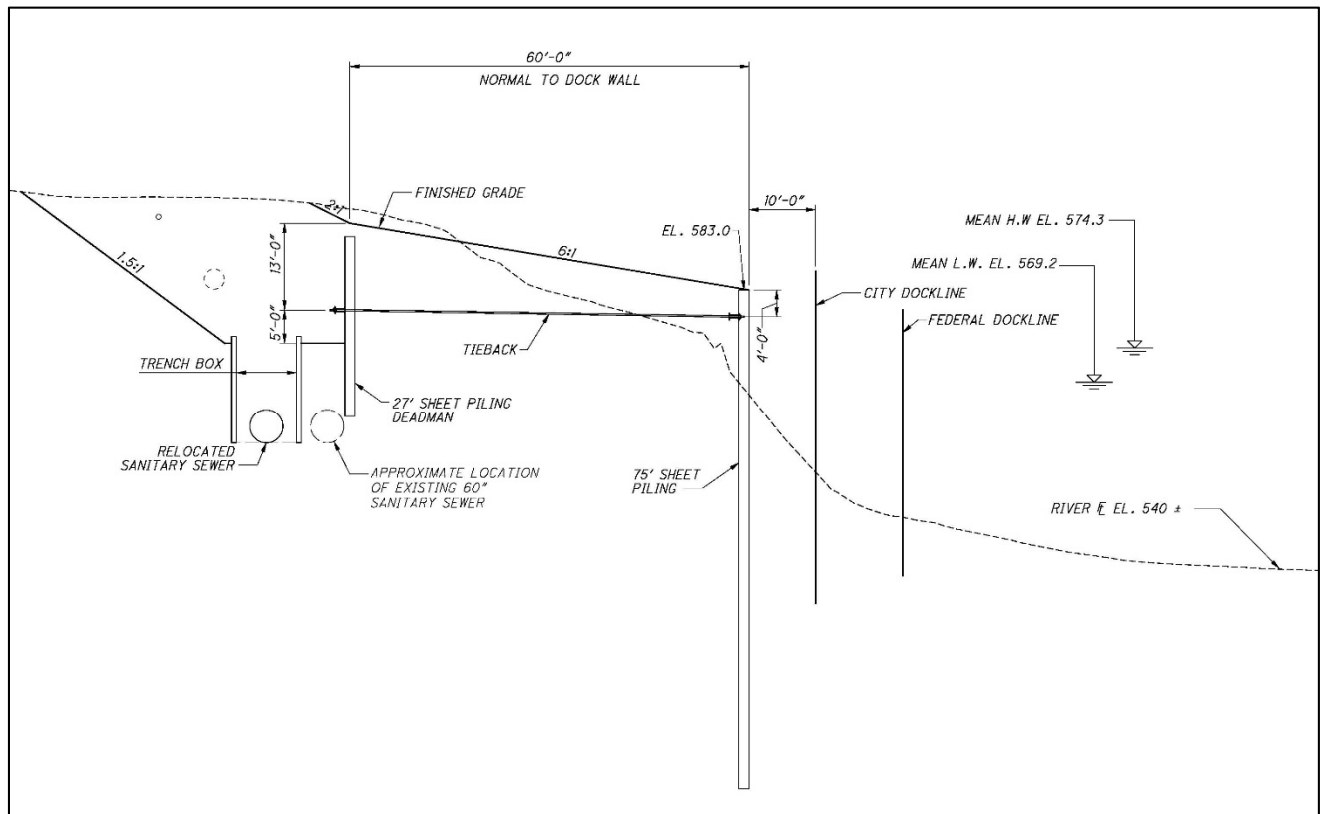
Figure 22: Tieback System in Coordination with Sanitary Replacement Shoring

To properly stabilize the project site, construction activities need to be carefully orchestrated with the environmental clearance, historical coordination, utility improvements and replacements, grading, and dewatering/drainage activities. The immediate course of action is to secure the toe of the slope and protect it from erosion and from the action of bow thrusters of freighters navigating the ship channel. In order to do this effectively, a steel bulkhead system will need to be constructed with a continuous deadman anchor system and tiebacks spaced at approximately 10'. Combining the needed improvements into one project will save significant costs for mobilization on a sensitive site, material transportation, excavation and dewatering activities.

The remaining length of the sewer appears to be stable and functioning as designed. The section between Manholes 185 and 188 is approximately 700' and could be replaced in conjunction with the installation of the bulkhead system. There would be advantages to combining the construction of the tieback system with the required excavation to expose and replace the damaged section of the sanitary line. In essence, the sheet piling designed for the bulkhead deadman system could function as a shoring system so that conventional trench boxes could be used for replacement of the line as shown in Figure 22. The bypass system already in place could be used to divert flow during the replacement process. The approach and design would require close coordination with NEORS staff. Coordinating efforts to repair the WLLI with stabilizing the hillside will reduce total cost and time necessary for global improvement to the site.
