I-480 *Bridge Repair*

The Emergency Bridge Closing and Repair of I-480 WB over the Rocky River (Bridge CUY-480-0647)

Preliminary Report

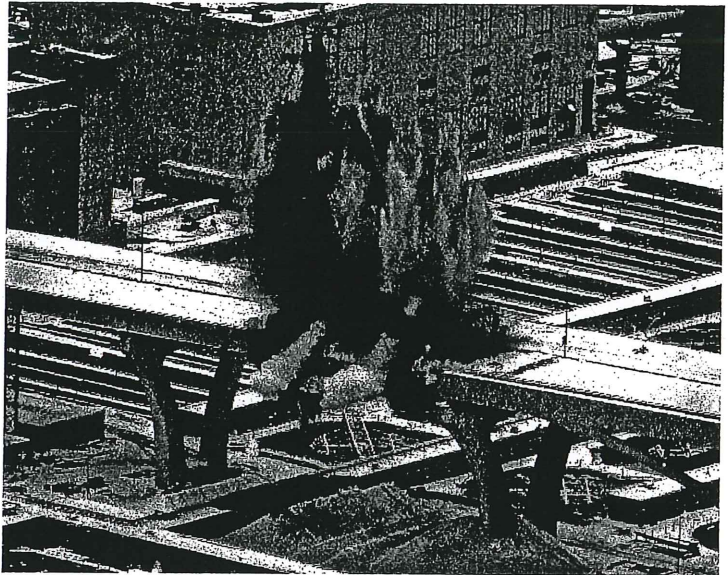
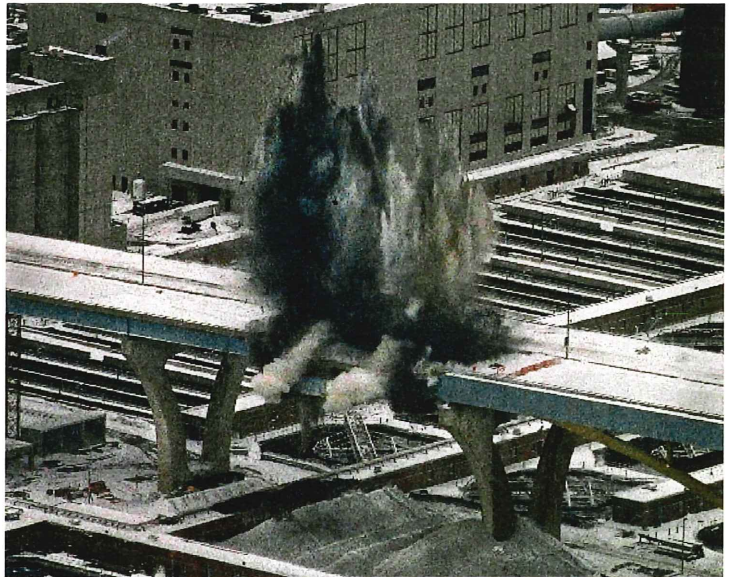
Picture 8 - Aerial View of the Hoan Bridge Demolition
Photo/Gary Porter

Coincidentally, a comparable bridge crisis occurred in Milwaukee, Wisconsin, one month after the I-480 incident. On December 13, 2000, a 216-foot section of the Hoan Bridge in downtown Milwaukee buckled and sagged four feet. Due to the girder failure, the bridge span could not be repaired and had to be demolished (see Picture 8), rerouting eight lanes of interstate traffic until a new structure is designed and built. The I-480 incident rerouted four lanes of interstate traffic for only one week. A major loss in a transportation link has by far, a greater impact on a region than a short term loss.

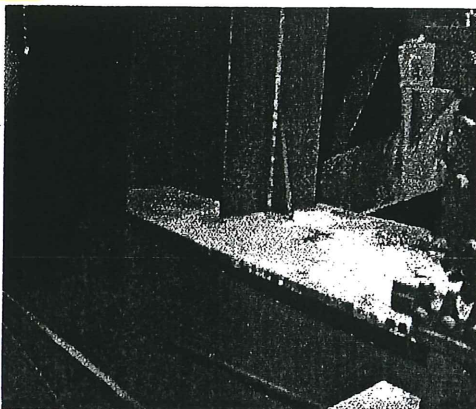
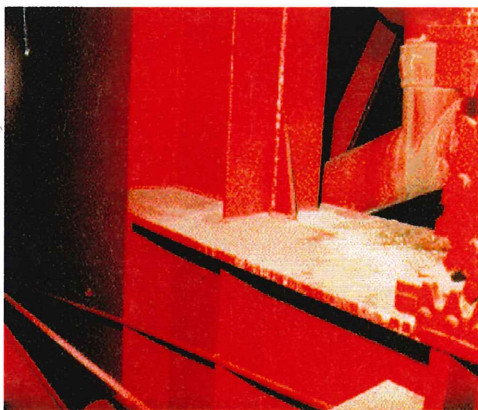
Picture 9 - CUY-480-1842 Hinge Detail
Photo/ODOT

District 12 has reviewed its bridge inventory for similar hinge details. Seventeen bridges in D-12 have seated hinges. Only CUY-480-0647 has three or less girder lines providing minimal redundancy. In the ongoing effort to inspect all of the seated hinges in D-12, hinge details on CUY-480-1842L&R were recently inspected. These structures have four girders instead of three, a triangular web extension, and additional stiffeners which dissipate the stress (see Picture 9). These bridges do not seem to be subject to the same problems as CUY-480-0647. District 12 intends to complete an evaluation of all seated hinge bridges by the end of 2001.

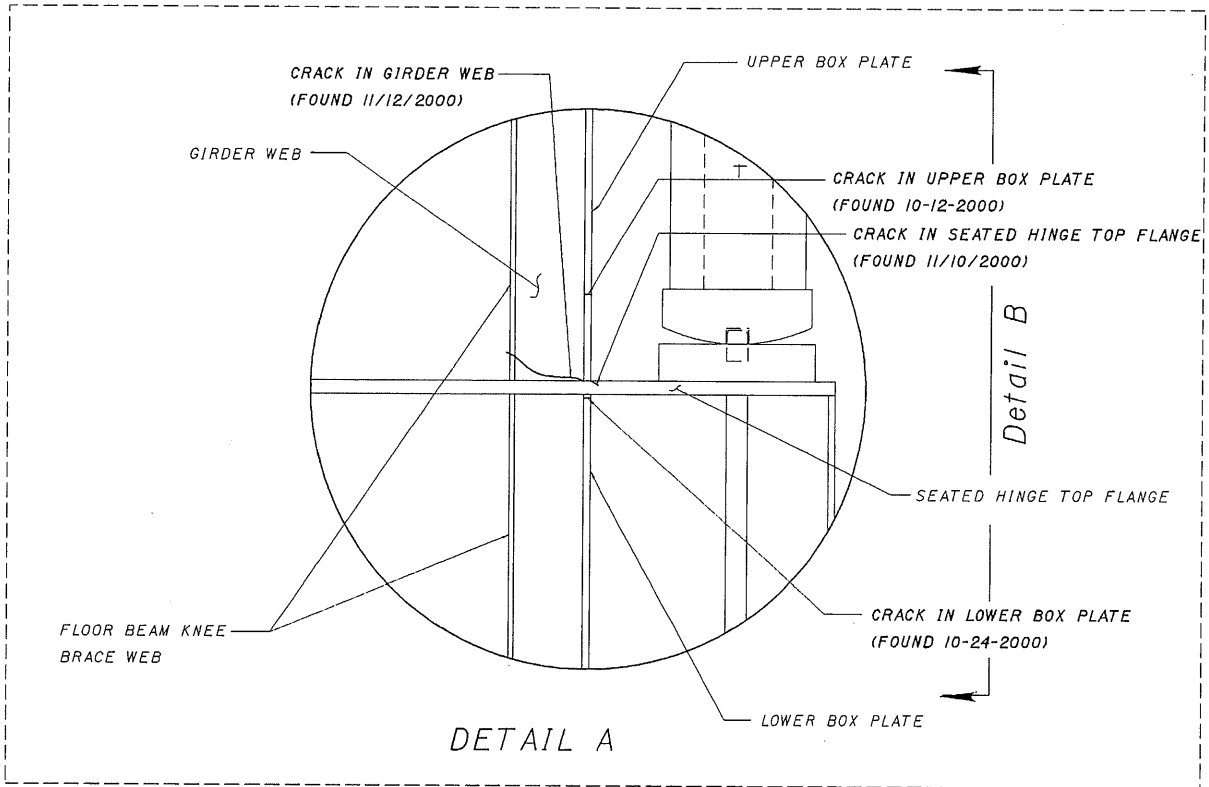
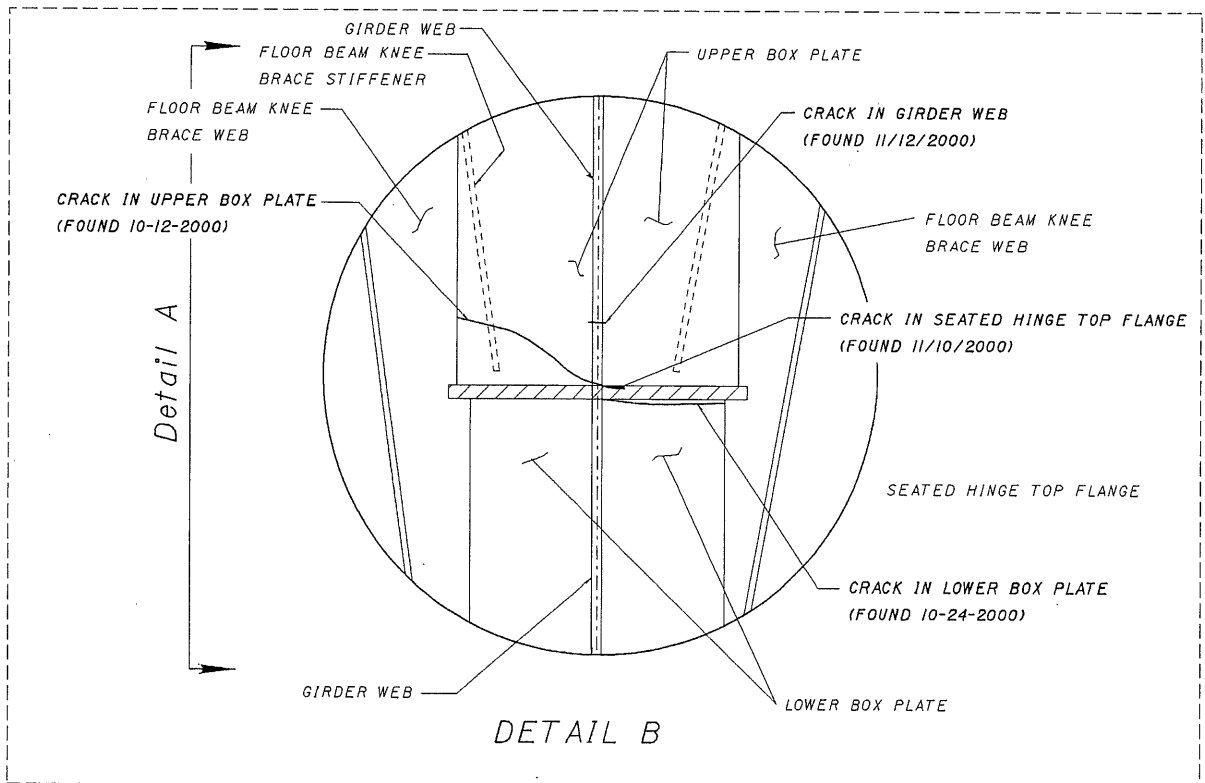
LOCATION OF THE CRACKS
(CRACKS SHOWN IN RED)

- October 2000** Cracks were found in the median fascia girder, which led to the temporary closing of this structure. The following is an overview of these events.

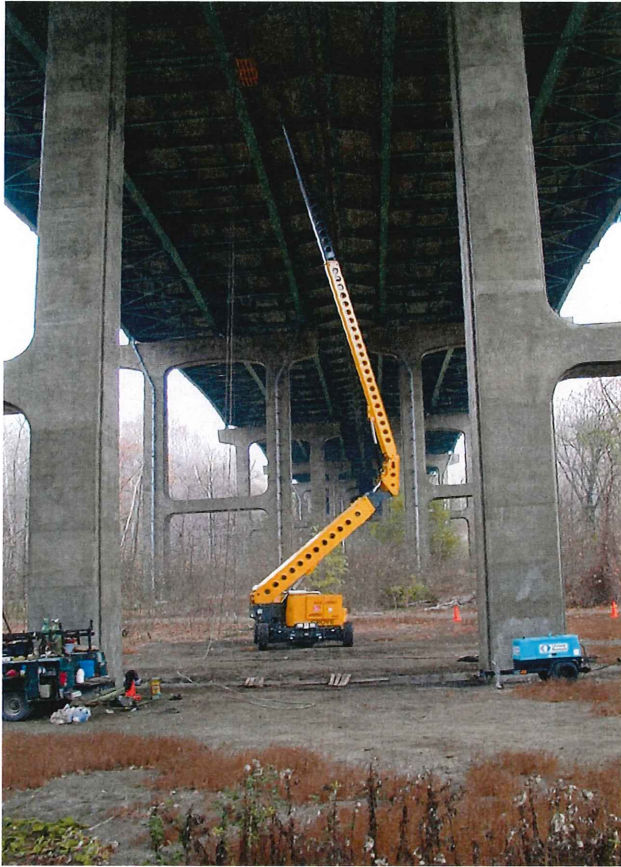
Picture 3 - Tri-State Worksite Photo/ODOT

Thursday, November 9 Tri-State commenced the work discussed on November 3 (see Picture 3).

Malloy, Slack and Hebebrand discussed a temporary repair of the girder with steel contractor Tri-State Steel. Inspection and repair access to the crack location had to be made by cutting a hole in the floor beam knee brace. Next, the contractor would have to grind out and re-weld the cracks, drill three retrofit holes in the girder web, and four retrofit holes in the box plates. This would be a temporary fix until a permanent retrofit could be designed and installed in project PID 21562.

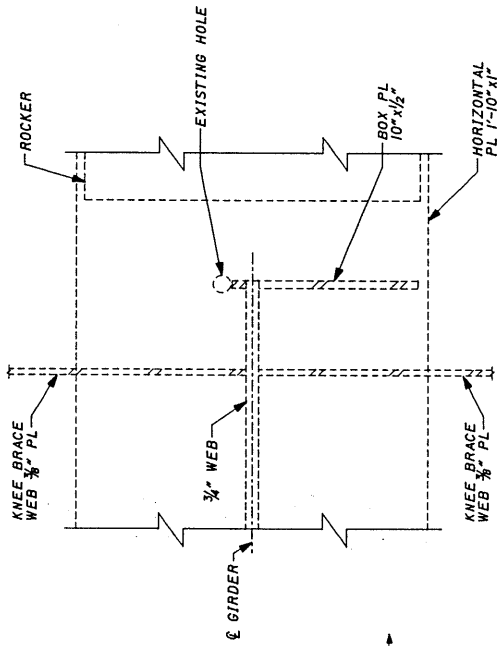
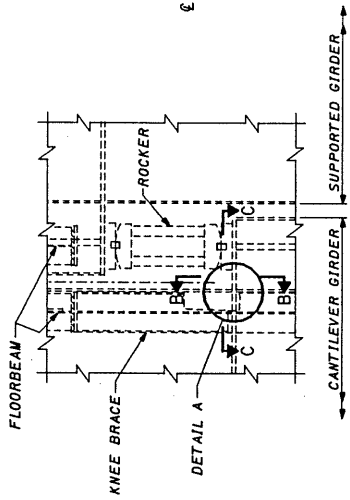
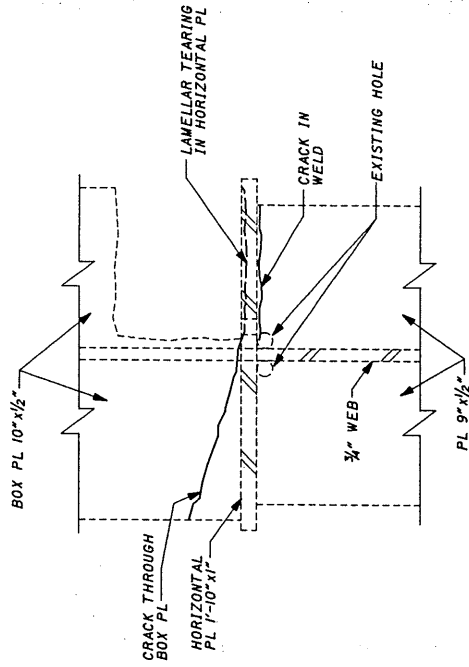
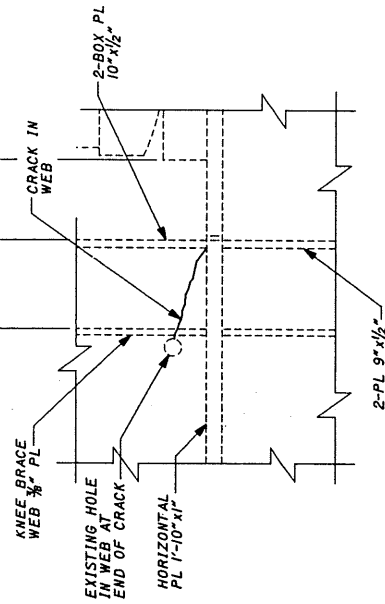
Figure No. 3

On October 12, 2000, a crack in a steel plate was found during a routine inspection. The steel plate was part of the steel girder cantilever supporting a compression hinge in span four of the median girder of the westbound structure. Further inspection discovered more cracks at the same location. (See Figure No. 3.) Welded repairs performed at the same location also cracked. On November 11, 2000, the westbound structure was closed to traffic. A temporary support beam was installed on November 17 and 18, and the westbound structure was reopened on November 19, 2000, with traffic restricted to three lanes.

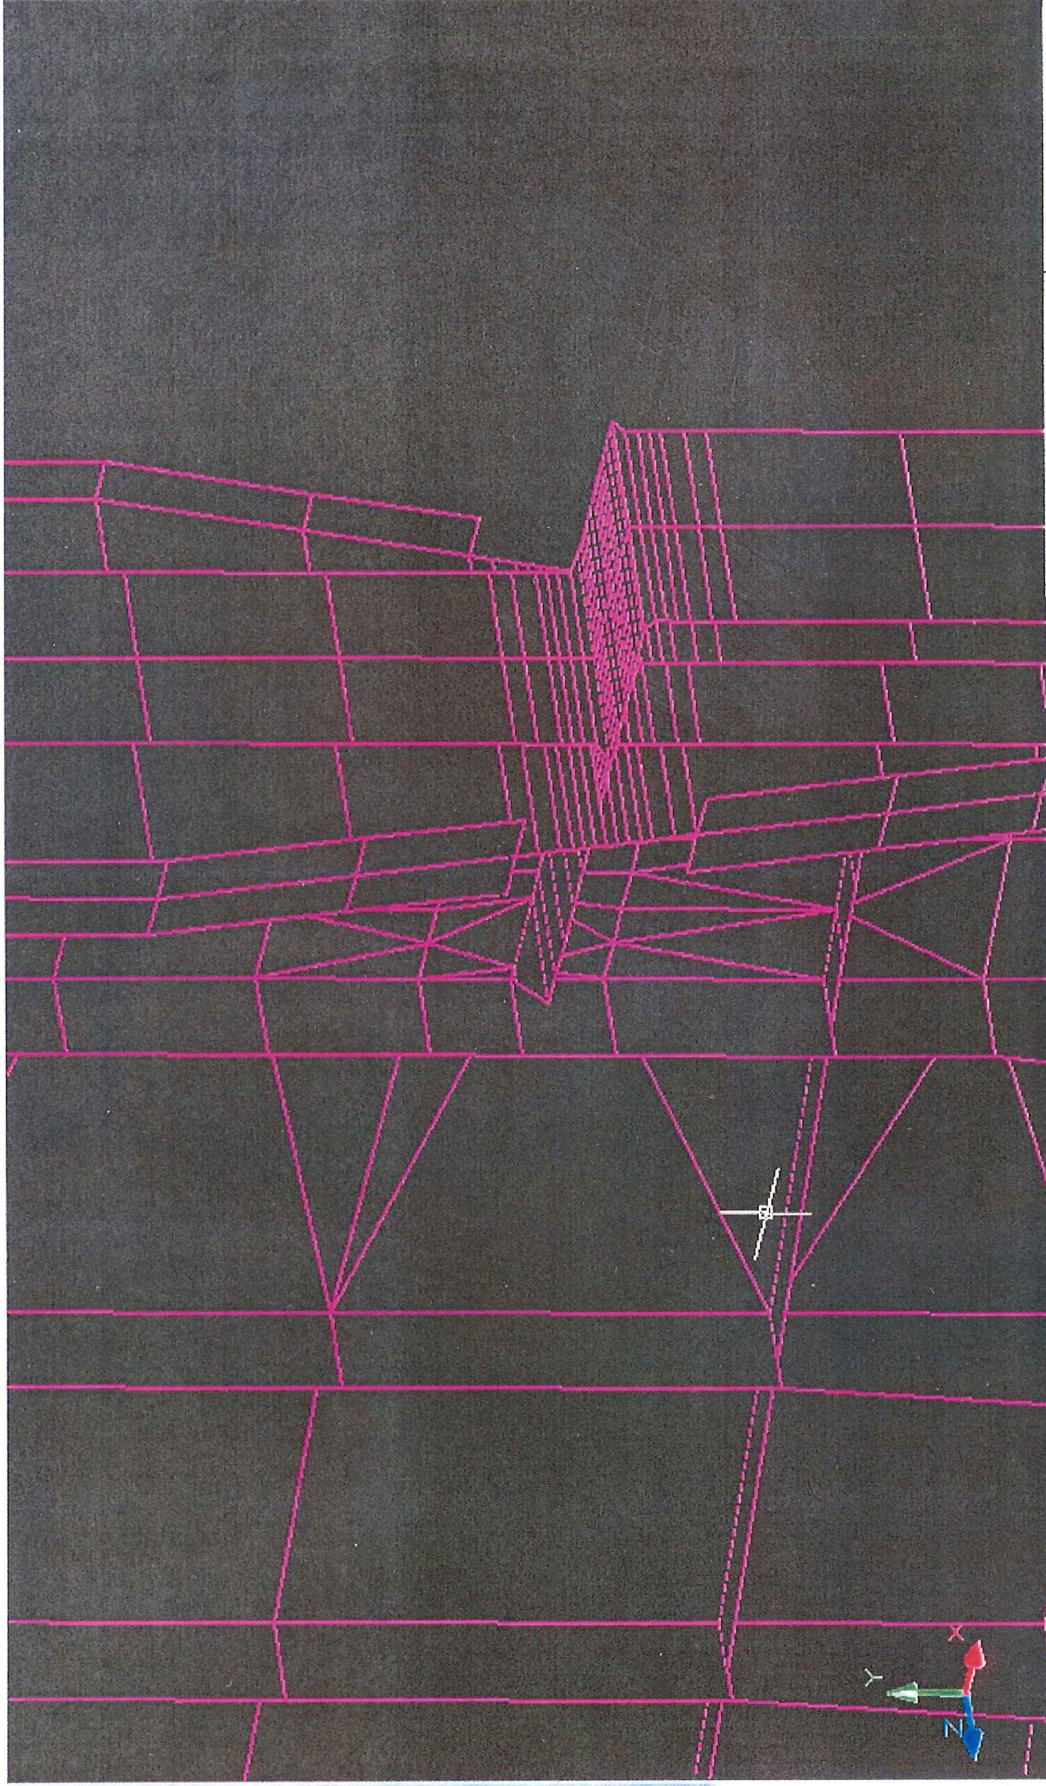
1. A finite element model was created for Girder GD from floorbeam 25, through floorbeam 26, to the cantilever end of the hinge. (See Figure No. 4.) The wireframe model was rendered using AutoCAD to check for "holes" in the model. (See Figure No. 5.) Dead load stress reached 17.4 ksi (See Figure No. 6.), and the live load stress was 6.7 ksi. This stress was concentrated in the web of the girder under the seat plate, next to the box plate.
2. The model was modified to reflect two cracks through the box plate, one above the seat plate on the outside of the girder and the other below the seat plate on the inside of the girder. This

Figure No. 4 - Wireframe rendition of finite element model.

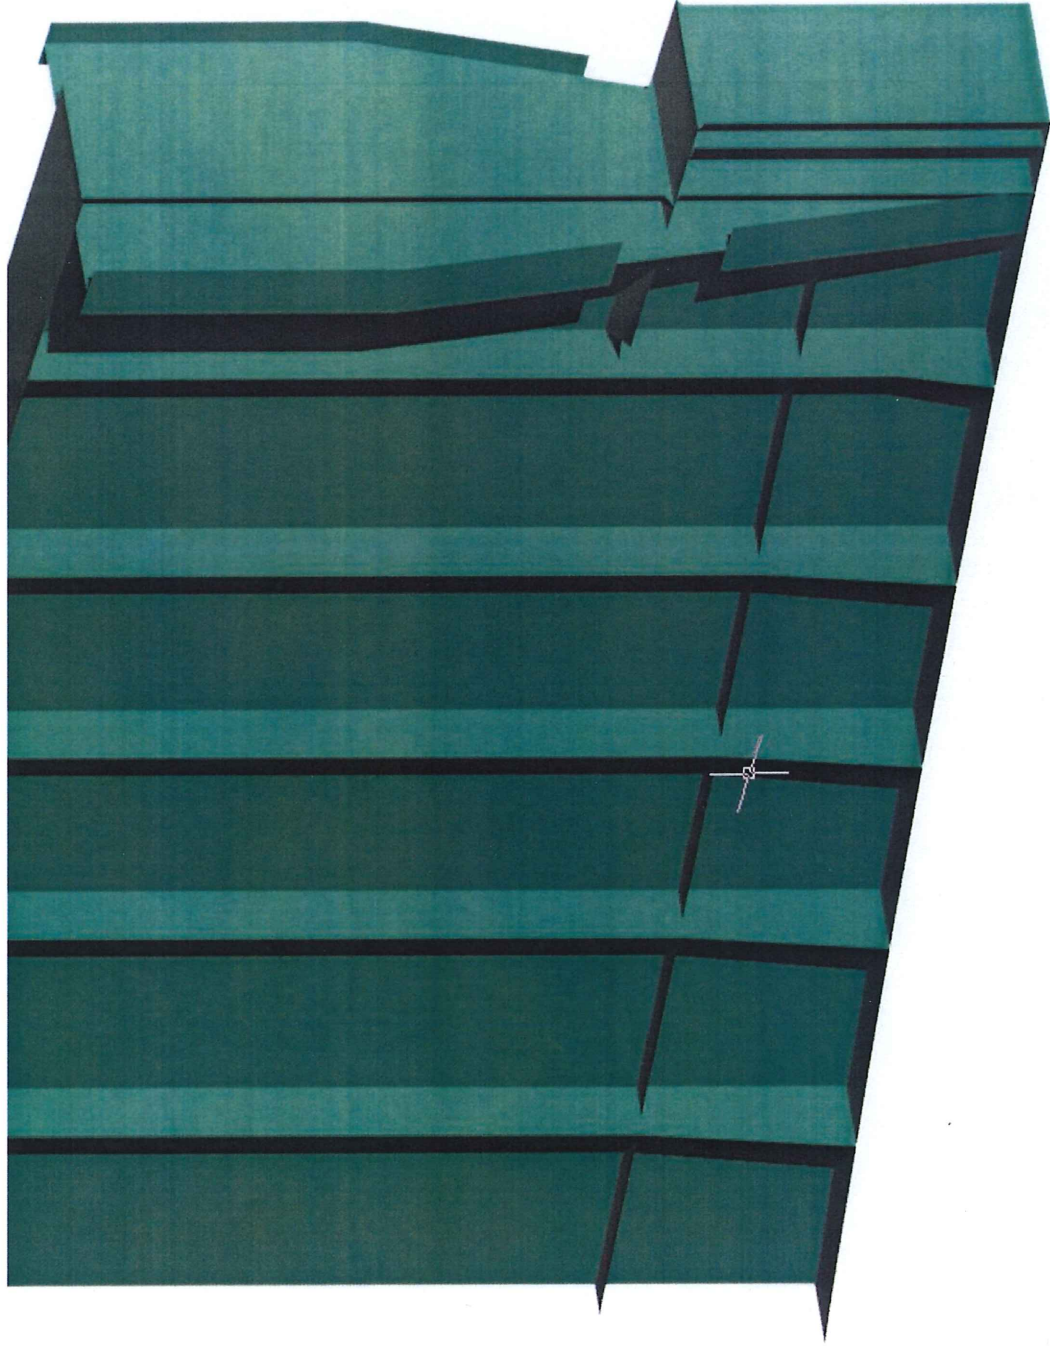
Figure No. 5 - 3-D rendition of finite element model.

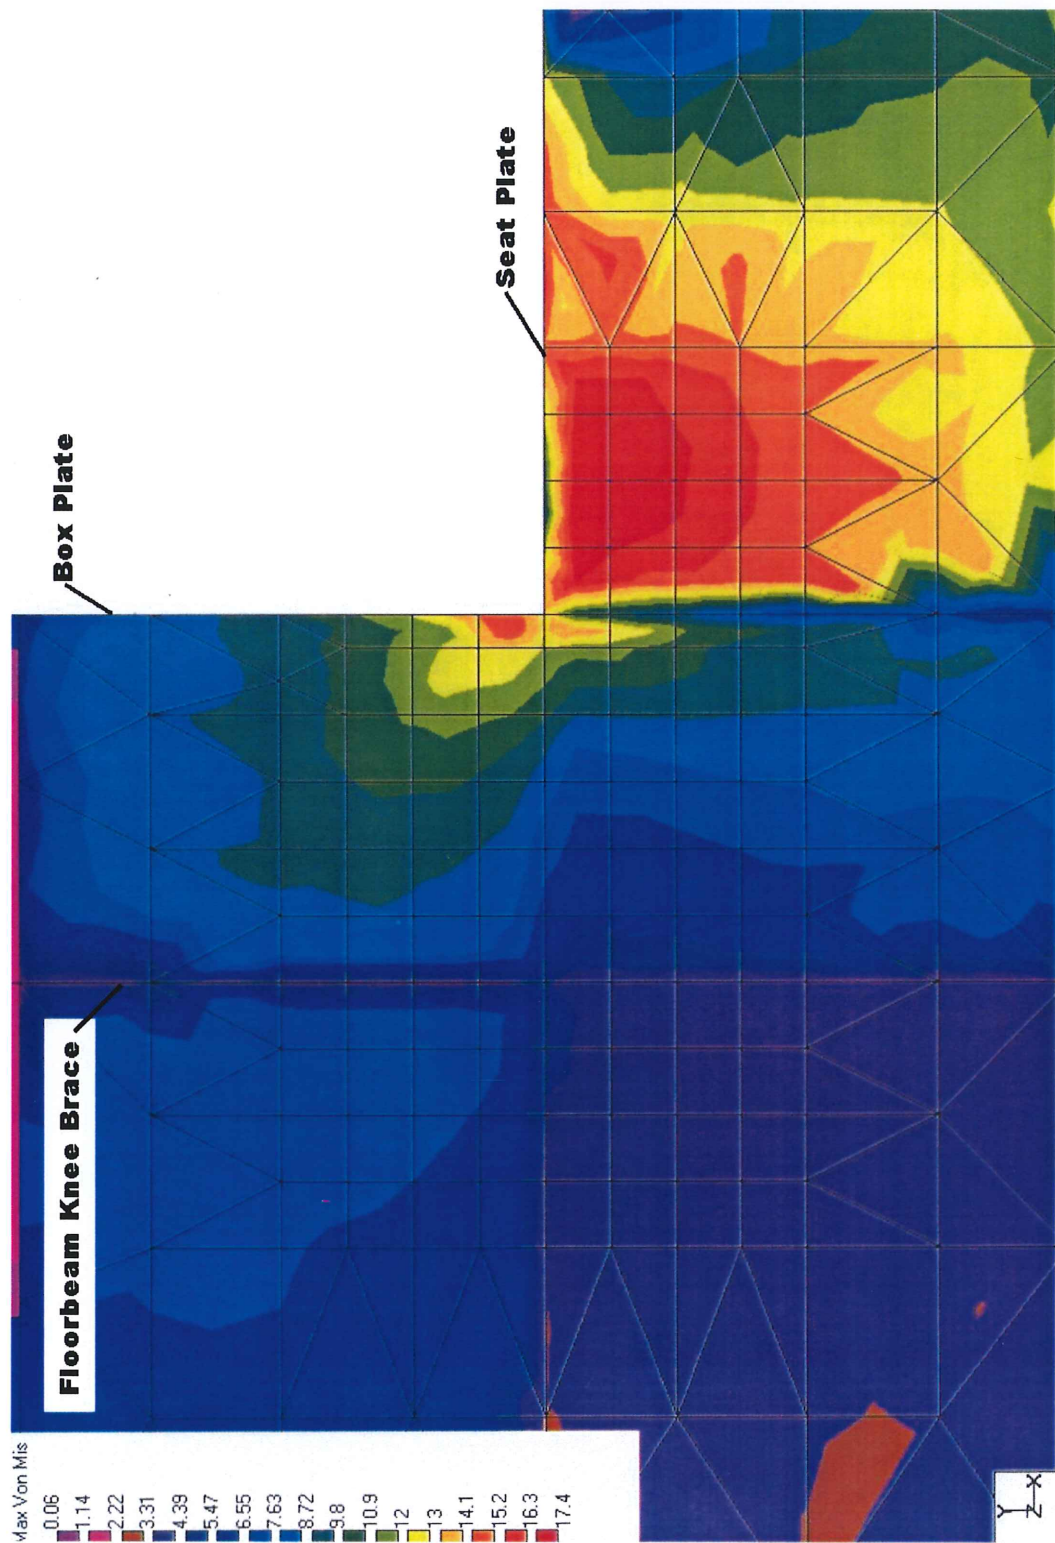
Figure No. 6 - Dead Load stress distribution for web of uncracked model.

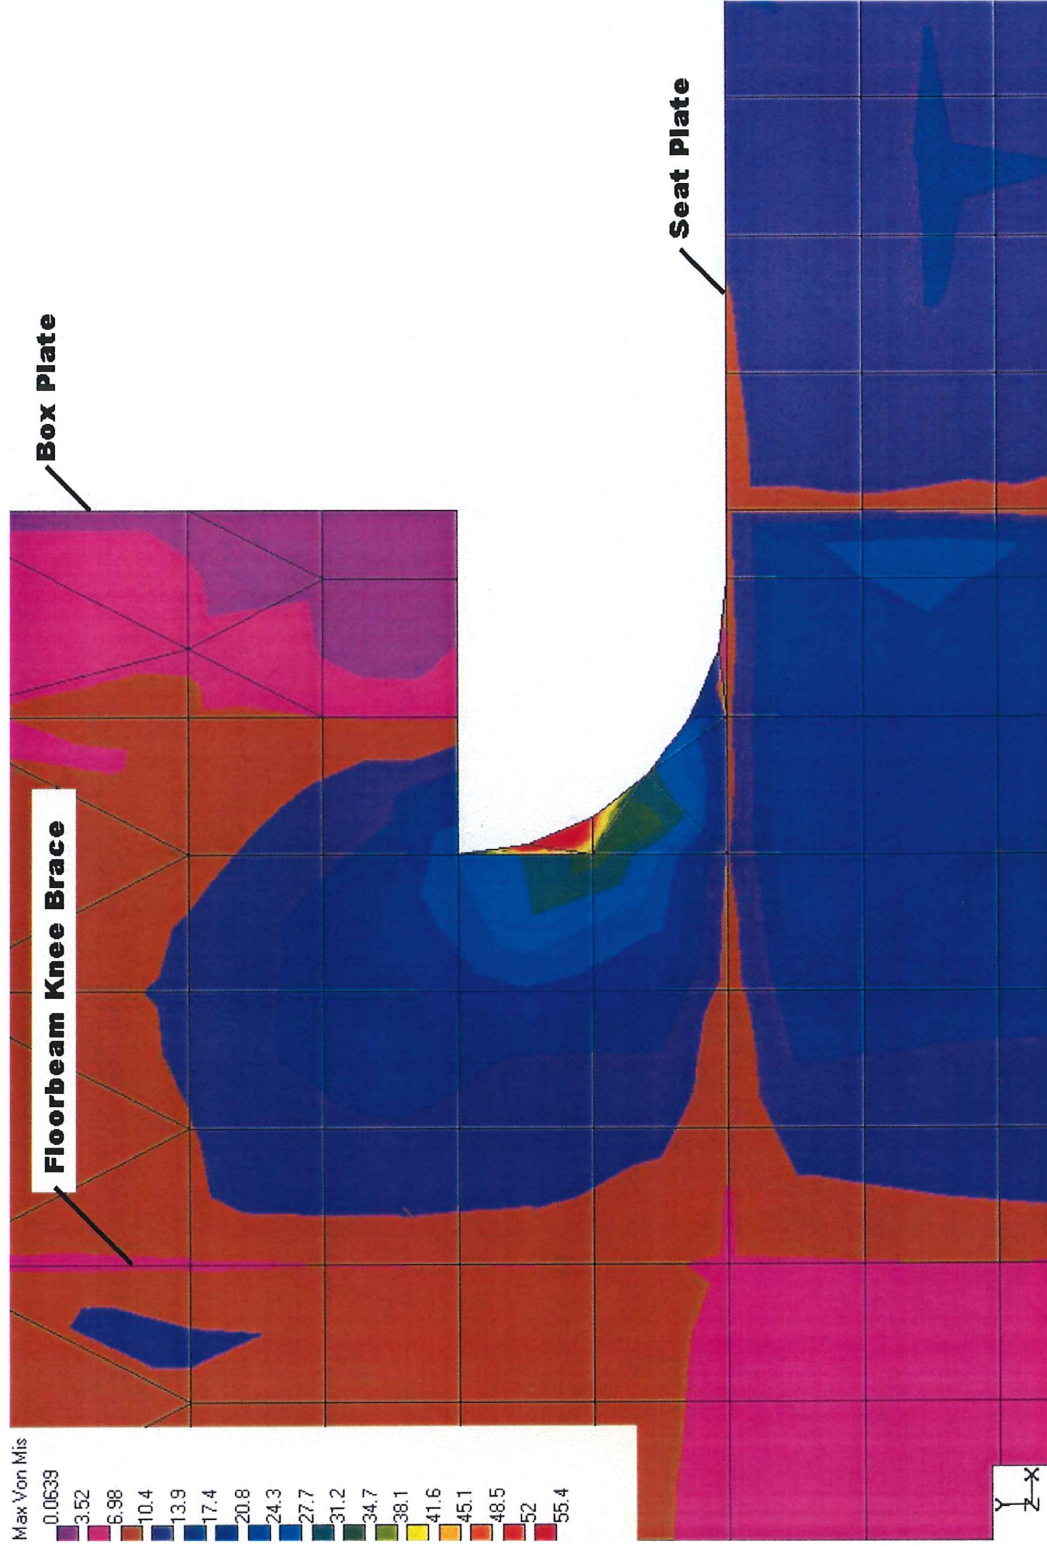
6. The original (uncracked) model was used again, changed to reflect three retrofit considerations:
 - a. The web is notched in a two-inch radius quarter-circle centered at the back of the box plate, two inches above the seat. The box plate is removed for two inches in this option. (See Figure No. 12.) The stresses are greatly amplified in this model - dead load, 55.4 ksi; live load, 21.3 ksi. This option was dismissed, since the dead load is at about the ultimate strength of A-36 steel (58 ksi). The locus of the stress concentration is on the radius of the web notch, about 1½ inches above the seat plate.

Figure No. 12 - Dead load stress distribution in web for retrofit model with quarter-circle notch.

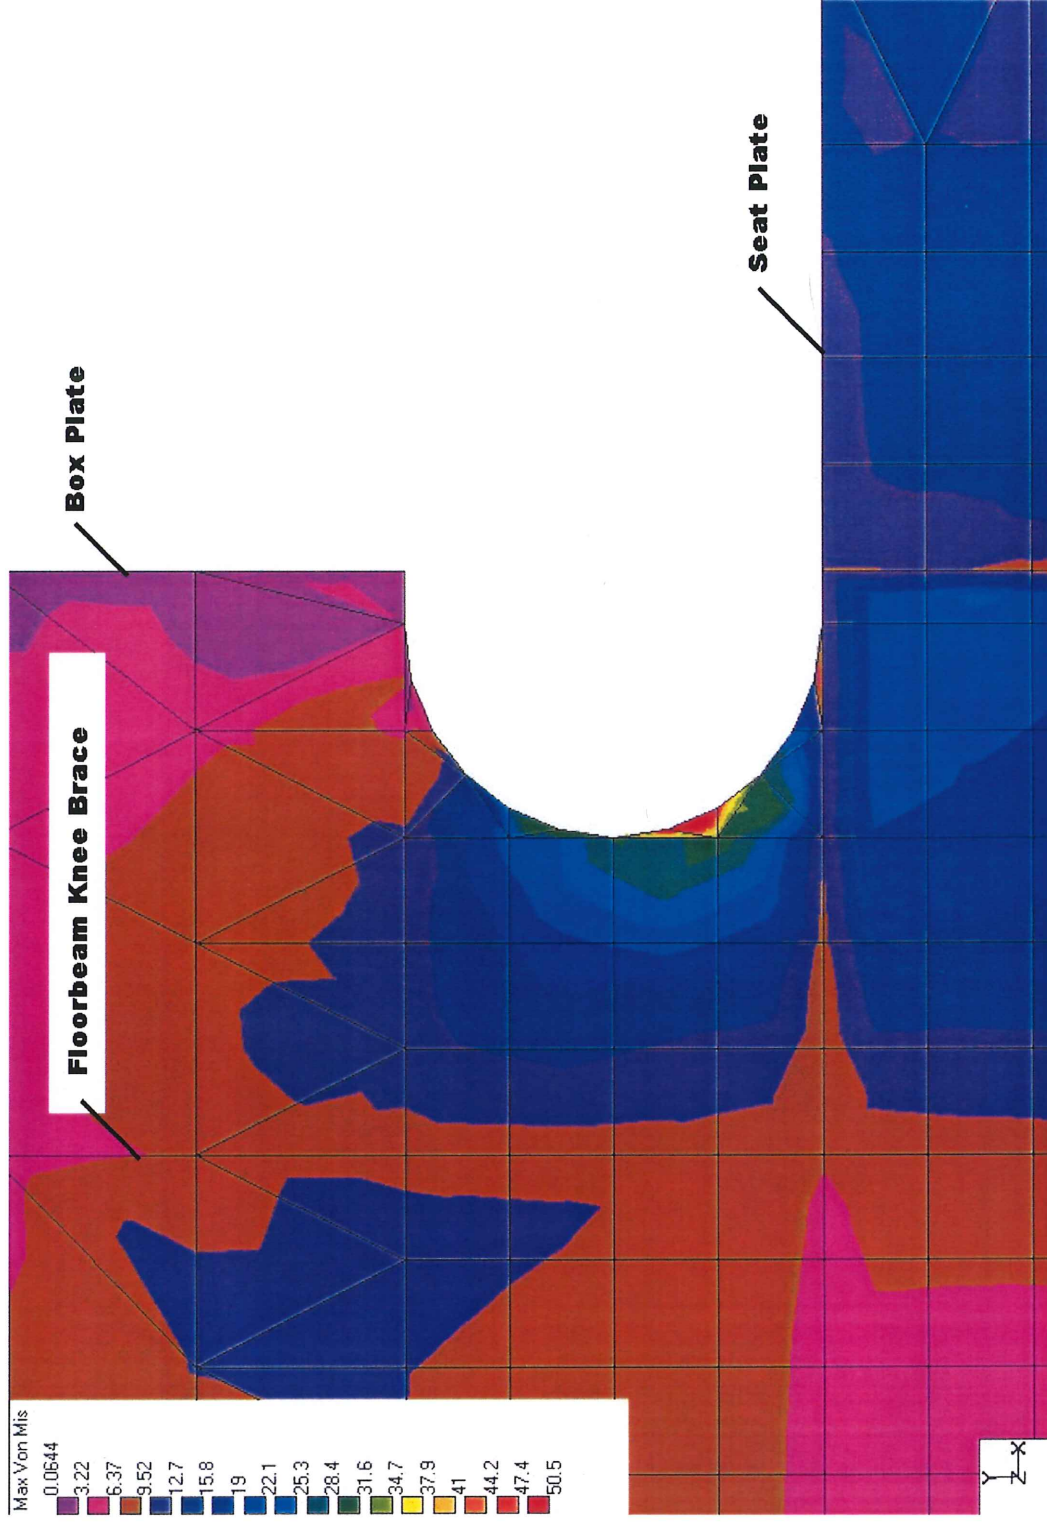
- b. This retrofit is similar to the previous model, except the web notch is a full semi-circle centered at the same location. (See Figure No. 13.) The locus of the stress concentration is about the same as in the previous model, while the stresses are about ten percent less. Dead load stress is 50.5 ksi, and live load stress is 19.4 ksi.

Figure No. 13 - Dead load stress distribution in web for retrofit model with half-circle notch.

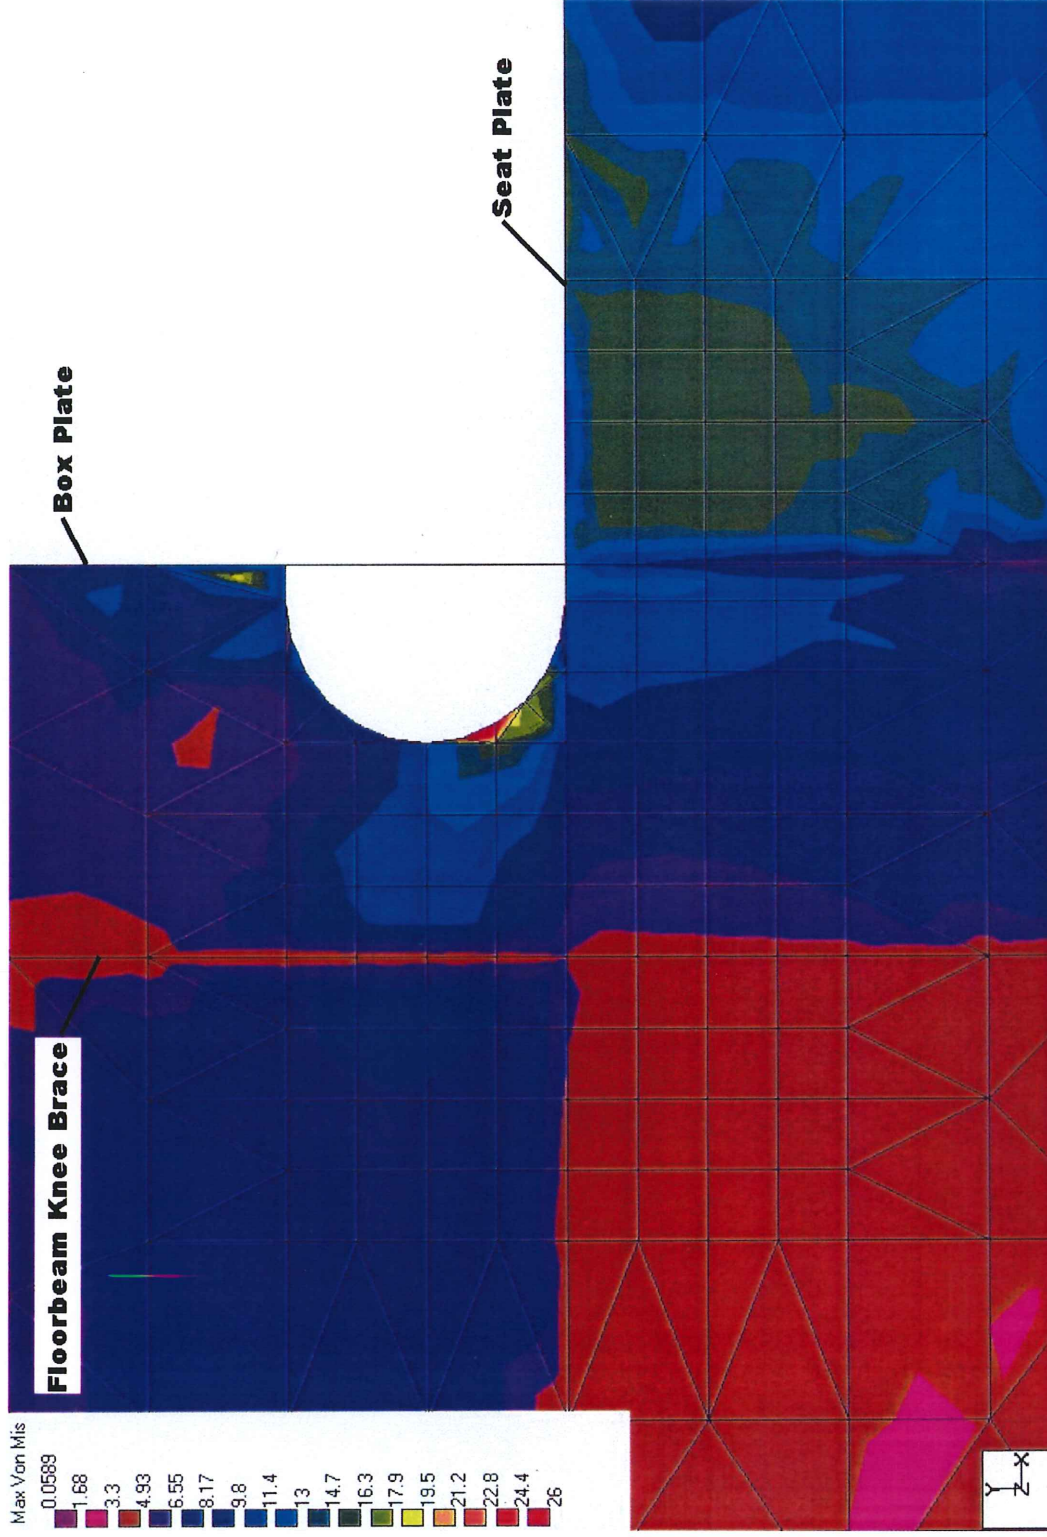
- c. Using the previous model and adding the box plate back in greatly reduced the stresses in the girder web. (See Figure No. 14.) The locus of the stress concentration stayed about the same, but the dead load stress dropped to about 26.0 ksi, and the live load stress to about 10.0 ksi. The box plate picks up much of the vertical load component, with dead load stress of about 16.3 ksi, and live load stress of about 6.3 ksi. (See Figure No. 15.)

Figure No. 14 - Dead load stress distribution in web for retrofit model with half-circle notch and box plate.

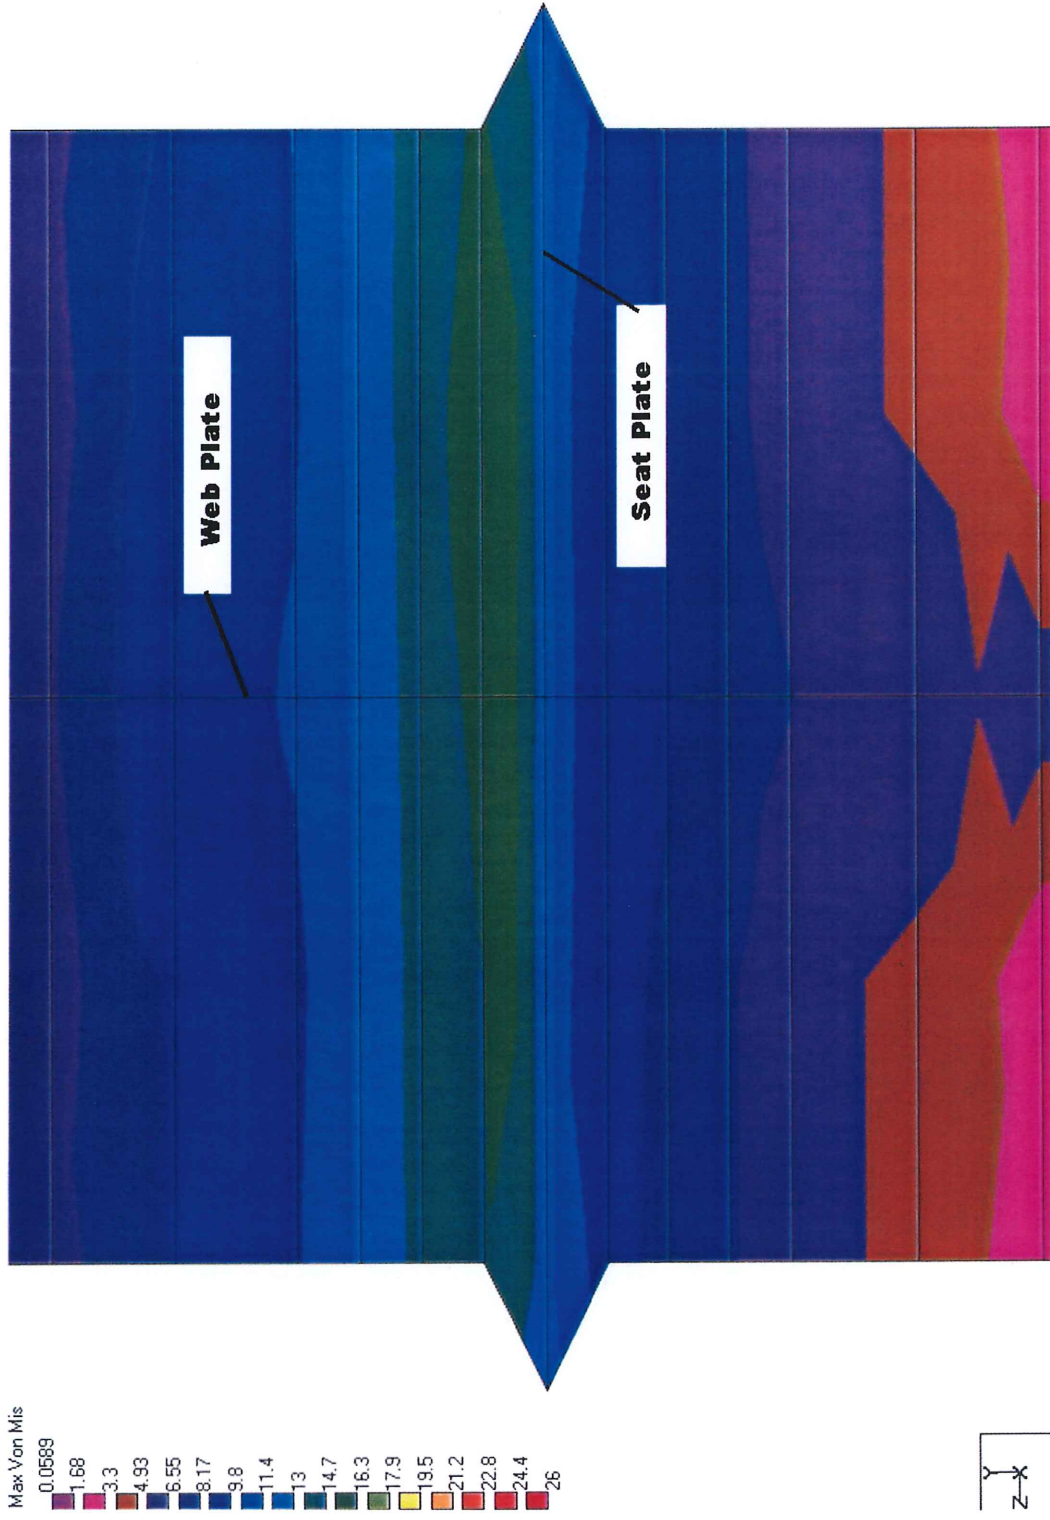
Figure No. 15 - Dead load stress distribution in box plate for retrofit model with half-circle notch and box plate.

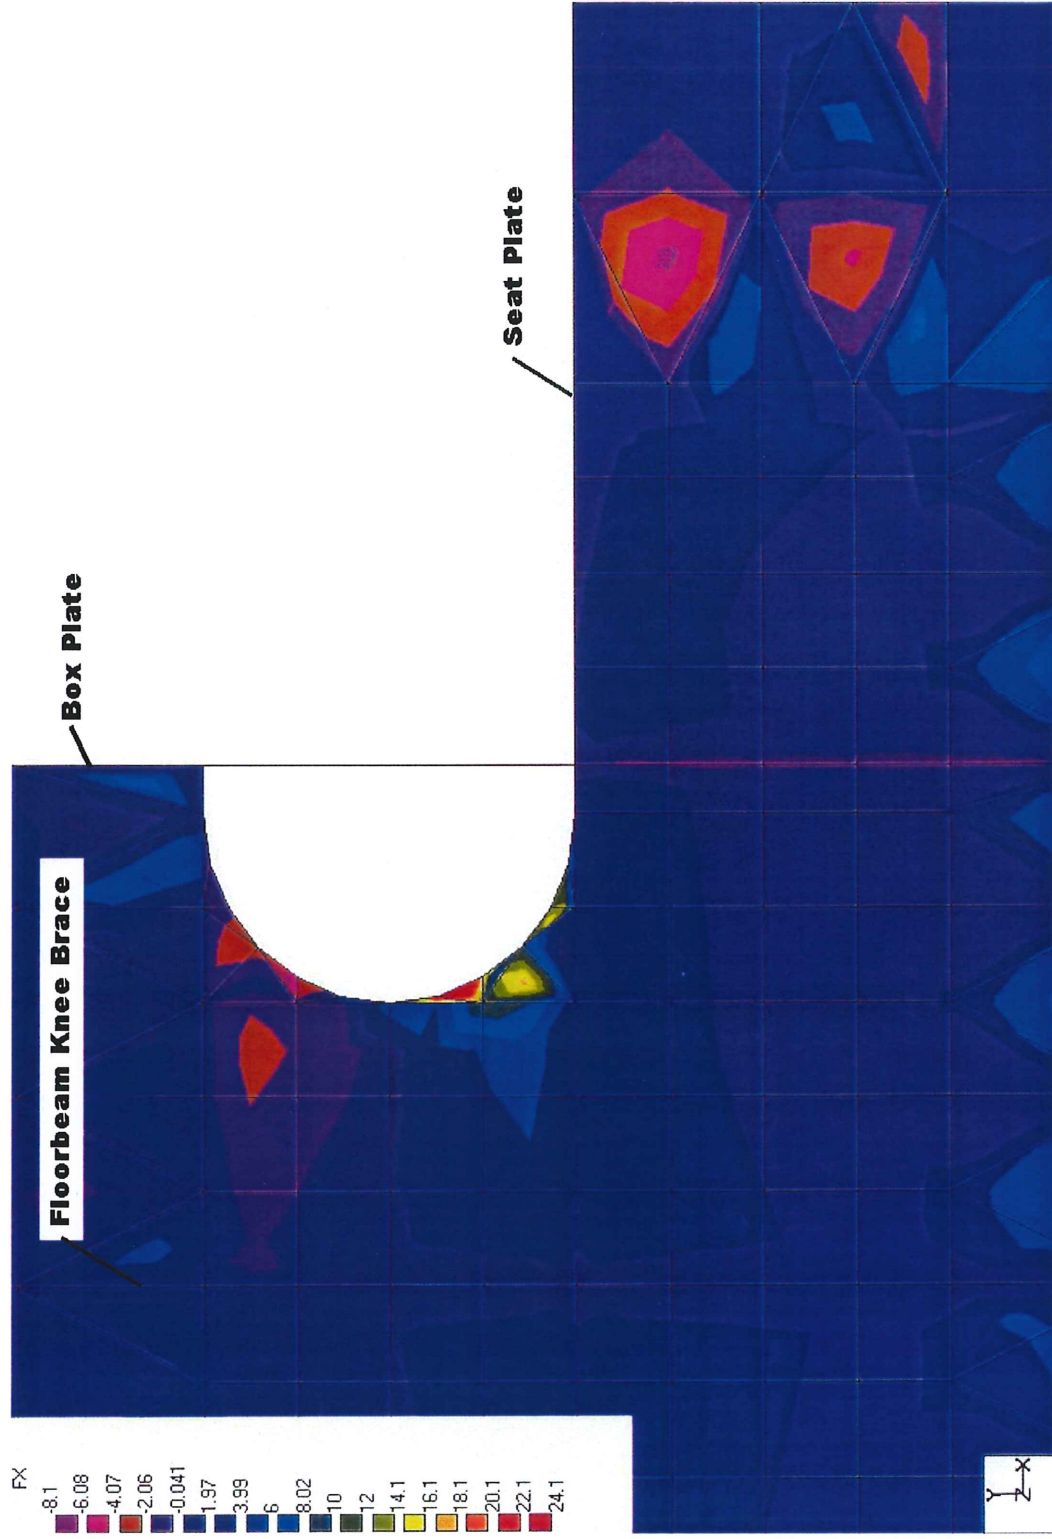
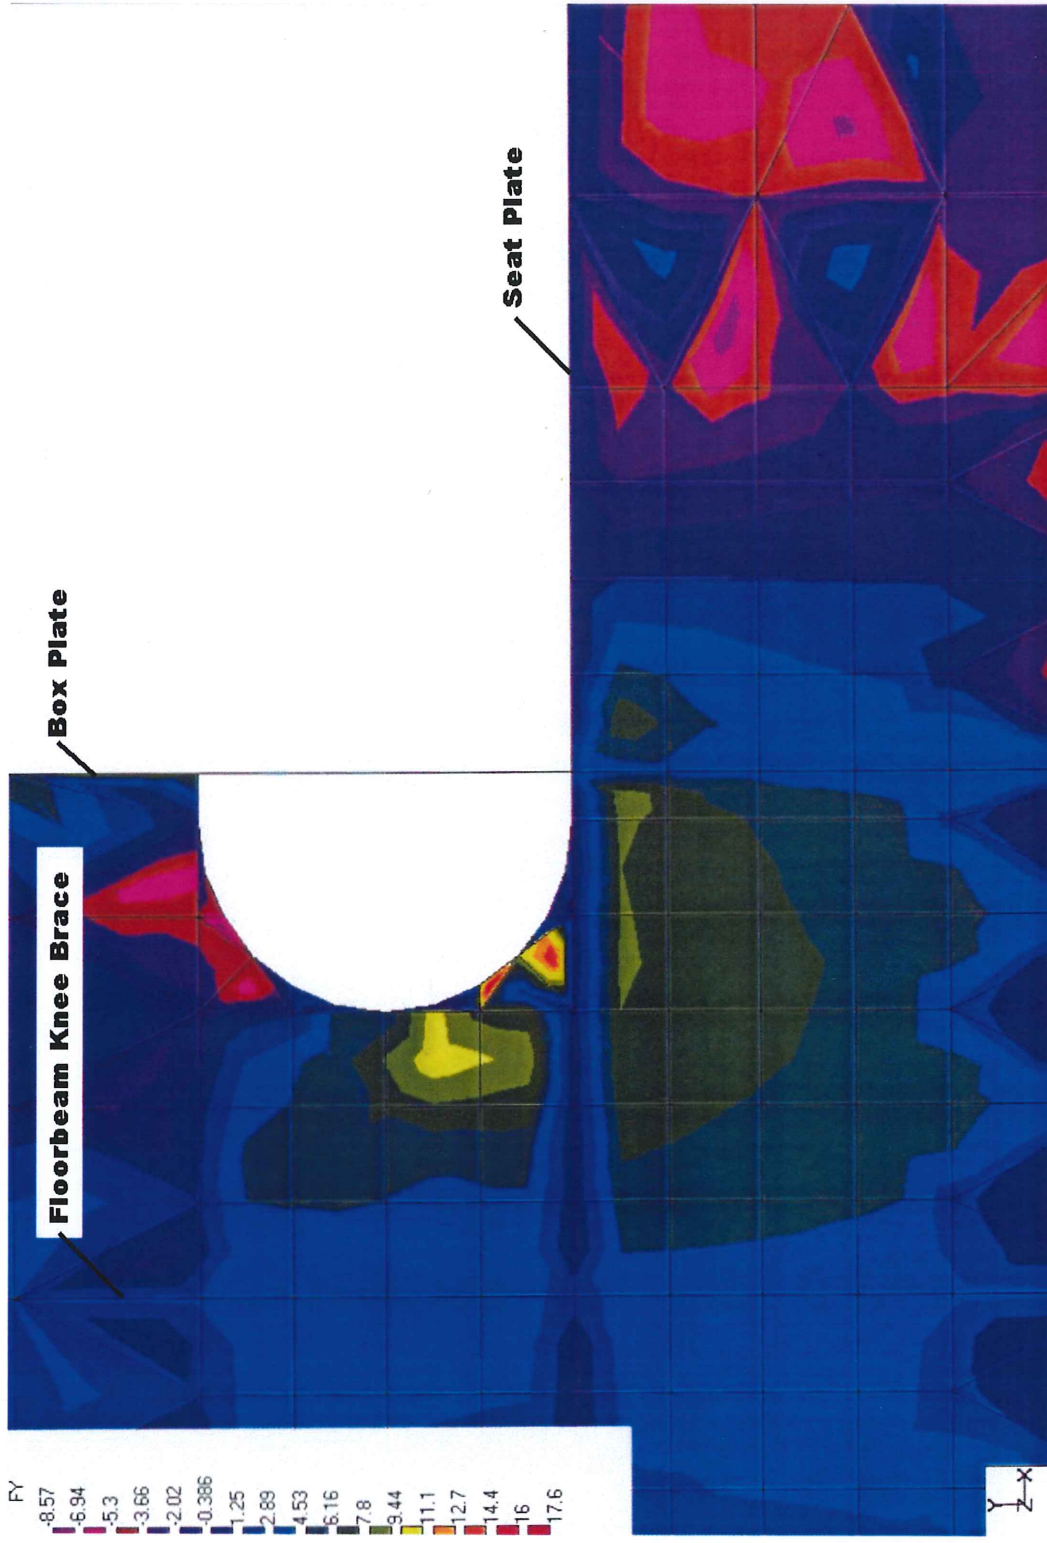
A further examination of the stresses in this scheme is instructive. The majority of the maximum stresses observed occur in the horizontal direction. (See Figures No. 16 and 17.) The dead load stresses are 24.1 ksi horizontal and 17.6 ksi vertical; live load, 9.3 ksi horizontal and 6.8 ksi vertical. This indicates that for this model, the primary stress is shear through the girder web caused by the beam action of the hinge cantilever, where the seat plate is the tension flange of the hinge. This in turn indicates that the web may be too thin to properly disperse the tension/shear field from the seat plate.

Figure No. 16 - Dead load stress distribution in web for retrofit model with half-circle notch and box plate, showing shear stresses acting in the X (horizontal) direction.

Figure 17 - Dead load stress distribution in web for retrofit model with half-circle notch and box plate, showing shear stresses acting in the Y (vertical) direction.
