I-480 *Bridge Repair*

The Emergency Bridge Closing and Repair of I-480 WB over the Rocky River (Bridge CUY-480-0647)

Preliminary Report

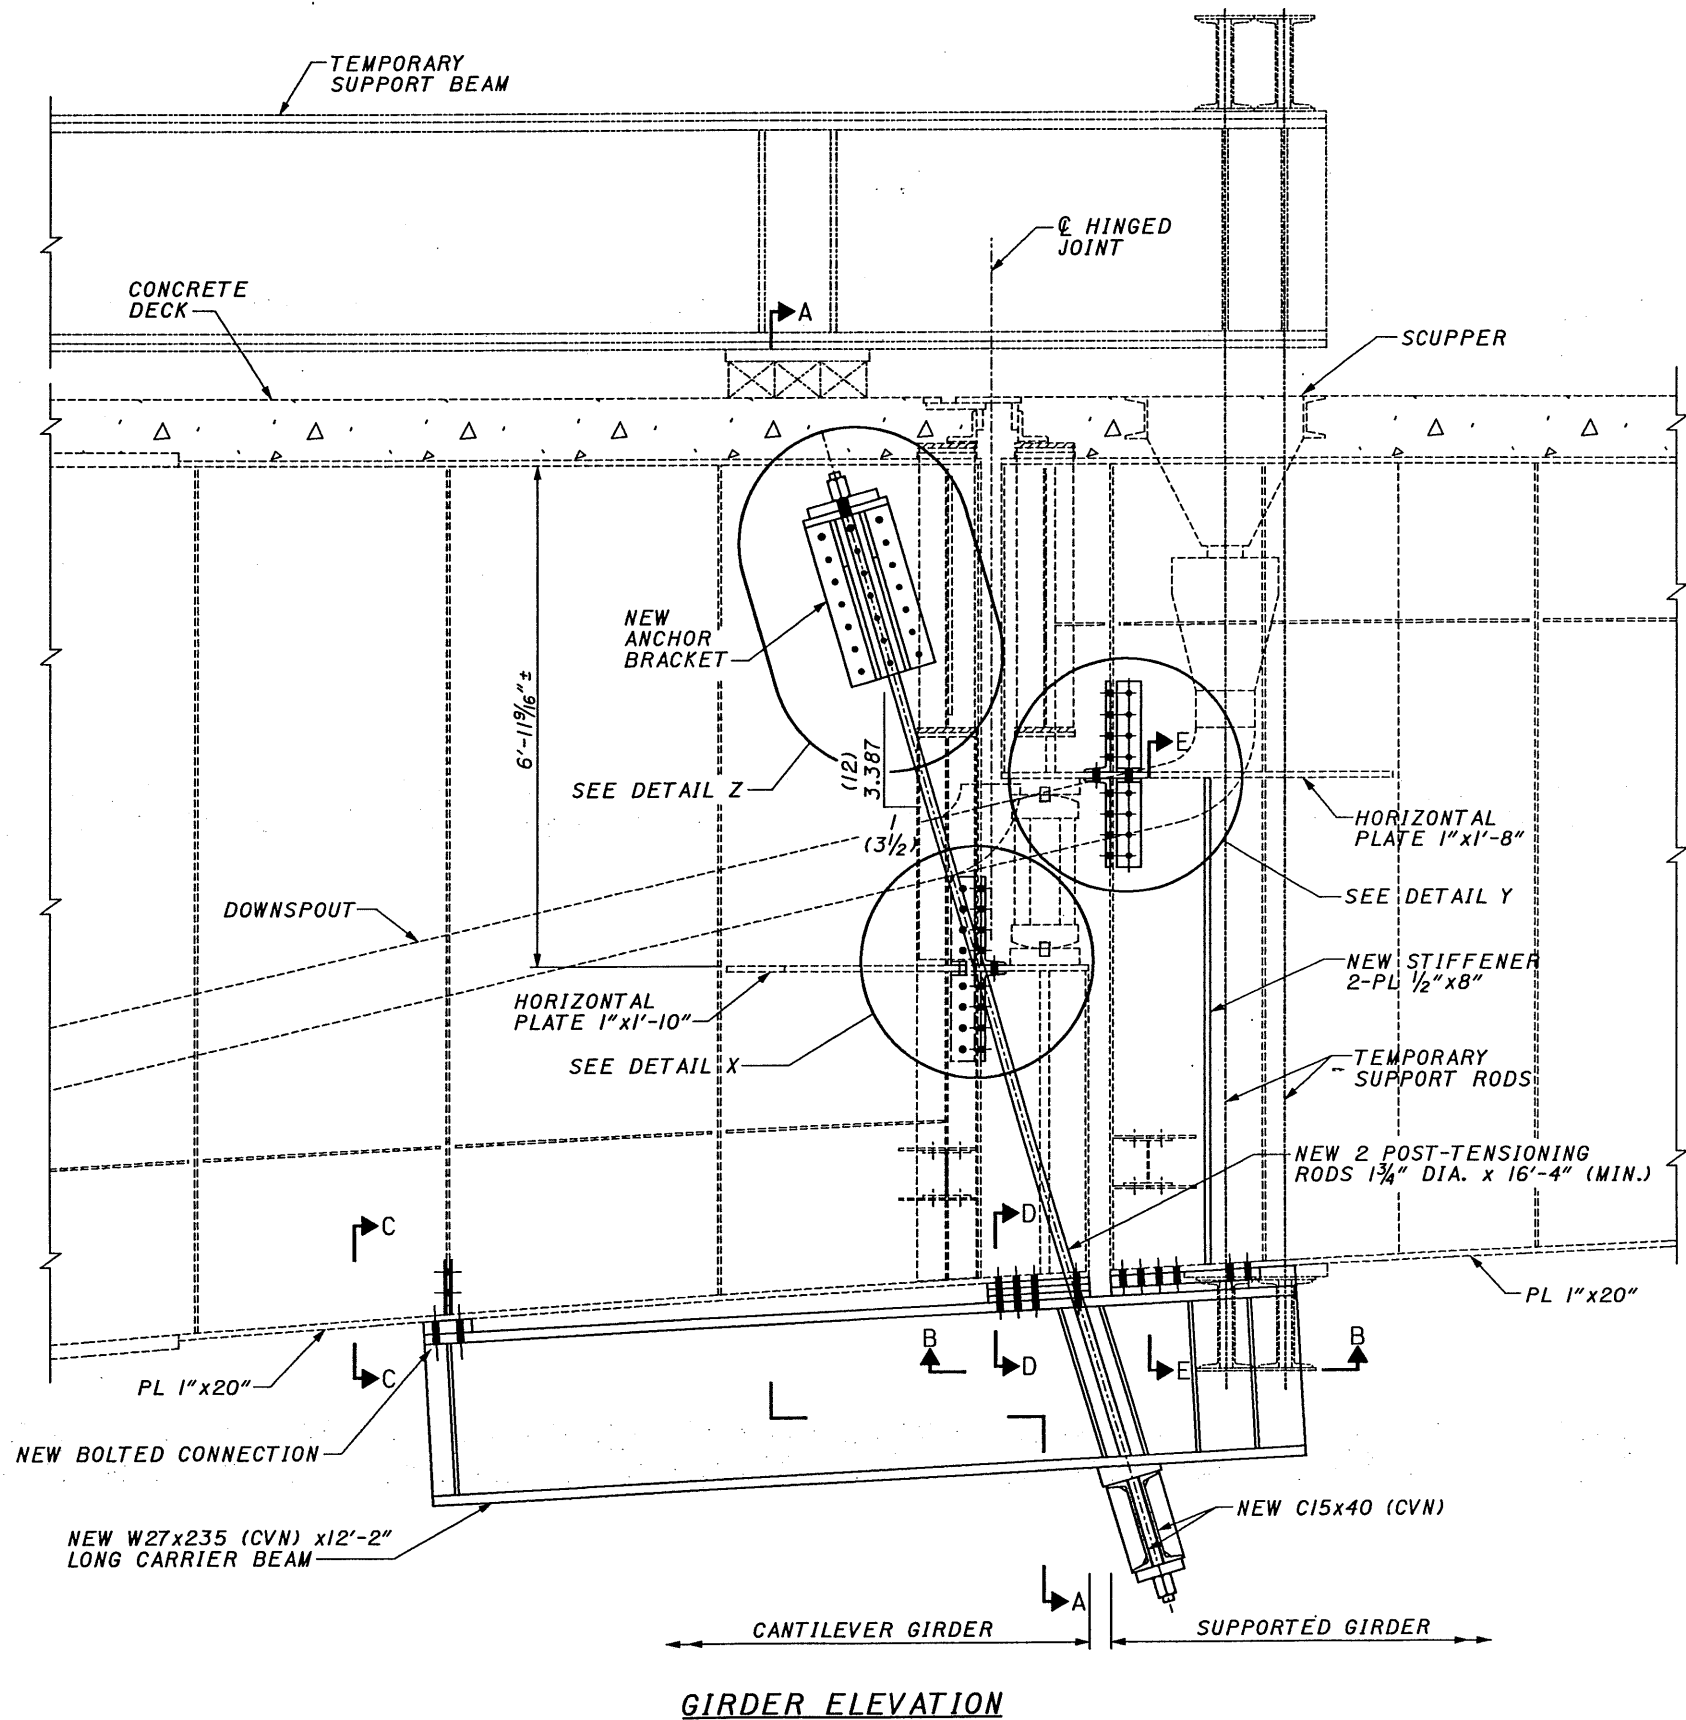
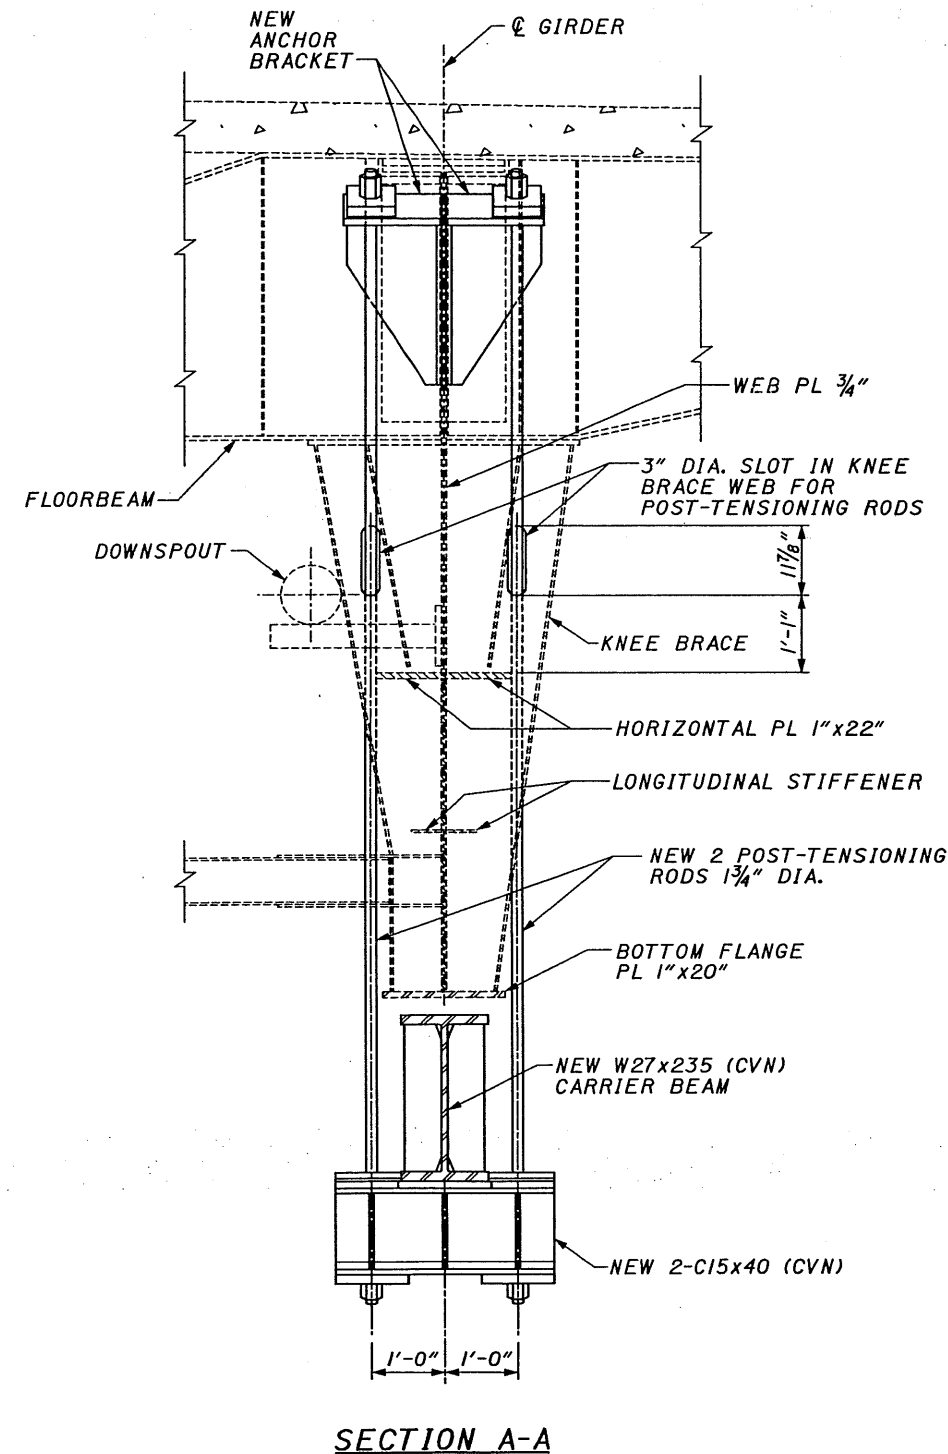
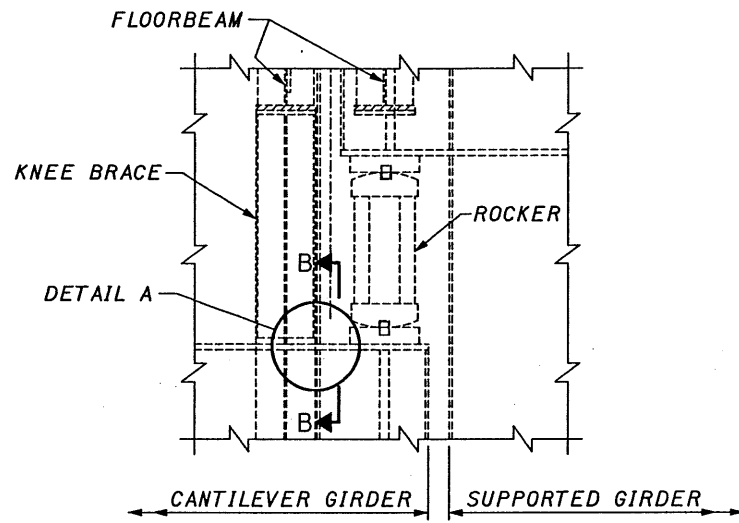
**PROPOSED WORK - EASTBOUND BRIDGE,
SPAN 4, NORTH GIRDER**

EXISTING CONDITIONS: CRACKS FOUND IN BOX PLATE WELDS ABOVE HORIZONTAL PLATE HAVE BEEN REWELDED.

1. FABRICATE NEW MATERIALS AND PRIME PAINT.
2. SUBDRILL (CUT) NEW HOLES IN WEB ABOVE LOWER HORIZONTAL PLATE THAT WILL BE BEHIND THE POST-TENSIONING RODS FOR CONNECTING NEW ANGLES. INSTALL ANCHOR BRACKET TO WEB.
3. INSTALL CARRIER BEAM AND POST-TENSIONING RODS.
4. POST-TENSION RODS TO 100% OF DEAD LOAD, 59 TONS PER ROD.
5. CUT BOX PLATES ABOVE HORIZONTAL PLATE AND REWELD (EXCEPT LEAVE GAP AT WEB PER DETAILS).
6. CUT OUT WELD INTERSECTIONS OF BOX PLATES TO WEB AND HORIZONTAL PLATE.
7. SUBDRILL (CUT) NEW HOLES FOR CONNECTING NEW ANGLE MATERIAL. INSTALL ANGLES AND REAM HOLES FOR BOLTED CONNECTION TO BOX PLATES, HORIZONTAL PLATES, AND WEB. INSTALL BOLTS AND TIGHTEN.
8. REDUCE LOAD IN POST-TENSIONING RODS TO 80% OF DEAD LOAD, 47 TONS PER ROD.
9. FINISH PAINT NEW MATERIAL AND TOUCH-UP PAINT EXISTING MATERIAL.

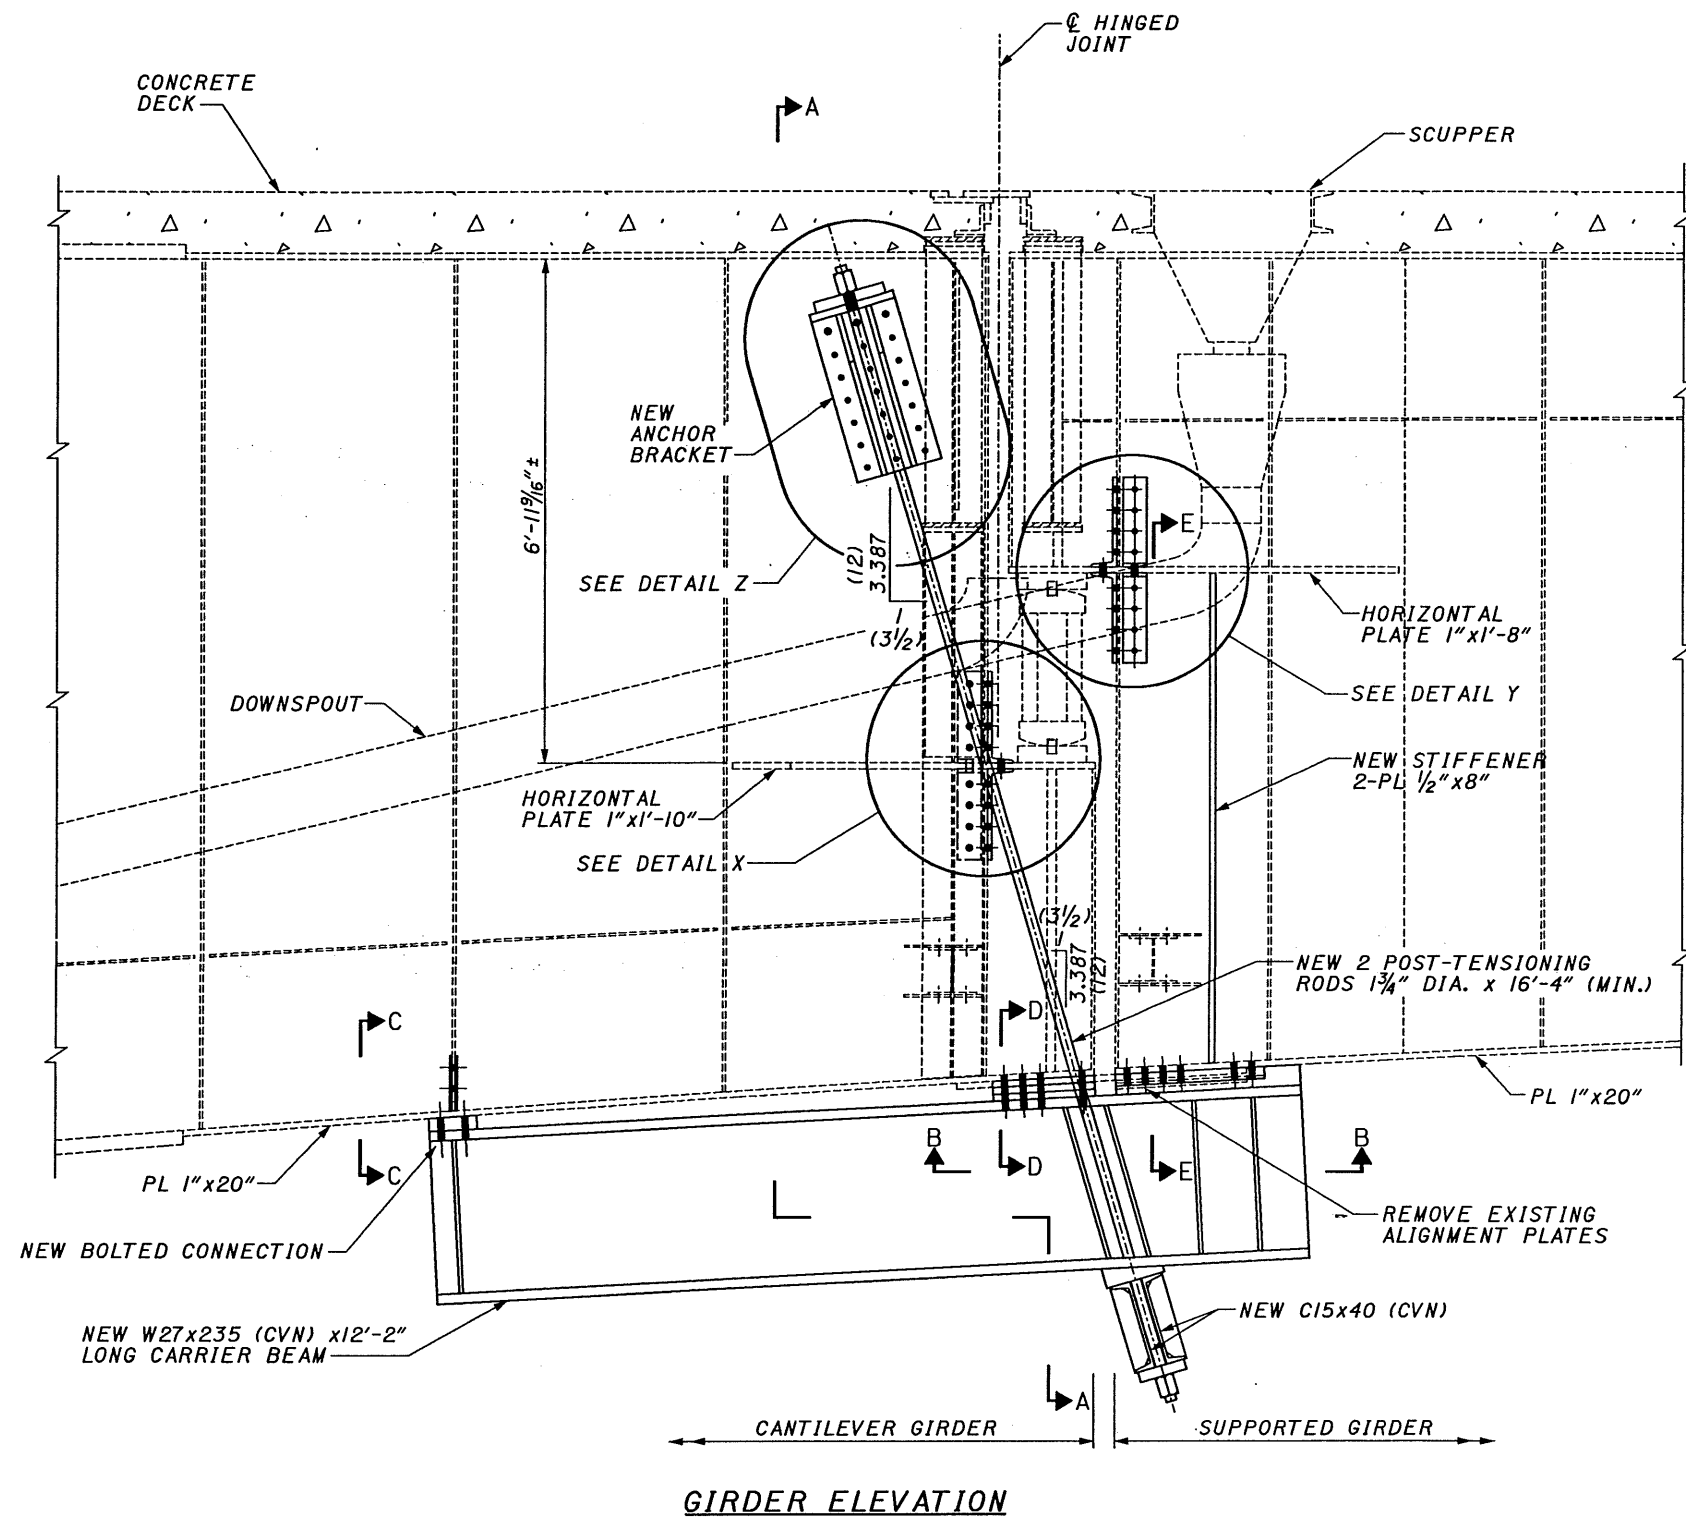
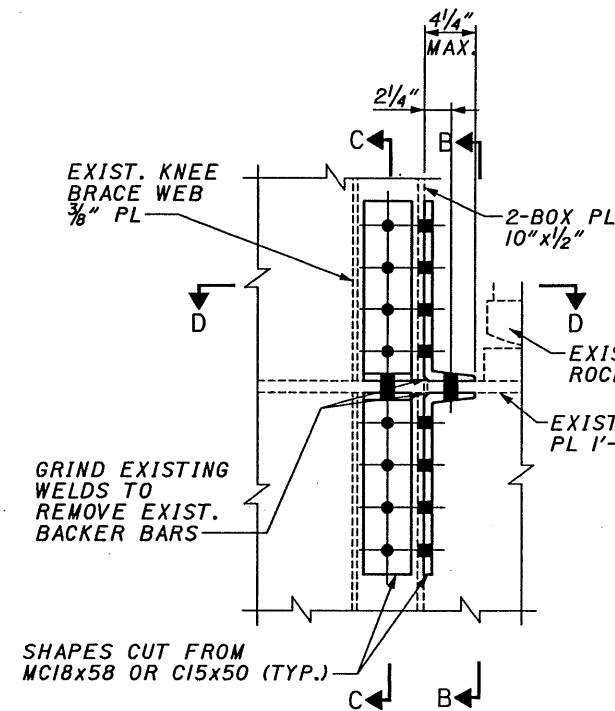
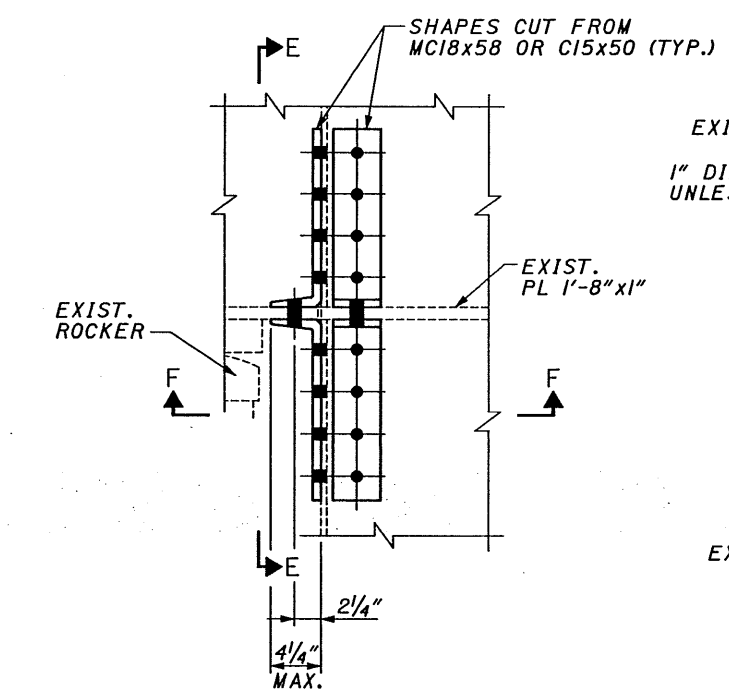
DETAIL X
(KNEE BRACE FLANGE NOT SHOWN)

EXISTING CONDITIONS: TEMPORARY SUPPORT BEAM IS IN PLACE WITH A SMALL AMOUNT OF TENSION IN THE TEMPORARY SUPPORT RODS. HOLES HAVE BEEN DRILLED AT ENDS OF CRACKS IN BOX PLATES AND WELDS.

3. SUBDRILL (CUT) NEW HOLES FOR CONNECTING NEW ANGLE MATERIAL. INSTALL ANCHOR BRACKET TO WEB.
4. GOUGE OUT CRACK IN HORIZONTAL PLATE, WELD AND GRIND TO ORIGINAL PLATE SIZE. PLUG WELD HOLE. PERFORM ULTRASONIC TESTING TO CONFIRM THERE ARE NO FLAWS REMAINING IN THE HORIZONTAL PLATE.

5. REWELD BOX PLATES ABOVE AND BELOW HORIZONTAL PLATE TO ORIGINAL CONDITION (EXCEPT LEAVE GAP AT WEB PER DETAILS).
6. CUT OUT WELD INTERSECTIONS OF BOX PLATES TO WEB AND HORIZONTAL PLATE.
