Fracture Critical Member (FCM) Inspection Procedure

Inspection Responsibility:	ODOT District 12
County-Route-SLM:	CUY-480-0647
Structural File Number:	1812831
Inspection Frequency:	24 Months
Fatigue Life Study:	Year of Study: <u>Not Calculated</u> Remaining Fatigue Life: <u>Not Calculated</u>
Load Path Redundant:	Main Spans: <u>No, Each structure is a three-girder system at 25'-6" spacing, and floorbeam spacing exceeds 14'.</u> Approach Spans: <u>None.</u>
Structurally Redundant:	<u>No, Girders are continuous spans.</u>
Internally Redundant:	<u>No, Tension members consist of welded built-up plate girders and built-up/rolled I-section members.</u>
System Redundant:	<u>No rigorous analysis performed (i.e. finite element, 3-D modeling)</u>

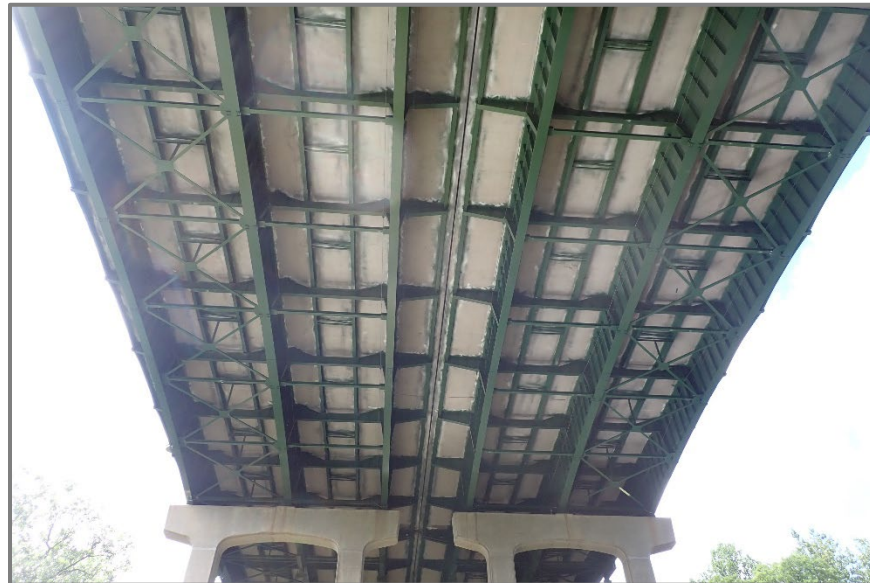
Figure 3 – CUY-480-0647 superstructure underside, looking west in Span 7.

The fracture critical members on this structure include all main girders (Girders A through F) and all floorbeams (Floorbeams 1 through 72).
