Defect Listing

Pipe Segment Reference CSO099A0010-CSO099A0009	City CLEVELAND	Street E 38th st	Material Corrugated Metal Pipe		Location Code Easement/Right of Way	Sewer Use Combined Pipe
Upstream MH CSO099A0010	Total Length 205.3	Year Laid	Shape Circular		Location Details	
Downstream MH CSO099A0009	Length surveyed 205.3	Year Renewed	Height 48	Width	Pipe Joint Length

SPR	30	MPR	13	PO Number	Customer HDR
SPRI	3	MPRI	2.2	Work Order	Purpose Routine Assessment
QSR	3A00	QMR	3125		
OPR	43	Surveyed By Shawn_Dunnell	Direction Downstream	Date 11/21/2022	Media label
OPRI	2.7	Certificate Number 07001437	Pre-Cleaning No Pre-Cleaning	Time 09:56	Weather Snow
		Date Cleaned		End Time 10:08	Additional Info

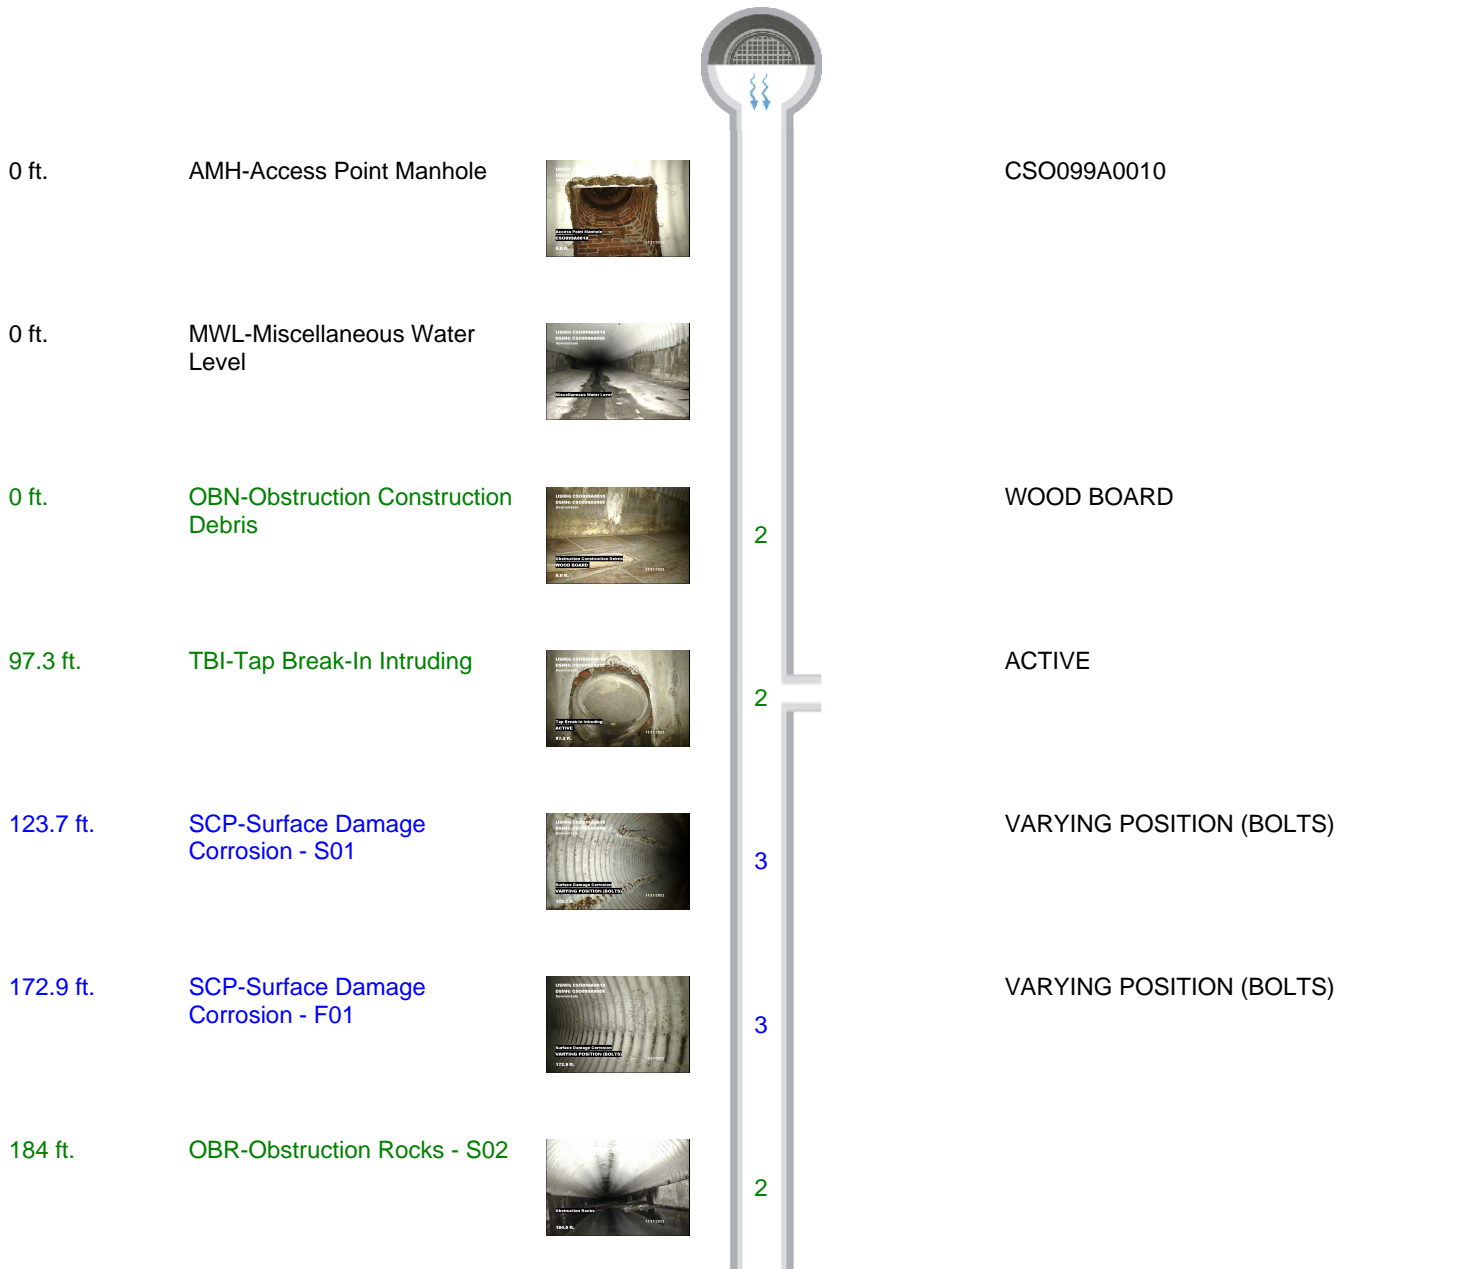
Defect Listing Plot

Distance	Condition	Cont. Dfct.	Values			Joint	Clock Position		Grade
			1st	2nd	%		At/From	To	
0	AMH-Access Point Manhole					<input type="checkbox"/>			
Remarks: CSO099A0010									
0	MWL-Miscellaneous Water Level				5	<input type="checkbox"/>			
0	OBN-Obstruction Construction Debris				5	<input type="checkbox"/>	6		2
Remarks: WOOD BOARD

97.3	TBI-Tap Break-In Intruding		18	4		<input type="checkbox"/>	9		2
Remarks: ACTIVE									
123.7	SCP-Surface Damage Corrosion	S01				<input type="checkbox"/>	11	1	3
Remarks: VARYING POSITION (BOLTS)

172.9	SCP-Surface Damage Corrosion	F01				<input type="checkbox"/>	11	1	3
Remarks: VARYING POSITION (BOLTS)									
184	OBR-Obstruction Rocks	S02			5	<input type="checkbox"/>	5	7	2

205.3	MSA-Miscellaneous Survey Abandoned					<input type="checkbox"/>			
Remarks: HEAVY DEBRIS THROUGHOUT
