Defect Listing

Pipe Segment Reference CSO099A0010A-CSO099A0010	City CLEVELAND	Street E 38th st	Material Corrugated Metal Pipe		Location Code Easement/Right of Way	Sewer Use Combined Pipe
Upstream MH CSO099A0010A	Total Length 44.1	Year Laid	Shape Circular		Location Details E 38TH	
Downstream MH CSO099A0010	Length surveyed 44.1	Year Renewed	Height 48	Width	Pipe Joint Length

4 Image Report

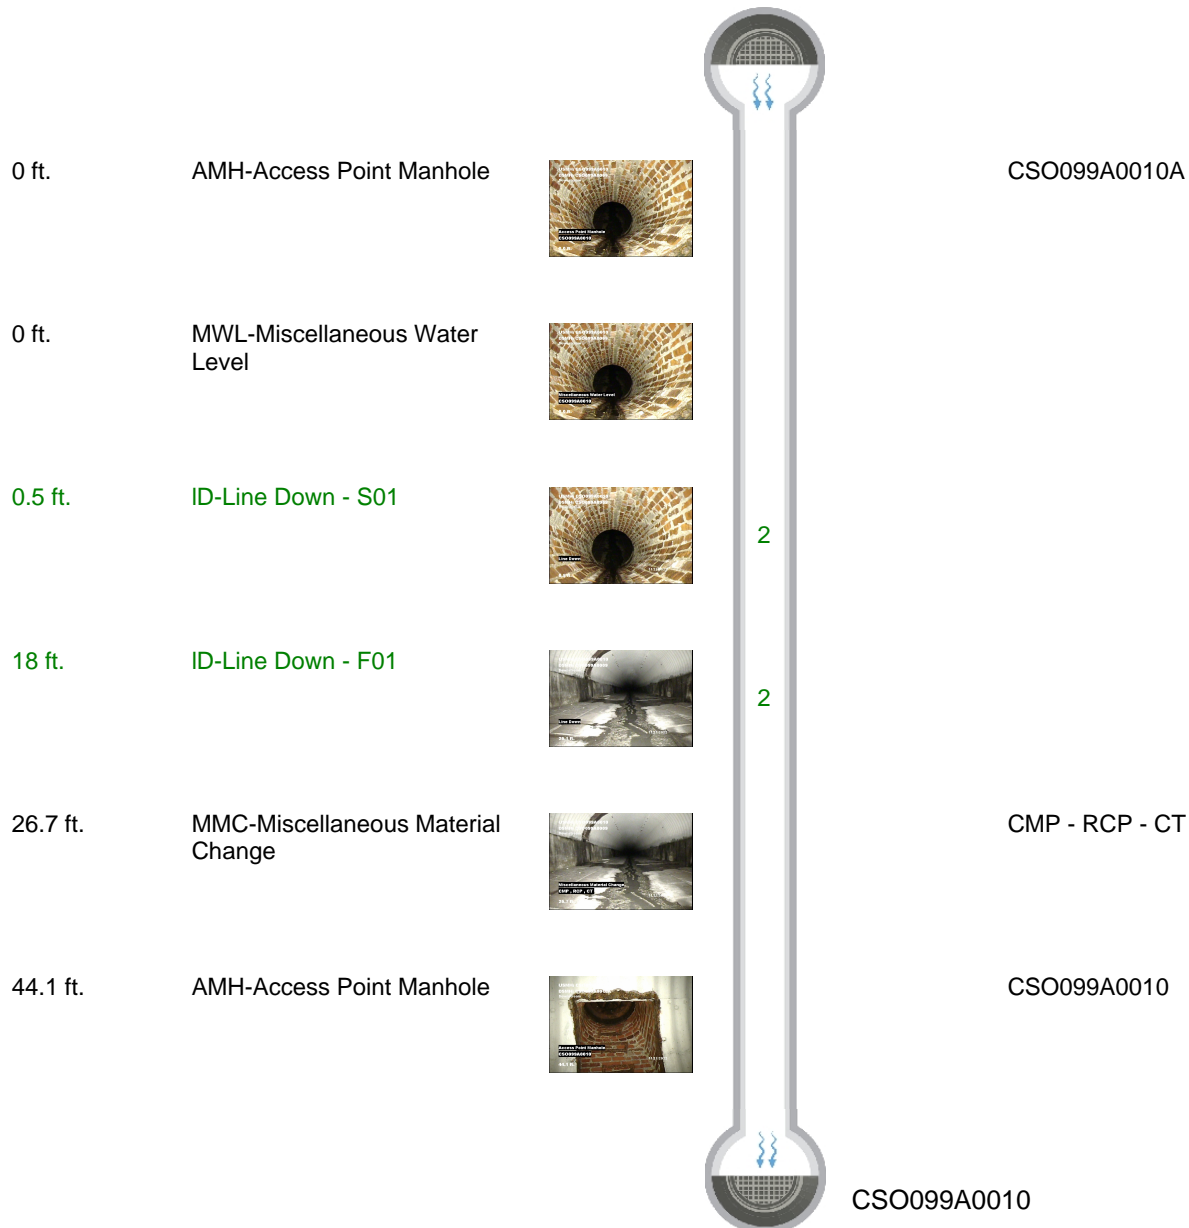
Defect Listing Plot

Distance	Condition	Cont. Dfct.	Values			Joint	Clock Position		Grade
			1st	2nd	%		At/From	To	
0	AMH-Access Point Manhole					<input type="checkbox"/>			
Remarks: CSO099A0010A									
0	MWL-Miscellaneous Water Level				5	<input type="checkbox"/>			
0.5	ID-Line Down	S01			15	<input type="checkbox"/>			2
18	ID-Line Down	F01			15	<input type="checkbox"/>			2
26.7	MMC-Miscellaneous Material Change					<input type="checkbox"/>			
Remarks: CMP - RCP - CT									
44.1	AMH-Access Point Manhole					<input type="checkbox"/>			
Remarks: CSO099A0010
