## Defect Listing

<b>Pipe Segment Reference</b> CSO200A0004-CSO200A0003	<b>City</b> CLEVELAND	<b>Street</b> MARGINAL	<b>Material</b> Corrugated Metal Pipe		<b>Location Code</b> Airport	<b>Sewer Use</b> Combined Pipe
<b>Upstream MH</b> CSO200A0004	Total Length 297.7	Year Laid	<b>Shape</b> Arched		Location Details BURKE AIRPORT	
<b>Downstream MH</b> CSO200A0003	Length surveyed 297.7	Year Renewed	<b>Height</b> 93	<b>Width</b> 150	Pipe Joint Length

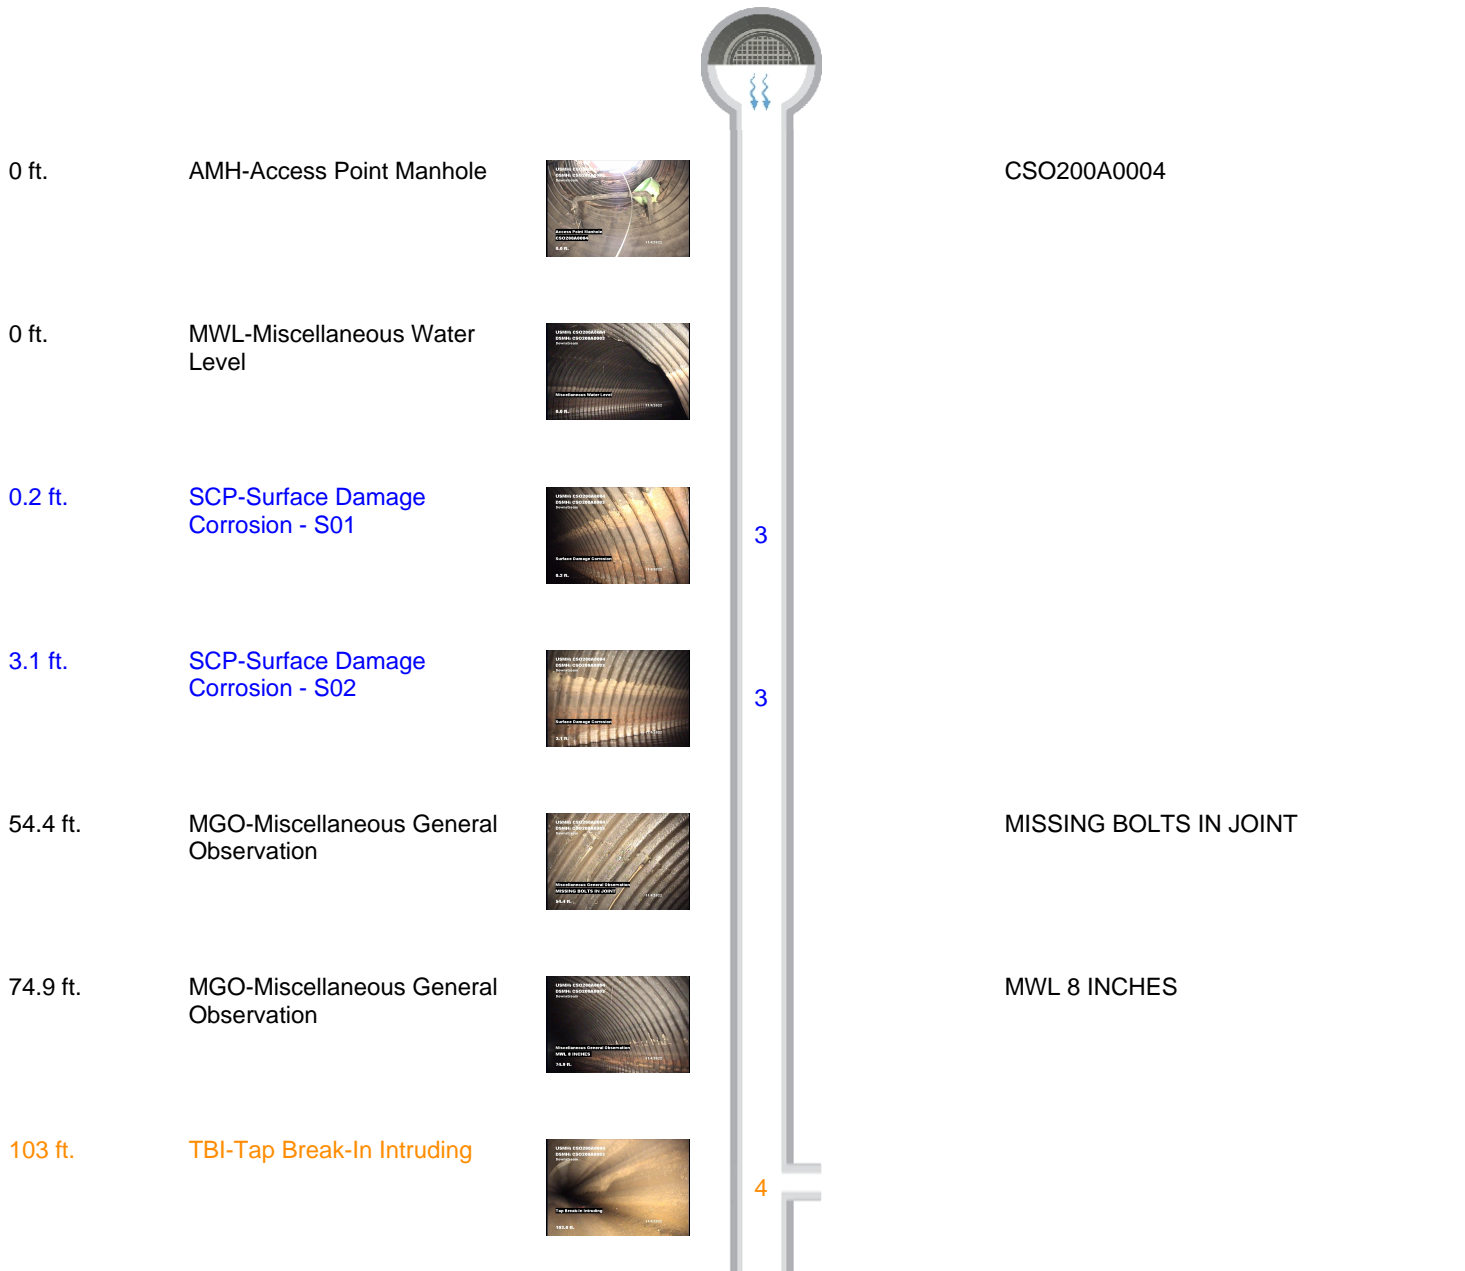
## Defect Listing Plot

0.2	SCP-Surface Damage Corrosion	S01				<input type="checkbox"/>	2	5	3
3.1	SCP-Surface Damage Corrosion	S02				<input type="checkbox"/>	7	10	3
54.4	MGO-Miscellaneous General Observation					<input type="checkbox"/>			
<b>Remarks:</b> MISSING BOLTS IN JOINT

74.9	MGO-Miscellaneous General Observation					<input type="checkbox"/>			
<b>Remarks:</b> MWL 8 INCHES									
103	TBI-Tap Break-In Intruding		36	24		<input type="checkbox"/>	9		4

163.3	TB-Tap Break-in/Hammer		12			<input type="checkbox"/>	1		
174.9	MGO-Miscellaneous General Observation					<input type="checkbox"/>			
<b>Remarks:</b> 15 INCHES

202.3	OBR-Obstruction Rocks				0	<input type="checkbox"/>	6		2
<b>Remarks:</b> LES THAN 5%									
293.3	SCP-Surface Damage Corrosion	F02				<input type="checkbox"/>	7	10	3

295.7	SCP-Surface Damage Corrosion	F01				<input type="checkbox"/>	2	5	3
297.7	AMH-Access Point Manhole					<input type="checkbox"/>			
<b>Remarks:</b> CSO200A0003
