Defect Listing

Pipe Segment Reference CSO200A0005-CSO200A0004	City CLEVELAND	Street MARGINAL	Material Corrugated Metal Pipe		Location Code Airport	Sewer Use Combined Pipe
Upstream MH CSO200A0005	Total Length 127.4	Year Laid	Shape Arched		Location Details BURKE AIRPORT	
Downstream MH CSO200A0004	Length surveyed 127.4	Year Renewed	Height 93	Width 150	Pipe Joint Length

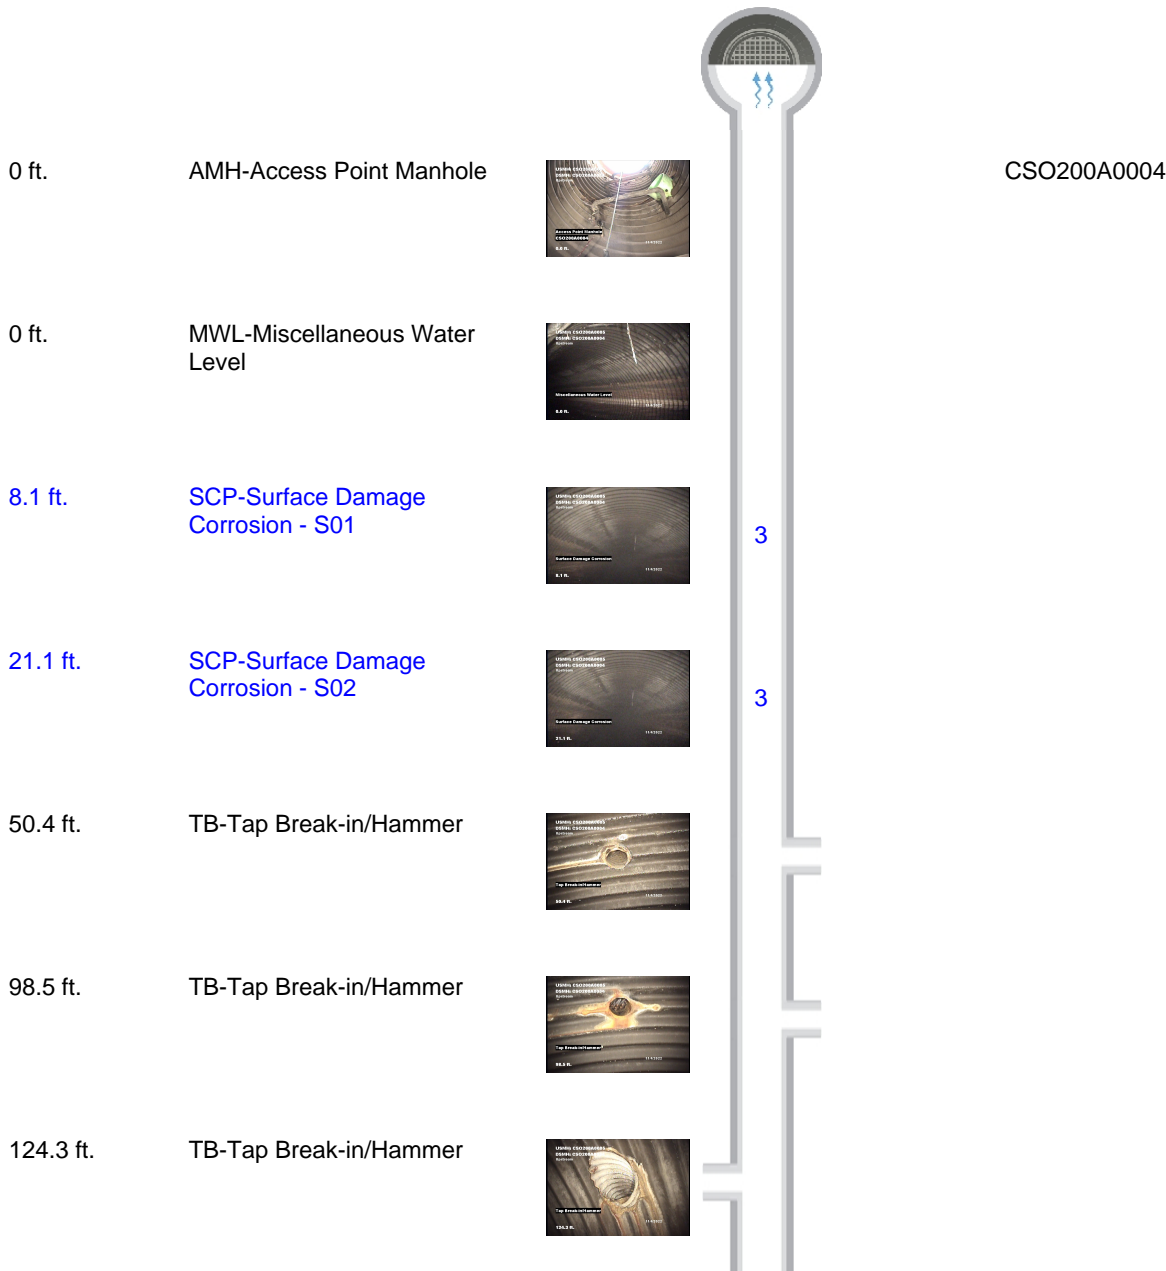
Defect Listing Plot

Distance	Condition	Cont. Dfct.	Values			Joint	Clock Position		Grade
			1st	2nd	%		At/From	To	
0	AMH-Access Point Manhole					<input type="checkbox"/>			
Remarks: CSO200A0004									
0	MWL-Miscellaneous Water Level				20	<input type="checkbox"/>			
8.1	SCP-Surface Damage Corrosion	S01				<input type="checkbox"/>	7	8	3
21.1	SCP-Surface Damage Corrosion	S02				<input type="checkbox"/>	2	5	3
50.4	TB-Tap Break-in/Hammer		6			<input type="checkbox"/>	12		
98.5	TB-Tap Break-in/Hammer		6			<input type="checkbox"/>	12		
124.3	TB-Tap Break-in/Hammer		12			<input type="checkbox"/>	2		
127.3	SCP-Surface Damage Corrosion	F02				<input type="checkbox"/>	2	5	3
127.3	SCP-Surface Damage Corrosion	F01				<input type="checkbox"/>	7	8	3
127.4	AMH-Access Point Manhole					<input type="checkbox"/>			
Remarks: CSO200A0005
