2018 UPDATE TO 2017 PHYSICAL CONDITION INSPECTION REPORT

Bridge CUY-490-0100

SFN 1811991

I-490 Bridge over the Cuyahoga River Valley

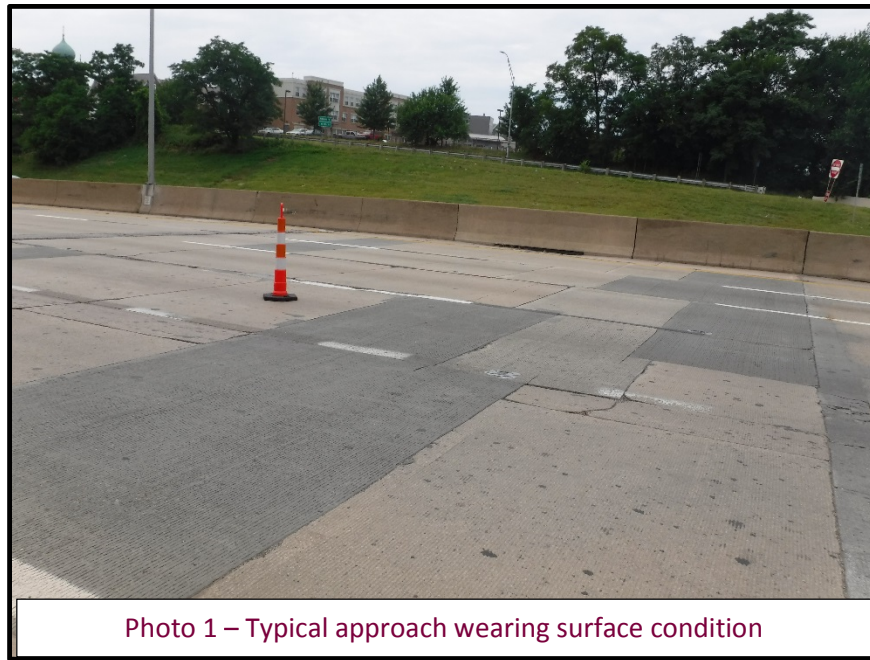
The approach pavement is in **fair** condition. The approach wearing surface is asphalt concrete. All of the mainline and ramp approaches have concrete and asphalt patches throughout. About 10% of the approach wearing surfaces have existing patches or need to be patched; these areas are exposing the underlying base. The approach wearing surfaces typically have potholes and patched areas that are unsound and breaking apart (see Photo 1). Longitudinal and transverse cracks are also common throughout all approach wearing surfaces.

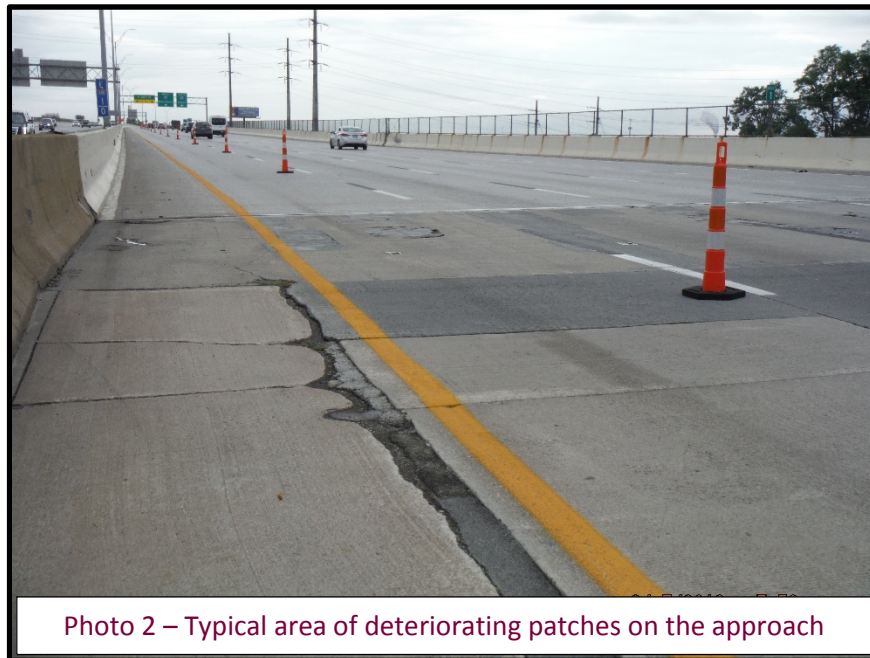
The approach slabs are in **fair** condition. Approximately 10% of the mainline approach slabs have been patched or are in a distressed state and need to be patched. Several concrete patched areas have completely deteriorated and are filled with asphalt concrete (see Photo 2). The approach slabs of Ramp C-B, Ramp B-C and Ramp C-7 are in good condition. None of the approach slabs appear to be settling and there is no evidence of undermining.

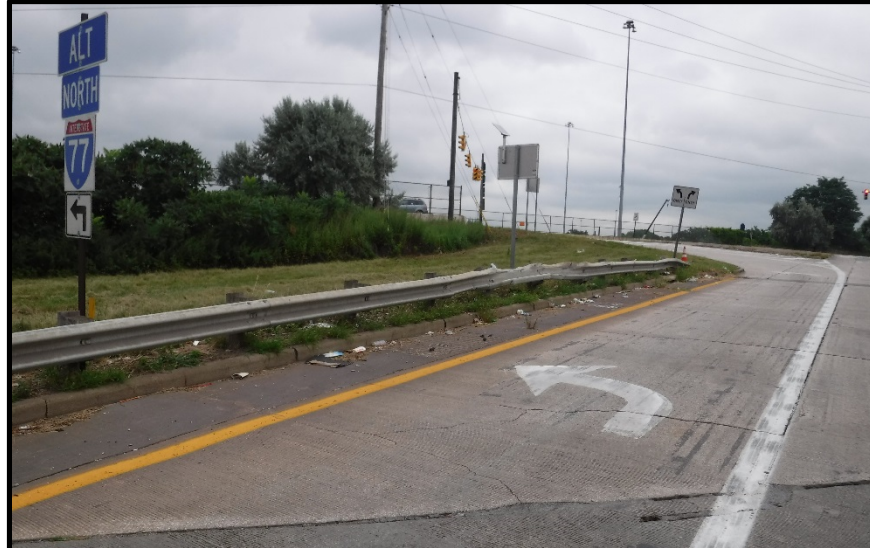
The guardrail is in **poor** condition. There are locations with minor cracking with rust staining at the guardrail connections to the concrete parapet. Two locations have sustained collision damage and are in serious condition. The guardrail on the North side of Ramp C-B is severely damaged and four (4) posts are bent and misaligned (see Photo 4). The guardrail on the South side of the Eastbound Forward Abutment is severely damaged with multiple posts that are missing or are damaged and the guardrail thrie-beam is misaligned and bent (see Photo 5). The remaining five (5) guardrail runs are in good condition exhibiting only minor scrapes and dents throughout. The concrete parapets on all of the approach slabs are in good condition with minor vertical cracks and minor spalls throughout. Minor map cracking is present at the Eastbound Mainline Forward Abutment parapet faces. There is one (1) significant spall with exposed reinforcing steel and cracking throughout the parapet faces at the Westbound mainline, South side (see Photo 6).

Photo 4 – Collision damage at the North side of the Eastbound Ramp C-B guardrail

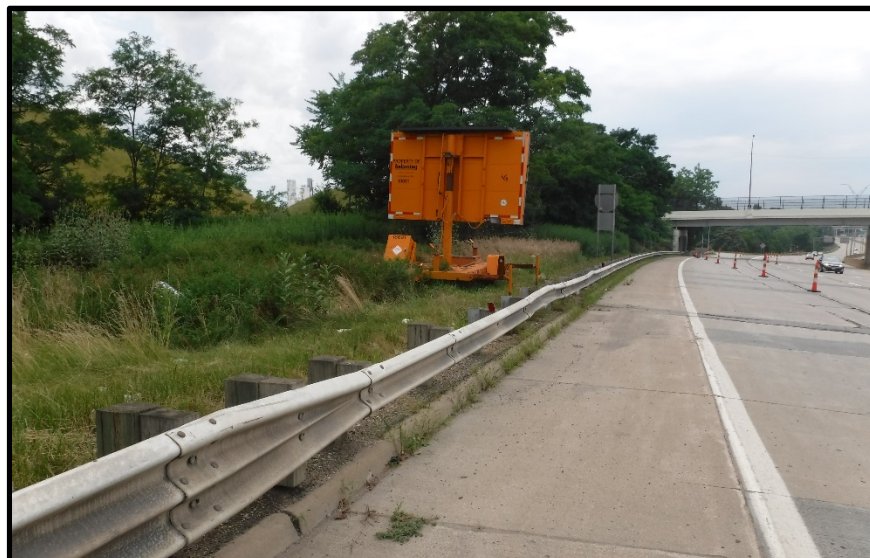
Photo 5 – Eastbound Mainline West Abutment, South shoulder guardrail damage

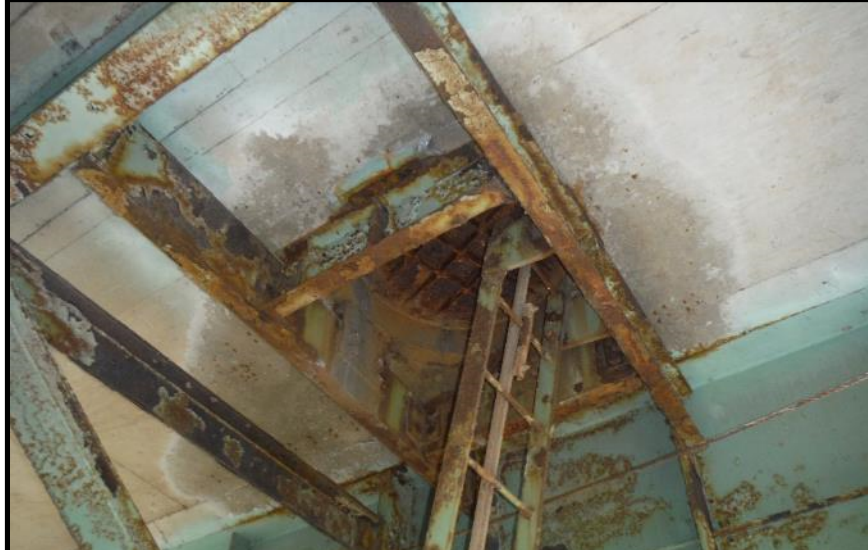
The concrete around the pier access manholes is damp and saturated in most locations (see Photo 9). The concrete appears to have minor cracks and rust staining in these areas. There is an open deck core just West of Pier 10 between Girder 3-F and Stringer 3-5. The open core is allowing water to leak through the deck and saturate the concrete around the core (see Photo 10).

Photo 9 – Manhole at Pier 14R with saturated concrete and minor rust staining

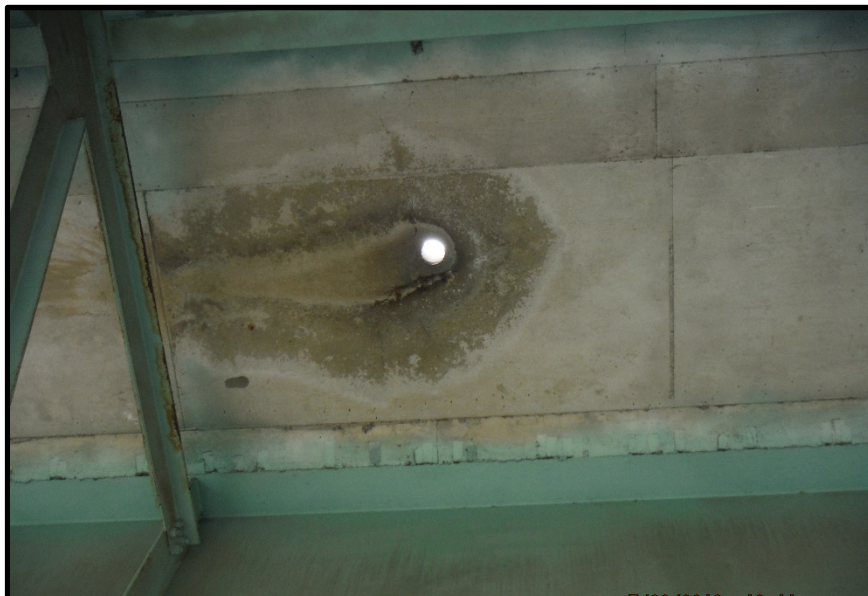
Photo 10 – Open deck core with saturated concrete West of Pier 10

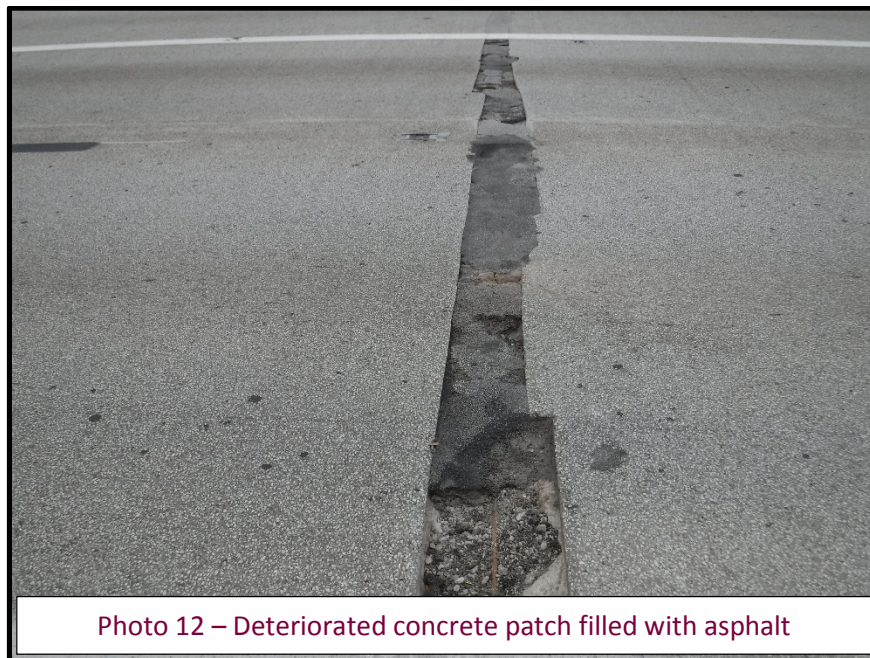
The Wearing Surface is in **good** condition. The wearing surface was visually inspected by walking the deck during the lane closures used for the snoopers inspection and an additional lane closure on the median sides. The wearing surface has transverse and longitudinal cracks throughout, which is allowing water to seep into the concrete deck and promoting deterioration of the floor. Most of the raised pavement markers are missing leaving approximately 6 inch by 6 inch by 1-inch-deep crevices in the deck where water ponds during rainy weather conditions. There are multiple locations of patches, some of which are concrete and some of which are asphalt concrete. In most cases, the patches seem to be performing and are in good condition; however, there are locations where patches are deteriorated. In some of these areas, asphalt patches have been placed over concrete patches (see Photo 12). These patches are common along the transverse deck pour construction joints.

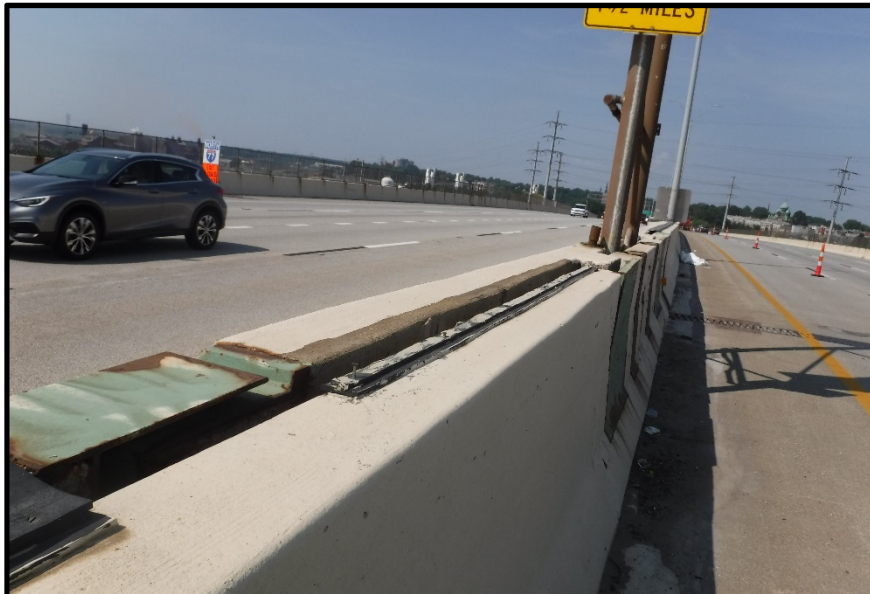
The reinforced concrete median parapets are in **fair** condition. There are multiple locations of cracking, mostly vertical, and spalls on the parapet faces. There are locations where the neoprene cover is missing from on top of the median, most notably on Span 13 and Span 14 (see Photo 13). **There is significant cracking and spalling with exposed reinforcing steel at the expansion joint plates and at sign support plates** (see Photo 14).

Photo 13 – Neoprene cover missing from the top of the median

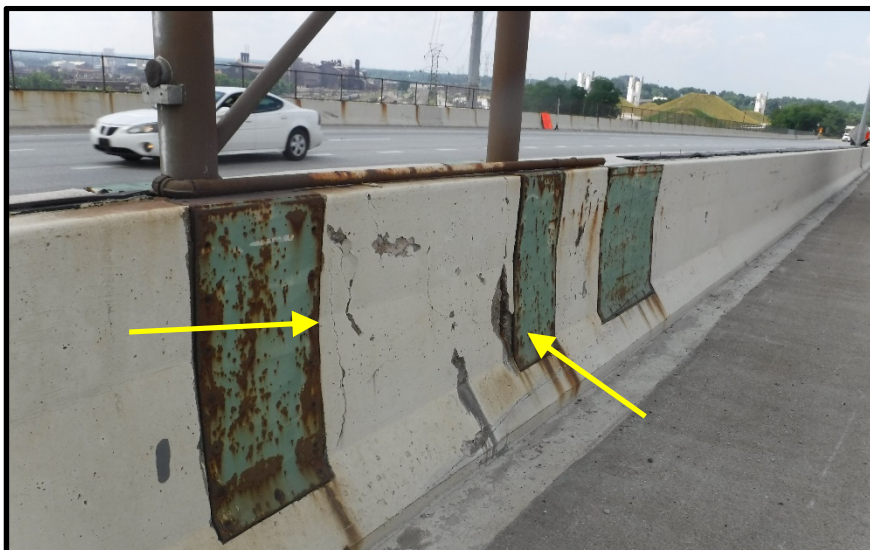
Photo 14 – Spalled and cracked median with exposed reinforcing steel at sign support plates

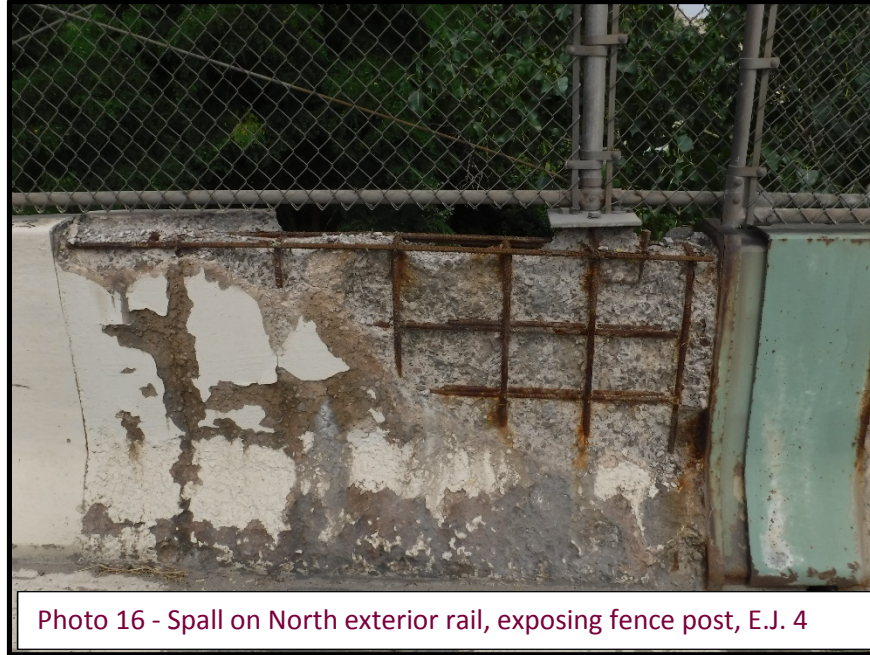
Large spalls with exposed and corroded rebar exist on both faces of the concrete parapet (see Photo 15). There are locations of spalling on the exterior side of the parapet which fully expose the vandal protection fence posts (see Photo 16). The majority of spalling occurs near fence posts. It is likely caused by the fence post anchors being drilled after the parapets were poured. In doing so the rebar in the parapet can be impacted and propagate a crack in the concrete. As water intrudes the crack and the freeze-thaw cycle continues, the crack expands and develops into a spall.

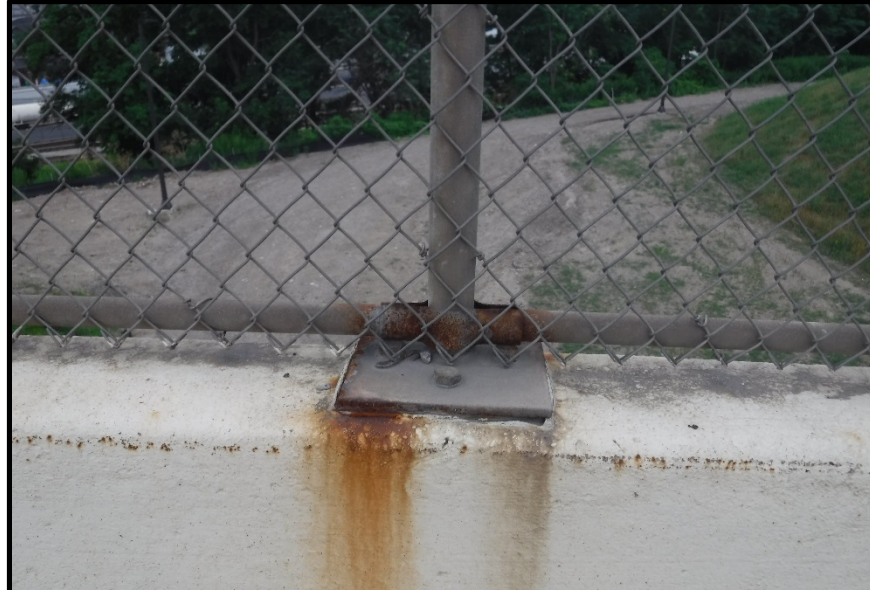
The fence on top of the parapet is in poor condition with many deficiencies throughout the length of the bridge. There are several locations on the Eastbound side where the fence fabric has been damaged and the fence posts are bent. At random locations throughout the bridge, the pack rust around the fence is prying up the fence base plate; this has also caused deterioration of the caulk around the base plates (see Photo 17). Many of the fence gates are unlocked. There are multiple locations where the horizontal rail splices are broken due to heavy corrosion. The East half of the exterior Eastbound fence has multiple locations where the horizontal rail to post connection has failed or is badly deteriorated due to heavy corrosion at the down-slope end of the rail (see Photo 18).

Photo 17 – Fence base plate separating from concrete in Span 5

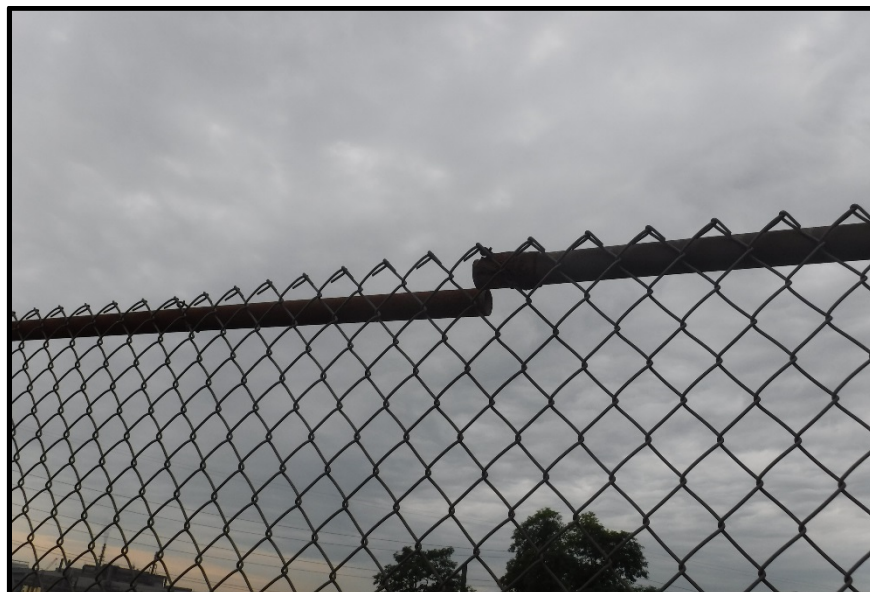
Photo 18 – Bottom railing failed due to corrosion at Span 14

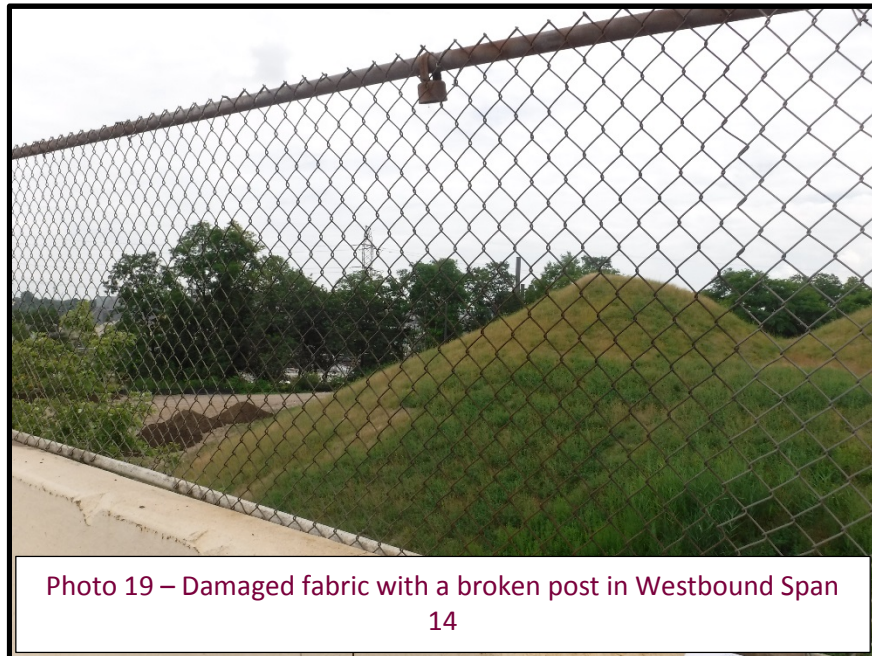
There are long stretches of fence with damaged diamond mesh fabric and with broken, missing or bent fence posts. 120 feet of damaged fence with a bent post is located on Westbound Span 16. Westbound Span 14 has 20 feet of damaged fabric with a broken post. Westbound Span 7 has over 40 feet of damaged and loose fabric. Eastbound Span 1 has one (1) fence post missing, effectively doubling the fabric span length (see Photo 19).

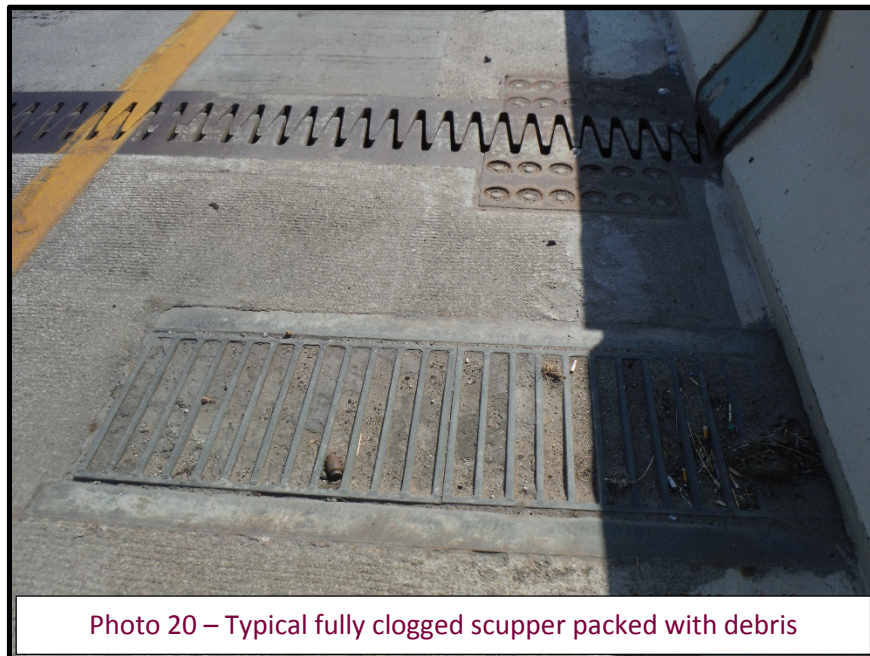
Only one (1) scupper on the deck flows freely, without debris, on the Eastbound structure and no scuppers flow freely on the Westbound structure. Most of the scuppers are partially clogged with six (6) scuppers being completely plugged and not conveying any water (see Photo 20). Loose trash and debris on the deck is accumulating near the scuppers. There is a loose scupper grate in the right exit lane on the Eastbound direction, it is the first scupper west of Expansion Joint 4. This scupper makes a loud banging noise when driven over.

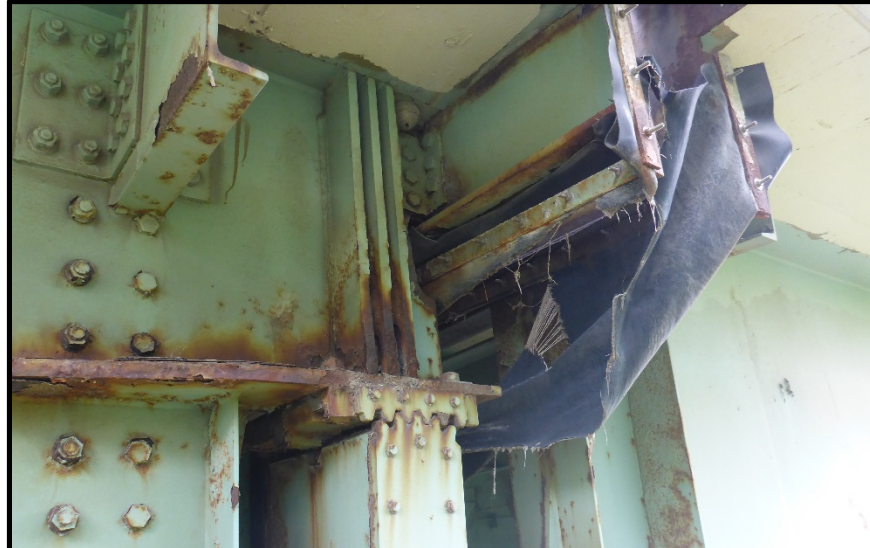
The neoprene drainage troughs run transversely below the finger expansion joints, they are mostly clogged and overflowing with debris. There are multiple locations where the neoprene troughs are torn open, leaking debris and water onto the steel framing below (see Photo 21). There are also several locations where the troughs are full of debris and missing bolts. Because the drainage troughs are full of debris or broken, drainage from the finger joint spills out of the drainage system and onto the piers and structural steel below. This spillage is causing adverse effects to the structural steel and to the piers adjacent to the expansion joints. Another problematic area of the drainage system is the drain from the scuppers to the collector pipe. Many of the couplers are misaligned (see Photo 22). Several connections to the hoppers are also misaligned and filled with debris, slowing any flow of water. The owner of a local truck garage informed HDR & DLZ inspectors that the Pier 9 drainage system does not properly drain. The water spills out of the drainage system onto his property below and leaves a sheet of ice during the winter months where he turns his truck around. This is also located over the Norfolk Southern Railroad tracks and may cause problems to their rail system. Below is a list of the drainage trough deficiencies:

Photo 21 – Torn neoprene sheeting causing debris to spill onto the steel below

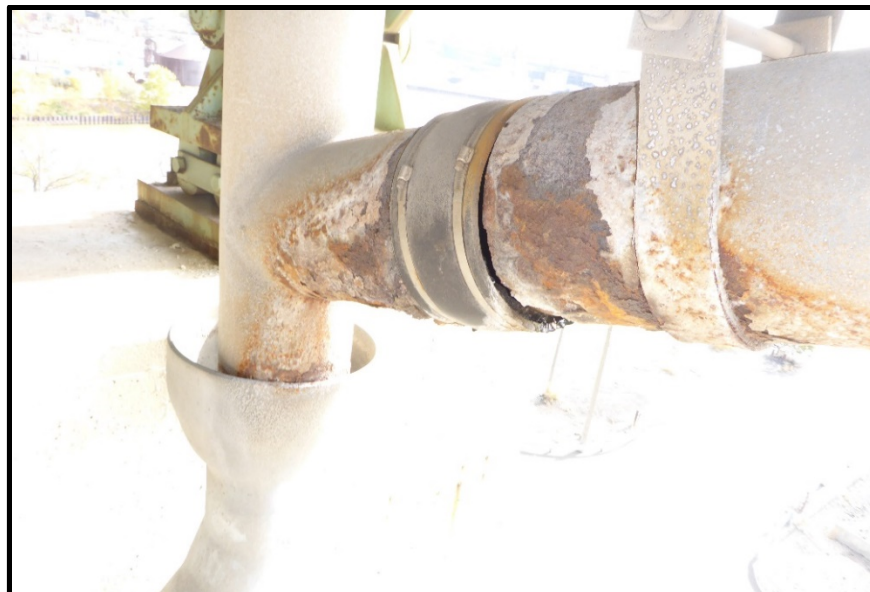
Photo 22 – Misaligned coupler at Pier 9 drainage spout

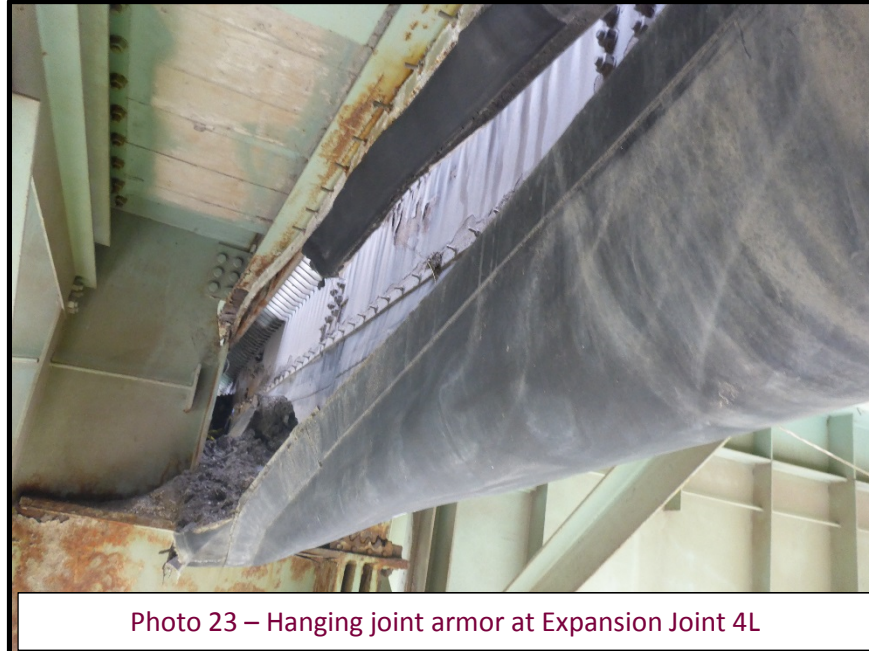
Photo 23 – Hanging joint armor at Expansion Joint 4L

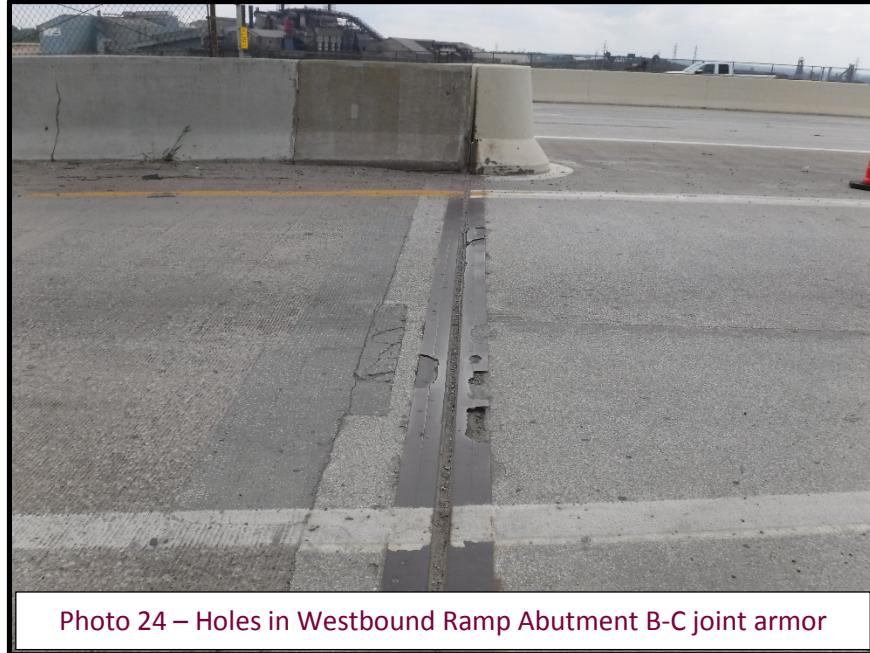
The mainline Eastbound Rear Abutment has several locations in which the steel joint is damaged and missing, and the Westbound entrance ramp joint at abutment B-C has similar damage (see Photo 24). These locations are in active travel lanes on Interstate 490 and could be deep enough to cause damage to a vehicle. The remaining abutment elastomeric strip seal joints are in good condition with only minor problems existing. Minor debris between the joints may prevent expansion between the joints. The elastomeric strip seals are present and prevent moisture from leaking onto the abutment backwalls. The expansion joint concrete headers exhibit spalling throughout causing potholes to form at the Rear and Forward Abutments.

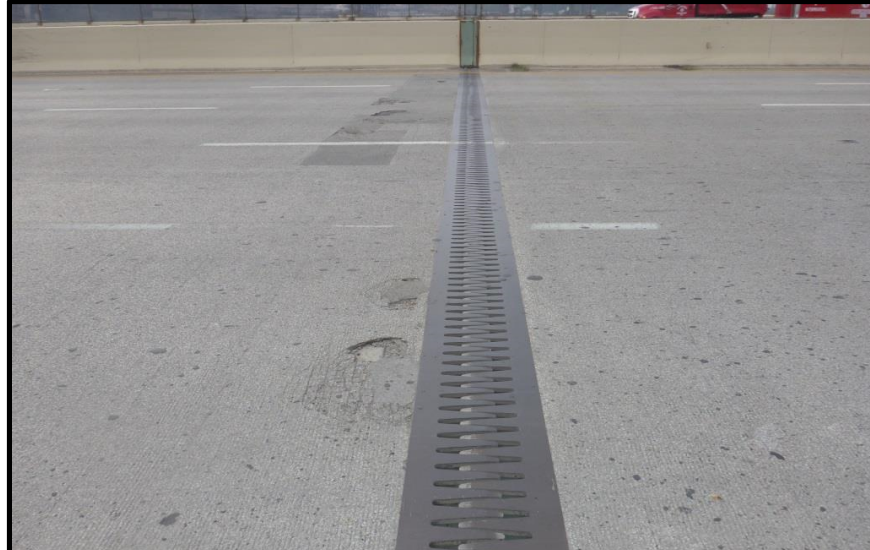
The intermediate finger joints have minor misalignment issues throughout, but are generally in good condition. Expansion Joint 2 fingers are misaligned horizontally, most notably at Westbound Expansion Joint 5 (see Photo 25). There are several areas of rust with most of the rust prevalent on the shoulders of the deck. Areas around the finger joints are patched but starting to deteriorate. Two teeth are missing from Westbound Expansion Joint 2 (see Photo 26).

Photo 25 – Transversely misaligned steel teeth at Westbound Expansion Joint 5

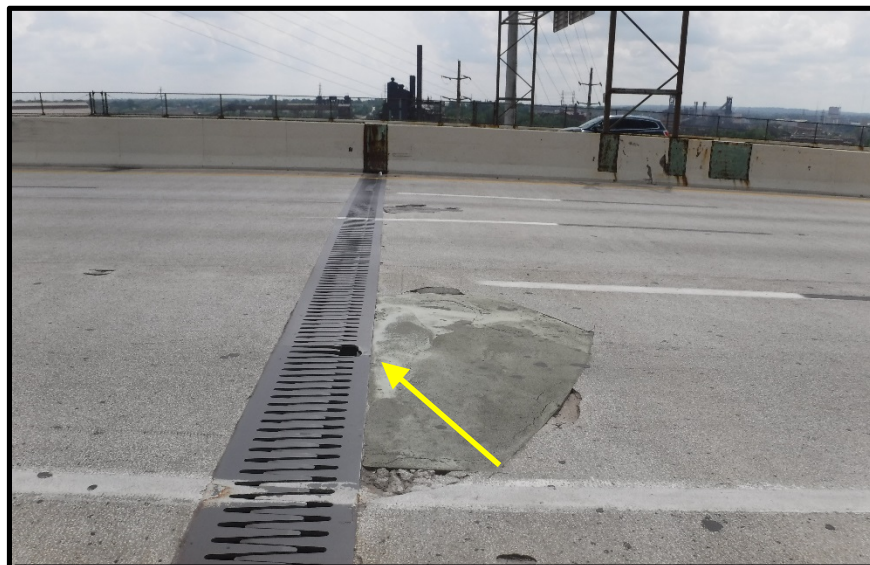
Photo 26 – Missing teeth at Westbound Expansion Joint 2; also note deck patch.

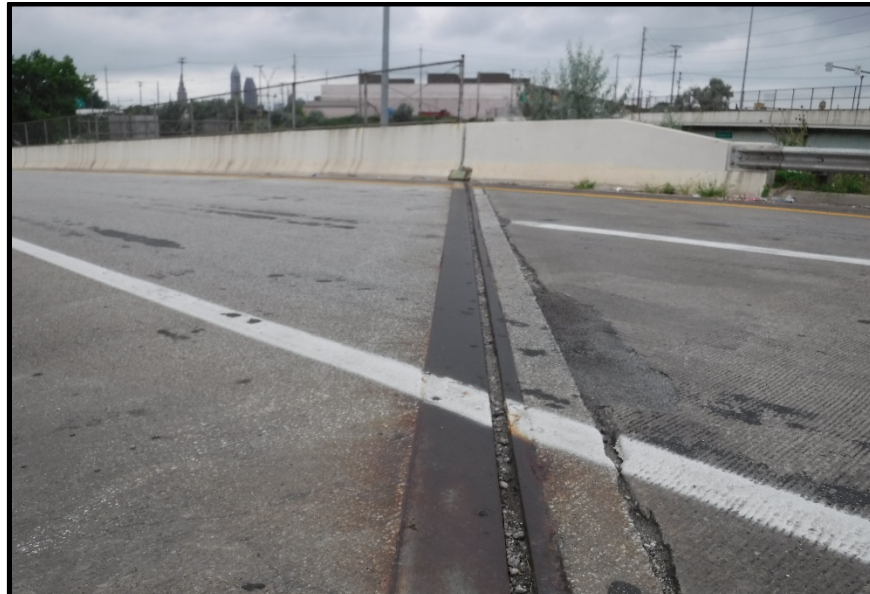
The sliding plate joints at the mainline Forward Abutments and at Ramp C-B are generally in good condition (see Photo 27). The joint sealer is not water tight and, based on the condition of the abutment backwalls, moisture is leaking onto the structure below. The leaking joint is causing corrosion and deterioration to the bridge deck, abutment, and steel members below the joint (see Photo 28).

Photo 27 – Typical sliding plate joint in good condition

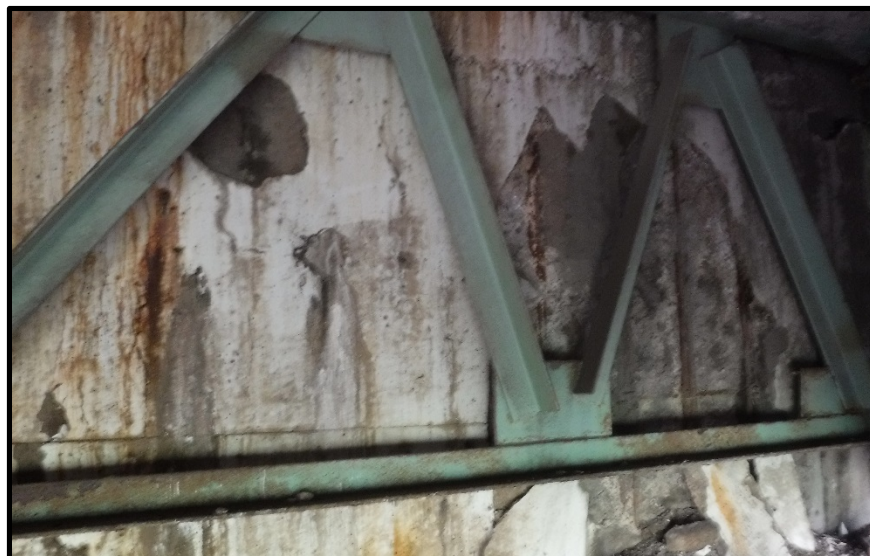
Photo 28 – Deterioration to Forward Abutment Backwall below sliding plate joint

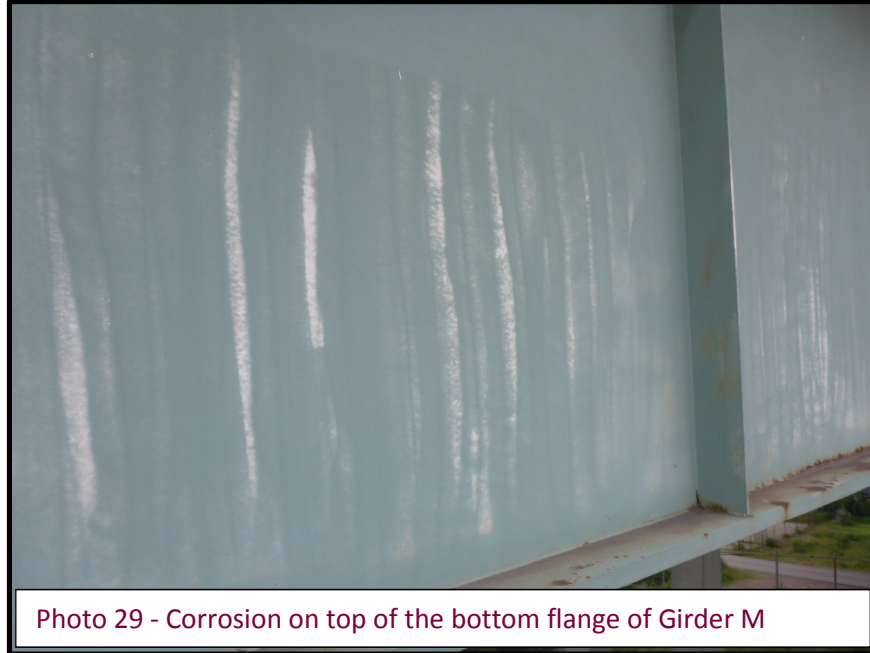
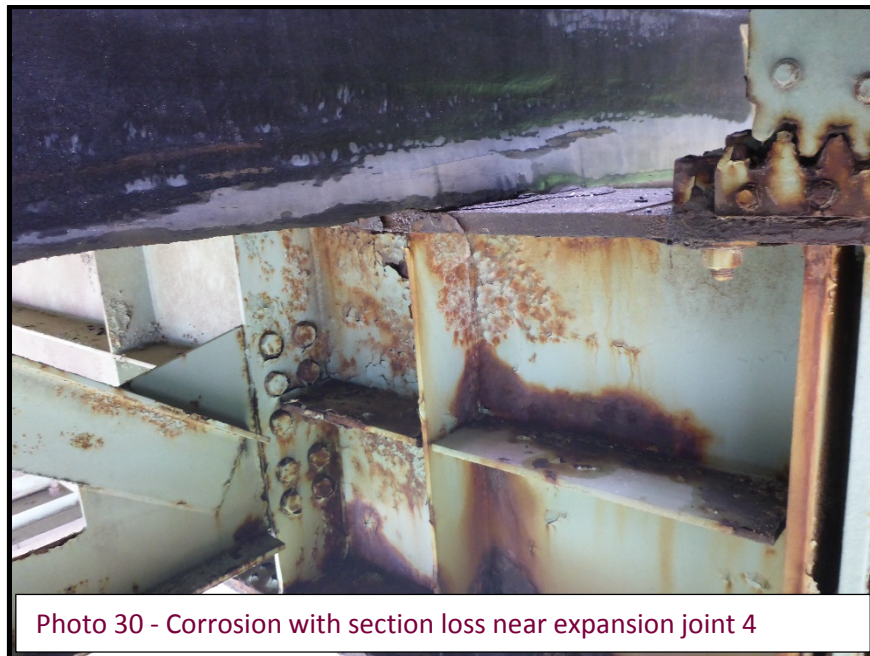
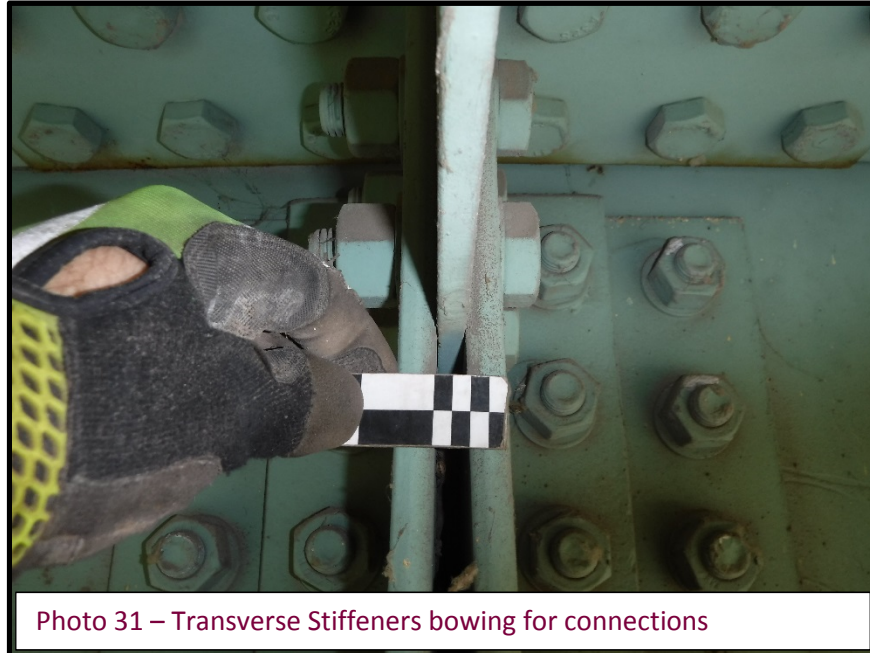
The Beams and Girders are in **good** condition. There are a large number of girder locations exhibiting peeling paint with corrosion or primer showing. Corrosion is common at the bottom of the webs and the tops of the bottom flanges along the fascia girders (see Photo 29). This corrosion is likely the result of water collecting and resting on the exterior sides of the beams during rain events and is consistent throughout the length of the bridge. Overall, corrosion is most active near the expansion joints. In these areas, the girders or beams exhibit heavier laminar rusting with moderate section loss up to 1/8" in some cases which typically extends about 10 to 15 feet on either side of the expansion joint (see Photo 30). **There are also several locations of the transverse stiffener bowed where located at a splice** (see Photo 31).

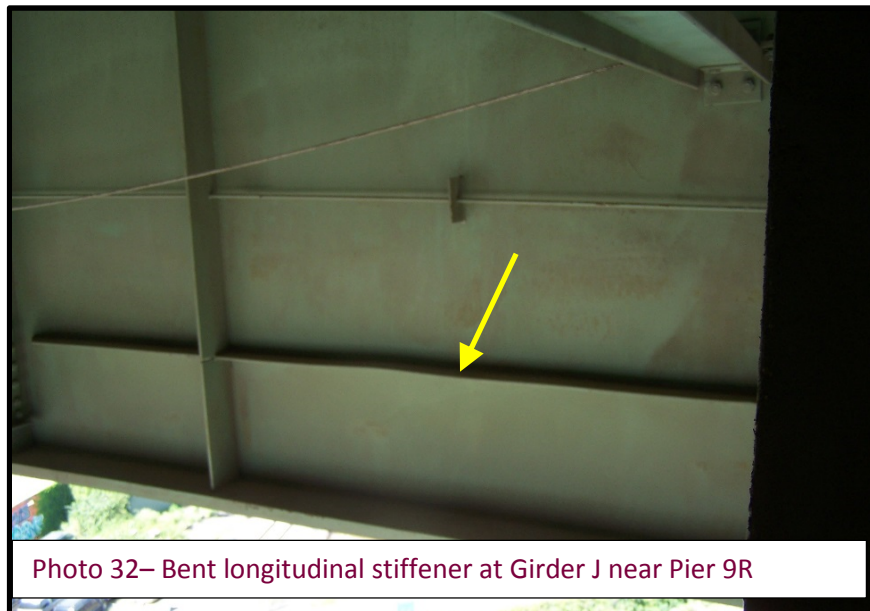
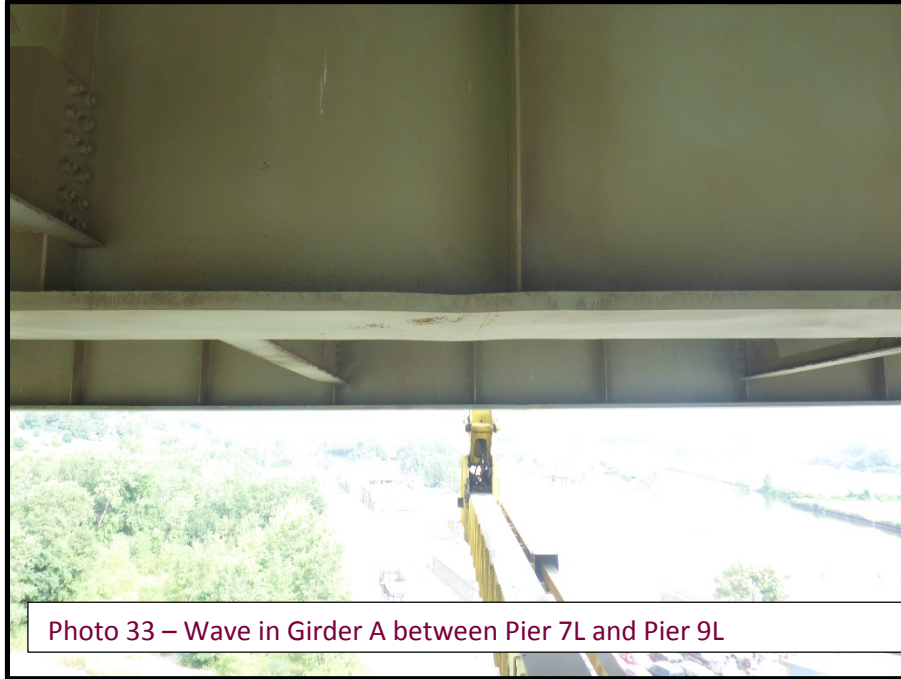
There are multiple locations where longitudinal stiffeners are slightly bent or bowed. The most severe bowed stiffener is at Girder J, Bay 12 between Pier 9R and 10R (see Photo 32). There are also multiple locations of misdrilled holes in the transverse stiffeners. These misdrilled holes are most likely handrail holes which were incorrectly placed or erection bolt holes that were drilled during construction to fit-up the crossframes. There is a location between Pier 7L and Pier 9L where the bottom girder flanges exhibit a wave which is most likely a fabrication or erection deficiency (see Photo 33).

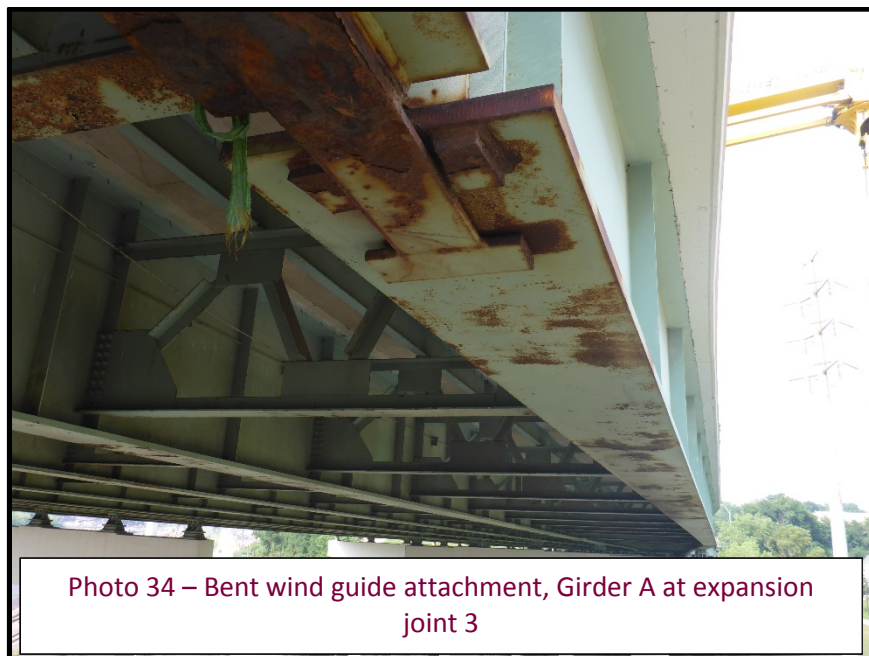
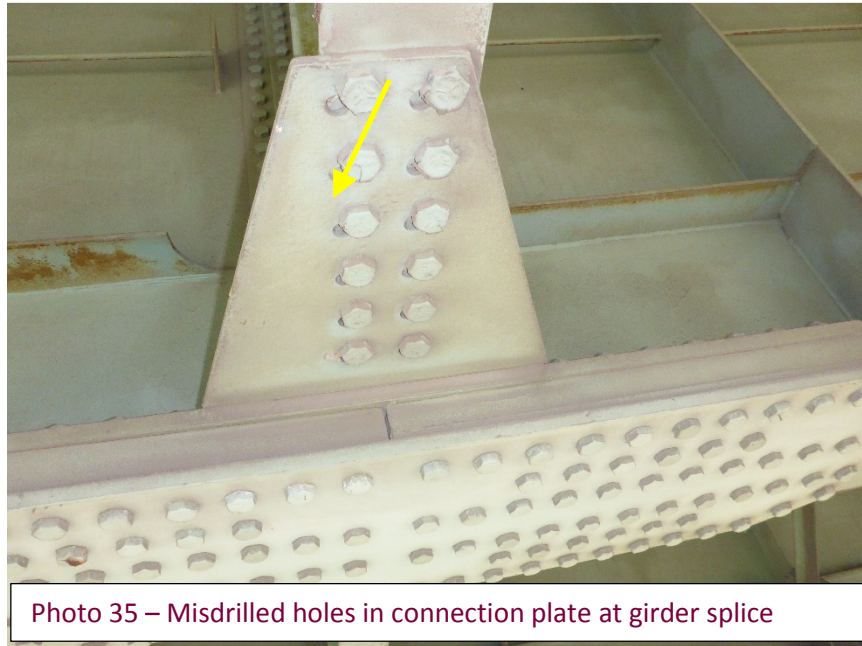
Multiple wind guide attachments are rusted and bent away from the girder (see Photo 34). **Many misdrilled holes were noted in the connection plates at splices** (see Photo 35).

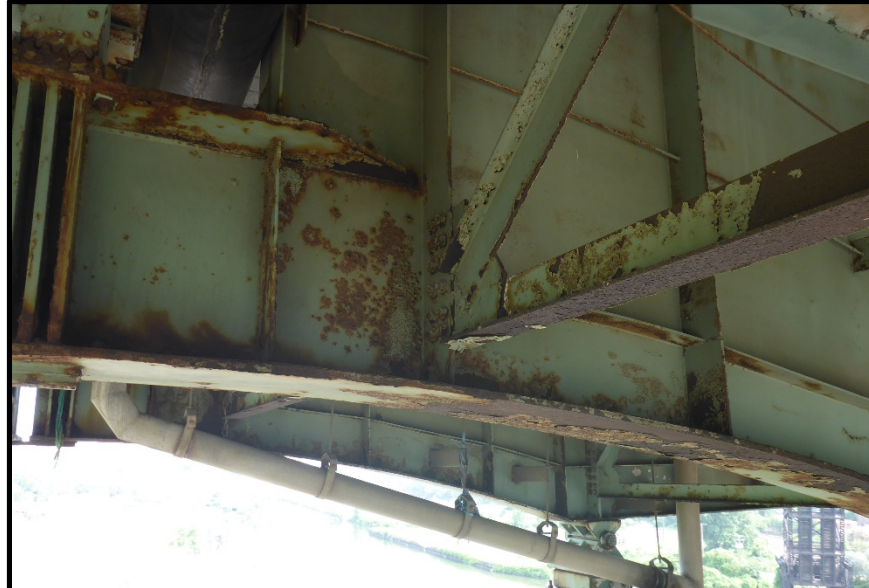
The X-frames are generally in **good** condition except at the deck joints. Units 1, 5, 6 and Ramp C-B have crossframes rated in this section. Girder crossframes in Units 2 through 4 are considered floorbeams. Most of the crossframes exhibit localized areas of peeling paint and light surface corrosion. The crossframes are in much worse condition at the abutments and under the expansion joints. These crossframes typically have advanced corrosion with severe section loss (see Photo 36).

Photo 36 - Crossframe corrosion near Expansion Joint

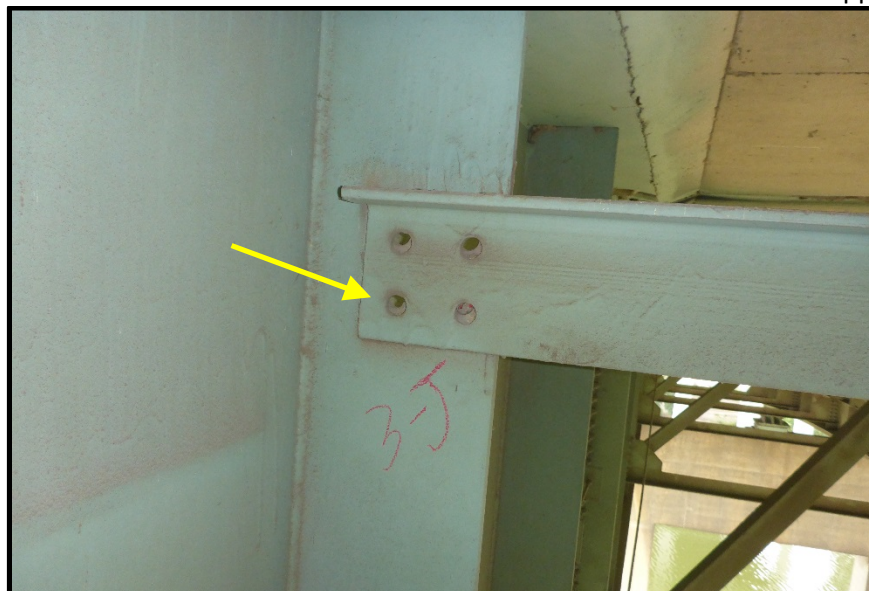
There are several locations throughout the length of the bridge where the crossframe connections to the girder or beam transverse stiffener have loose bolts, missing bolts or misdrilled holes (see Photo 37). Based on the PCS and the overall physical condition of the girders and crossframes, this defect does not negatively affect the surrounding members or the overall structure. A full list of these locations is shown in Appendix VI.

Photo 37 - Crossframe missing bolts in Unit 3 Span 3

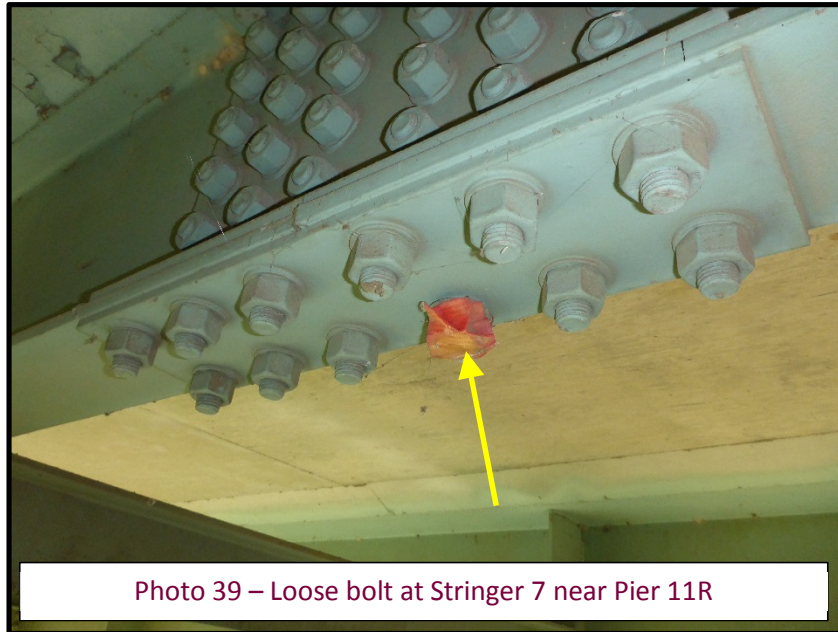
The stringers are in **good** condition. The most common area of corrosion is along the edge of the top flange of the stringer along the deck haunch (see Photo 38). The condition of the stringers worsens near the expansion joints and over the river, most likely due to the presence of moisture. There are some minor areas of corrosion and freckled rust at these locations, although no section loss or pitting is notable. Additionally, there are loose bolts in the bottom splice plates of Stringers 7 and 8 near Floorbeam 23 between Pier 10R and 11R (see Photo 39).

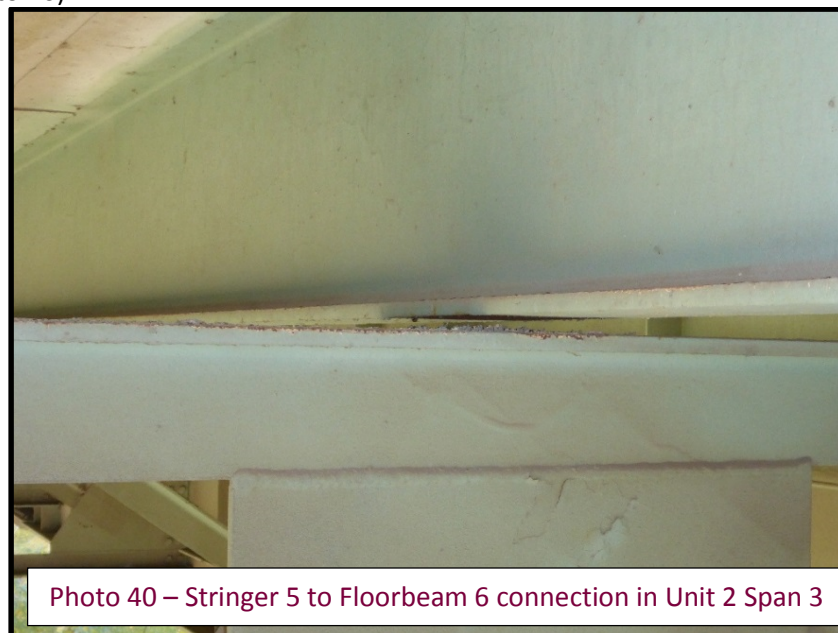
However, Stringer 5 at Floorbeam 6 in the span between Pier 6L and 7L is completely disconnected from the floorbeam and is floating. A half inch gap exists between the floorbeam and the stringer. The gap effectively doubles the span length of the stringer; however, the stringer and the area around it appear to be in good condition (see Photo 40).

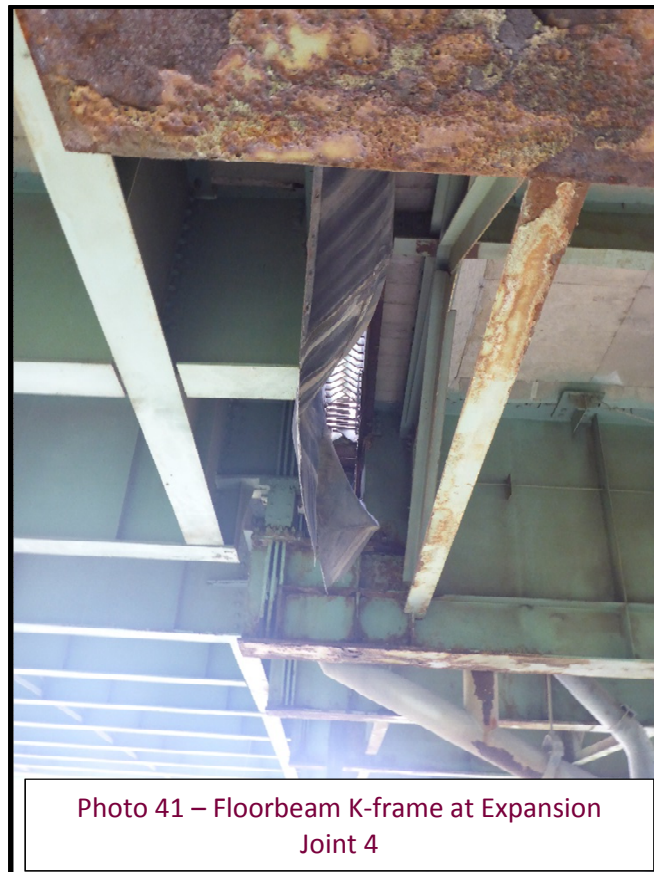
The Floorbeams are in **good** condition. Floorbeam K-frames are located in Units 3, 4 and 5, and are connected to the girder with bolts to the girder transverse stiffeners at the top and through the use of bolted connection plates at the base. The floorbeams located below the expansion joints are typically in worse condition than the other floorbeams. At most expansion joints, the floorbeams have active corrosion and rust because of the water falling from the clogged drainage system (see Photo 41). The remainder of the floorbeams exhibit areas of minor rust. Freckled rusting is common on the diagonal members of the K-frames.

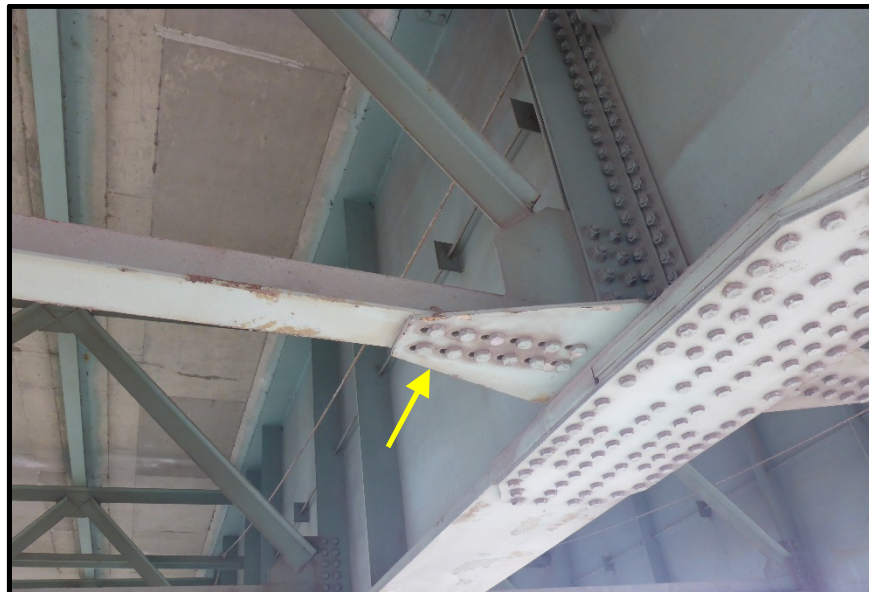
on the floorbeam connection plate or a portion of the floorbeam itself (see Photo 42). Based on the PCS and physical condition of the plate, these locations were most likely missed during construction and do not seem to be causing adverse effects on the structure. There are also locations where bolts were never installed, and, in one severe location on the 7th floorbeam located after Pier 11R, there are no bolts connecting the floorbeam to the top of the transverse stiffener on Girder J (see Photo 43). **In locations without bolts the floorbeams are welded to the girder connection plates.**

Photo 42 – Floorbeam misdrilled holes at connection plate

- Tighten loose bolts and replace missing bolts in cross-frames, floorbeams, stringers, bearings and hinges
 - Clean and repaint structural steel
 - Repair portions of safety cable which were incorrectly installed or missing
