2018 UPDATE TO 2017 PHYSICAL CONDITION INSPECTION REPORT

Bridge CUY-490-0100

SFN 1811991

I-490 Bridge over the Cuyahoga River Valley

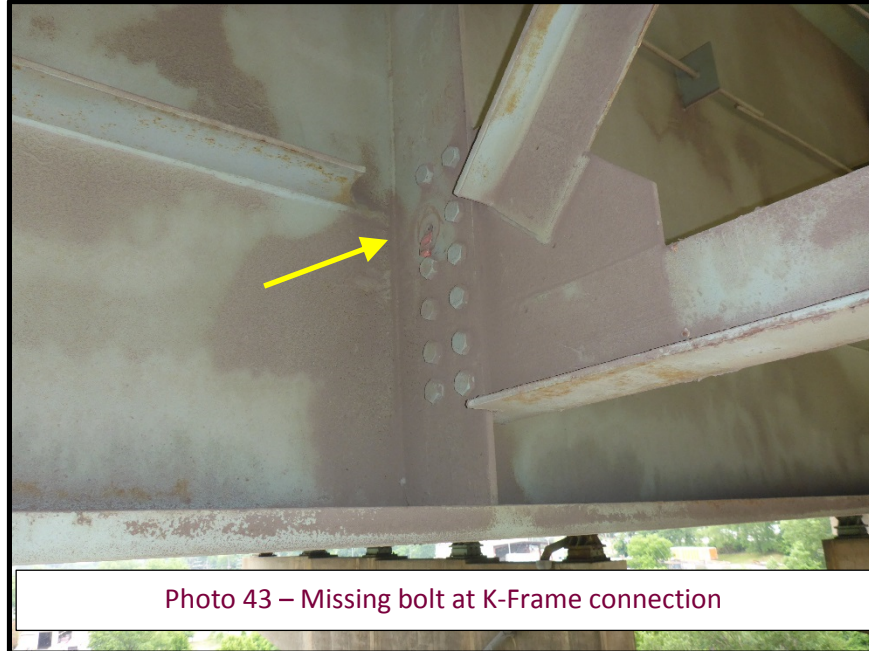
on the floorbeam connection plate or a portion of the floorbeam itself (see Photo 42). Based on the PCS and physical condition of the plate, these locations were most likely missed during construction and do not seem to be causing adverse effects on the structure. There are also locations where bolts were never installed, and, in one severe location on the 7th floorbeam located after Pier 11R, there are no bolts connecting the floorbeam to the top of the transverse stiffener on Girder J (see Photo 43). **In locations without bolts the floorbeams are welded to the girder connection plates.**

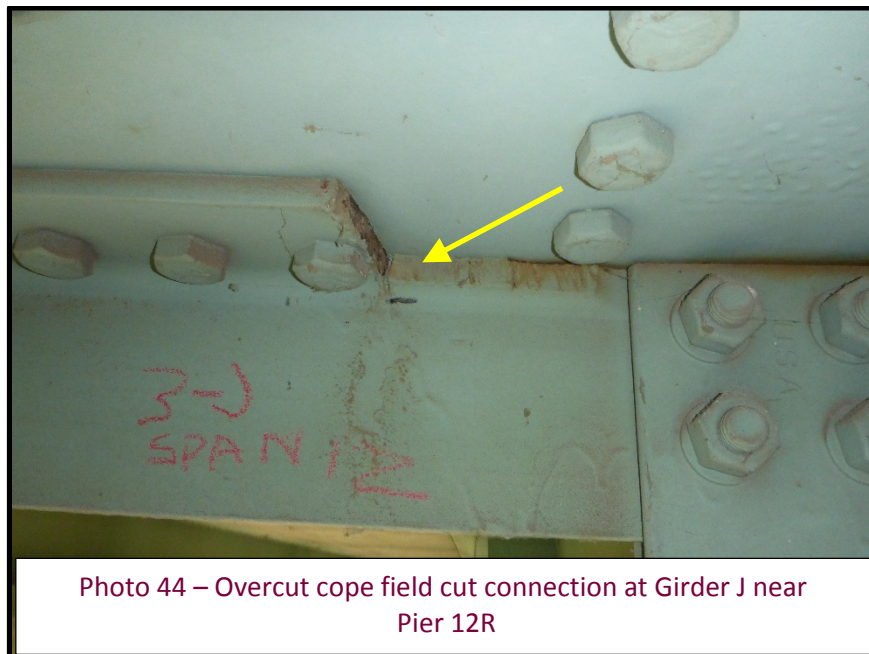
There are also several locations where the edge distance of the bolts in the steel connection plates is not adequate. In one location, the connection plate appears to be field cut to fit into place; the cope was overcut leaving minimal distance between the edge of the plate and the last row of bolts (see Photo 44).

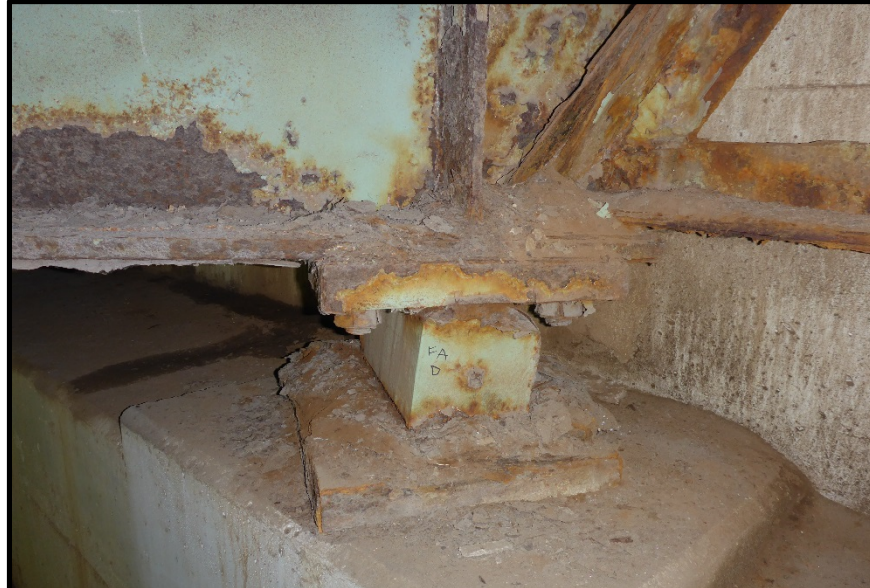
Photo 46 – Laminar corrosion on base plate and bolts of bearings

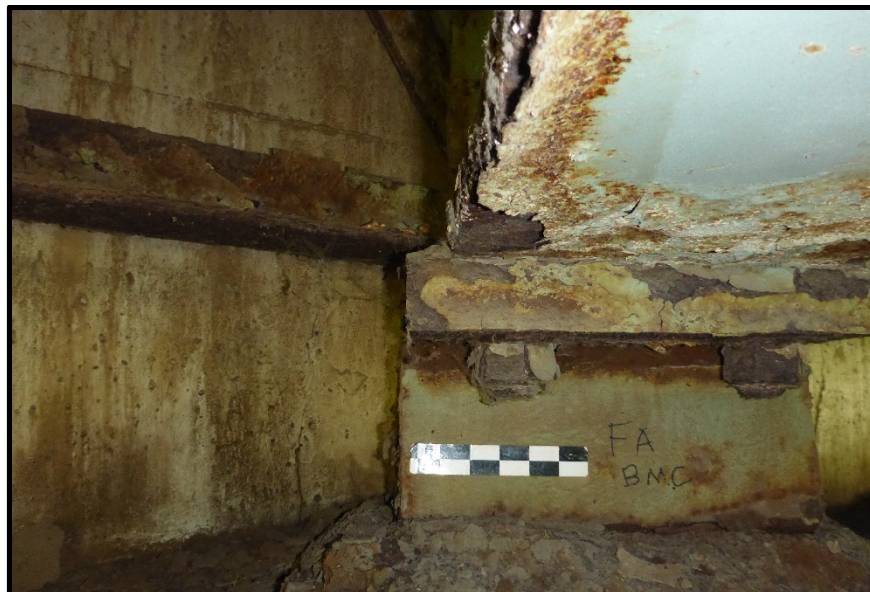
Photo 47 – Forward Abutment Bearing Off Center

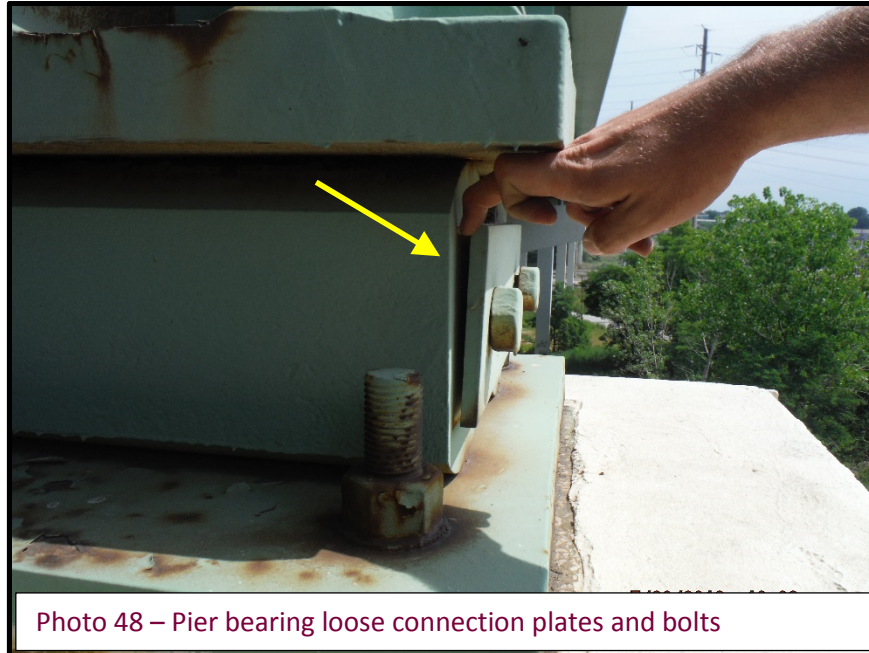
during inspection. **There are several locations where the bearing connection bolts and plates are loose on the piers** (see Photo 48). The pier bearings near the expansion joint drainage pipes are generally in worse condition. Bearings near the drainage pipes exhibit surface rust to the bearing and pier connection plate (see Photo 49). For a complete list of bearing conditions and translations see Appendix VII.

- Tighten loose bolts and replace missing bolts in cross-frames, floorbeams, stringers, bearings and hinges
 - Clean and repaint structural steel
 - Repair portions of safety cable which were incorrectly installed or missing

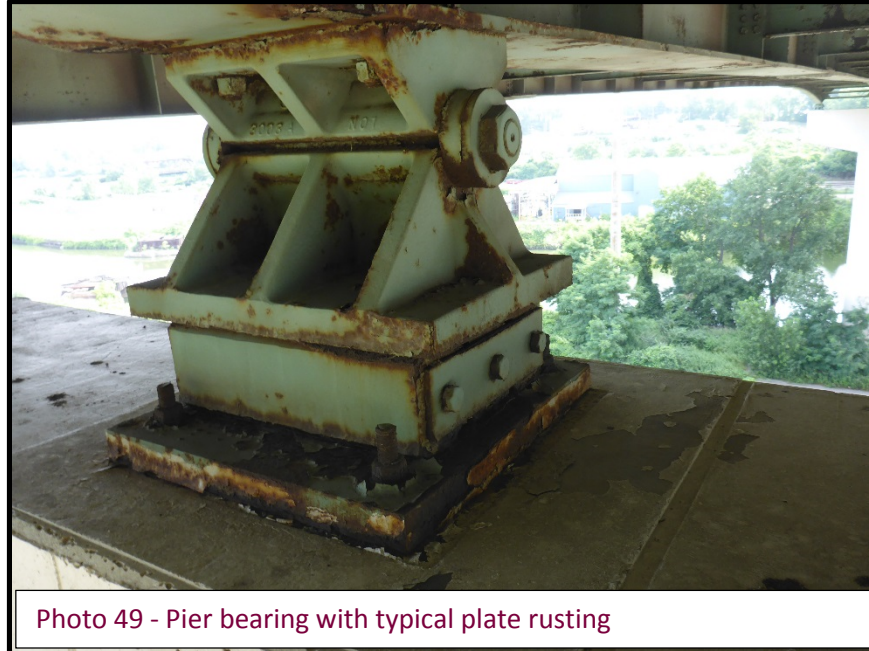
Photo 49 - Pier bearing with typical plate rusting

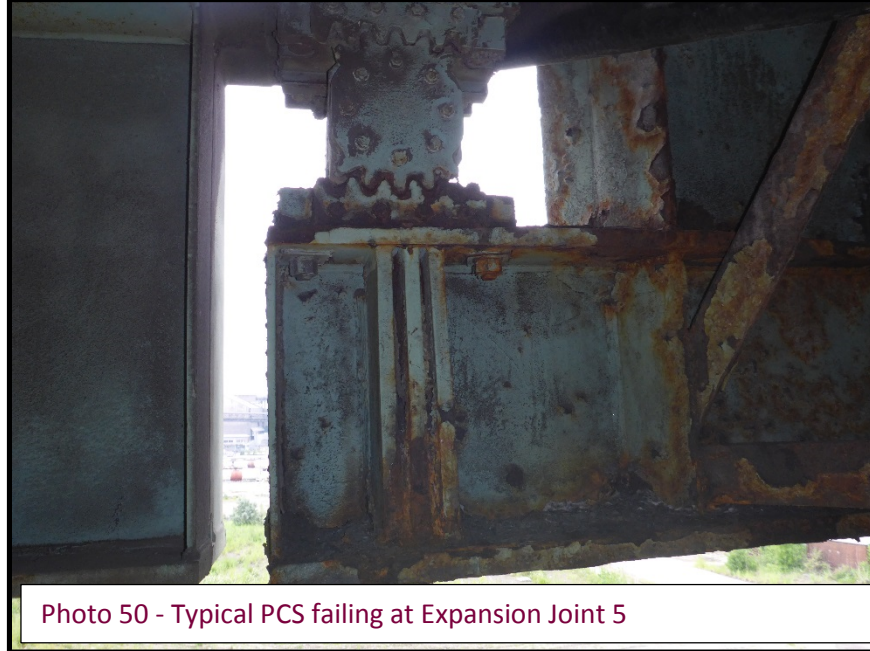
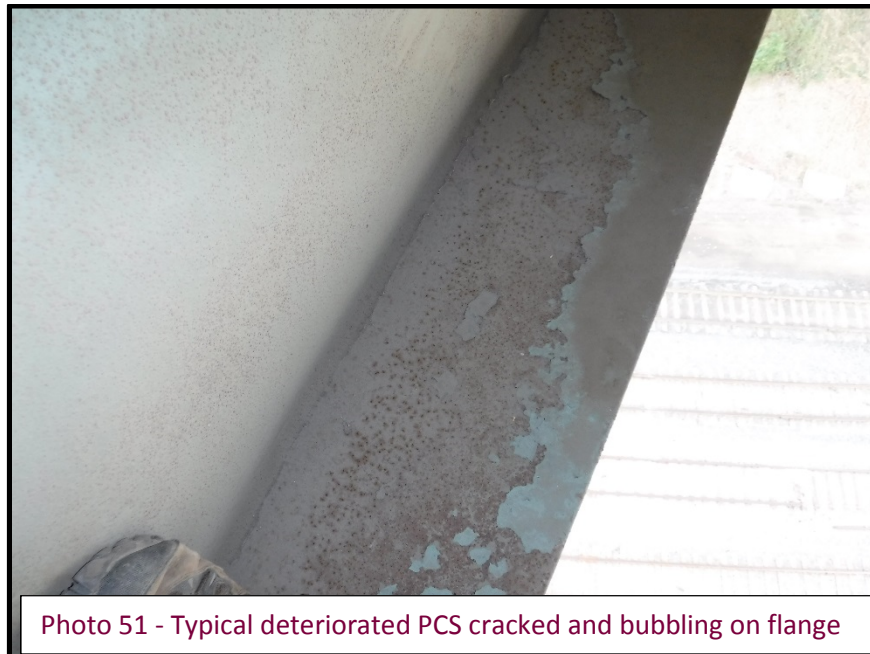
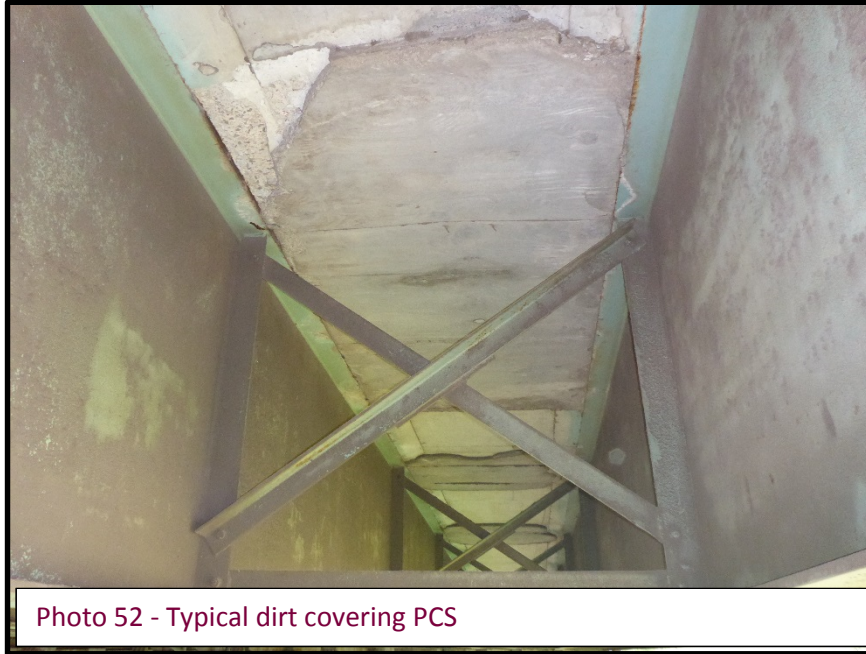
The Protective Coating System is in **fair** condition. Areas around the drainage system show the most deterioration to the PCS. In these areas, there's both surface corrosion and laminar corrosion to the girders, floorbeams, crossframes, and bearings (see Photo 50). **Areas in several spans exhibit bubbled and cracked PCS along the webs and tops of the bottom flanges with areas of exposed corroded metal (see Photo 51).** There are also localized areas throughout the bridge where the paint is missing and the primer is exposed. Additionally, the paint has failed along portions of the handrail that is attached to the girder. Units 3 through 6 have a thick layer of dust over the North face of the beams and girders. Units 5 and 6 are almost completely covered with a similar dirt layer. Dirt cover makes it difficult to see PCS failure and steel deficiencies (see Photo 52).

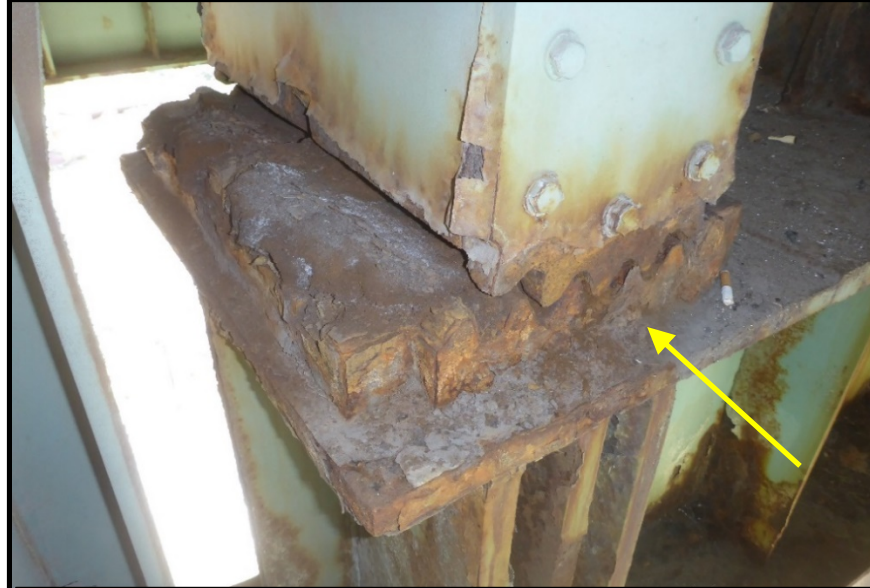
The Hinges are in **fair** condition. All of the hinges appear to be operating as designed during the 2018 inspection. Surface corrosion and debris on the bottom plates is common on the expansion hinges and can hinder proper hinge movement. As previously mentioned, this is a direct result of the leaking expansion joint and drainage trough systems. There is one (1) missing bolt in the sole plate of Girder 3-K at Expansion Hinge 3 and **two (2) missing bolts in the sole plate of Girder 4-D at Expansion Hinge 3 (see Photo 53)**. Several bolts appear to be missing or broken bolt heads due to the large build-up of rust around the expansion hinges (see Photo 54).

Photo 54 – Expansion Hinge 3 Girder D missing or broken bolts

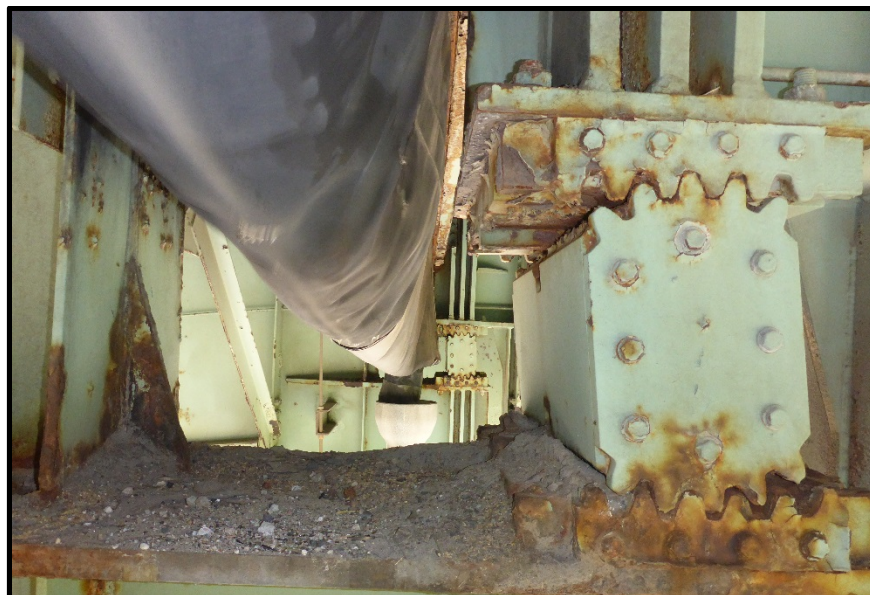
The area adjacent to the hinges commonly has debris piled on top of the girder flange (see Photo 55). This is problematic because the debris will hold water on the girder flange causing further rusting. It is recommended that this gets removed as part of a general maintenance program. These conditions are causing accelerated deterioration to the structural elements adjacent to the expansion joints.

Photo 55 – Debris Piled on Girder Flange around hinges

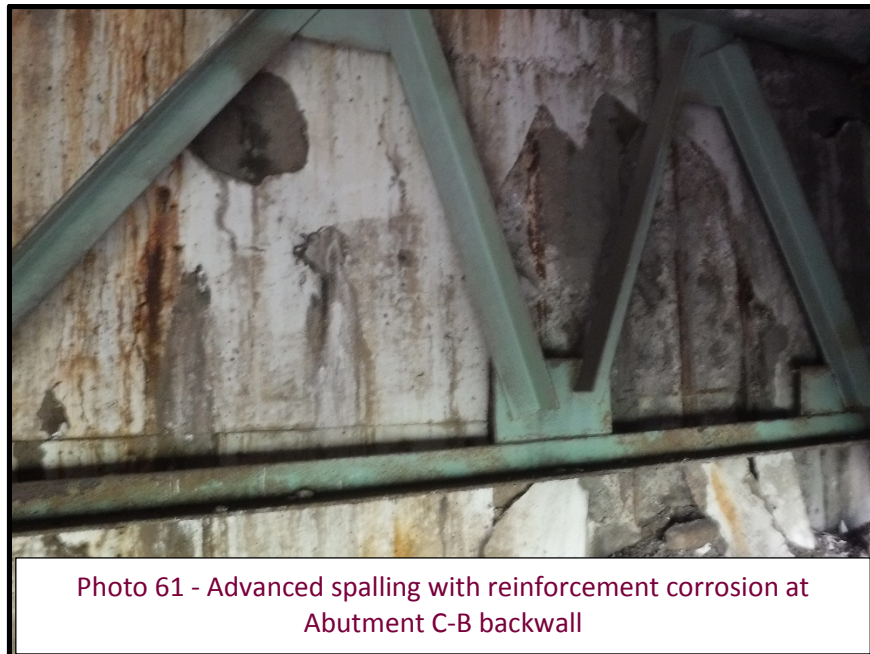
The backwalls are in **fair** condition. The backwalls on the Rear Abutments and Ramp C-7 are generally in good condition. The elastomeric strip seals at these abutments are in good condition and very little moisture appears to be affecting the backwalls. The backwalls on the Forward Abutments are in fair condition and have minor deficiencies. Both Forward Abutment backwalls exhibit many vertical cracks with spalling and delaminations. Some of the cracking exhibits efflorescence and rust staining. The Ramp B-C backwall is in good condition with a few minor vertical cracks. The Ramp C-B backwall is in poor condition. Large portions of the backwall are delaminated or spalling with exposed reinforcing (see Photo 61). The backwall also exhibits many vertical cracks with rust staining. The continuous progression of the backwall deterioration is most likely caused by the leaking from the strip seal expansion joint.

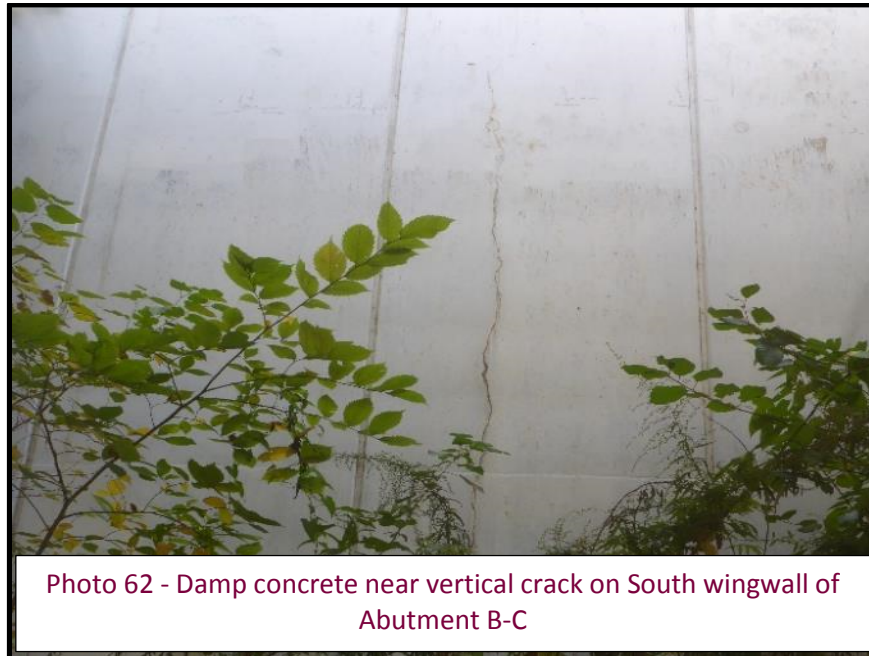
The wingwalls are in **good** condition. There are areas of cracking and spalling near the ground lines of the wingwalls. The South wingwall at Eastbound Ramp B-C has a large vertical crack with moisture leaking through it (see Photo 62). No other significant deficiencies were noted.

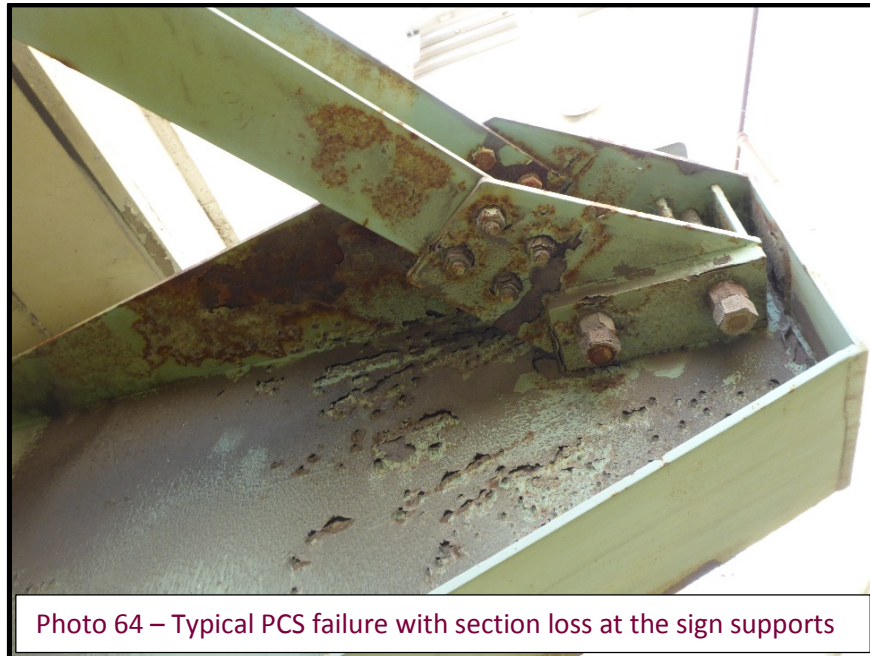
The sign supports are in **good** condition. The sign supports were inspected from a snoopers. The sign supports typically have PCS failure with very minor section loss to the structural steel (see Photo 64). Debris build-up around the signs bases is also typical.

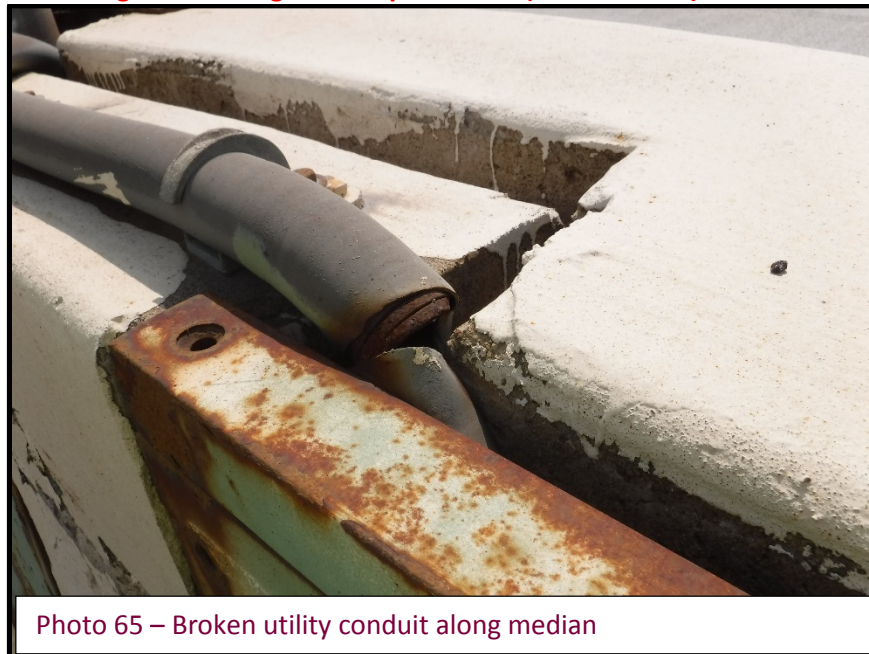
The utilities are in **good** condition. The light poles on the bridge are in generally good condition. Minor PCS loss was noted on the light poles throughout the bridge. The light poles and junction boxes on the bridge are typically rusting and are missing in several locations. **Conduit running across the top of the median at the West end has broken casing with rusting interior protection (see Photo 65).**

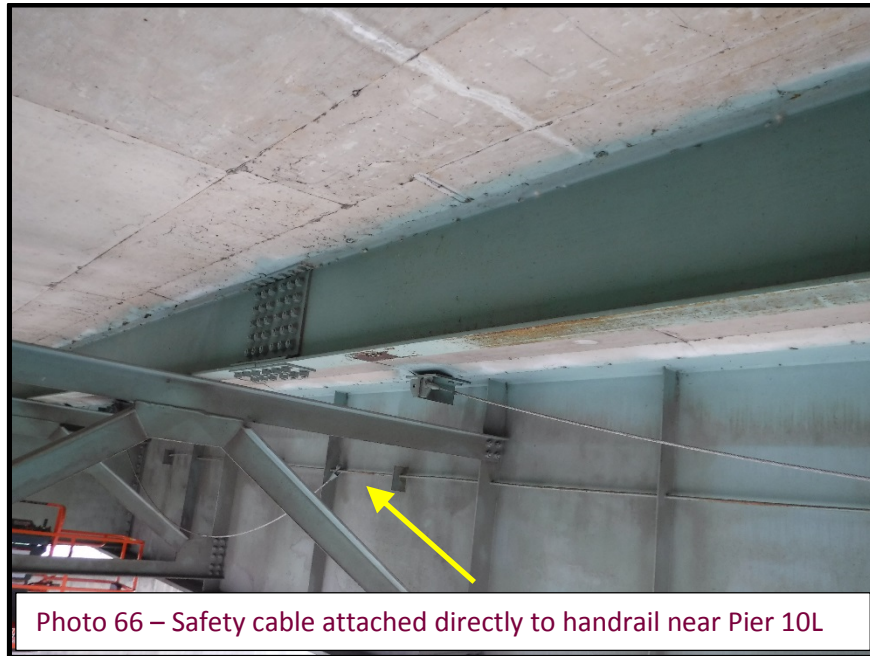
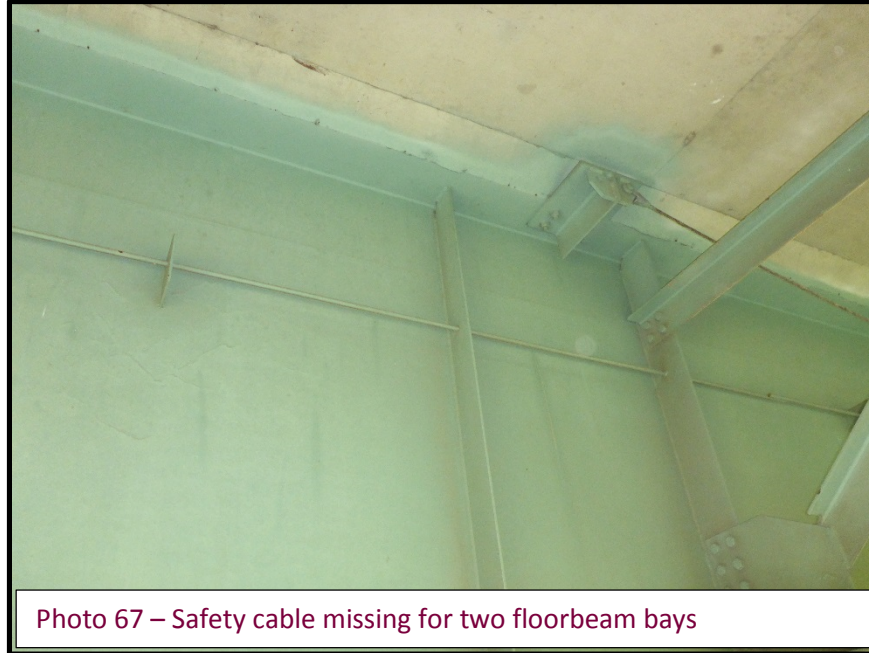
The inspection handrails and safety cables in Unit 2 through Unit 4 are in generally good condition. These two features are essential to provide safe access for inspection. They allow an inspection to occur without interruption to the traffic above. There are a few areas on the handrail where the PCS has failed and the handrail is corroding, especially near the downspouts. The safety cable is not properly anchored in a few places and is attached directly onto the handrail (see Photo 66). **Two (2) floorbeam bay lengths are missing the safety cable, but the handrail is in good condition (see Photo 67).** It is typical that the safety cable does not extend

all the way up to the expansion joint, making hinges more difficult to inspect. Because of the lack of handrail near the expansion joints, it is difficult to cross the expansion joint while walking the girders; especially the joints where the neoprene trough is completely full of debris, blocking the inspector's path.

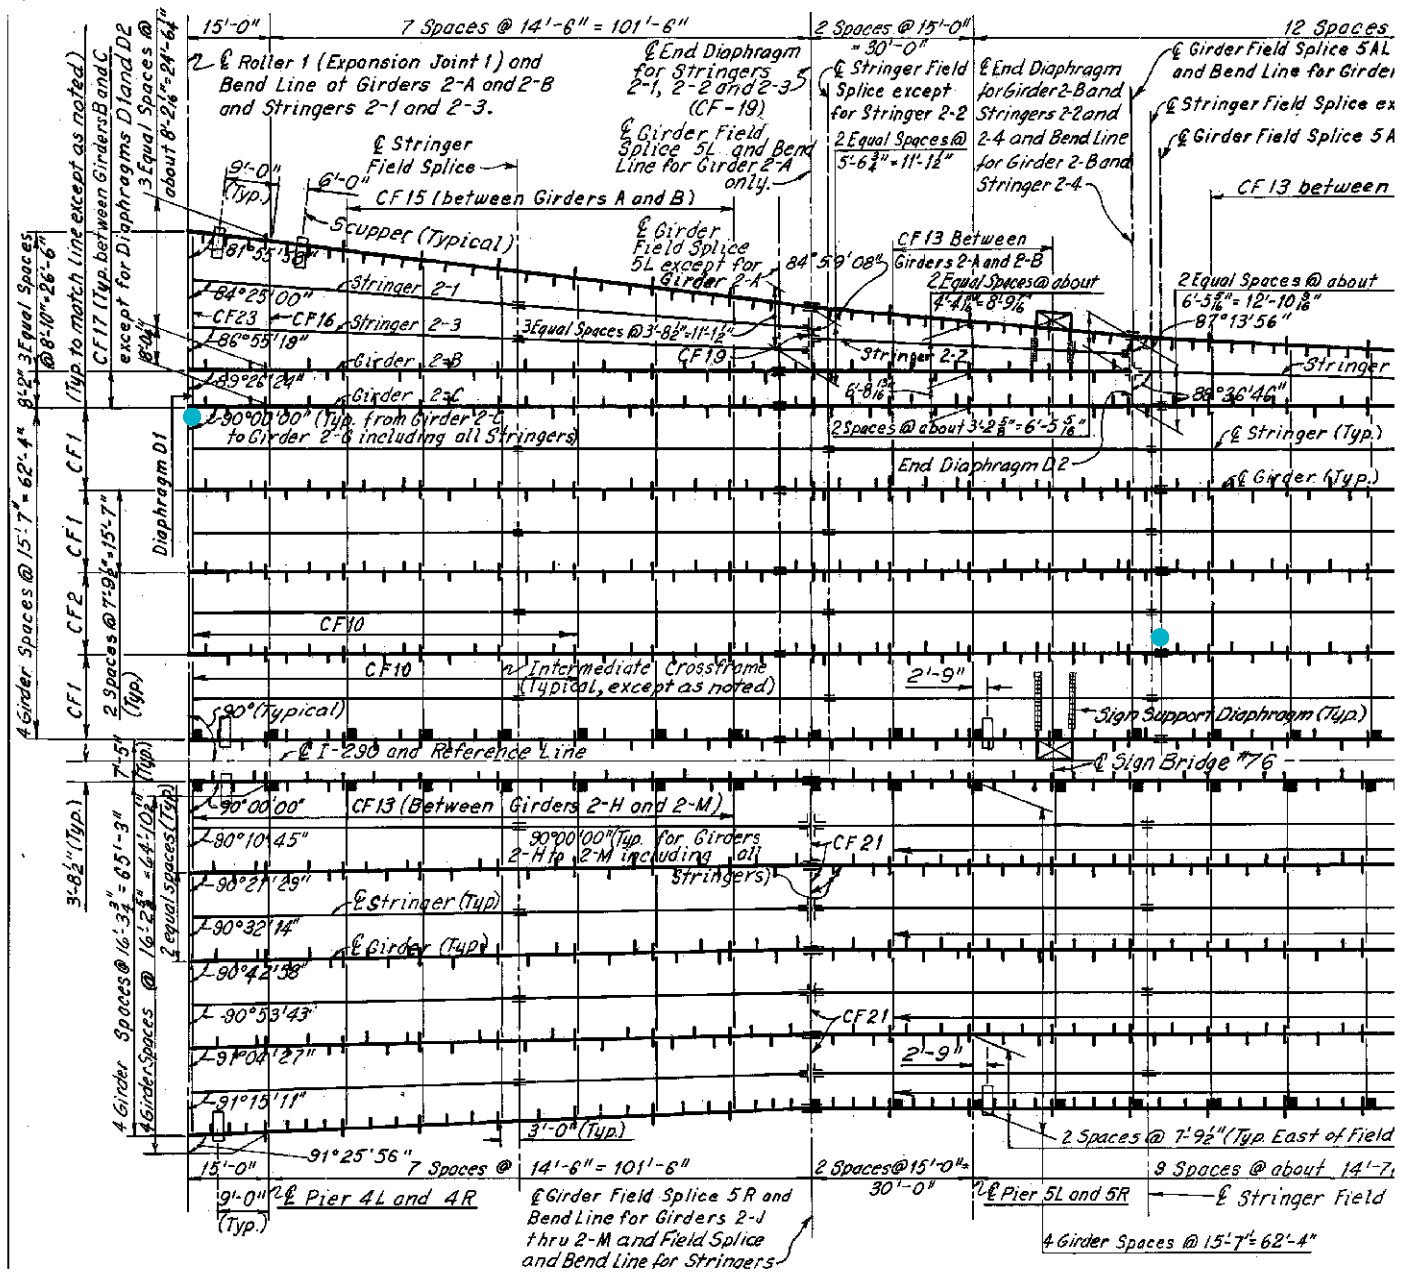
Unit 2 (Part 1)

- Loose Bolt
- Missing Bolt
- Misdrilled Holes

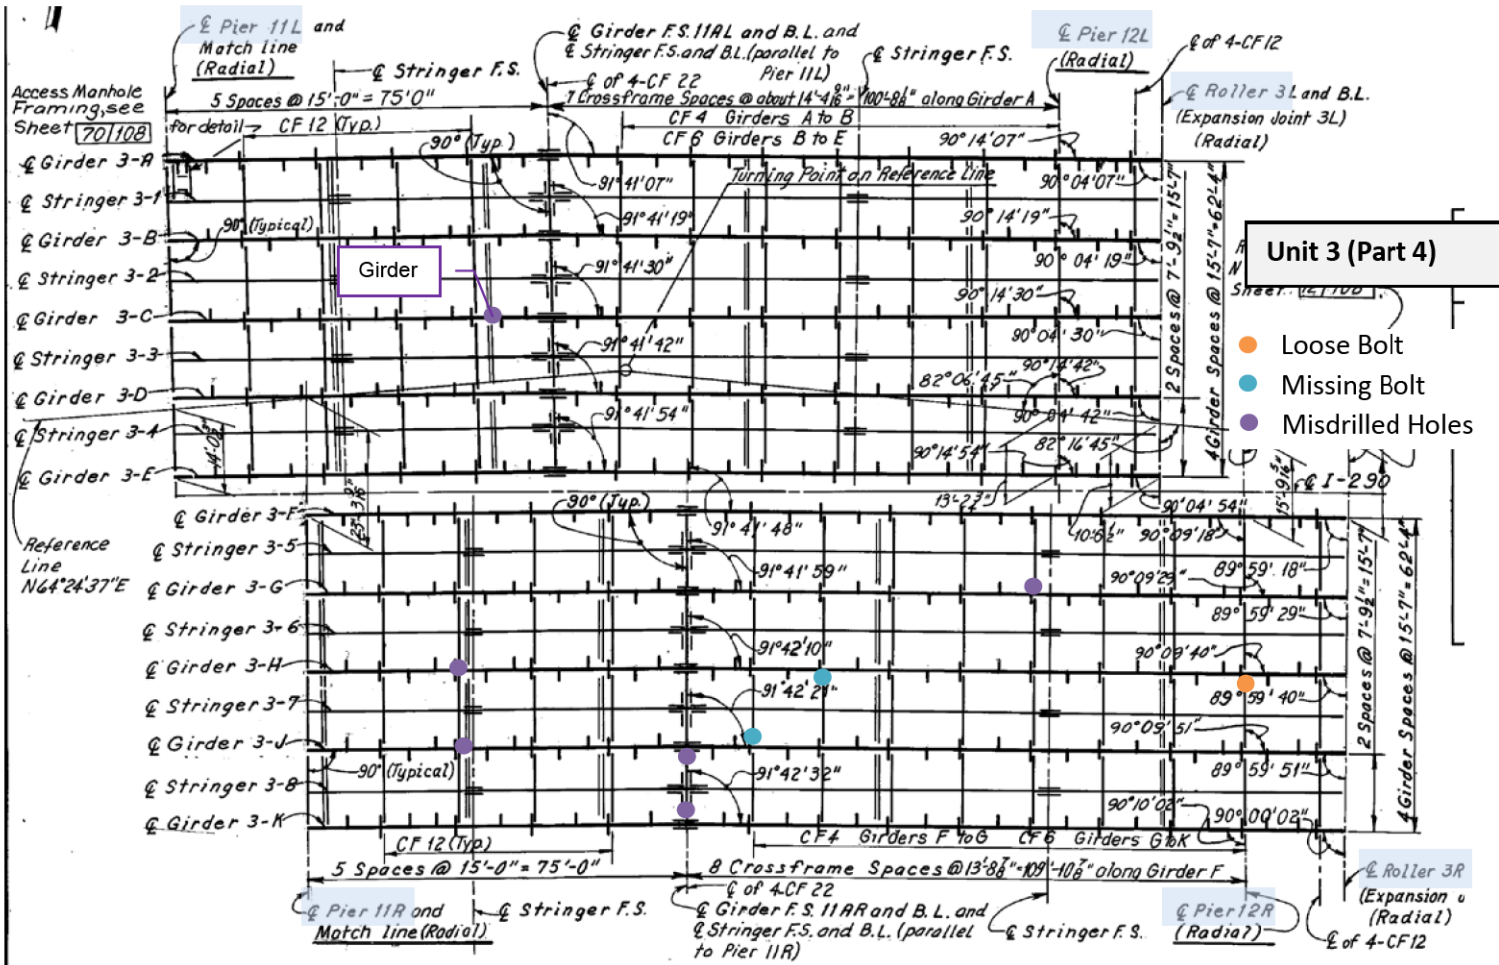
Unit 3 (Part 4)

- Loose Bolt
- Missing Bolt
- Misdrilled Holes

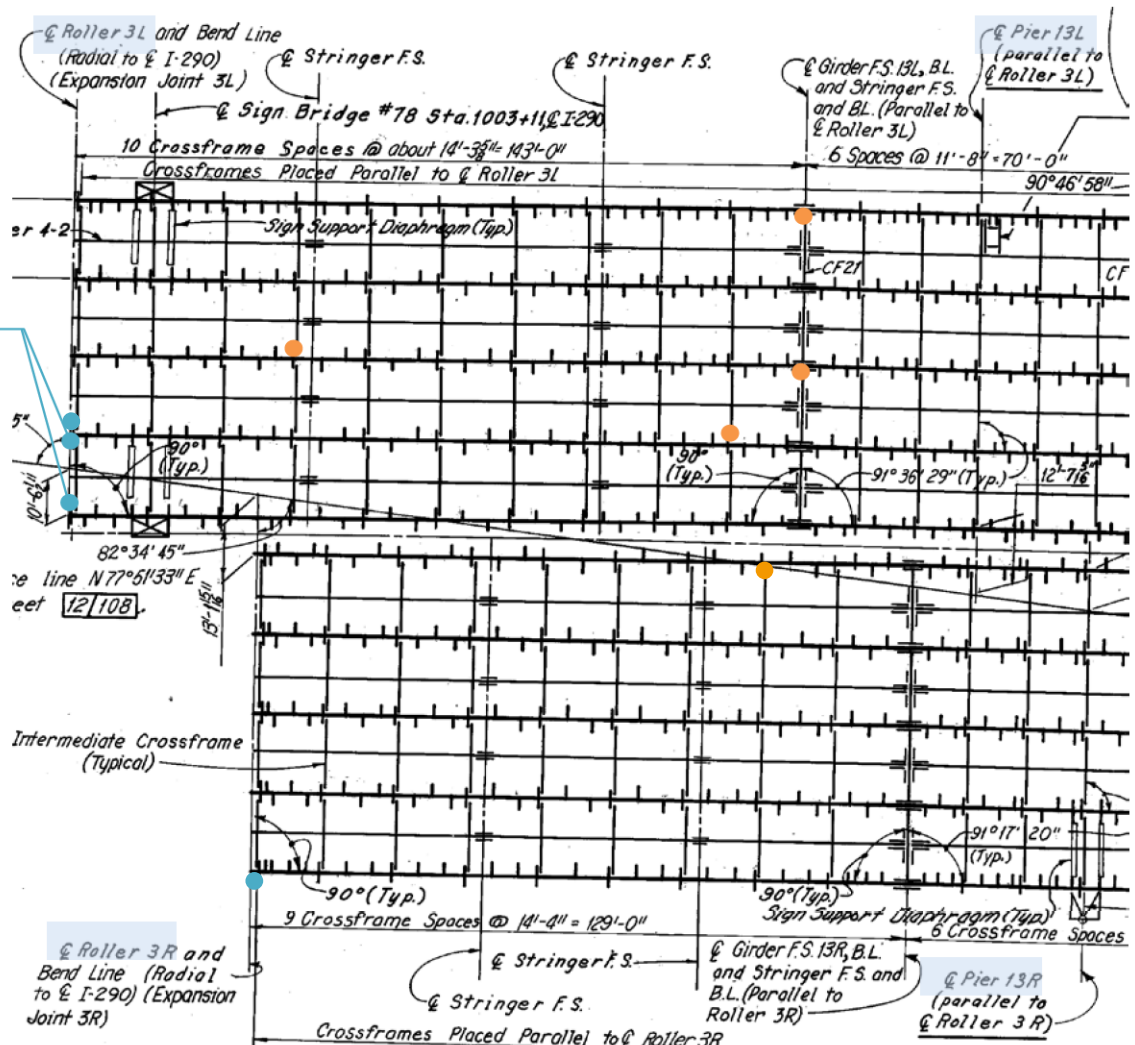
Unit 4 (Part 1)

- Loose Bolt
- Missing Bolt
- Misdrilled Holes

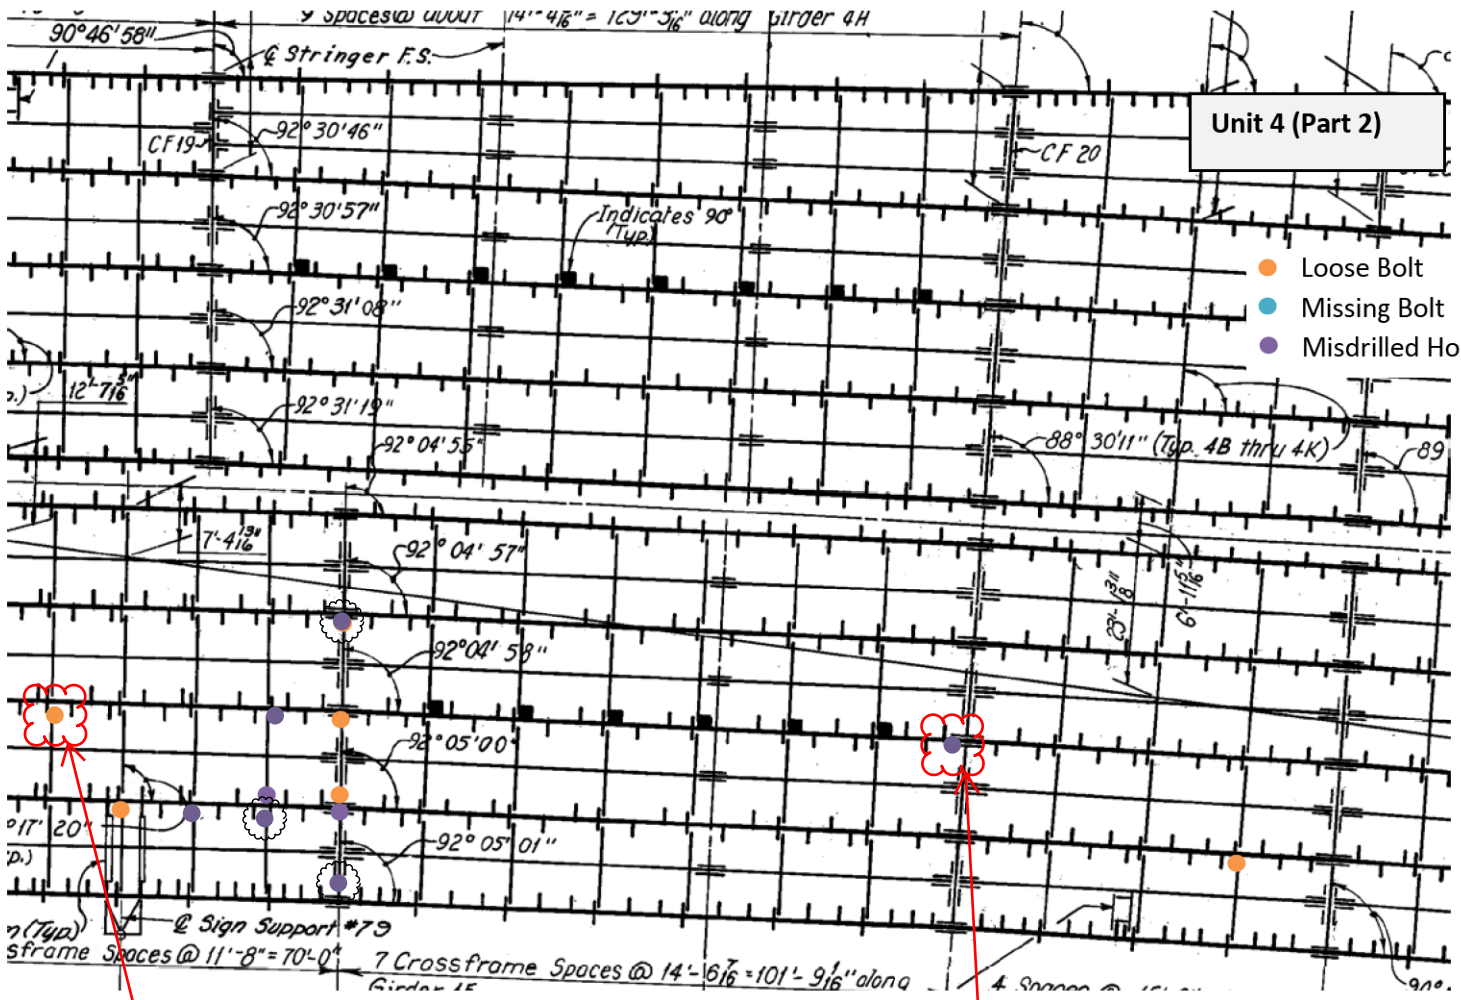
Unit 4 (Part 2)

- Loose Bolt
- Missing Bolt
- Misdrilled Holes

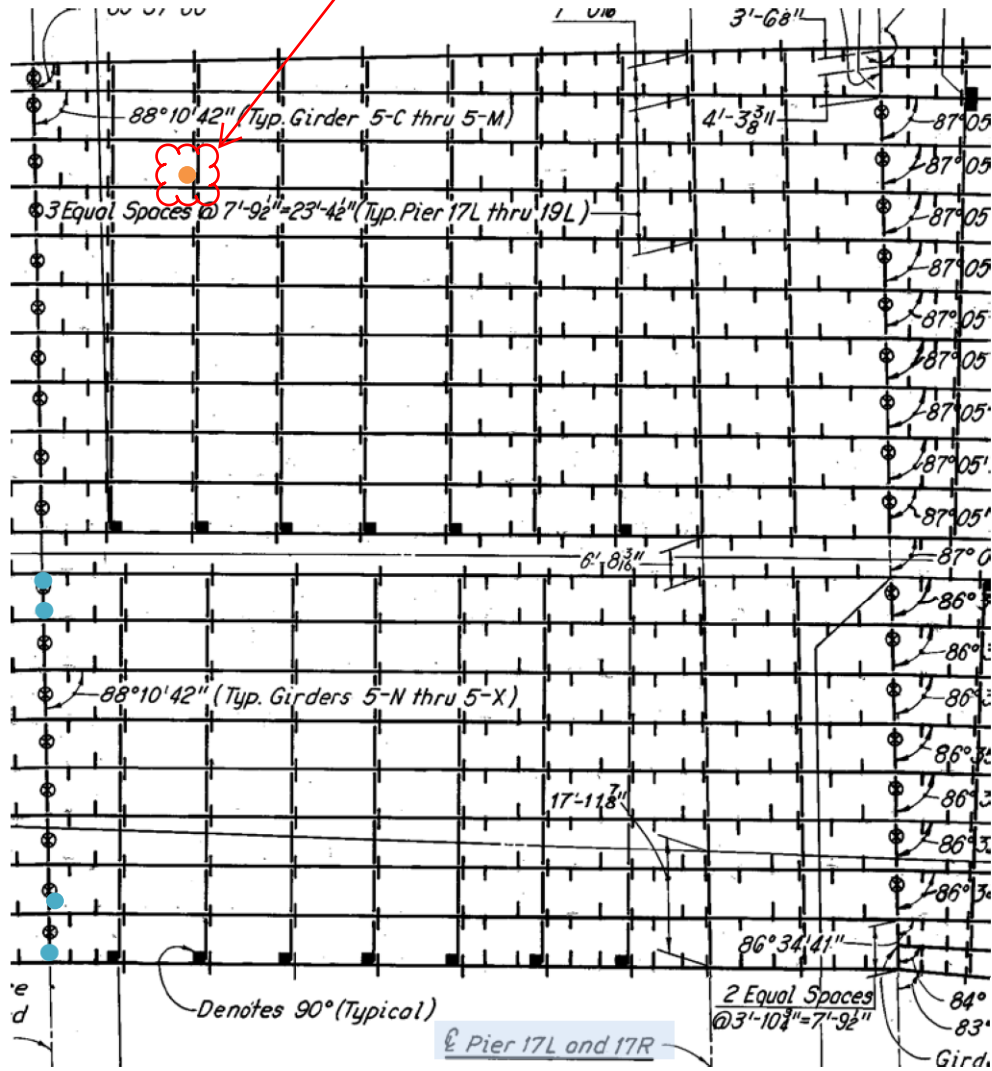
Unit 5 (Part 2)

- Loose Bolt
- Missing Bolt
- Misdrilled Holes

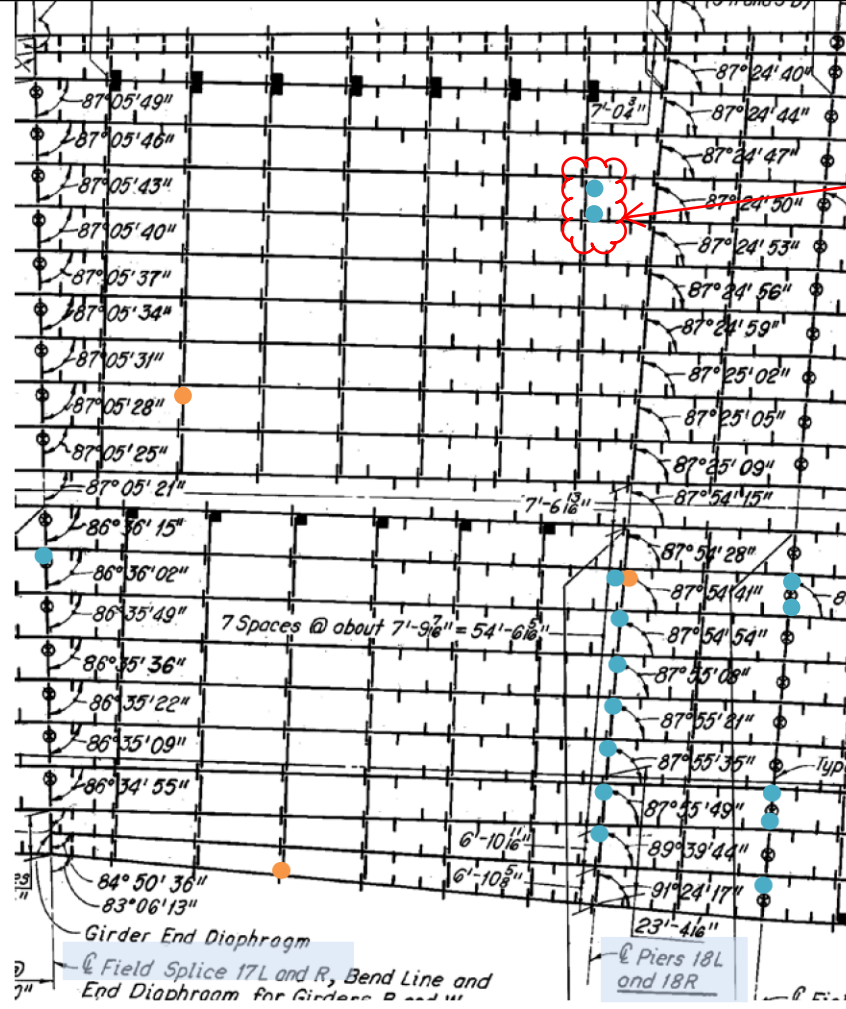
Unit 5 (Part 3)

- Loose Bolt
- Missing Bolt
- Misdrilled Holes

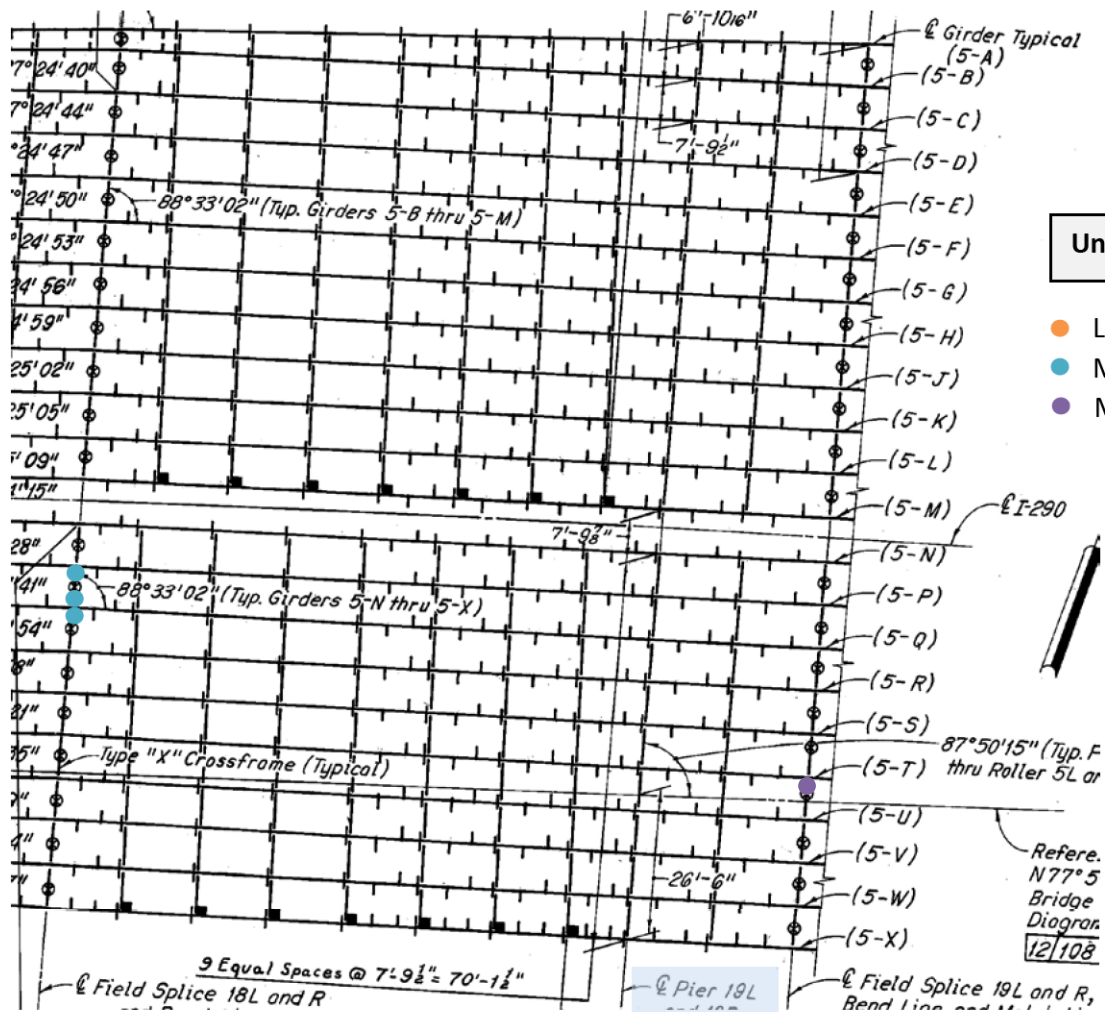
Unit 5 (Part 4)

- Loose Bolt
- Missing Bolt
- Misdrilled Holes

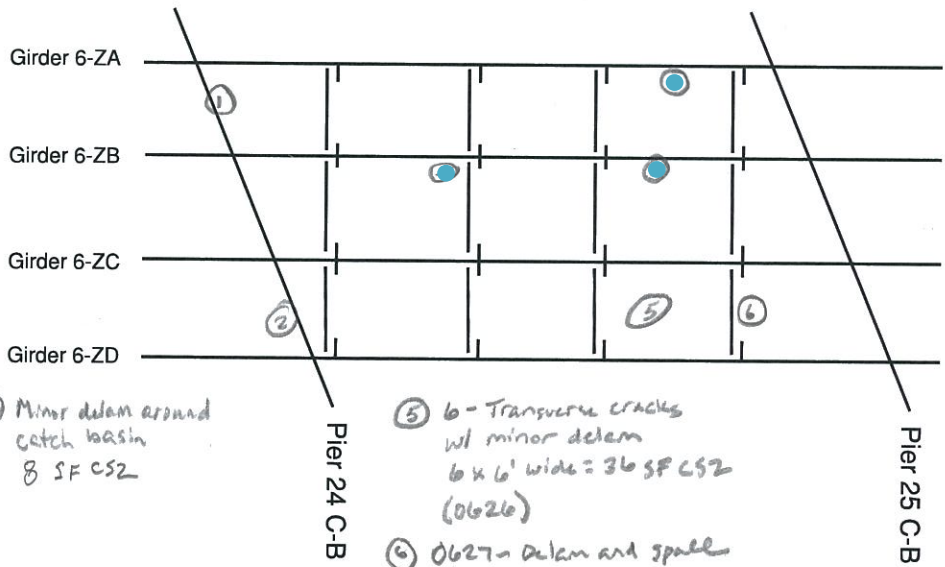
- ① Transverse crack 2 SF CS2
- ② Missing erection bolt Top horizontal at Splice Plate (0625)
- ④ Missing erection bolt

- ③ Minor delam around catch basin 8 SF CS2

- ⑤ 6 - Transverse cracks w/ minor delam 6 x 6' wide = 36 SF CS2 (0626)

- ⑥ 0627 - Delam and spall 6' x 2' = 12 SF CS2

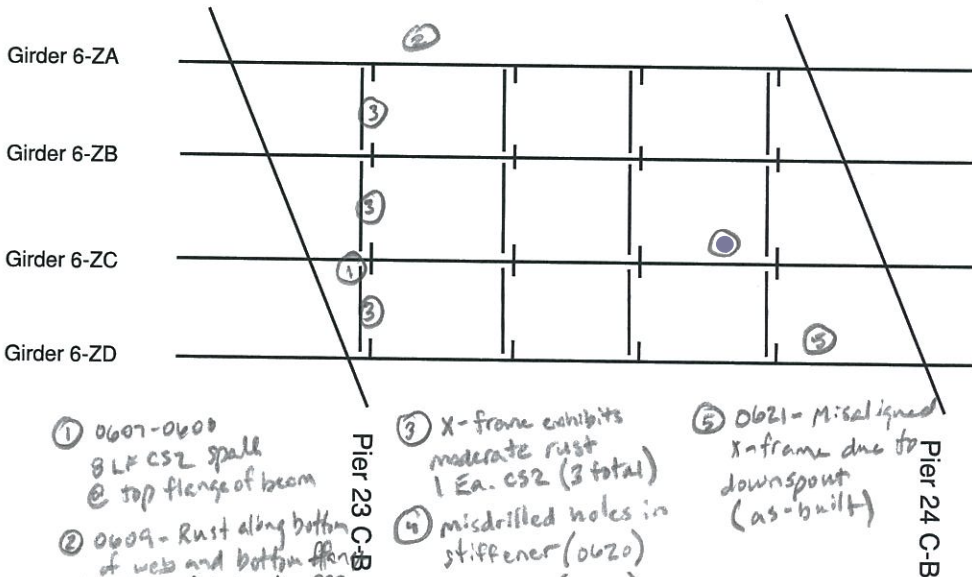
- ① 0607-0608 8 LF CS2 spall @ top flange of beam

- ② 0609 - Rust along bottom of web and bottom flange typical full length CS2

- ③ X-frame exhibits moderate rust 1 Ea. CS2 (3 total)

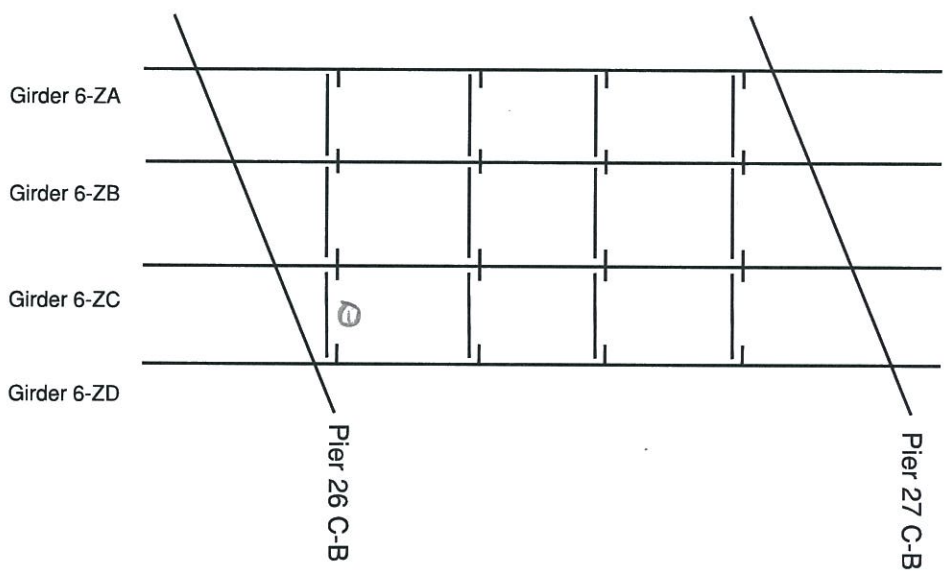
① 0631 - Transverse leaching crack 6 SF CS2

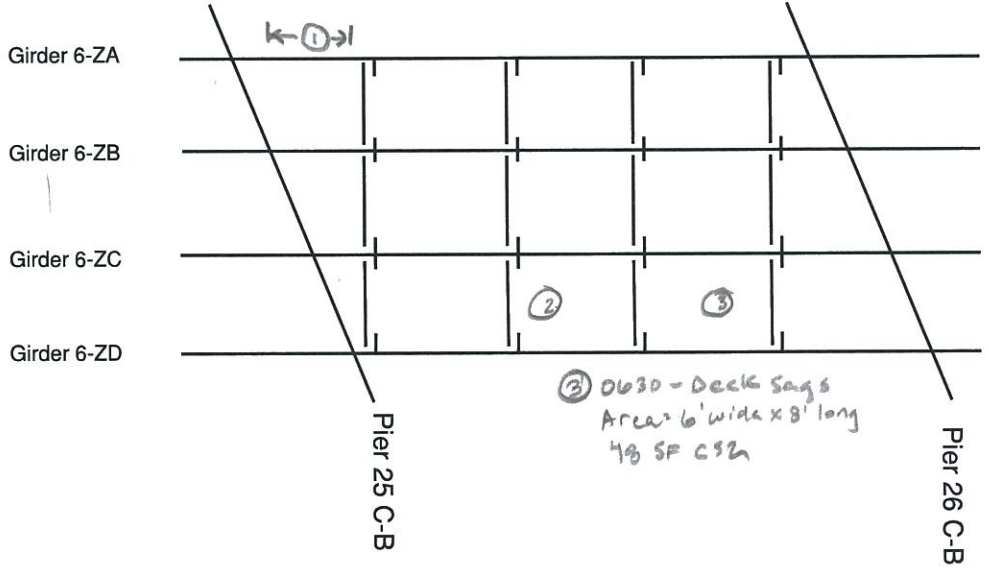
Superstructure - Ramp C-B

① 0628 - Flaking rust along top of bottom flange B LF CS2

② 0629 - Transverse crack w/ delam, 6' x 3' wide 18 SF CS2

③ 0630 - Deck Sags Area 6' wide x 8' long 48 SF CS2
