2018 UPDATE TO 2017 PHYSICAL CONDITION INSPECTION REPORT

Bridge CUY-490-0100

SFN 1811991

I-490 Bridge over the Cuyahoga River Valley

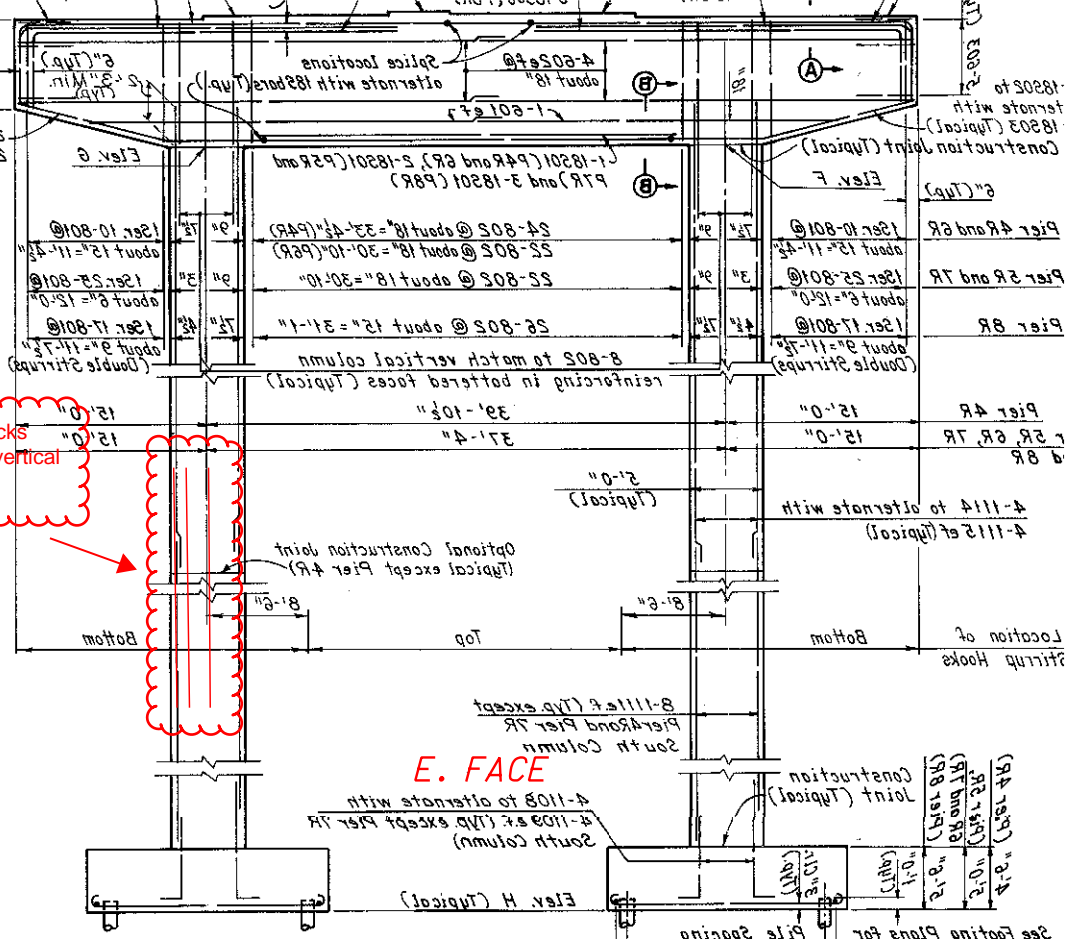
Pier 4R

3-10" vertical cracks and 1 full height vertical crack South face

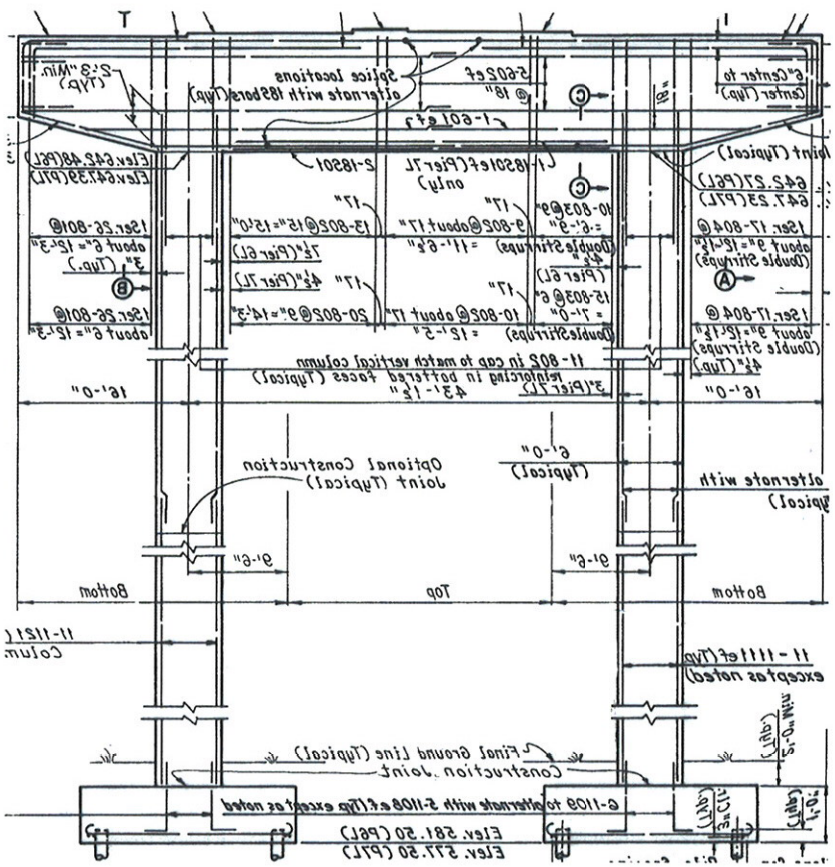
Pier 7L

4' HL crack, N Face
3' HL crack, N Face.

12ft vertical crack,
6'-0" S face

12ft vertical crack,
N face

30ft vertical crack

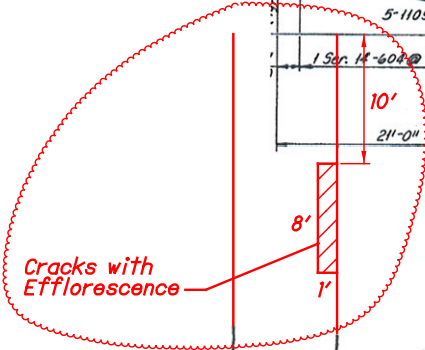
Pier 9L

15F HL
MAP CR

10'x15" DELAM

15ft crack

4ft crack

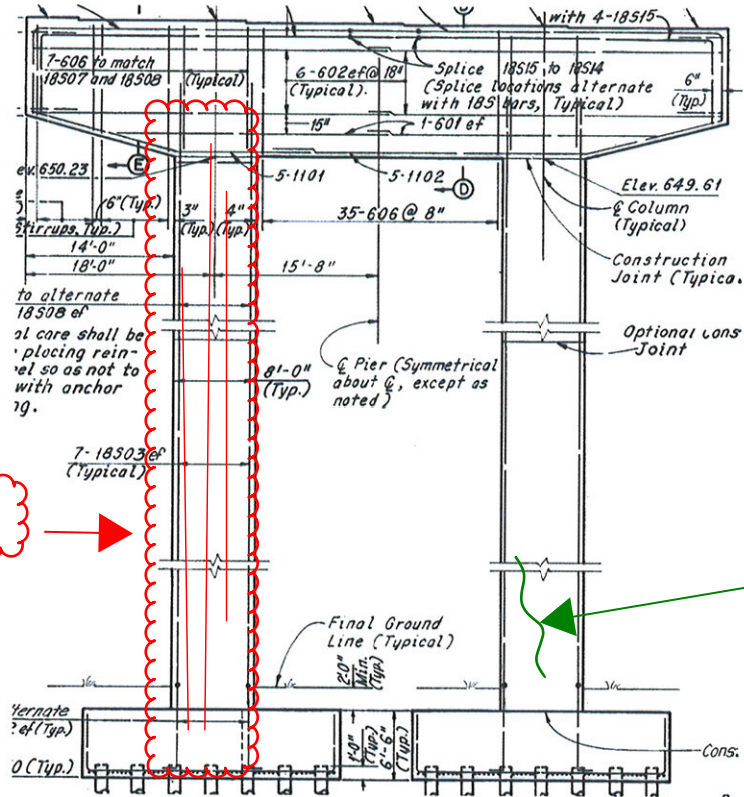
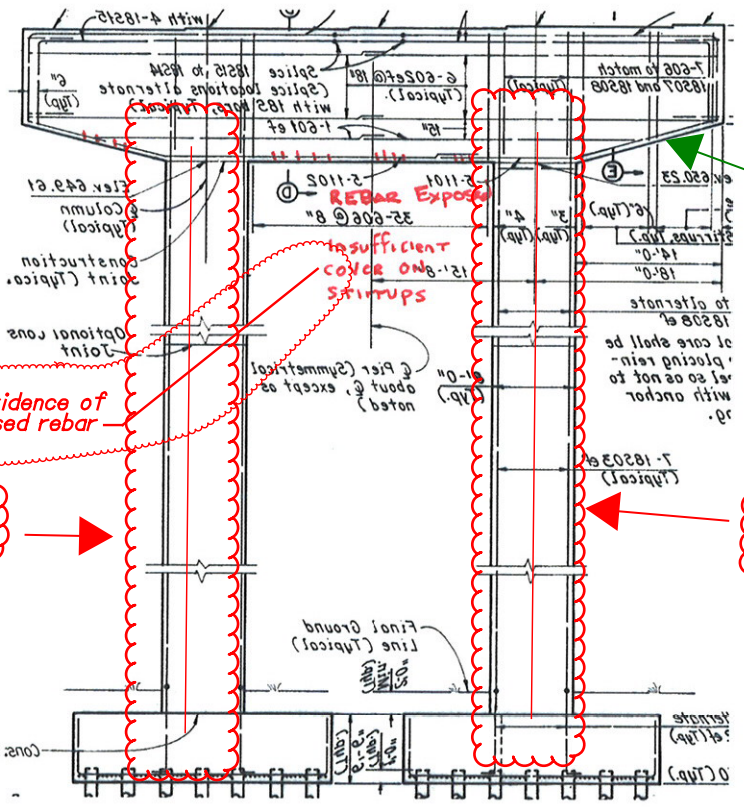
Pier 10R

3 Near full height vertical cracks

10ft crack

7ft crack underside

No evidence of exposed rebar

Full height vertical crack

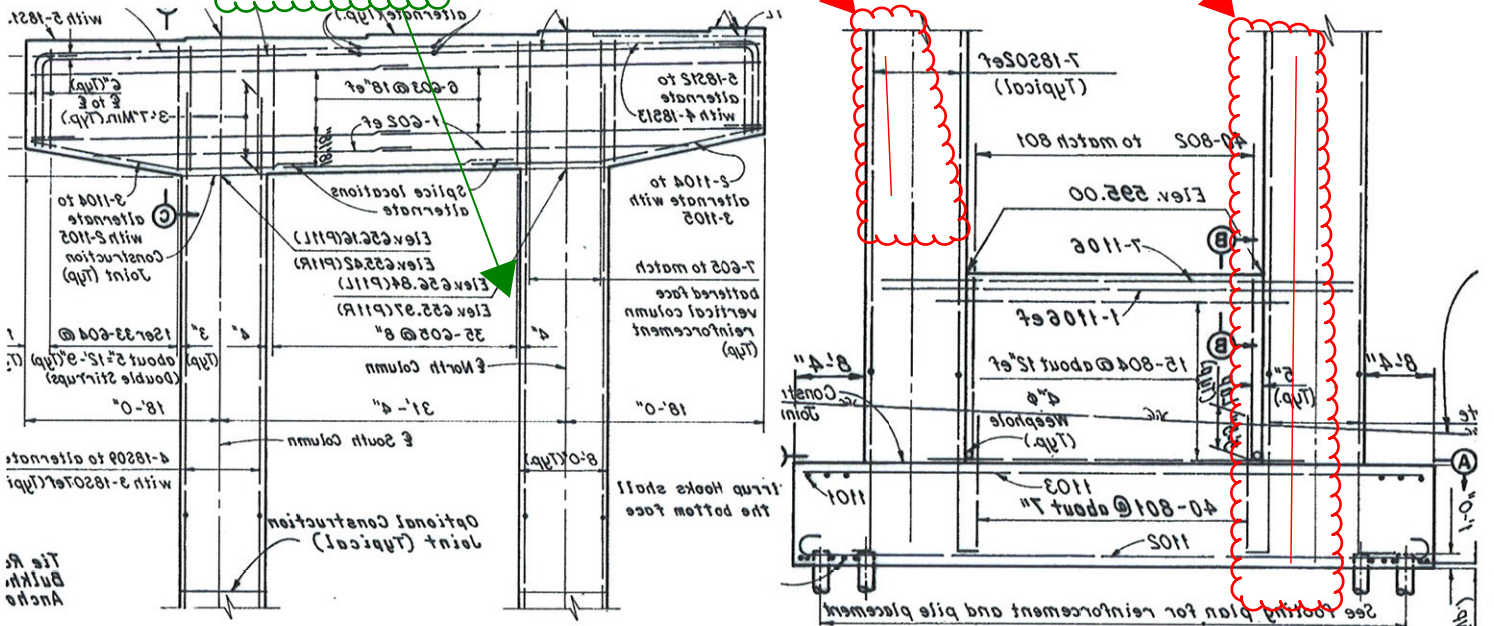
multiple vert cracks, full height both side faces

10' Vertical Crack with delaminations

Full height vertical crack

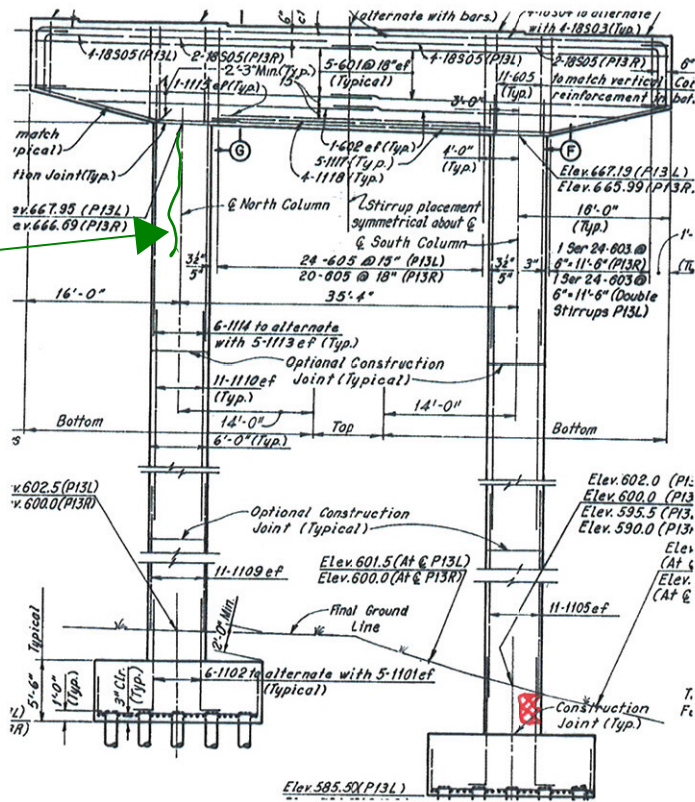
Pier 13R

15ft crack

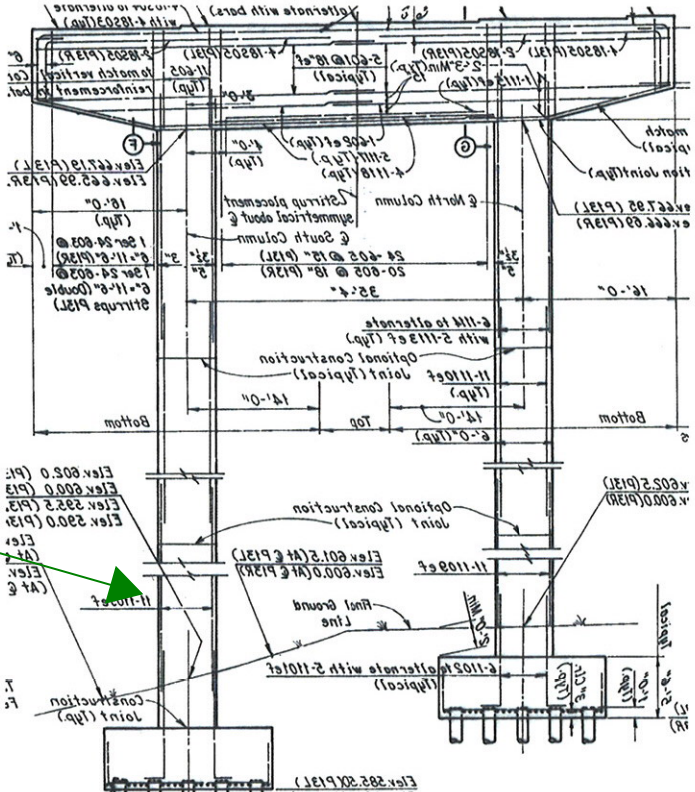
10ft vert cracks, both side faces

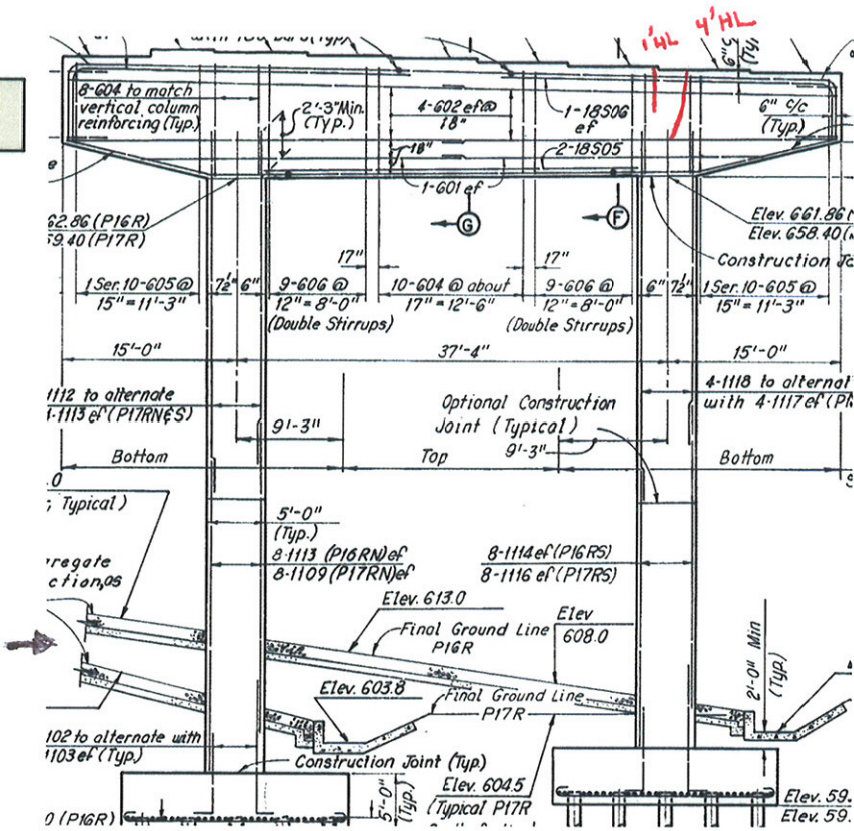
Pier 17R

5' x 3'

cracking similar on LT piers 16, 18, 19, 20, 21, 22, 23 and on RT piers 18, 19, 20, 21, 22

trans cracking on underside

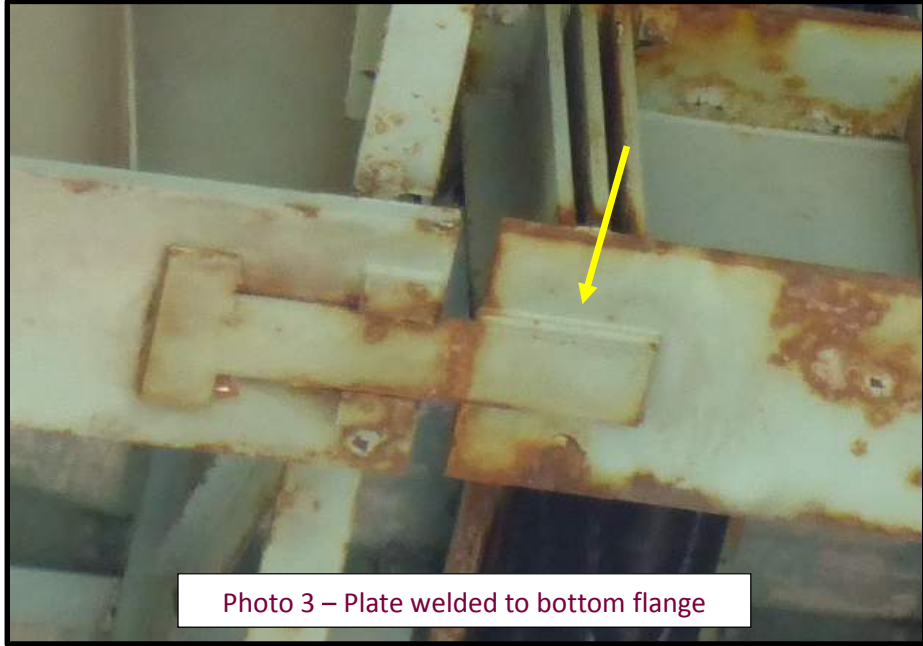
Photo 3 – Plate welded to bottom flange

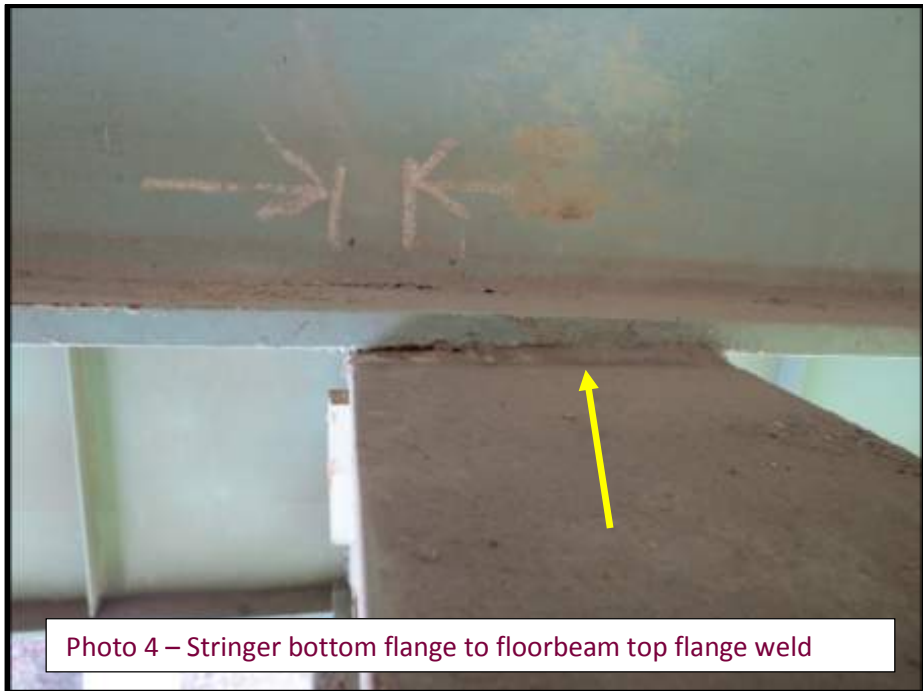
Photo 4 – Stringer bottom flange to floorbeam top flange weld

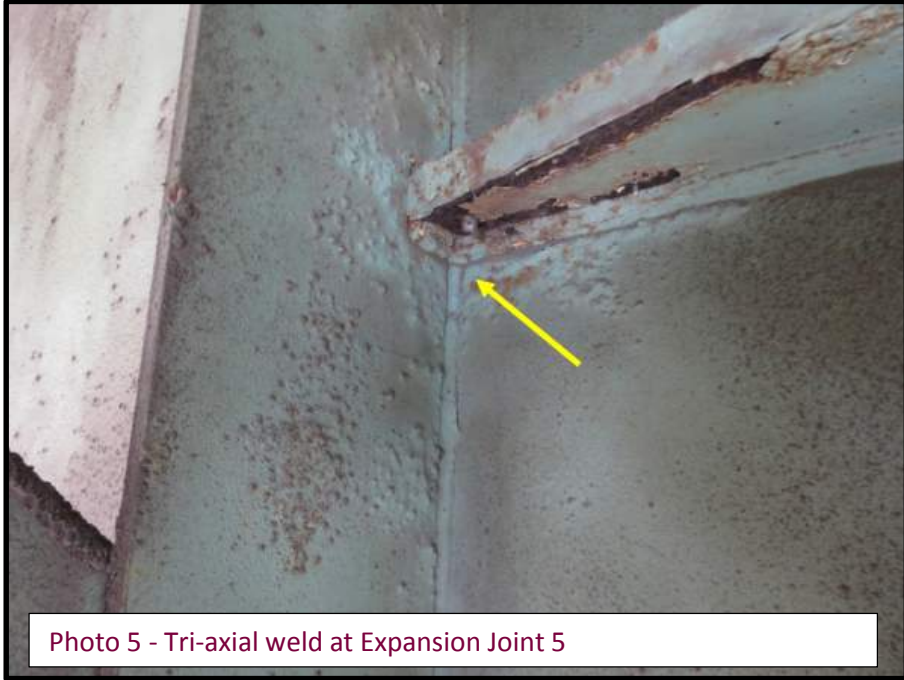
Photo 5 - Tri-axial weld at Expansion Joint 5
