PHASE I ENVIRONMENTAL SITE ASSESSMENT

PORTSMOUTH BYPASS PROJECT
SCI-823, PID No. 19415

OHIO DEPARTMENT OF TRANSPORTATION

AUGUST 1, 2003

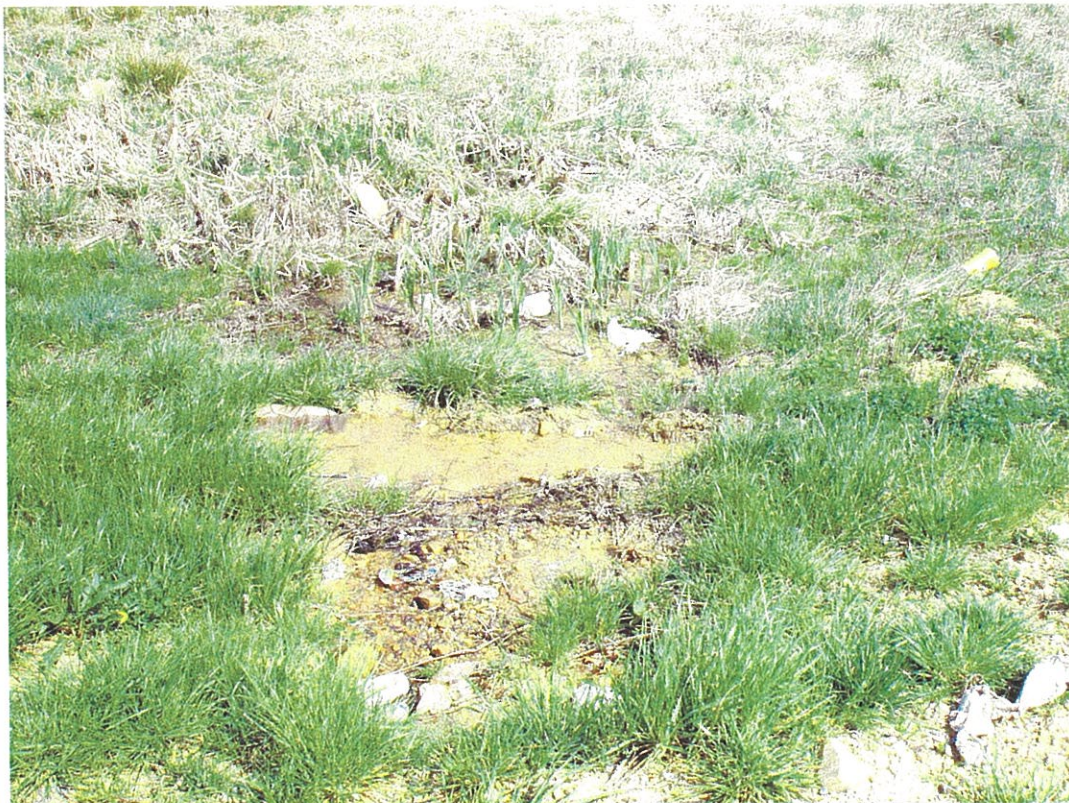
(PID 08-0401.002)

Photo 10. View of spring area with wetland vegetation located on the northwest portion of the Terry Turner property.

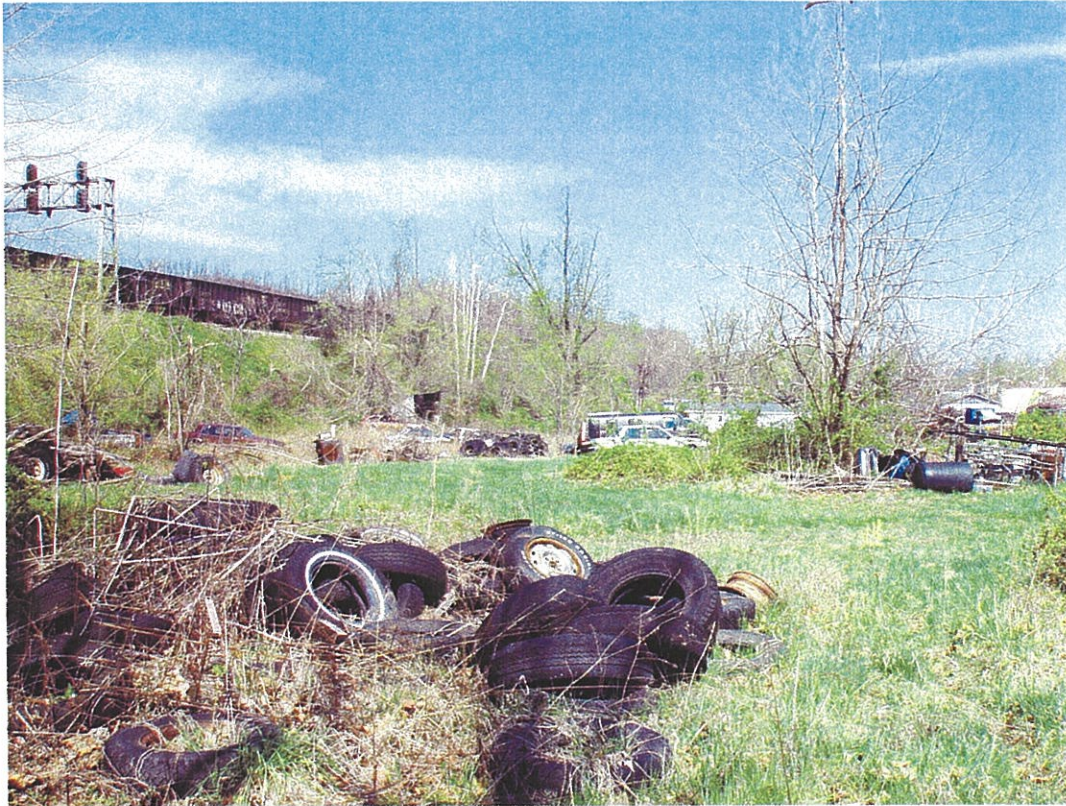
(PID 16-0837.000, 16-0838.000, 16-0839.000 & 16-0840.000)

Photo 25. View looking at used tires and other used materials located on the McGuire property.

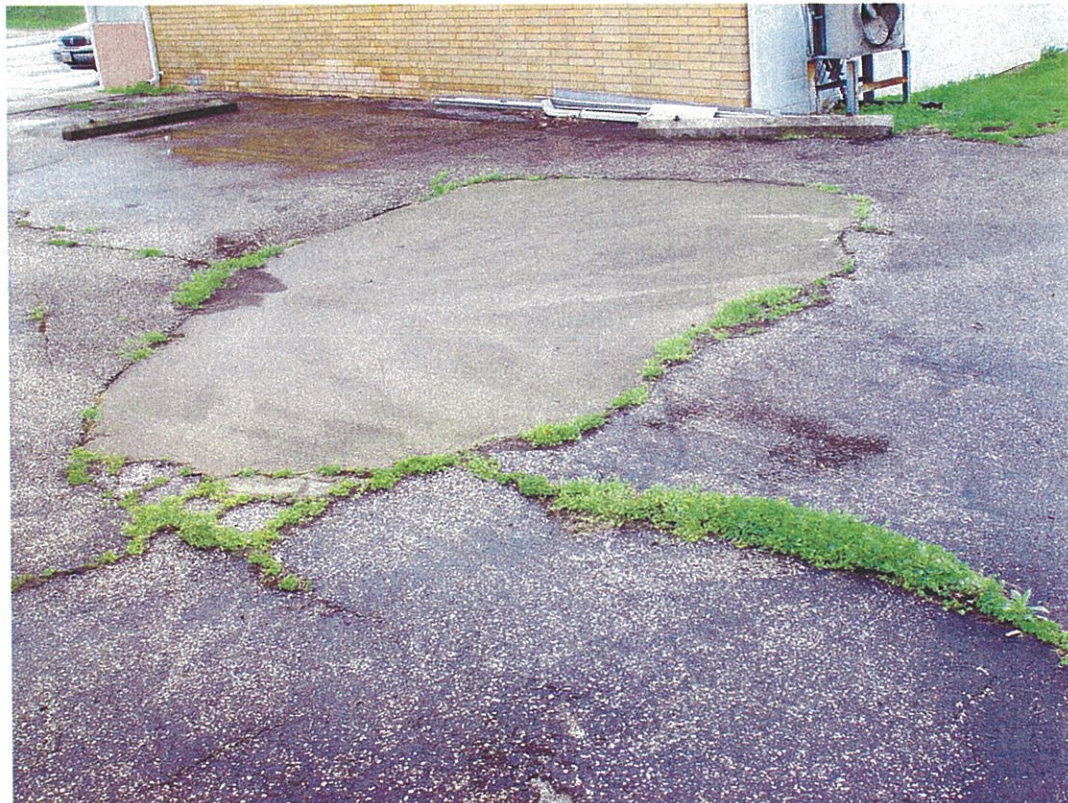
(PID 24-0824.000)

Photo 36. View of the patched pavement located on the eastern portion of the Harwood's gasoline station property.

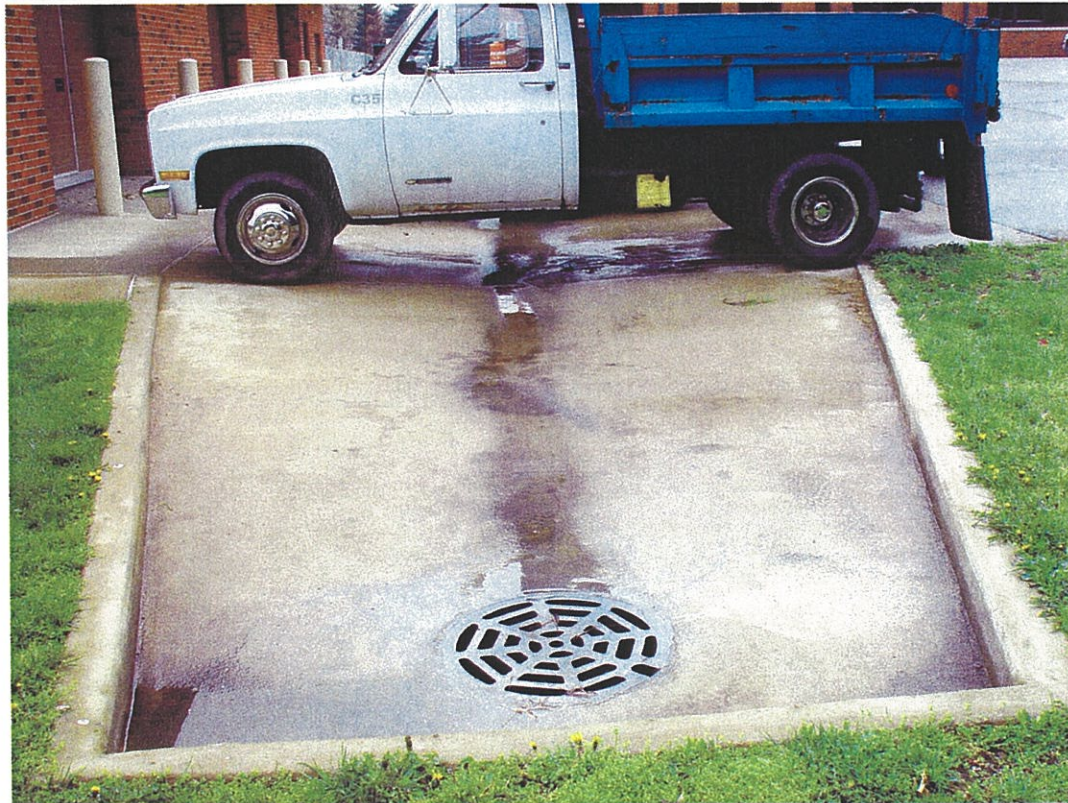
(PID 24-1603.000)

Photo 44. View of the Valley Middle School LUST property looking at the storm drain.

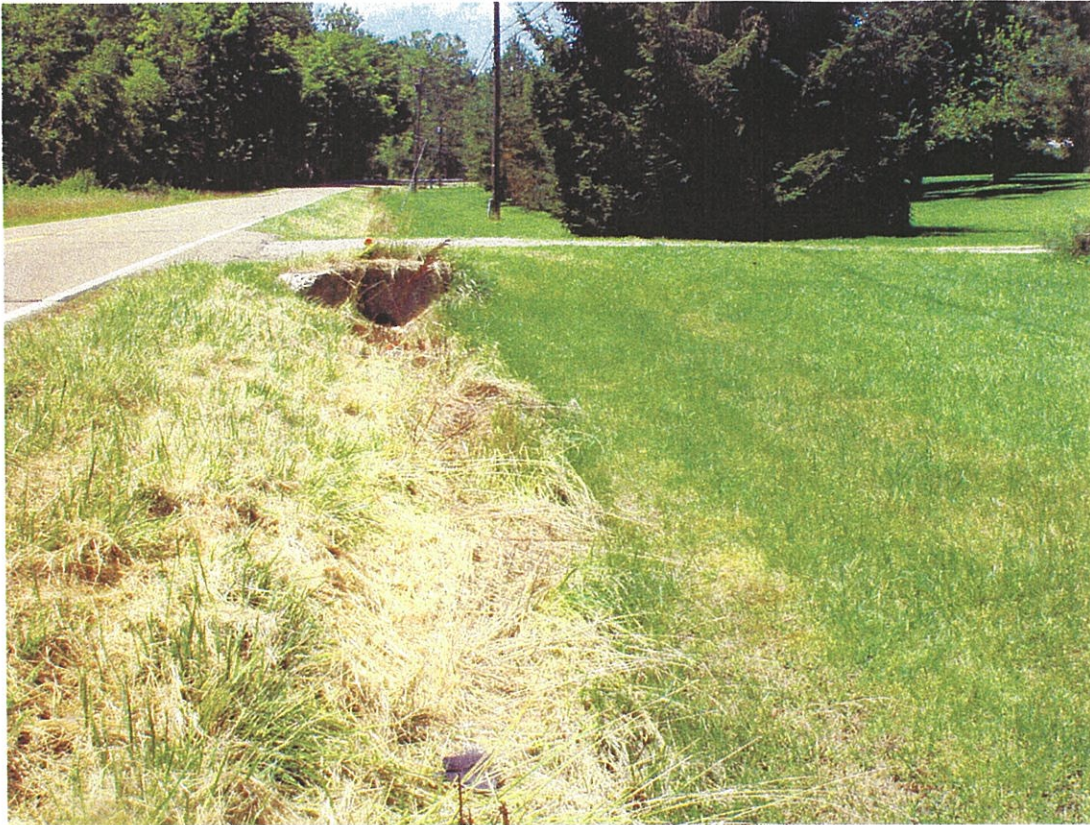
(PID 07-1374.002)

Photo 49. View looking west along SR 728 (southern property boundary) from the southeast corner of the Trowbridge property.

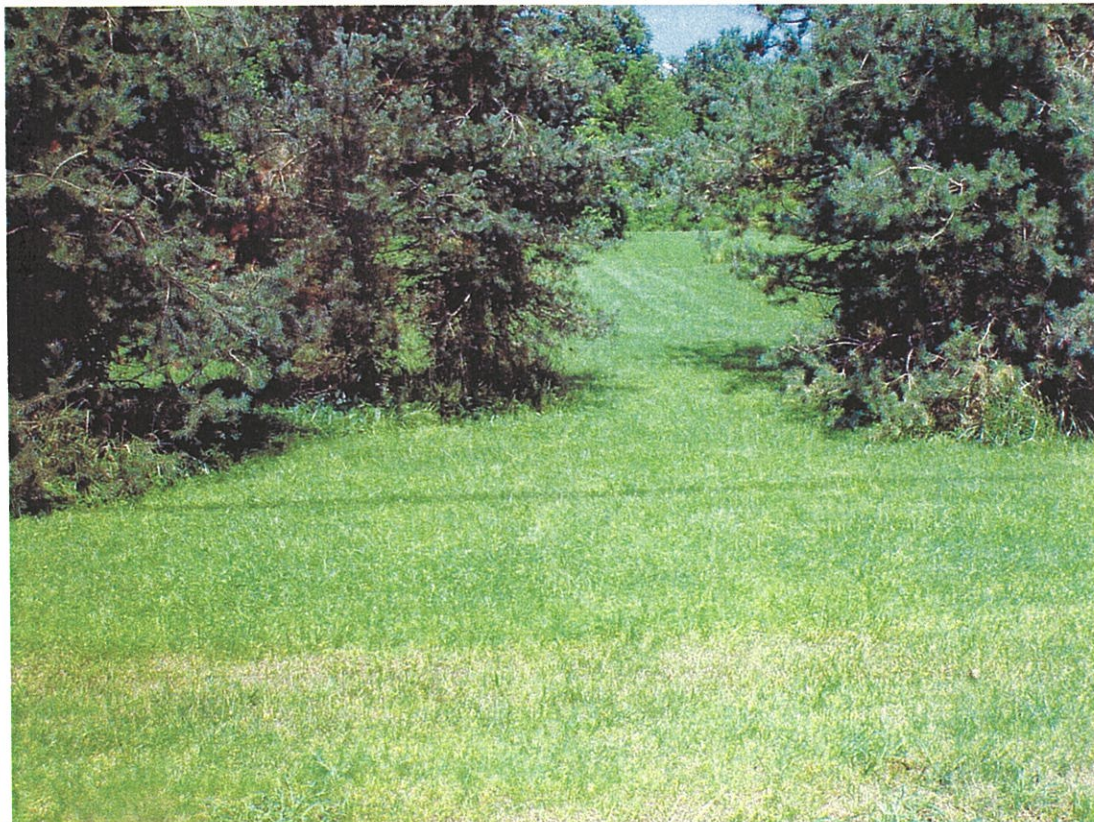
(PID 07-1374.002)

Photo 50. View looking north along the eastern property boundary from the southeast corner of the Trowbridge property.

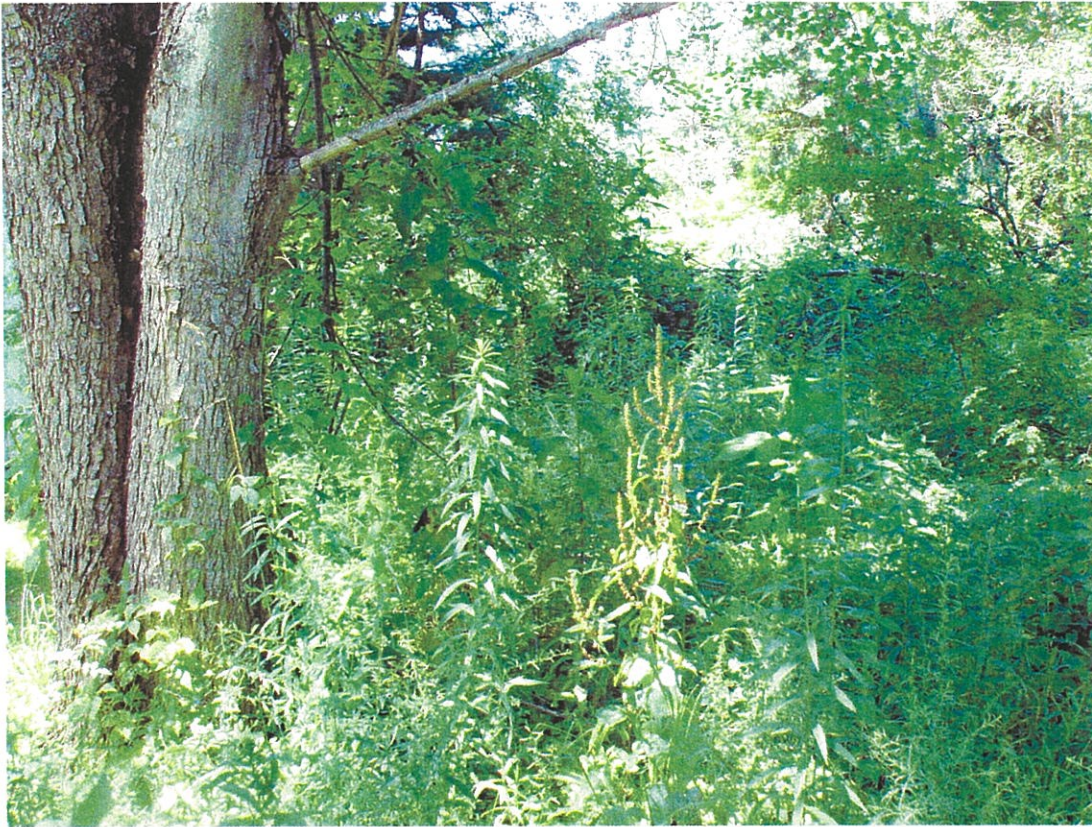
(PID 07-1374.002)

Photo 51. View looking west along the northern property boundary from the northeast corner of the Trowbridge property.

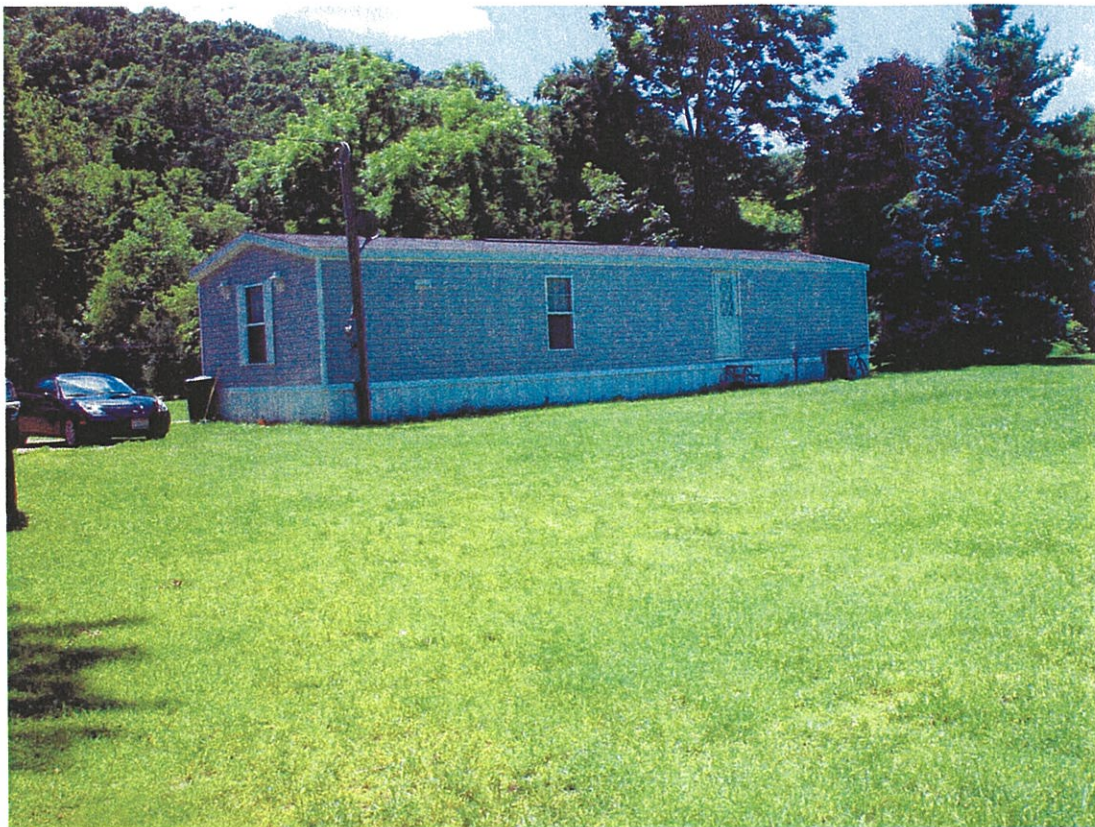
(PID 07-1374.002)

Photo 53. View looking at the Trowbridge mobile home located on the central portion of the Trowbridge property.

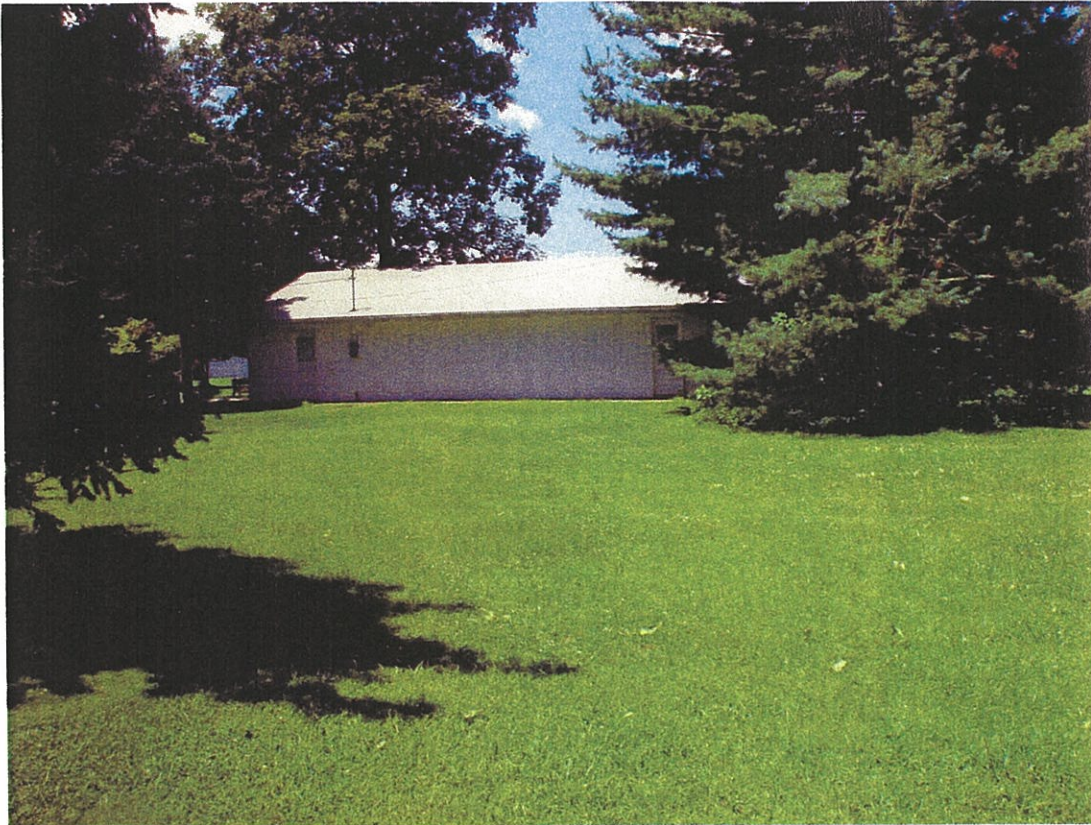
(PID 07-1374.002)

Photo 55. View looking at the print shop located on the western portion of the Trowbridge property.
