Geology and Field Reconnaissance  
Portsmouth Bypass  
Project SCI-823-0.00  
Phase 3 – Stage I  
Scioto County, Ohio

**REPORT OF  
GEOLOGY AND FIELD RECONNAISSANCE  
FOR  
PROJECT SCI-823-0.00  
PHASE 3 – STAGE I  
SCIOTO COUNTY, OHIO**

DLZ Job. No. 0121-3070.03  
PID No. 77366  
Document No. 0089

November 16, 2007

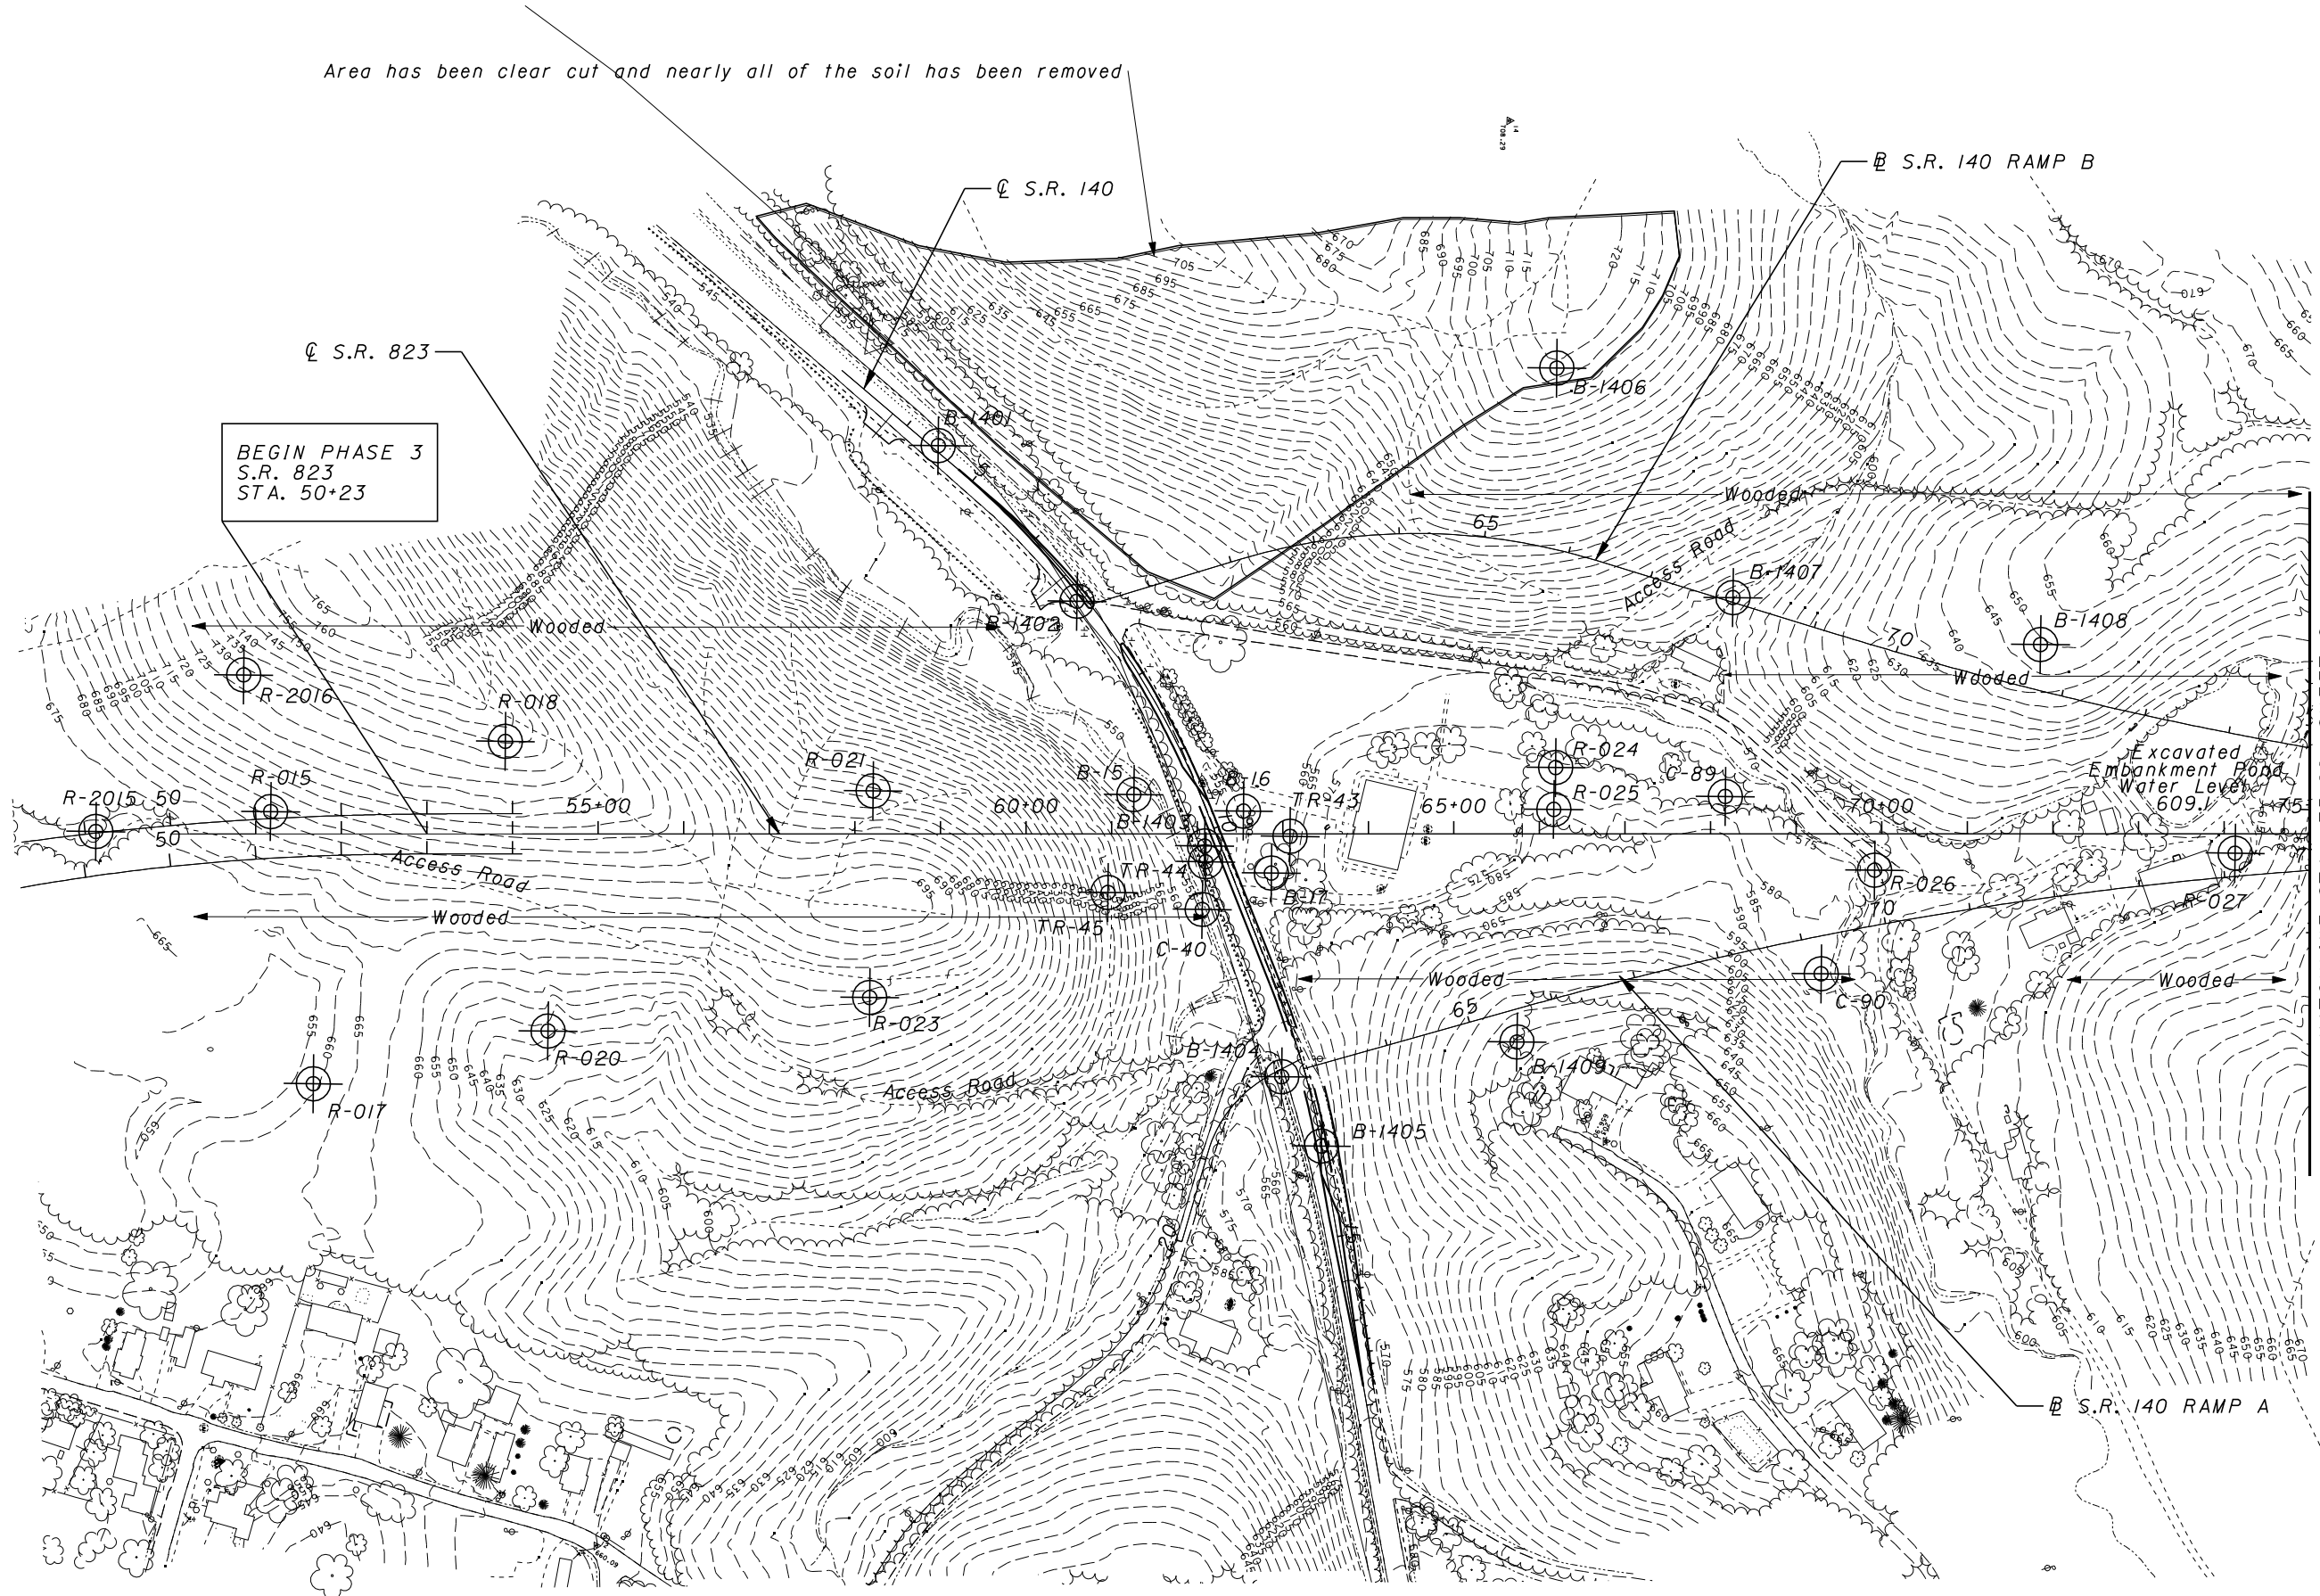
**LAND USE AND RECONNAISSANCE NOTES**  
**S.R. 823 STA. 50+23 TO STA. 75+00**

Area has been clear cut and nearly all of the soil has been removed
