# C-01 CORE LOG

**Project:** PIC-23-17.37, PID 112877      **Date:** 6/29/2022  
**Location:** Pickaway County, Ohio      **Core Type / Alignment:** Pavement / Vertical  
**Client:** Stantec Consulting Services, Inc.      **Coring Crew:** PGI - Jason Kash  
**Core Barrel Size (O.D.):** 4.00"      **Hole Patched w/:** Cold Patch Asphalt

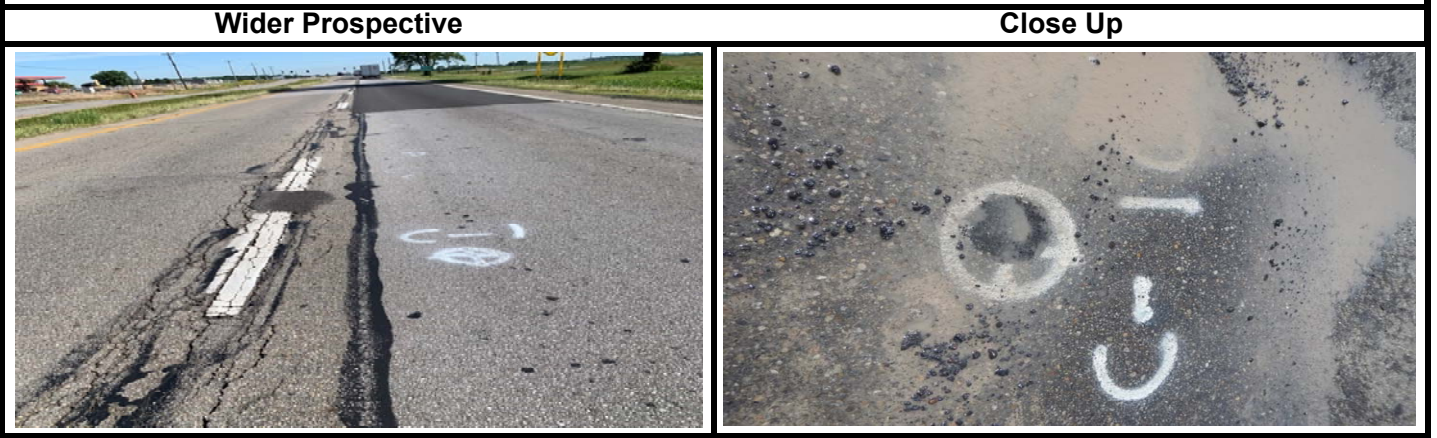
### Core Location

**Core Location:** Station: 917+13.60, North Bound Right Lane 2.5' to the right of the lane line.  
Approximate Distance measured from the west leg of SR 316 Centerline = 614'.

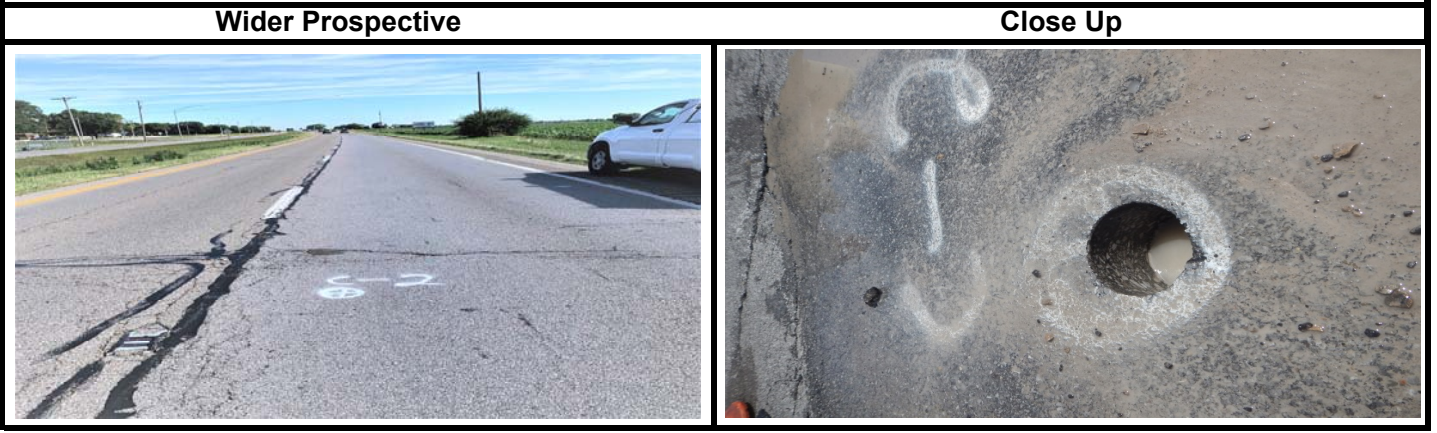
### Core Location

**Core Location:** Station: 969+93.60, North Bound Right Lane 2.4' to the right of the lane line.  
 Approximate Distance measured from the west leg of SR 316 Centerline = 5894'.

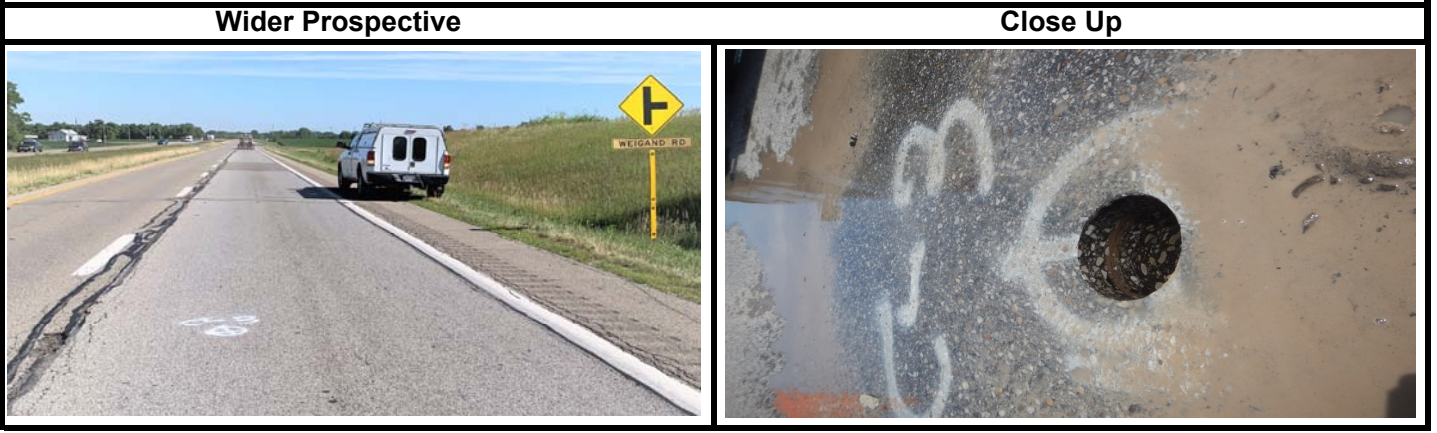
## Core Location

**Core Location:** Station: 1022+73.60, North Bound Right Lane 3.7' to the right of the lane line.  
 Approximate Distance measured from the west leg of SR 316 Centerline = 11174'.

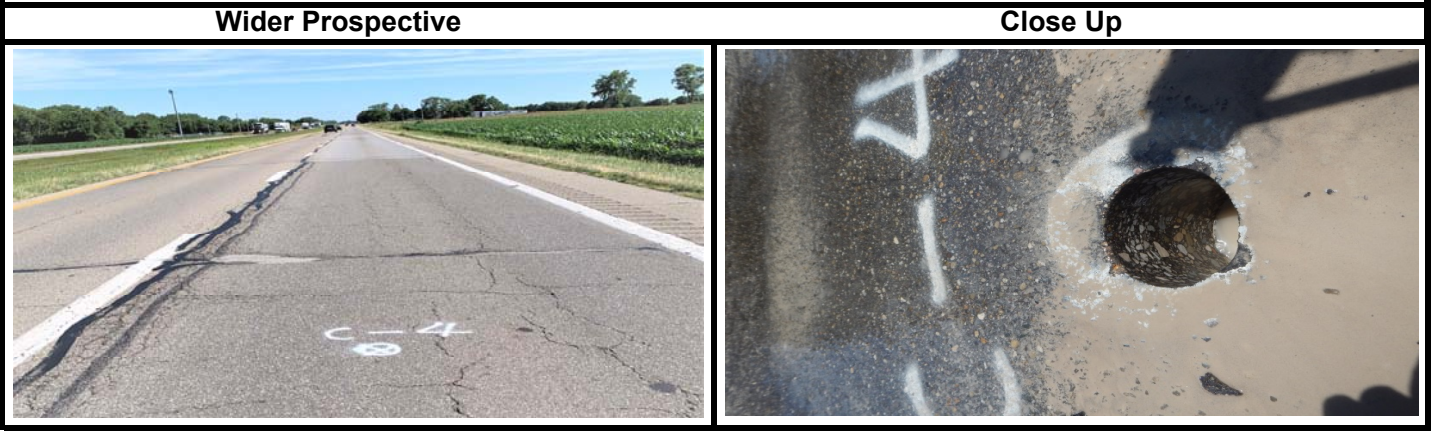
## Core Location

**Core Location:** Station: 1075+53.60, North Bound Right Lane 5.1' to the right of the lane line.  
 Approximate Distance measured from the west leg of SR 316 Centerline = 16454'.

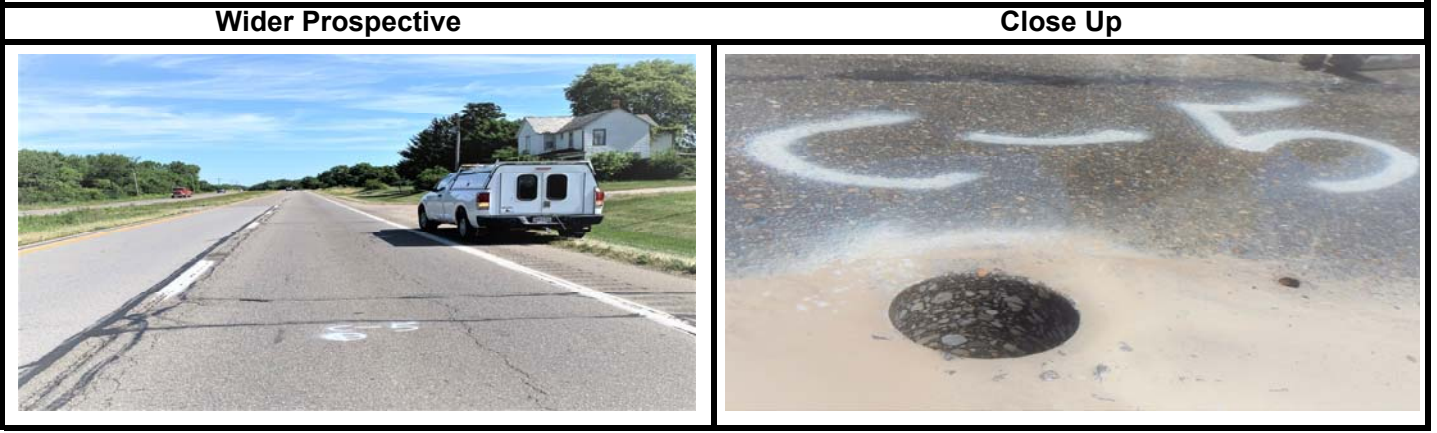
### Core Location

**Core Location:** Station: 1128+33.60, North Bound Right Lane 4.9' to the right of the lane line.  
 Approximate Distance measured from the west leg of SR 316 Centerline = 21734'.

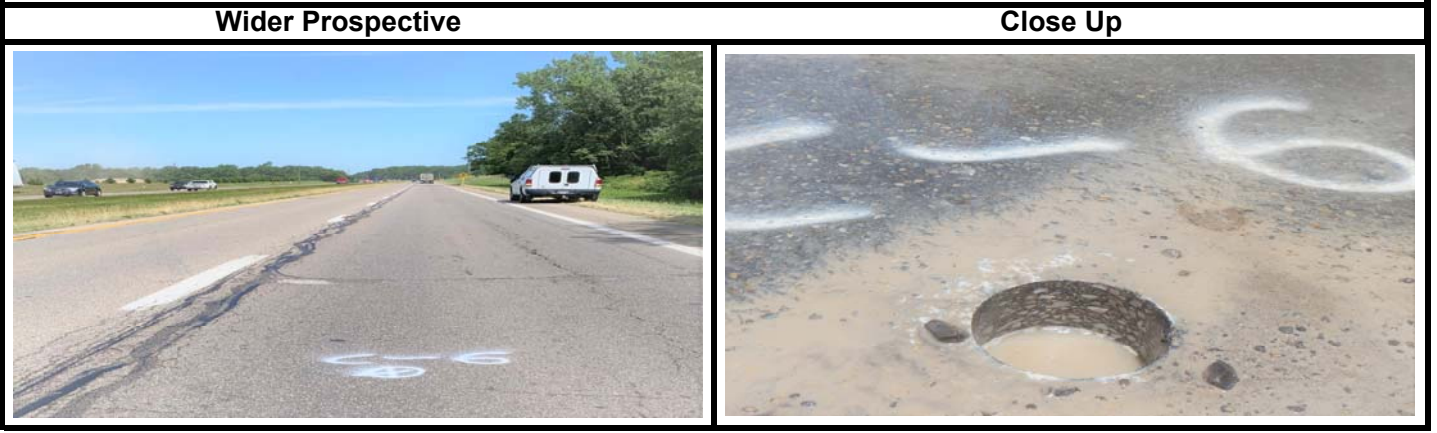
### Core Location

**Core Location:** Station: 1181+13.60, North Bound Right Lane 4.2' to the right of the lane line.  
 Approximate Distance measured from the west leg of SR 316 Centerline = 27014'.

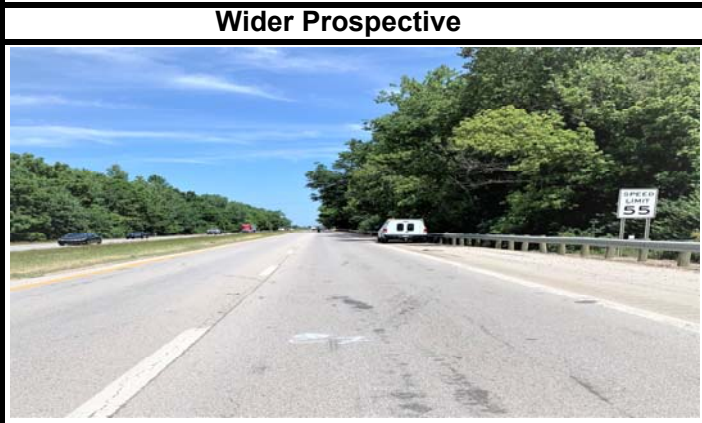
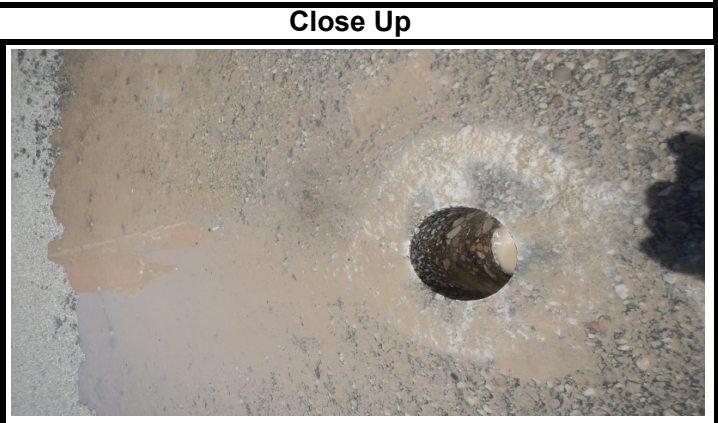
## Core Location

**Core Location:** Station: 1222+84.80, North Bound Right Lane 2.9' to the right of the lane line.  
 Approximate Distance measured from the west leg of SR 316 Centerline = 31185'.

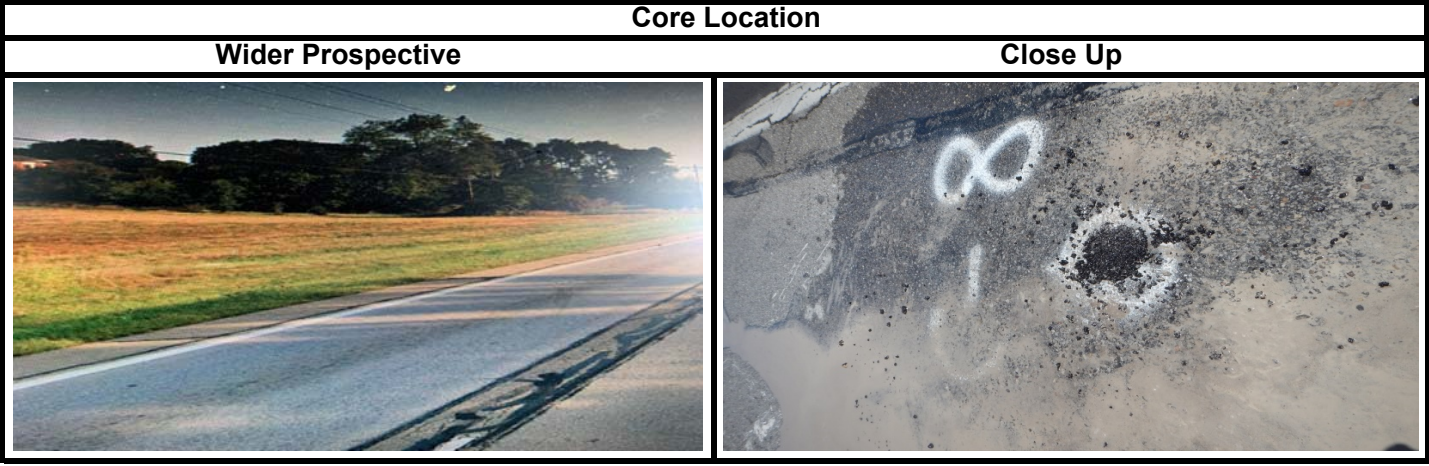
**Core Location:** Station: 917+13.60, South Bound Right Lane 2.4' to the right of the lane line.  
 Approximate Distance measured from the west leg of SR 316 Centerline = 614'.

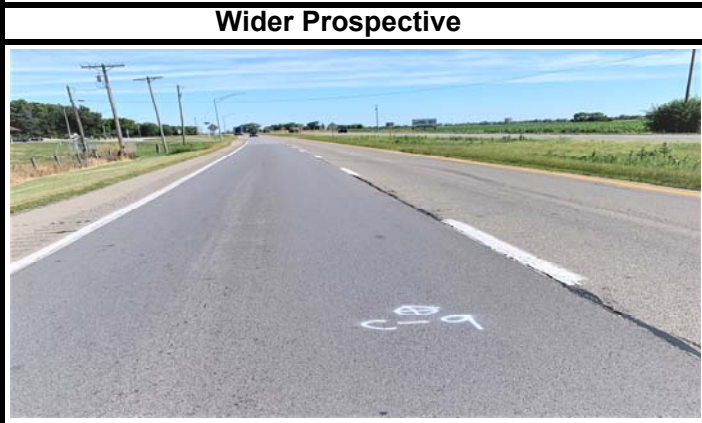
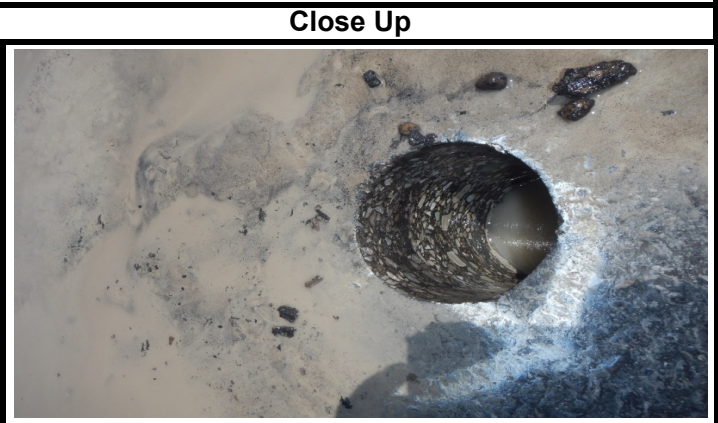
### Core Location

**Core Location:** Station: 969+93.60, South Bound Right Lane 3.3' to the right of the lane line.  
 Approximate Distance measured from the west leg of SR 316 Centerline = 5894'.

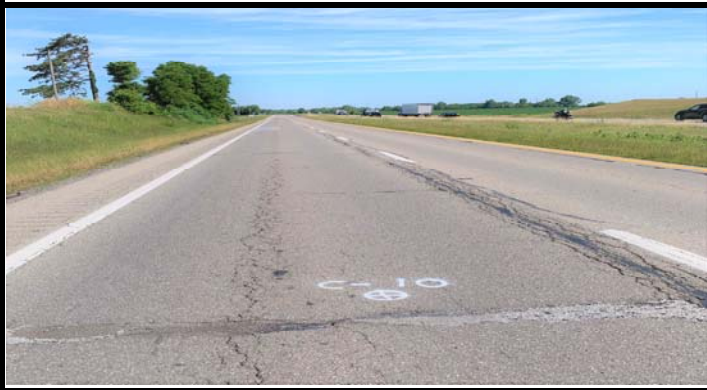
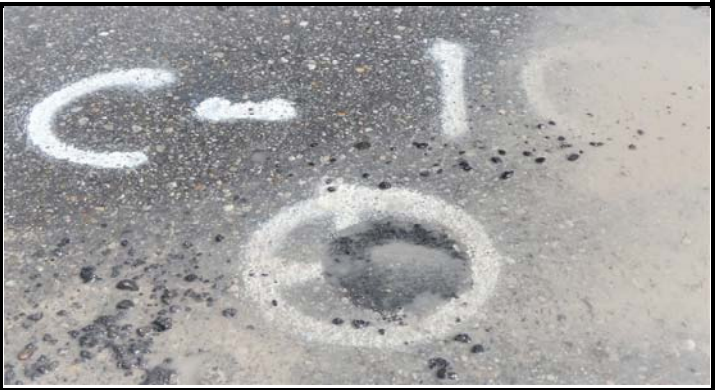
**Core Location:** Station: 1022+73.60, South Bound Right Lane 5.5' to the right of the lane line.  
 Approximate Distance measured from the west leg of SR 316 Centerline = 11174'.

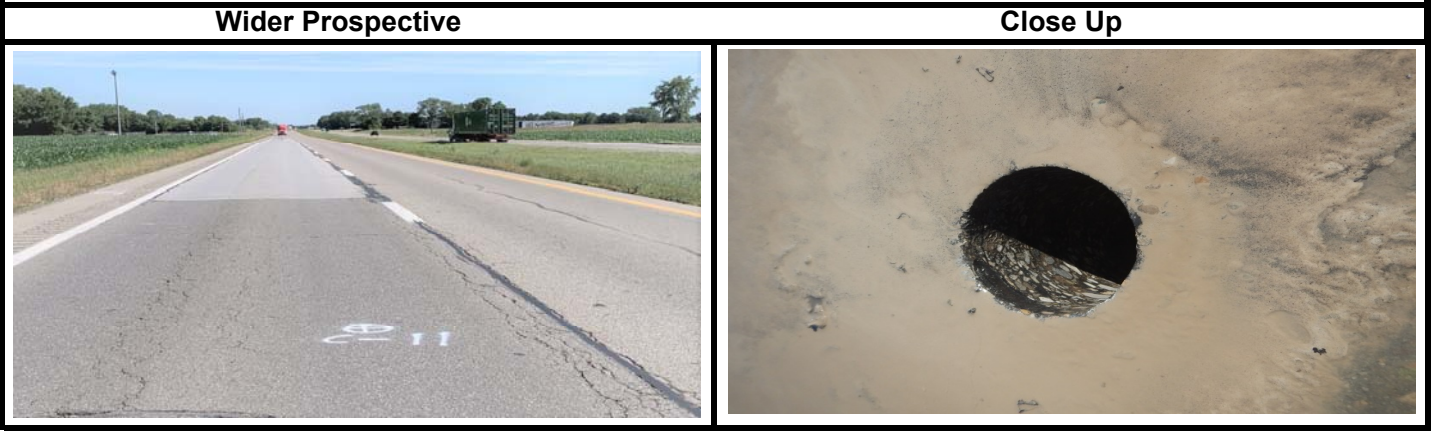
### Core Location

**Core Location:** Station: 1075+53.60, South Bound Right Lane 3.3' to the right of the lane line.  
 Approximate Distance measured from the west leg of SR 316 Centerline = 16454'.

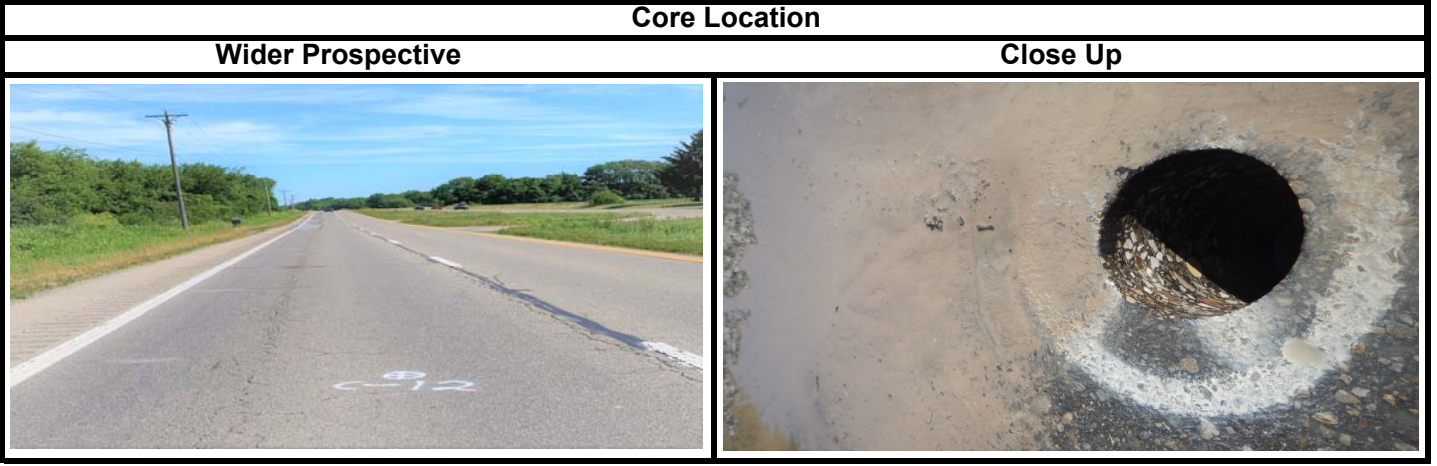
**Core Location:** Station: 1128+33.60, South Bound Right Lane 4.8' to the right of the lane line.  
 Approximate Distance measured from the west leg of SR 316 Centerline = 21734'.

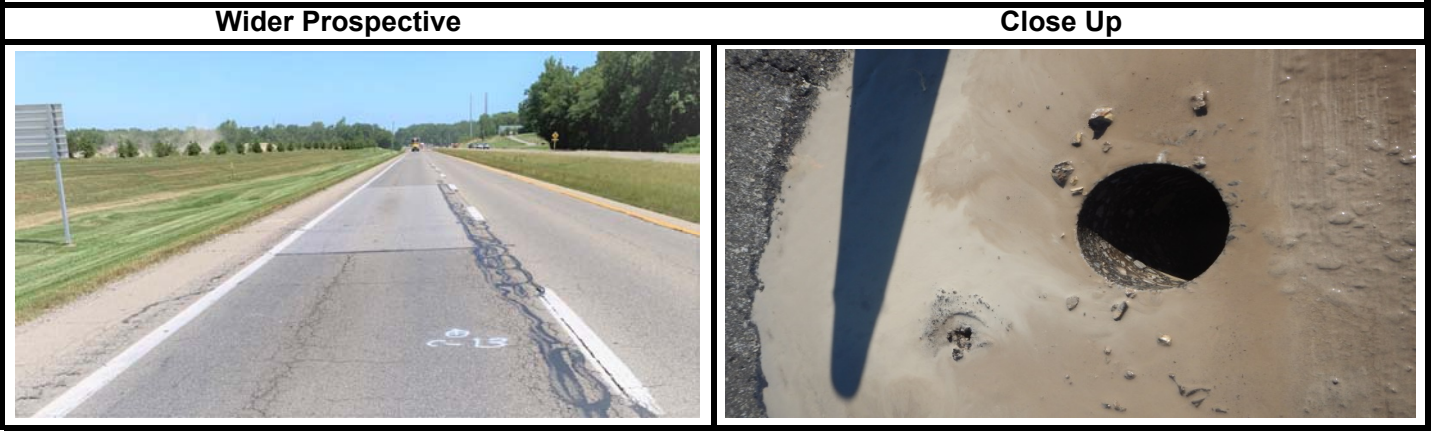
**Core Location**

**Core Location:** Station: 1181+13.60, South Bound Right Lane 4.3' to the right of the lane line.  
 Approximate Distance measured from the west leg of SR 316 Centerline = 27014'.

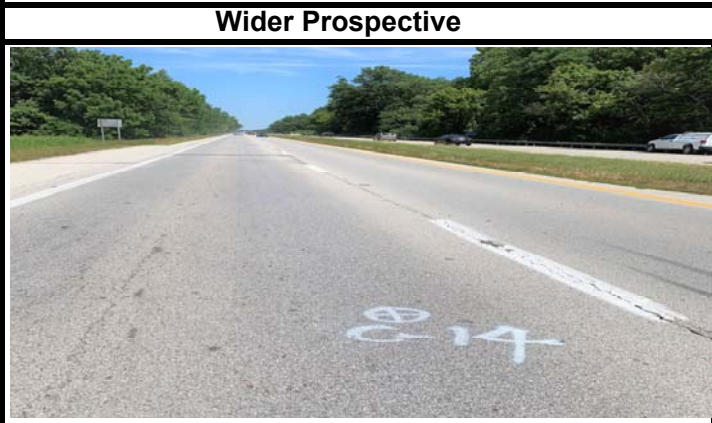
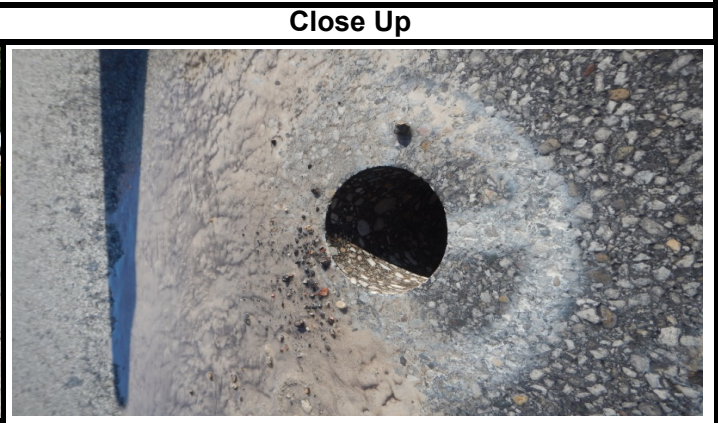
### Core Location

**Core Location:** Station: 1222+84.80, South Bound Right Lane 3.2' to the right of the lane line.  
 Approximate Distance measured from the west leg of SR 316 Centerline = 31185'.
