**REPORT
ROADWAY EXPLORATION REPORT
UNI/DEL 42-4.92/0.00
UNION & DELAWARE COUNTIES, OHIO
PID#: 111381**

NEAS PROJECT 20-0072

May 25, 2021

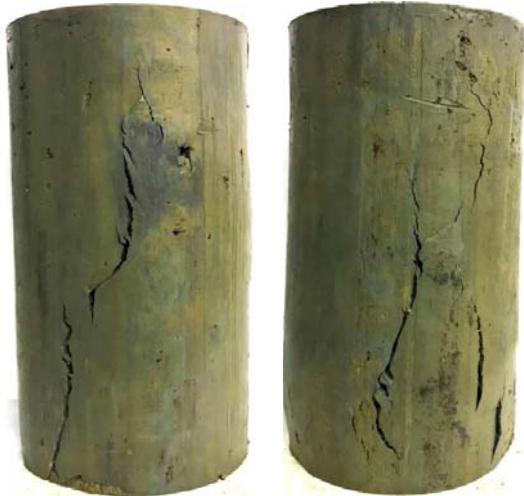
Final Specimen Figure

Unconfined Compressive Strength (psf): **1273**
 Strain (%): **0.9**

Notes: Medium stiff, brownish gray mottled with orangish brown, CLAY, "and" sand, trace silt, trace gravel, moist. Specimen contained slickensides after testing

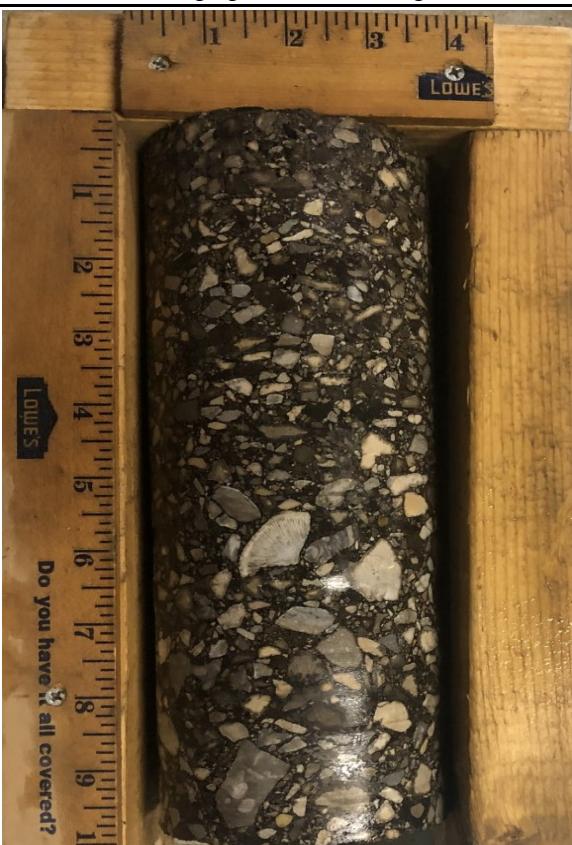
<p>FACE OF THE CORE IS AT ZERO</p> <p>- ±1.00" Surface Course</p> <p>- ±4.50" Surface Course</p> <p>- ±4.50" Base Course</p> <p>Total Core Recovery = 10.00"</p>

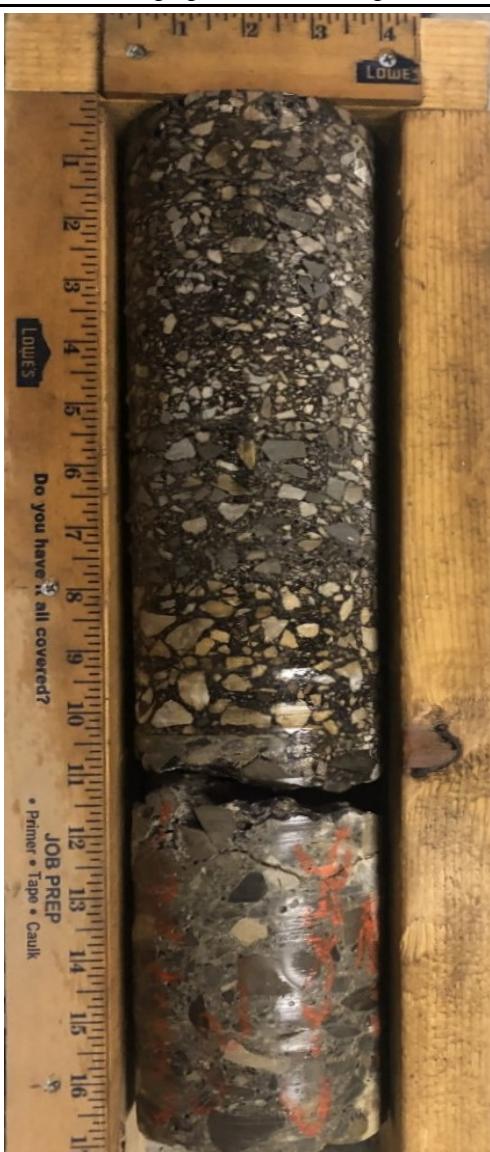
<p>FACE OF THE CORE IS AT ZERO</p> <p>- ±1.50" Surface Course</p> <p>- ±3.75" Surface Course</p> <p>- ±2.50" Base Course</p> <p>- ±2.50" Base Course</p> <p>- ±6.50" Concrete</p> <p>Total Core Recovery = 16.75</p>

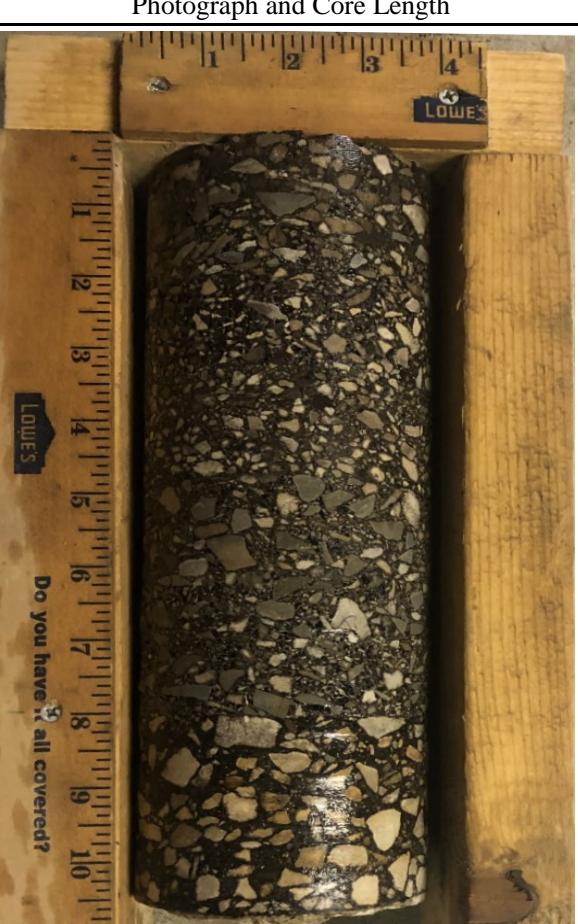
<p>FACE OF THE CORE IS AT ZERO</p> <p>- ±4.75" Surface Course</p> <p>- ±3.50" Surface Course</p> <p>- ±2.50" Intermediate Course</p> <p>- ±3.00" Base Course</p> <p>Total Core Recovery = 10.75"</p>

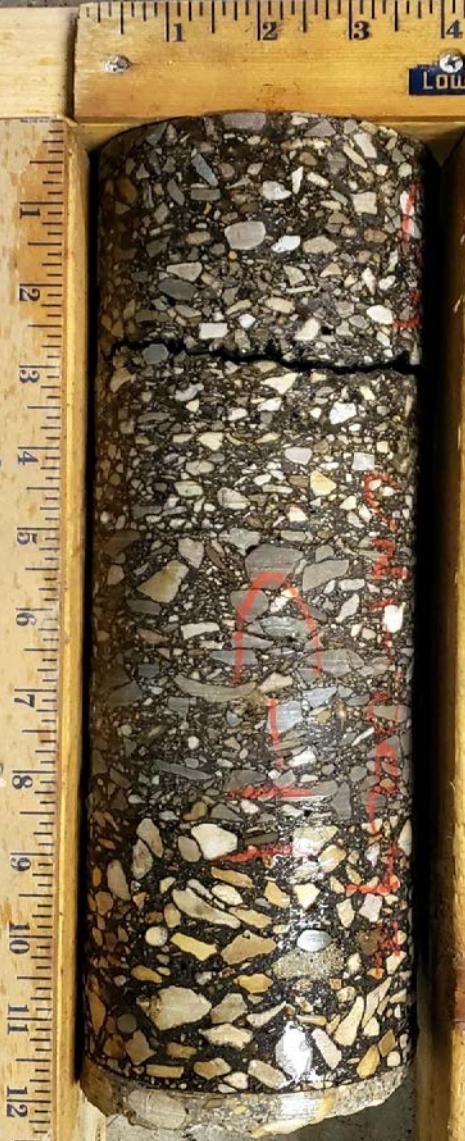
<p>FACE OF THE CORE IS AT ZERO</p> <p>- ±1.75" Surface Course</p> <p>- ±3.25" Surface Course</p> <p>- ±3.50" Intermediate Course</p> <p>- ±3.25" Base Course</p> <p>- ±0.75" Concrete</p> <p>Total Core Recovery = 12.50"</p>

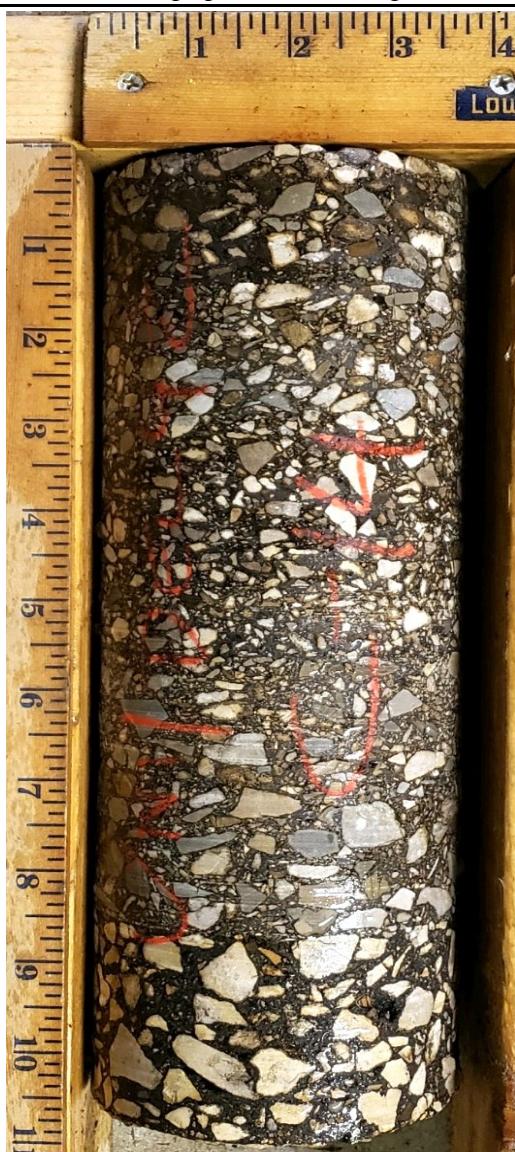
<p>FACE OF THE CORE IS AT ZERO</p> <p>- ±1.50" Surface Course</p> <p>- ±4.00" Surface Course</p> <p>- ±3.00" Intermediate Course</p> <p>- ±2.50" Base Course</p> <p>Total Core Recovery = 11.00"</p>

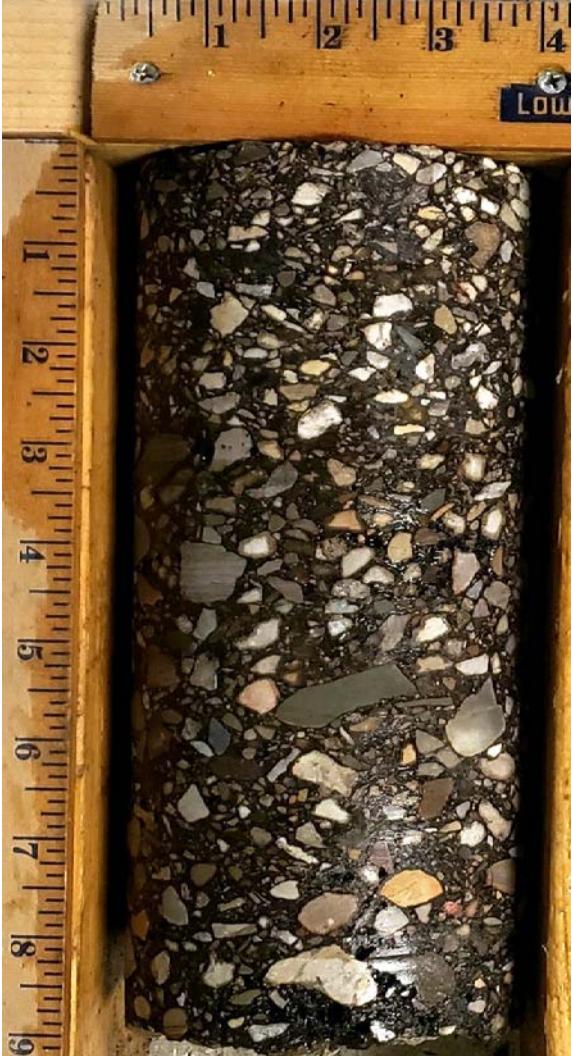
FACE OF THE CORE IS AT ZERO - ±9.50" Asphalt	Total Core Recovery = 9.50"

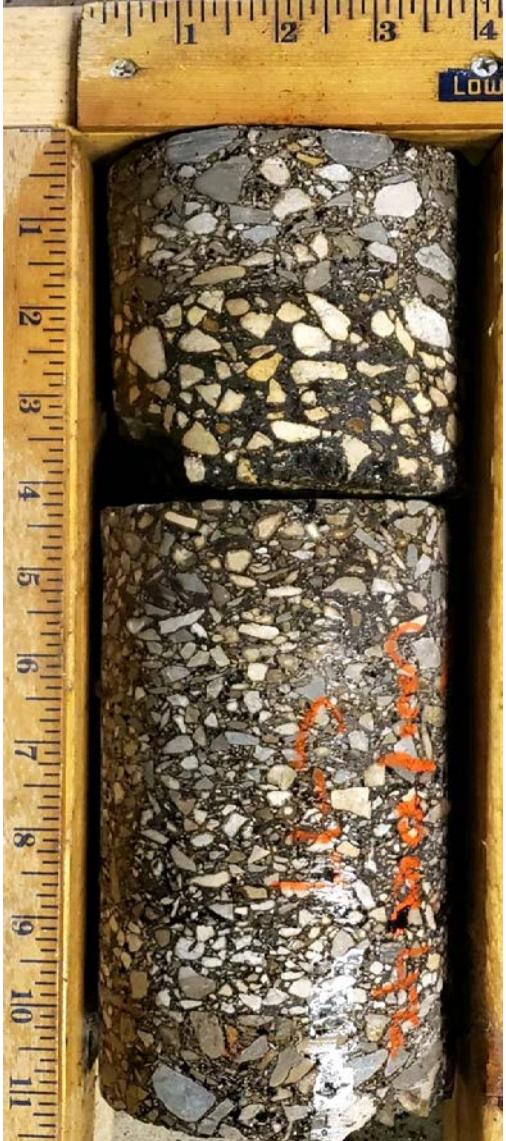
<p>FACE OF THE CORE IS AT ZERO</p> <p>- ±1.75" Surface Course</p> <p>- ±4.00" Surface Course</p> <p>- ±4.00" Intermediate Course</p> <p>- ±1.75" Base Course</p> <p>Total Core Recovery = 11.50"</p>

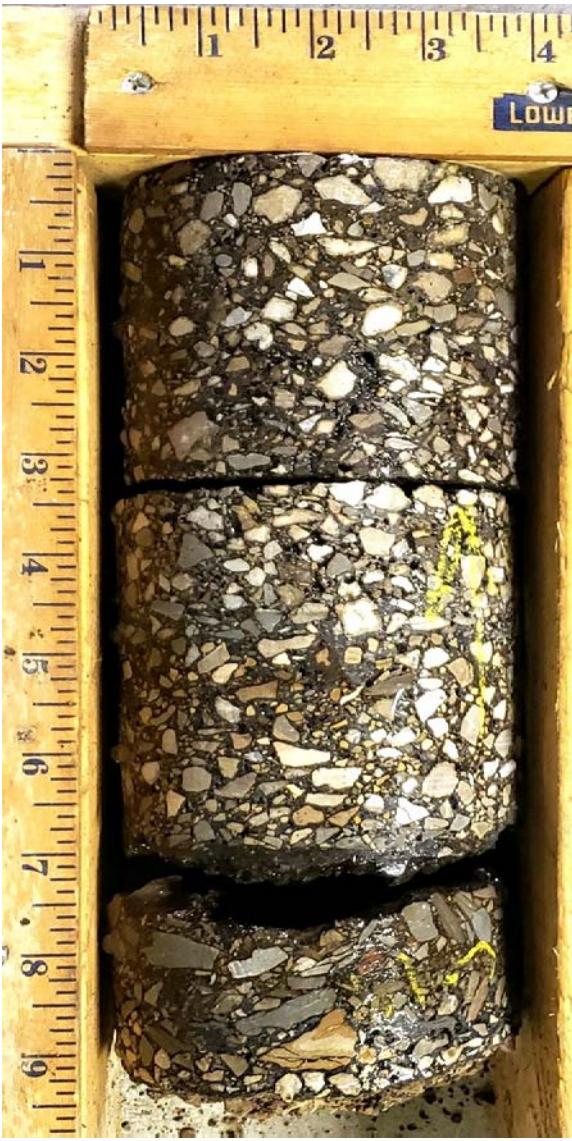
<p>FACE OF THE CORE IS AT ZERO</p> <p>- ±3.25" Surface Course</p> <p>- ±3.75" Surface Course</p> <p>- ±2.50" Base Course</p> <p>Total Core Recovery = 9.50"</p>

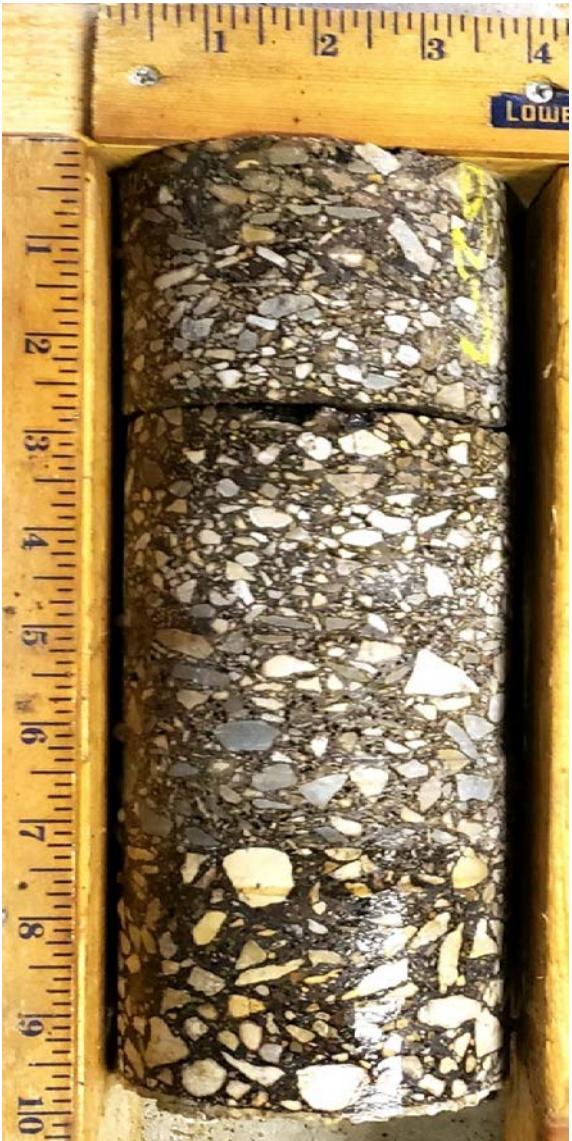
<p>FACE OF THE CORE IS AT ZERO</p> <p>- ±2.75" Surface Course</p> <p>- ±4.50" Surface Course</p> <p>- ±3.00" Base Course</p> <p>Total Core Recovery = 10.25"</p>

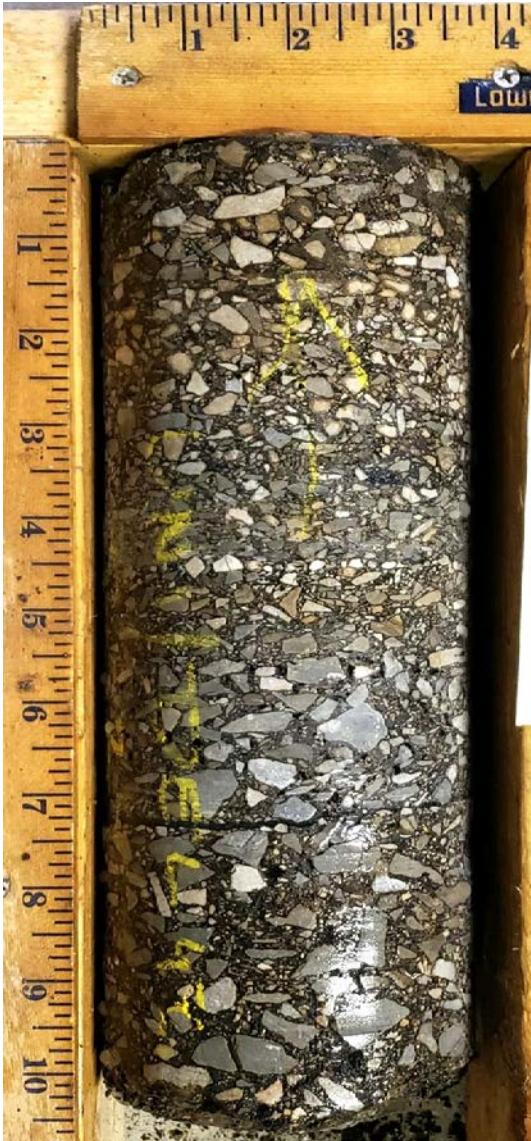
<p>FACE OF THE CORE IS AT ZERO</p> <p>- ±1.50" Surface Course</p> <p>- ±5.75" Surface Course</p> <p>- ±4.00" Base Course</p> <p>Total Core Recovery = 11.25"</p>

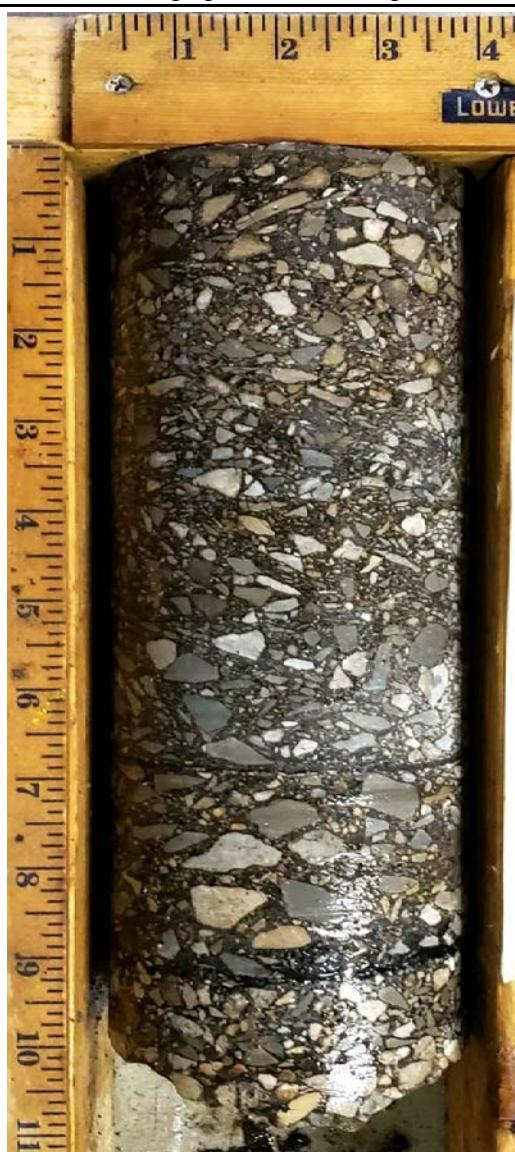
<p>FACE OF THE CORE IS AT ZERO</p> <p>- ±1.25" Surface Course</p> <p>- ±2.50" Surface Course</p> <p>- ±3.00" Intermediate Course</p> <p>- ±2.25" Base Course</p> <p>- ±1.75" Base Course</p> <p>Total Core Recovery = 10.75"</p>
