# Waterville City Council

## June 1, 2026

## **Roche de Boeuf Bridge Physical Condition Report May 2026**

***ROCHE DE BOEUF BRIDGE COMMITTEE  
PHYSICAL CONDITION & PRESERVATION  
ALTERNATIVES REPORT***

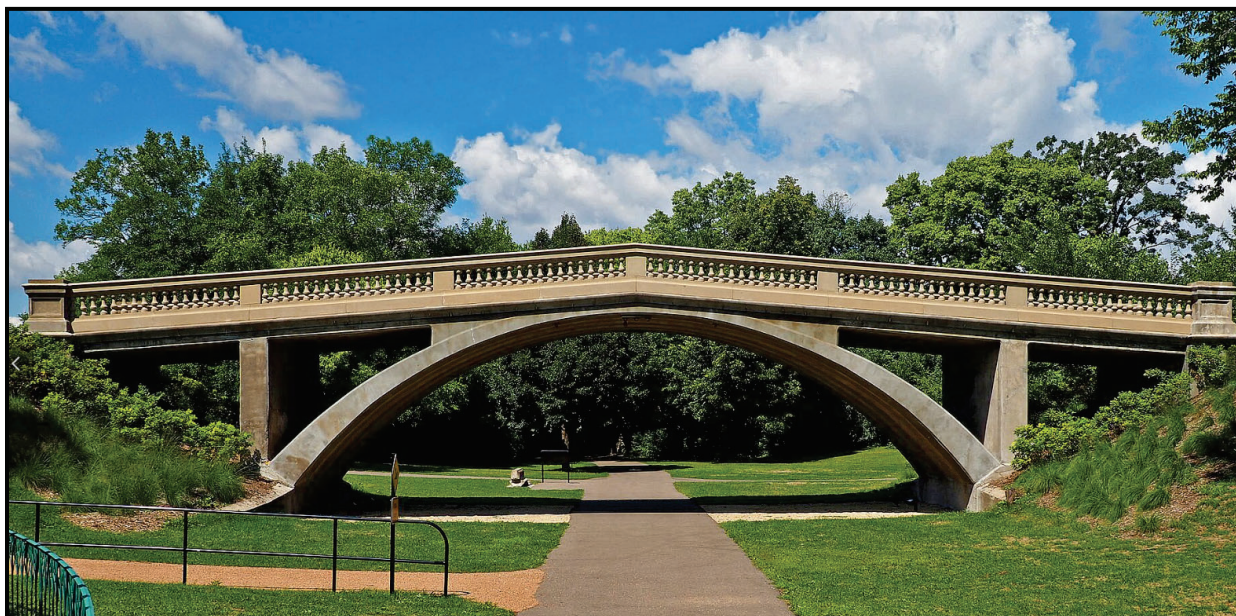
The Interurban Bridge is a three-span reinforced concrete bridge featuring a Milan arch main span (Photo 1). By the 2000s the bridge was in serious condition and closed to pedestrian traffic both on and below. Lacking rehabilitation funds, the initial preservation plan for the structure was to remove deteriorated concrete and to maintain the structure as an abandoned artifact. Eventually rehabilitation funds were secured, and the structure was fully rehabilitated by 2020.

**Photo 1 – Restored Interurban Bridge, Como Park, June 2024.**

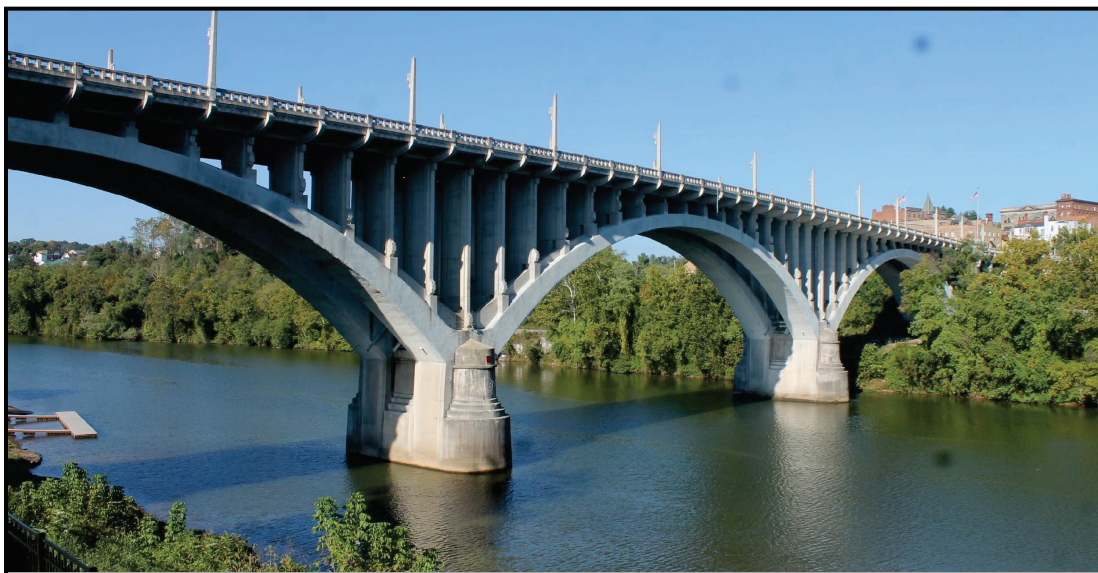
Opened in 1921, the Jefferson Street Bridge over the Monongahela River in Fairmont, West Virginia, has been a notable landmark in its region.<sup>1</sup> Following advanced deterioration, a major rehabilitation was performed to save the bridge in the late 1990s. This project included demolition of all concrete down to the tops of the arch ribs with near exact replication of these components (**Photo 9**). The arch ribs were “bulked up” with a concrete surface layer encapsulating a titanium mesh for cathodic protection.<sup>2</sup> This bridge has remained on the National Register of Historic Places.

**Photo 9 – Restored Jefferson Street Bridge, October 2016.**
