?: THIS WORK RELOCATES SOUTH OAKLEY 54 FOR NEW ODOT BIKE PATH AND RETAINING WALL WORK. HEAVY TRAFFIC AND HIGHWAY CROSSINGS. STEEP SLOPES, WATCH YOUR FOOTING

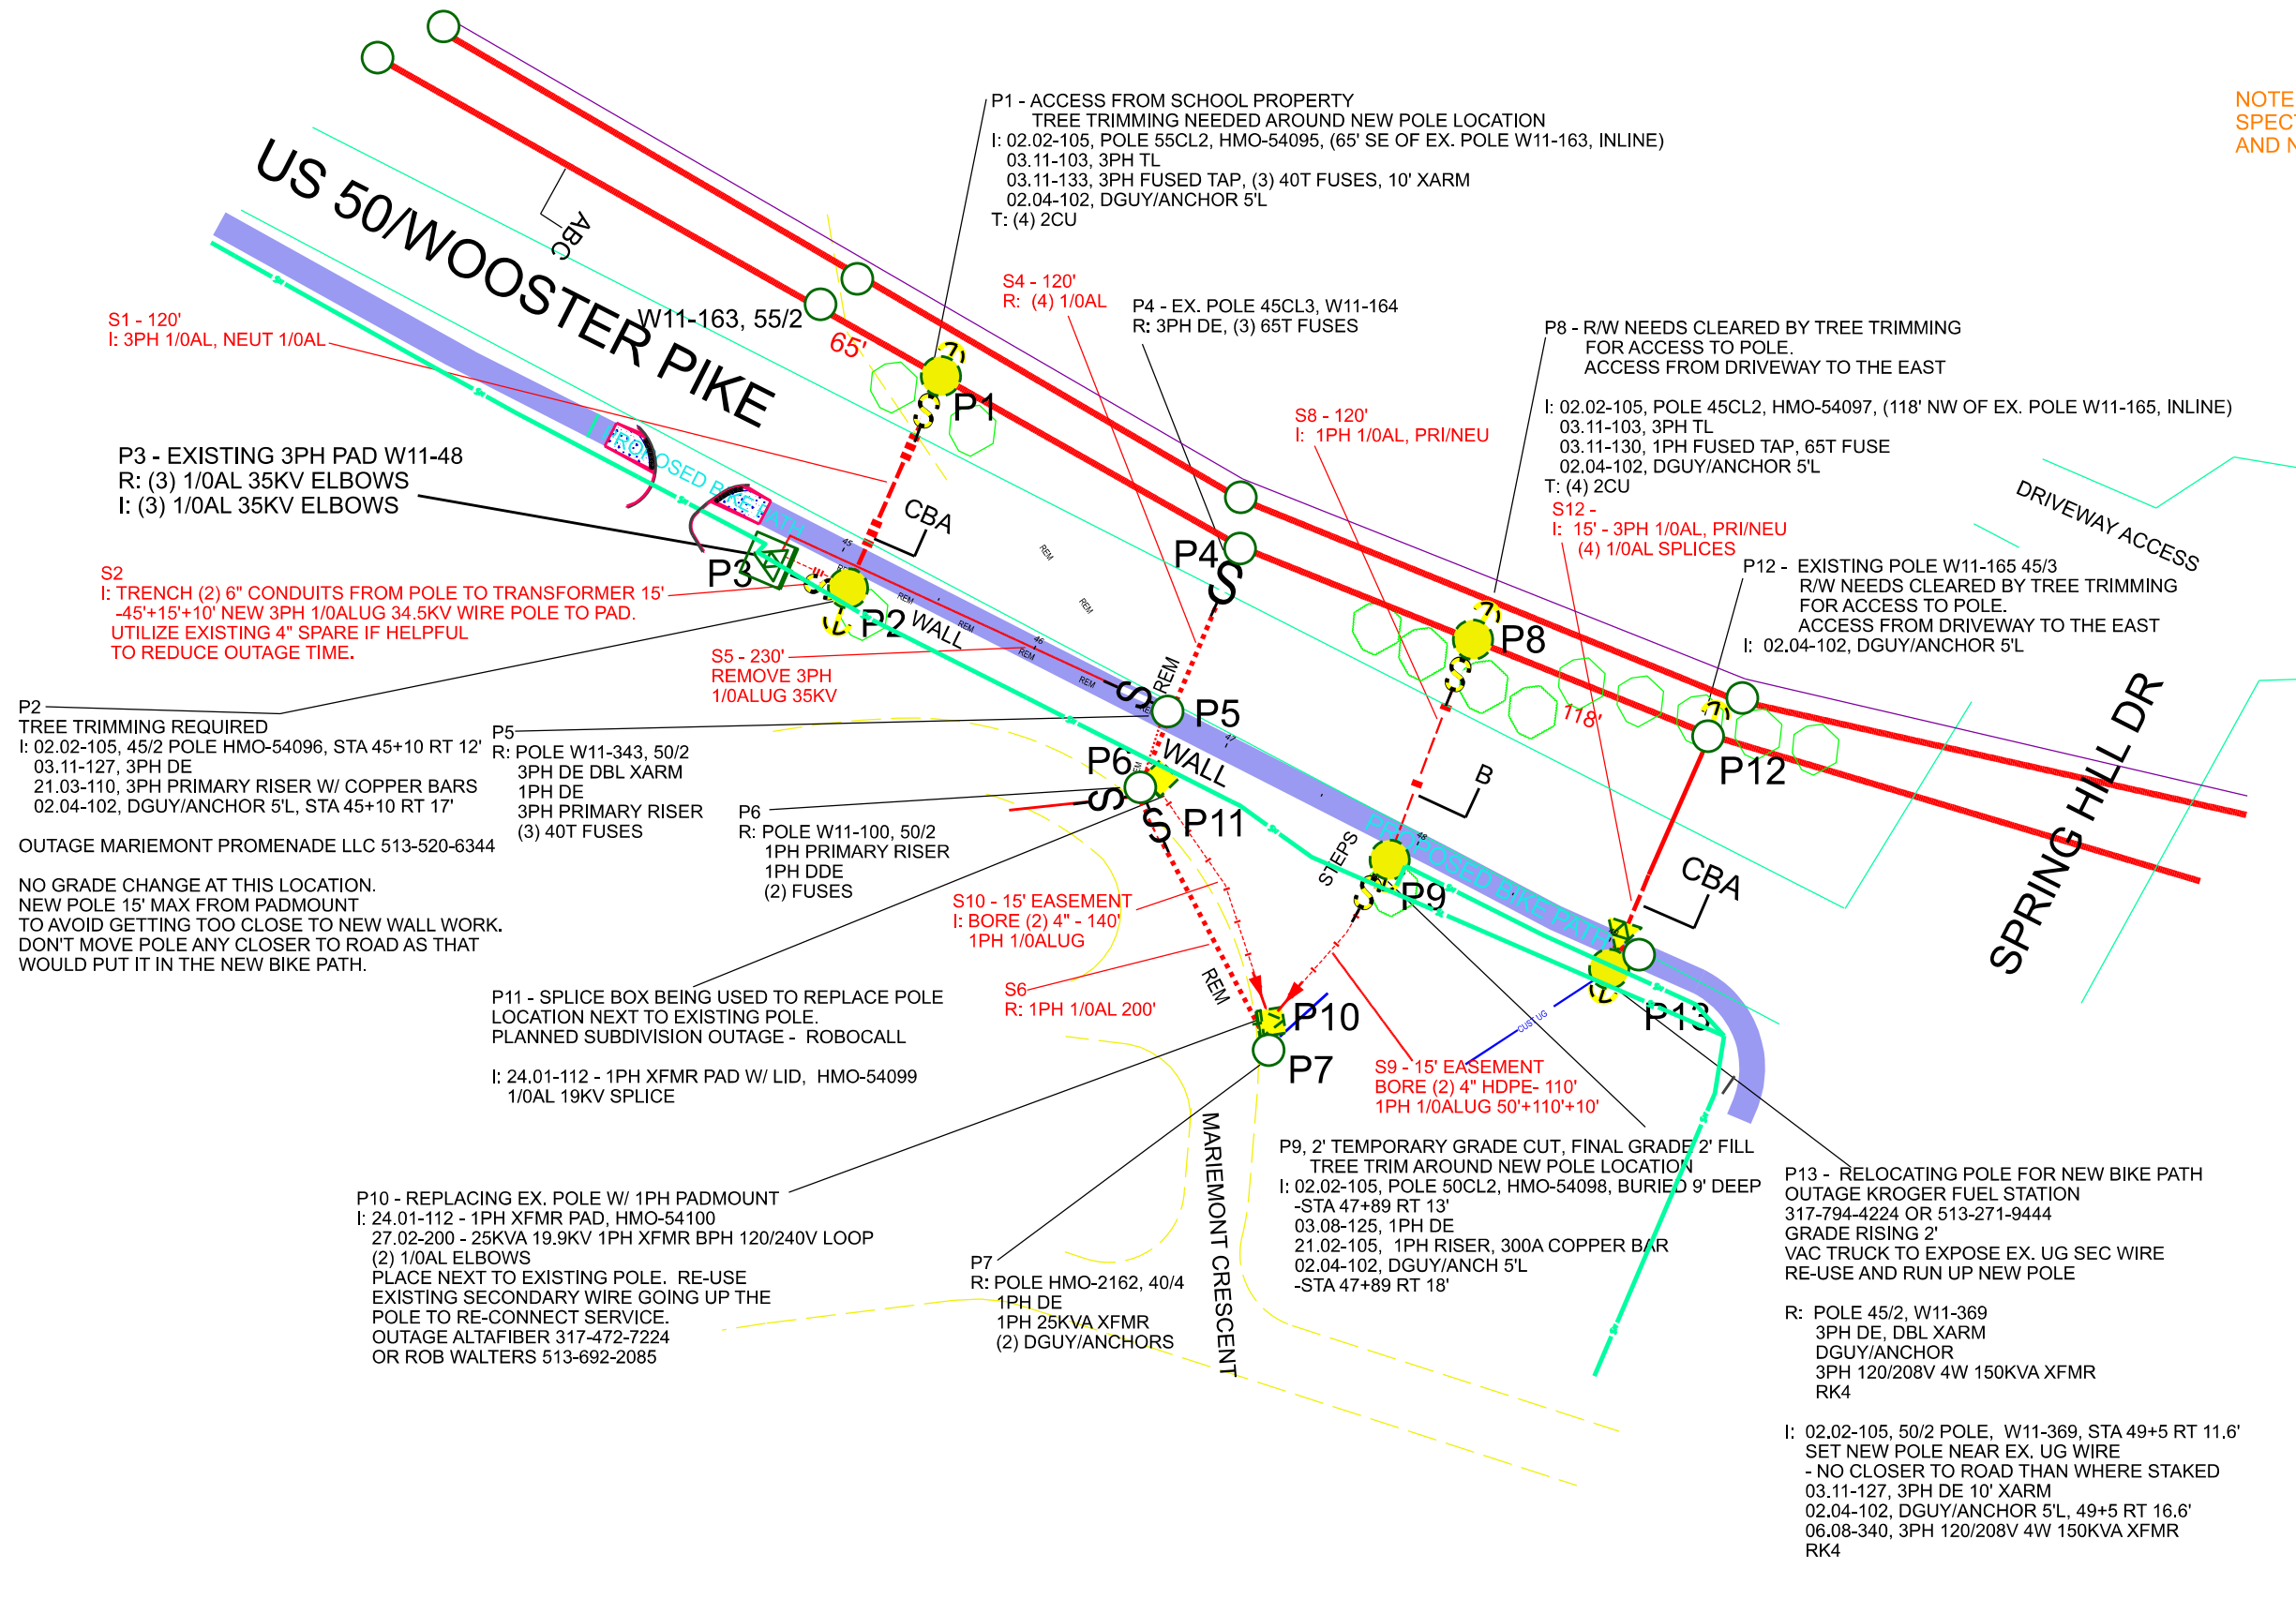
**P1 - ACCESS FROM SCHOOL PROPERTY**  
TREE TRIMMING NEEDED AROUND NEW POLE LOCATION  
I: 02.02-105, POLE 55CL2, HMO-54095, (65' SE OF EX. POLE W11-163, INLINE)  
03.11-103, 3PH TL  
03.11-133, 3PH FUSED TAP, (3) 40T FUSES, 10' XARM  
02.04-102, DGUY/ANCHOR 5'L  
T: (4) 2CU

**P3 - EXISTING 3PH PAD W11-48**  
R: (3) 1/0AL 35KV ELBOWS  
I: (3) 1/0AL 35KV ELBOWS

**S2**  
I: TRENCH (2) 6" CONDUITS FROM POLE TO TRANSFORMER 15' -45'+15'+10' NEW 3PH 1/0ALUG 34.5KV WIRE POLE TO PAD. UTILIZE EXISTING 4" SPARE IF HELPFUL TO REDUCE OUTAGE TIME.

**P2**  
TREE TRIMMING REQUIRED  
I: 02.02-105, 45/2 POLE HMO-54096, STA 45+10 RT 12'  
03.11-127, 3PH DE  
21.03-110, 3PH PRIMARY RISER W/ COPPER BARS  
02.04-102, DGUY/ANCHOR 5'L, STA 45+10 RT 17'

**P5**  
R: POLE W11-343, 50/2  
3PH DE DBL XARM  
1PH DE  
3PH PRIMARY RISER  
(3) 40T FUSES

NO GRADE CHANGE AT THIS LOCATION. NEW POLE 15' MAX FROM PADMOUNT TO AVOID GETTING TOO CLOSE TO NEW WALL WORK. DON'T MOVE POLE ANY CLOSER TO ROAD AS THAT WOULD PUT IT IN THE NEW BIKE PATH.

**P11 - SPLICE BOX BEING USED TO REPLACE POLE LOCATION NEXT TO EXISTING POLE.**  
PLANNED SUBDIVISION OUTAGE - ROBOCALL

I: 24.01-112 - 1PH XFMR PAD W/ LID, HMO-54099  
1/0AL 19KV SPLICE

**P7**  
R: POLE HMO-2162, 40/4  
1PH DE  
1PH 25KVA XFMR  
(2) DGUY/ANCHORS

R: POLE 45/2, W11-369  
3PH DE, DBL XARM  
DGUY/ANCHOR  
3PH 120/208V 4W 150KVA XFMR  
RK4
