Subgrade Exploration Report - Final TRU-80-11.32 Truck Parking Hubbard, Trumbull County, Ohio S&ME Project No. 23170065D

Reference: Subgrade Exploration Report - Final

TRU-80-11.32 Truck Parking (PID 121698)

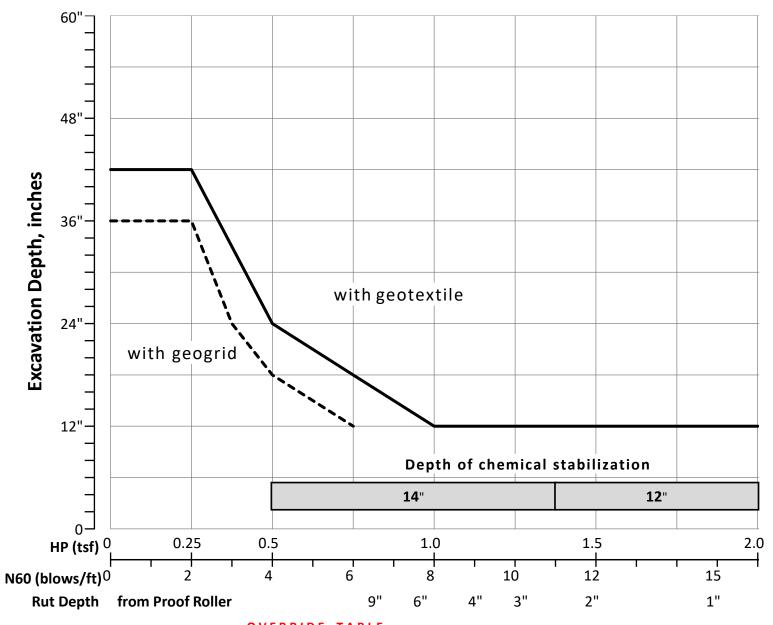
Fig. 600-1 – Subgrade Stabilization

Calculated Average	New Values	Check to Override
3.51		HP
20.00		N60L

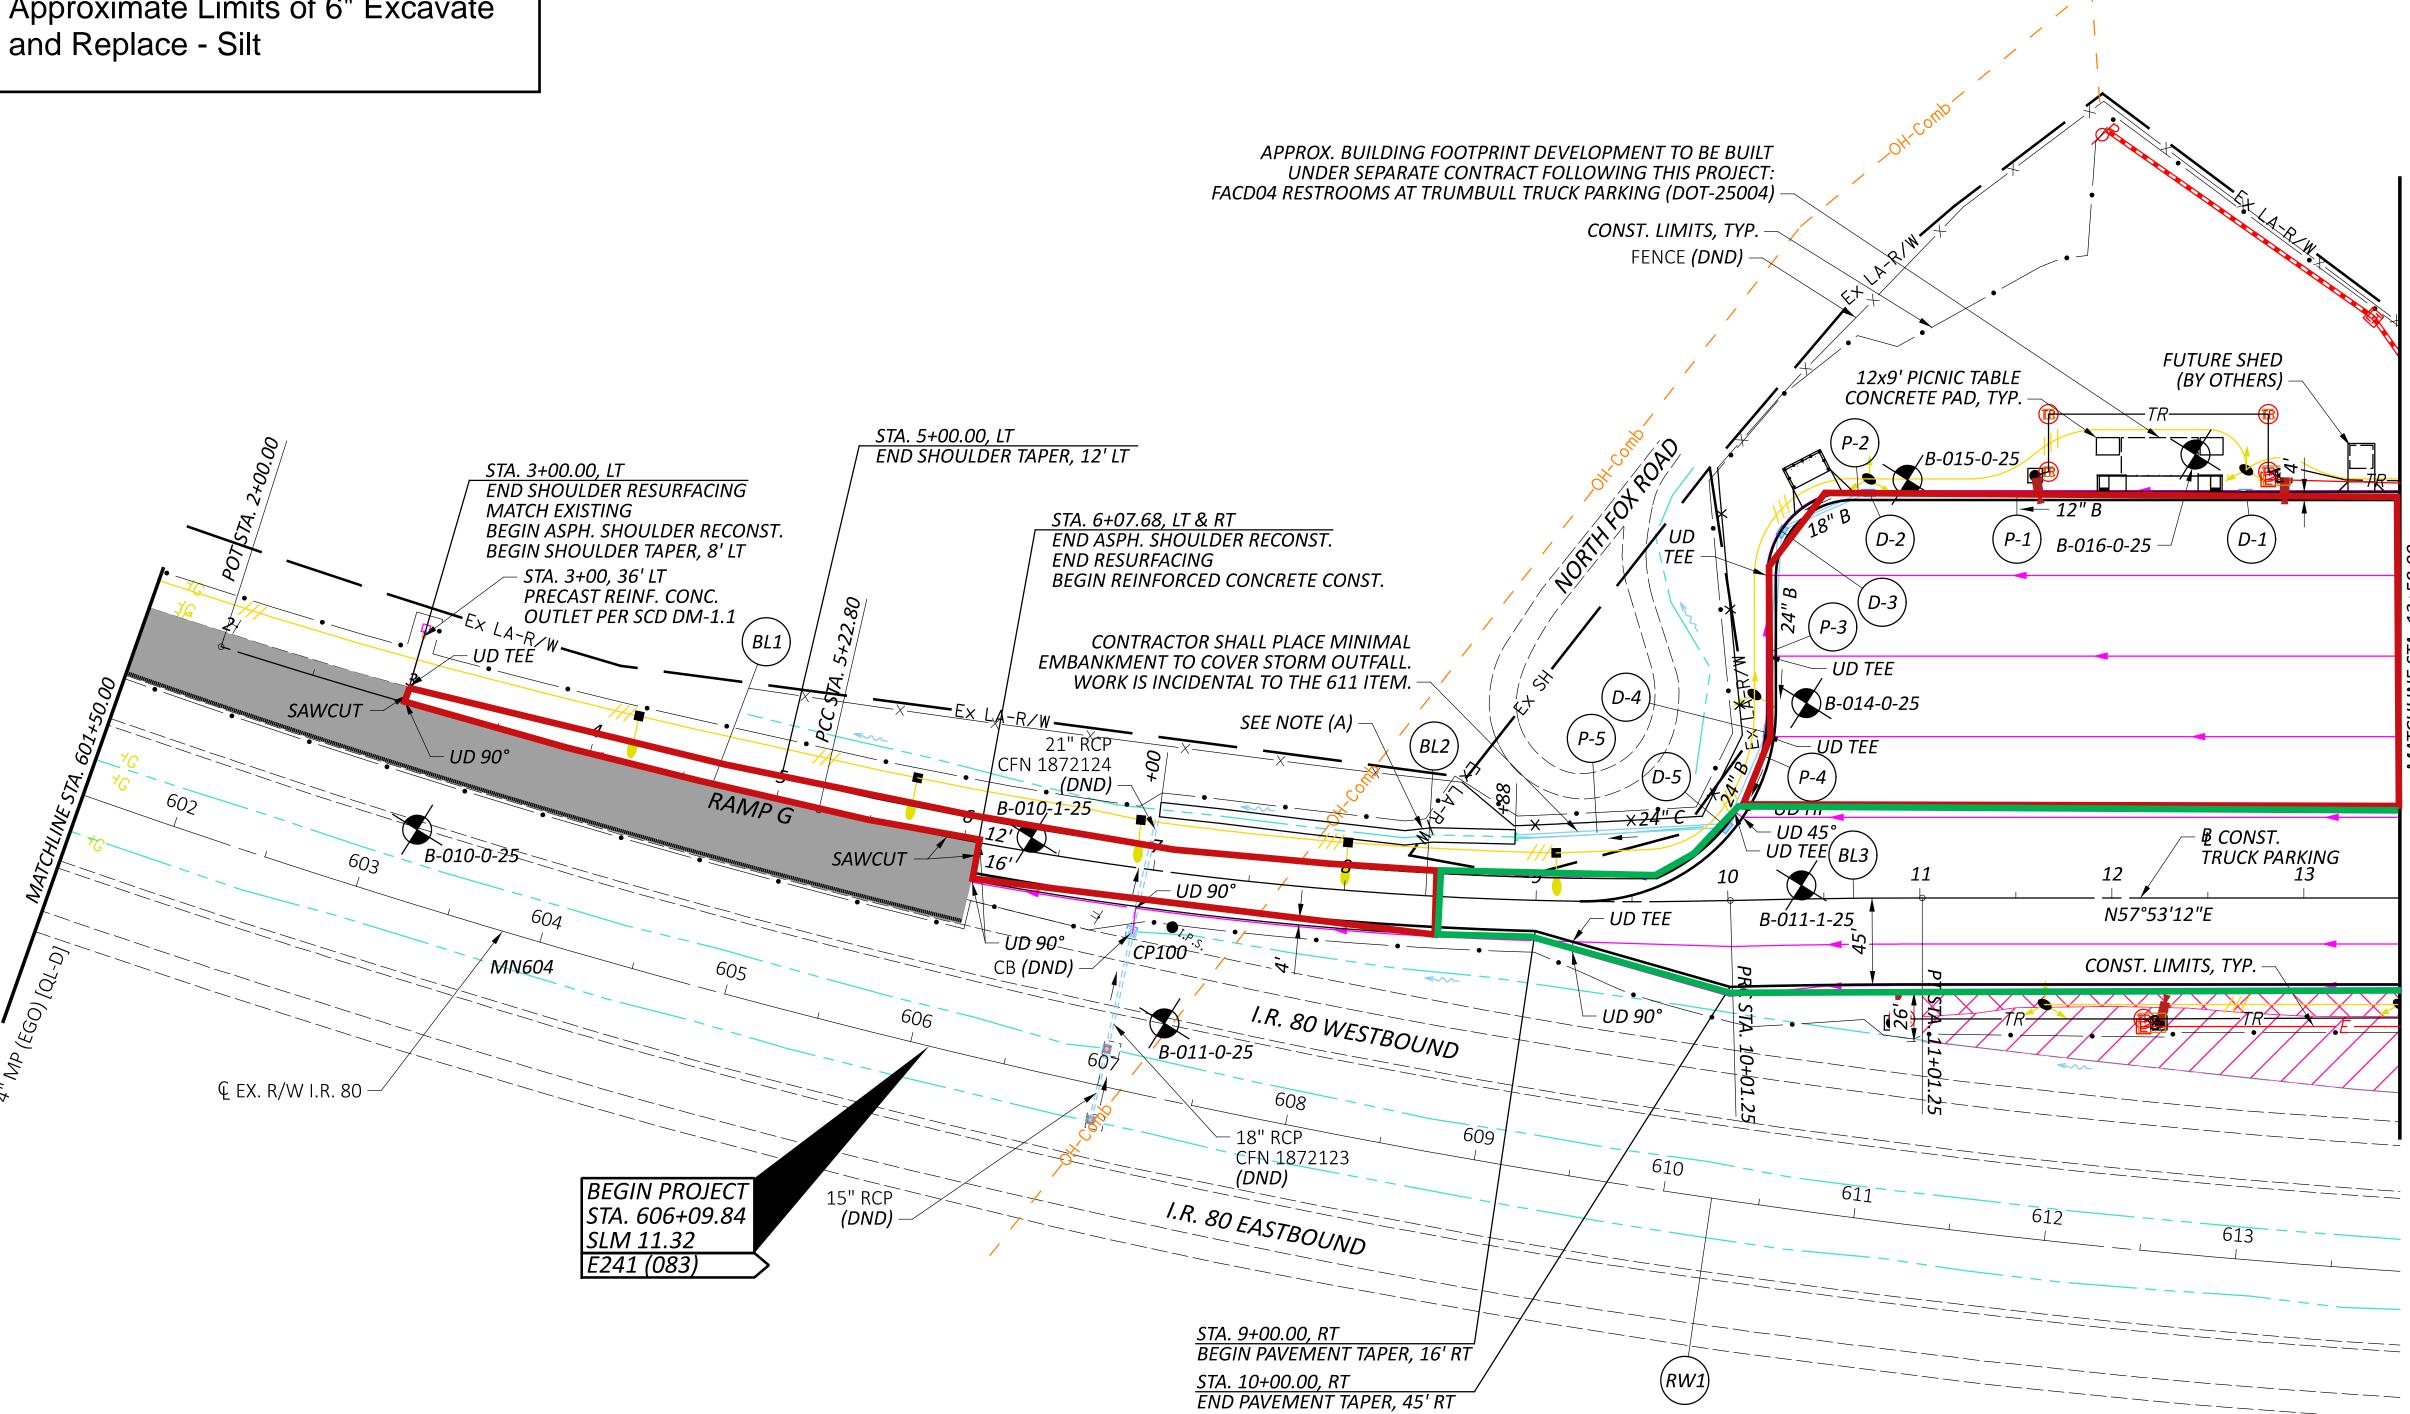
CONCEPTUAL DELINEATION OF ESTIMATED AREAS FOR "EXCAVATE AND REPLACE" SUBGRADE REMEDIATION

Approximate Limits of 12" Excavate and Replace - Unstable Soil

Approximate Limits of 6" Excavate
