STATE OF OHIO DEPARTMENT OF TRANSPORTATION
BRIDGE INSPECTION REPORT

Inventory Bridge Number: CUY 00010 08.690 N

SR 10 over VALLEY PKWY/ROCKY RIVER

Inspection Date: 09/16/2014

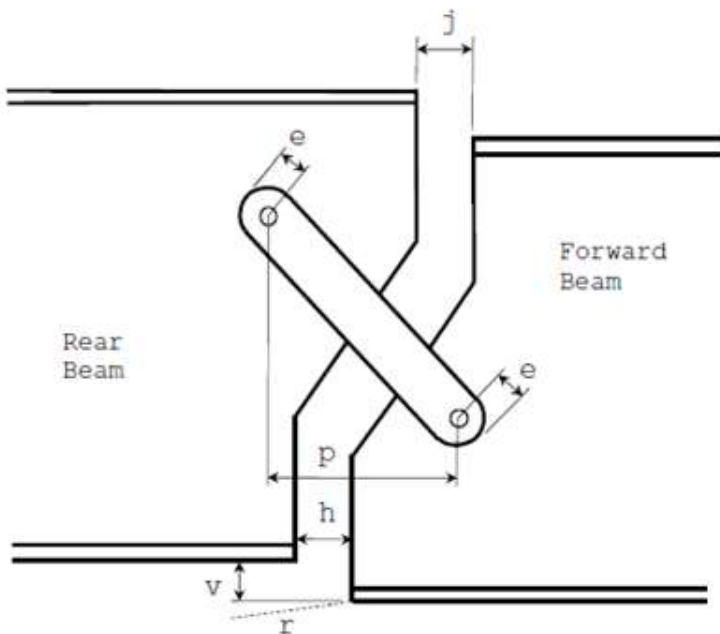
Beams labeled left to right looking up station.

Values are in inches:

h-horizontal at bottom of flange
