RE: District 12/3 General Engineering Services Agreement  
GES PID No. 117276  
CRS: D12/D3 GES FY2023-2025 Subsurface  
Agreement No. 38659  
Task Order Number (38659-D-12-4)  
County-Route-Section LAK-20-19.59  
Task PID No. 108665

The attached data report presents the results of our CPT and SPT exploration for LAK-20-19.59 in Perry, Ohio.

This data report presents the results of our CPT and SPT exploration for the LAK-20-19.59 project in Perry, Ohio. Subsurface conditions were identified by performing Cone Penetration Tests (CPT) at two locations, designated C-001-0-23 and C-001-1-23, and a Standard Penetration Test (SPT) boring, designated B-001-0-23. The SPT boring was performed below the termination depth at C-001-0-23. The tests were performed through pre-cored holes, which were measured in the field to determine pavement material thicknesses.

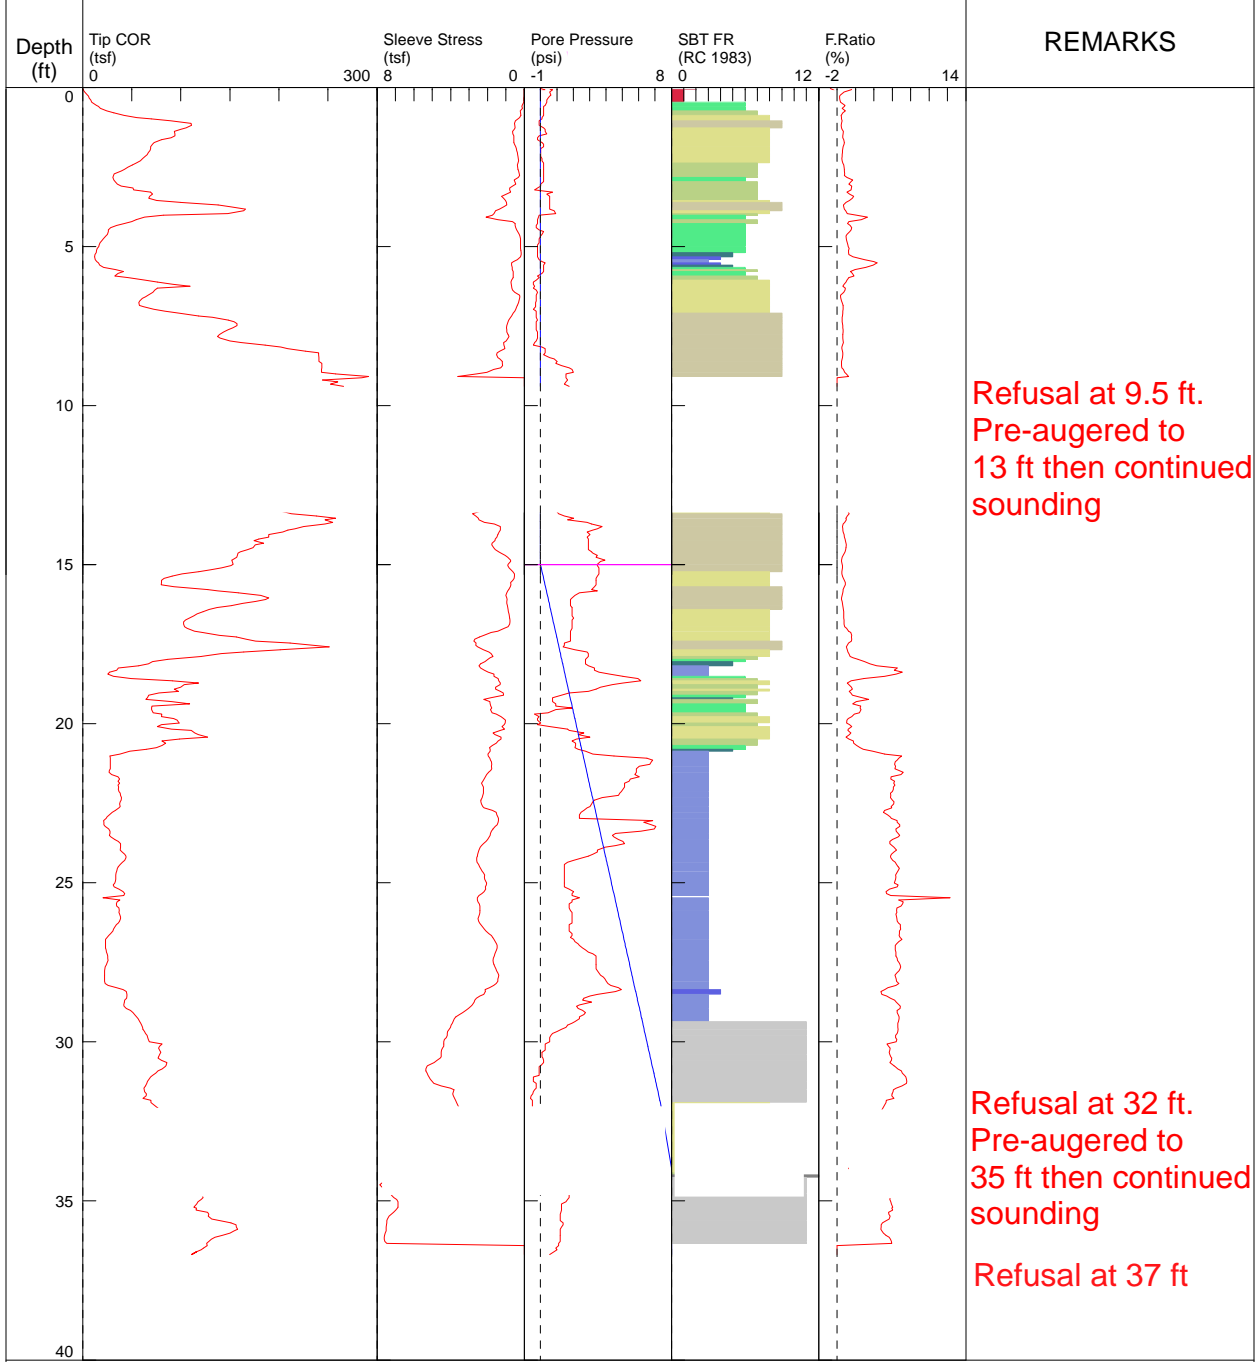
# SOUNDING

PROJECT: Lak-20-19.59 (PID 108665)  
 LOCATION: N Ridge Road, Perry, Ohio  
 TEST ID: C-001-0-23  
 CLIENT: ODOT  
 SITE: Elevation 653 ft

COMPANY: SME  
 OPERATOR: J Hall  
 PROBE ID: 4644.171XX  
 TEST DATE: Fri 14/Jul/2023  
 START TIME: 09:12:59

FINAL BASELINE: -90.19 (tsf)      FINAL BASELINE: -0.0050 (tsf)      FINAL BASELINE: 8.600 (psi)

The raw CPT data is available upon request. The CPT and SPT logs included as attachments to this report are for informational purposes only. The CPT logs have been corrected for inclination at depth and filtered for data spikes. Additionally, for each sounding, the measured values of  $q_c$  and  $f_s$  were shifted relative to one another with a cross correlation function.

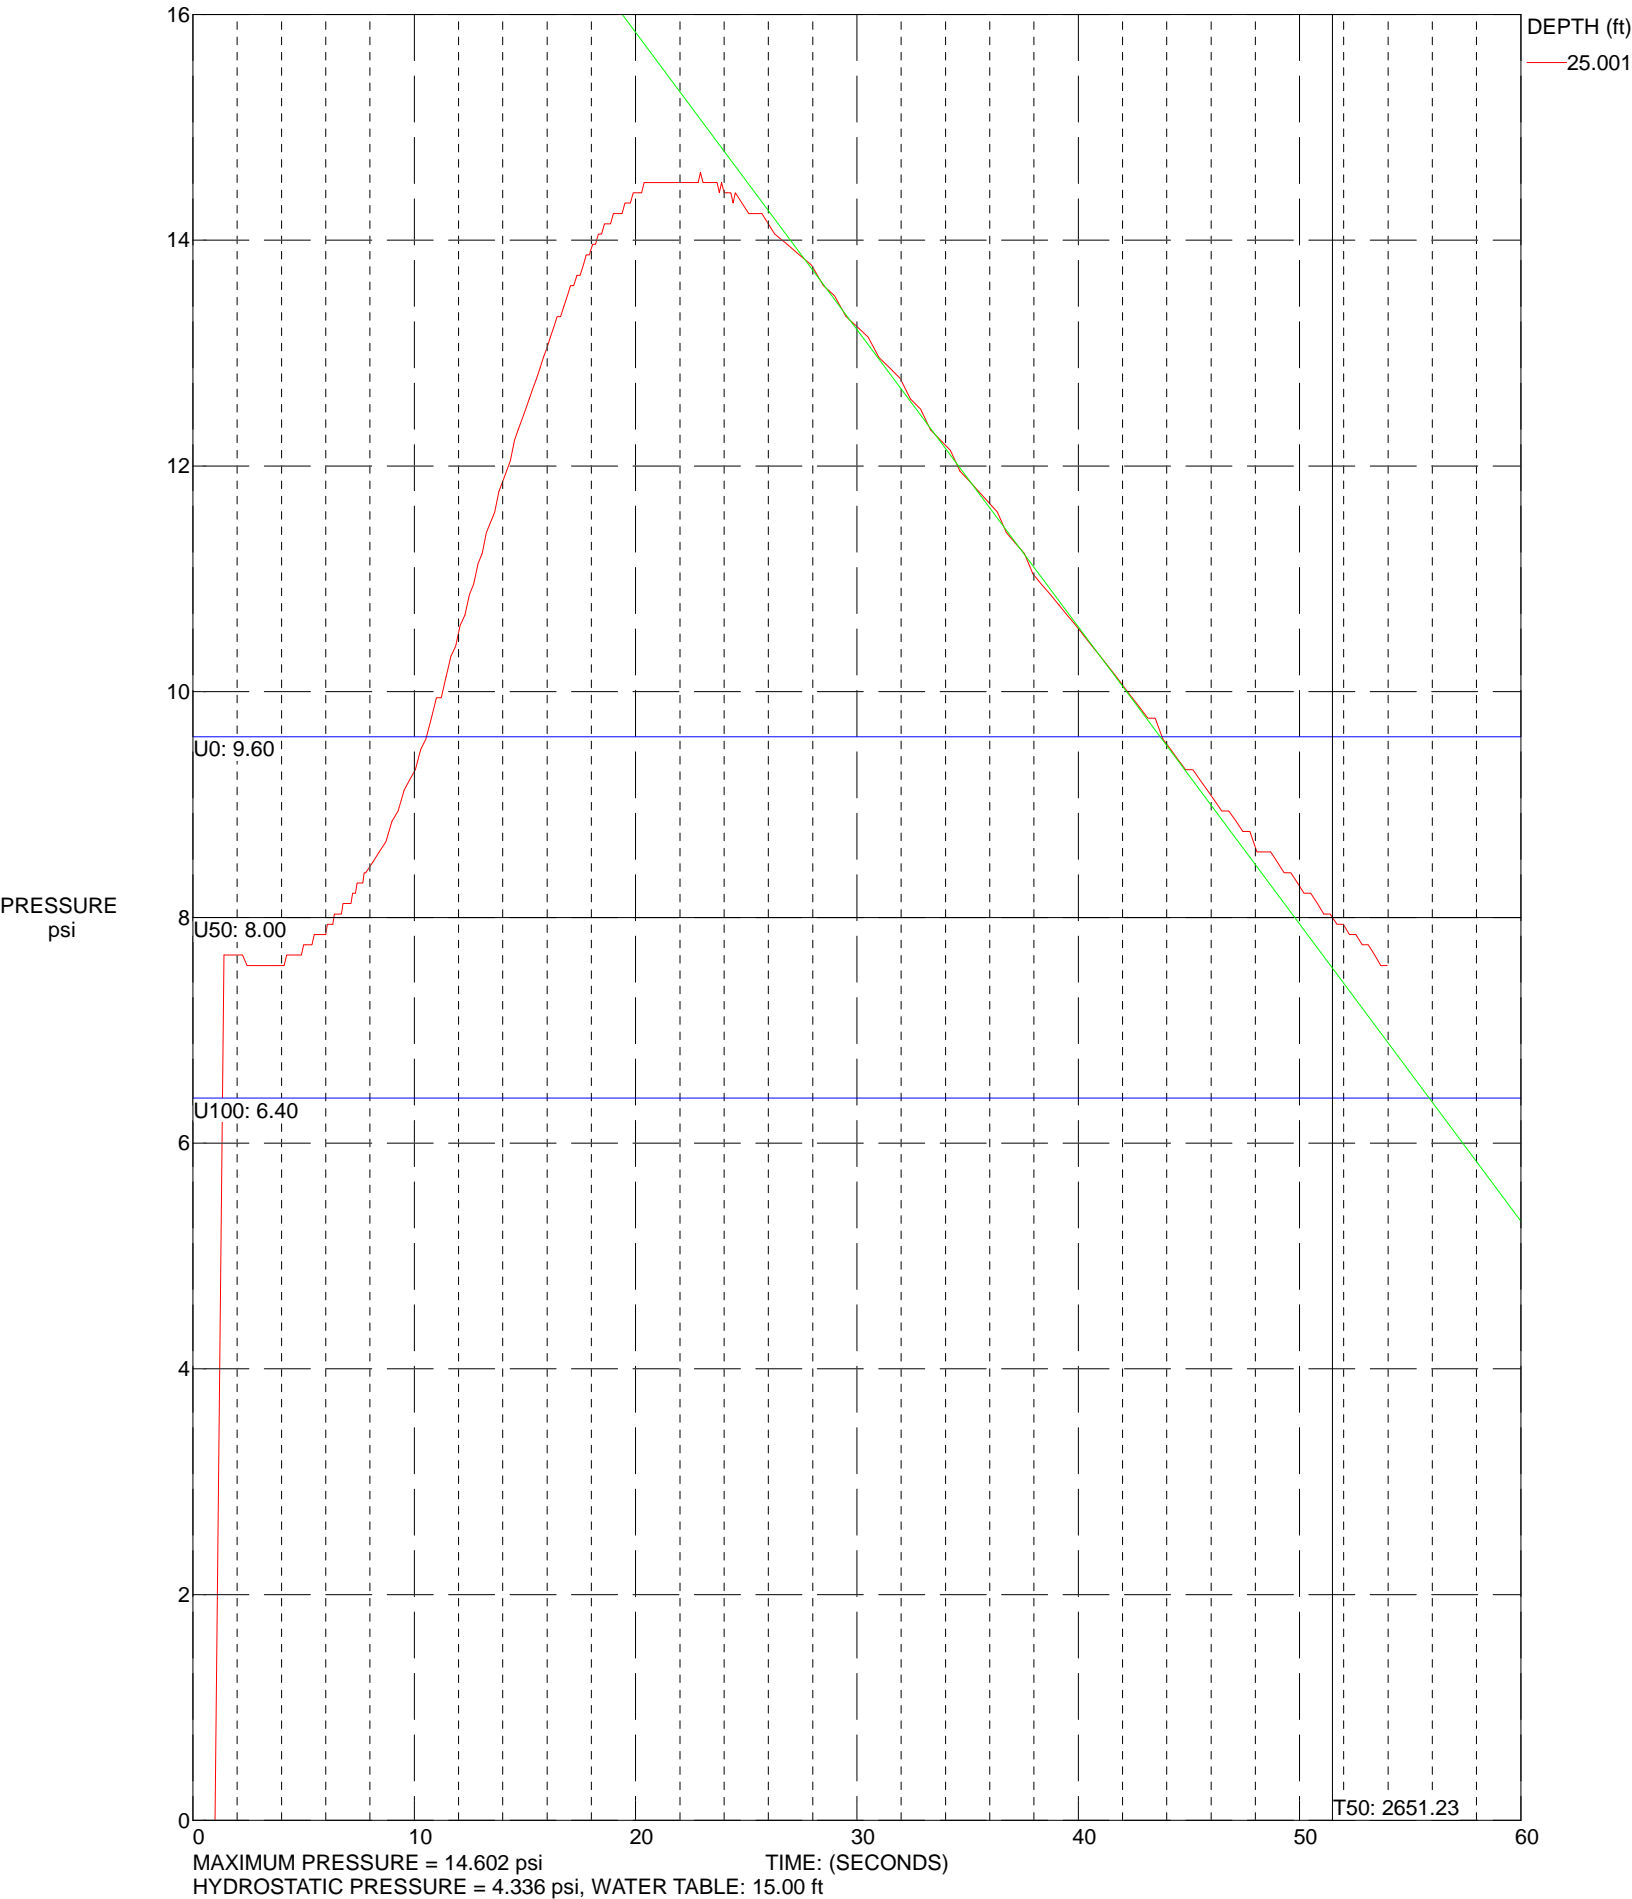
# DISSIPATION

PROJECT: Lak-20-19.59 (PID 108665)  
LOCATION: N Ridge Road, Perry, Ohio  
TEST ID: C-001-1-23  
CLIENT: ODOT

COMPANY: SME  
OPERATOR: J Hall  
COMMENT: Offset 5' E from C-001-0-23  
TEST DATE: Fri 14/Jul/2023  
START TIME: 13:18:11
