PRE-INSPECTION REPORT

BRIDGE NO HAM-50-1903L

WESTBOUND US 50 OVER CSX RAILROAD, CENTRAL
RAILROAD OF INDIANA AND MILL CREEK

**APPENDIX C – FATIGUE PRONE DETAILS FOR
HAM-50-1903L**

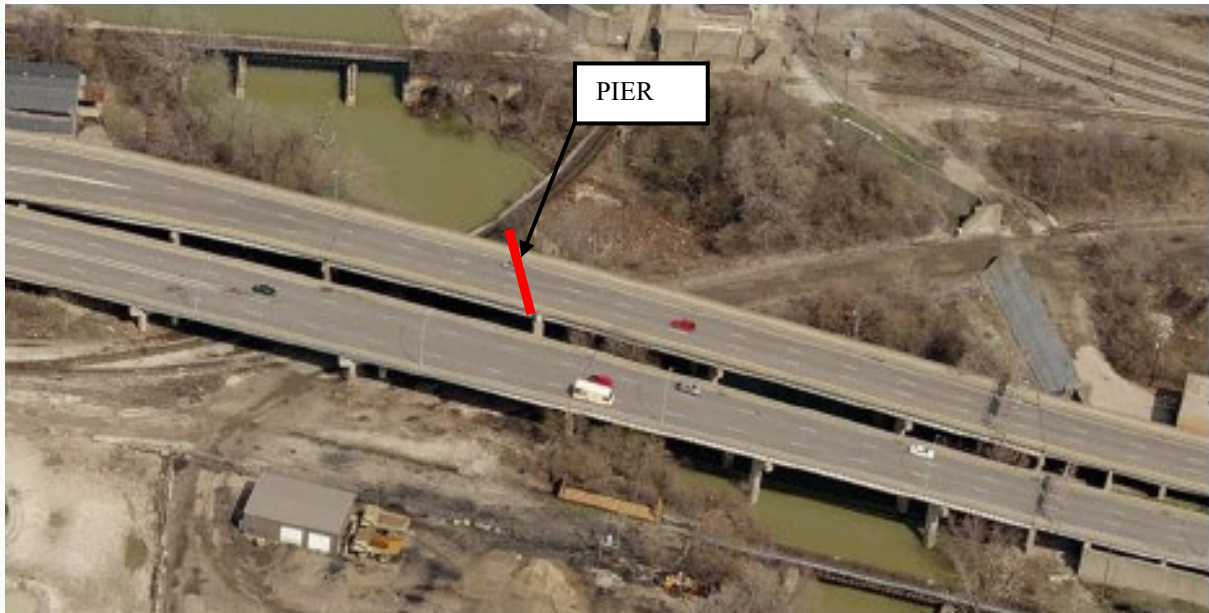
The HAM-50-1903L Bridge is a 14-span, welded steel plate girder structure with a reinforced concrete deck that carries westbound US 50 traffic over Mill Creek, CSX Transportation and the Indiana & Ohio Railways railroad tracks. The overall length of the bridge is 1,049.0'. The structure has one fracture critical pier cap located at Pier 5N. This cap spans over the Indiana & Ohio railroad track (*see below*). The cap is a welded steel box beam simply supported by two concrete columns. Six bridge girders frame into the pier cap. Pier Cap 5N is a 67'-5" simply supported welded steel box beam. A 24" diameter water line passes through the cap at mid-span. Fatigue prone details were retrofit in a previous rehabilitation (see Appendix C).

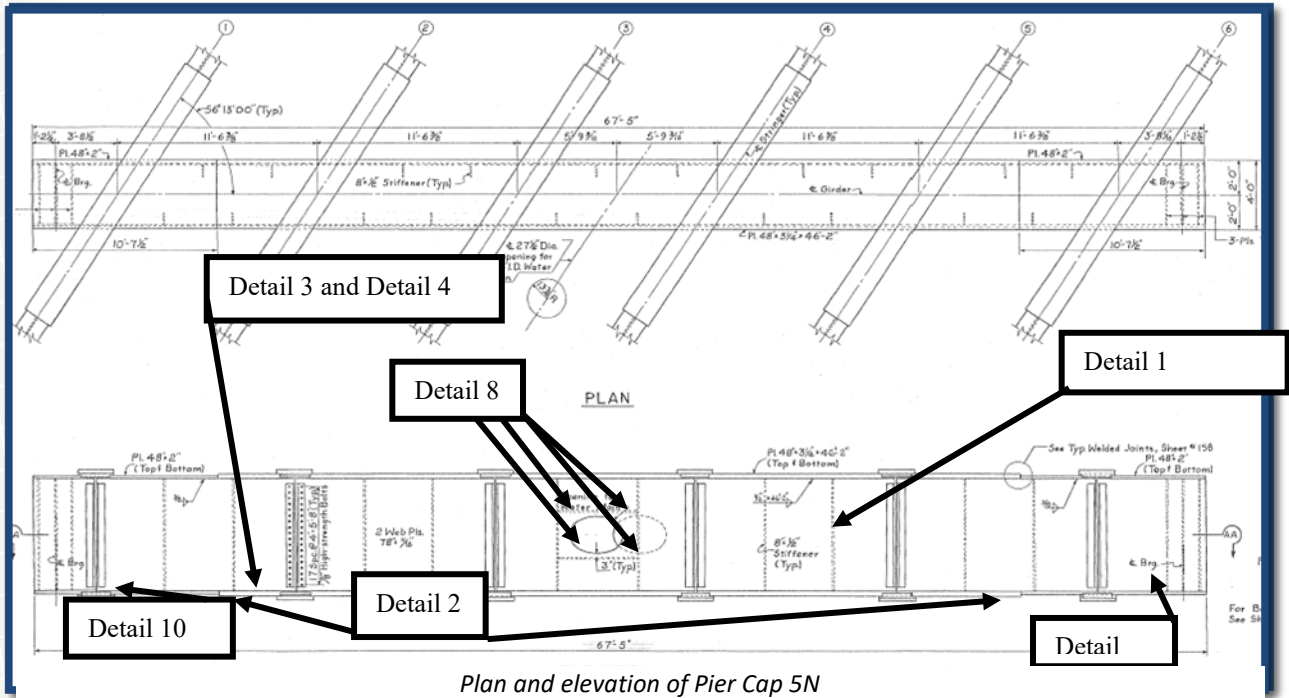
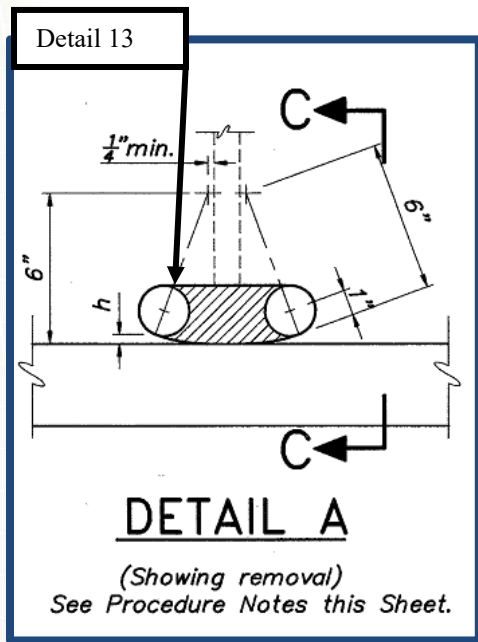
Weld intersection retrofit.

Category: C

Location: Bottom of web plates at all transverse stiffeners.
